Structural Appraisal carried out on 12th March 2014

**Cowley Brook Farm
Higher Road/Stoneygate Lane
Longridge
Preston
PR3 2YX**

**For the Proposed Conversion of Derelict House to form 2No.
Holiday Lets**

Project Ref: BUTC/01

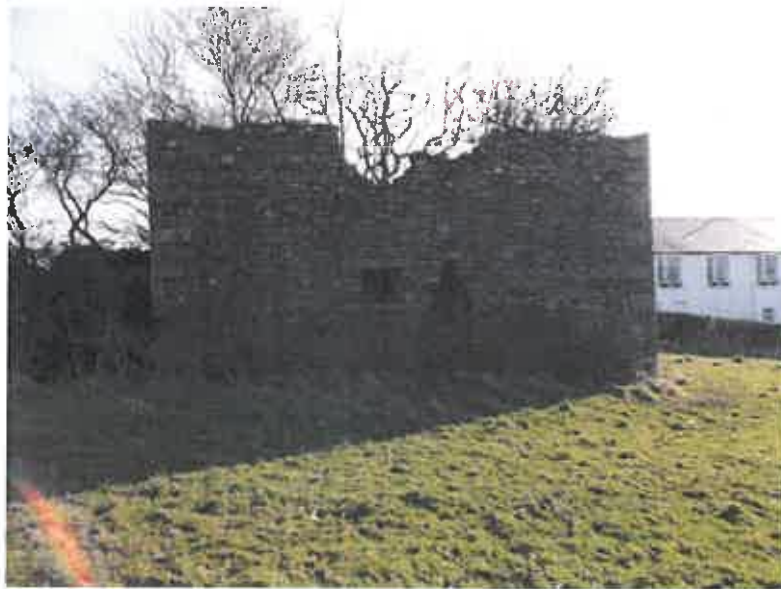
The building is currently vacant; but there is clear evidence of vegetation type overgrowth throughout the building, which may have been aided because there is no roof on the building.
