320140803P

RIBBLE VALLEY  
BOROUGH COUNCIL

# **1. GUIDELINES FOR THE PREPARATION OF THE CONVERSION ASSESSMENT AND METHOD STATEMENT**

OXFORD FARM

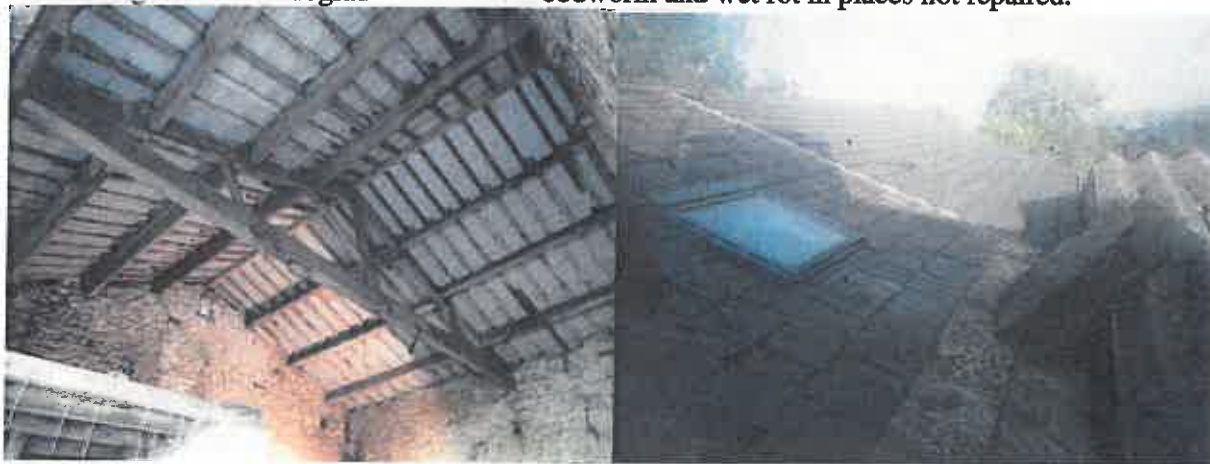
Barn roof is a traditional dual pitched roof with a mixture of concrete tile, slate and stone tile set on battens, rafters and purlins supported on kingpost truss. The roof has recently had repairs with replacement purlins, rafters and battons and addition of felt/sarkin. The timber is all of softwood and is suffering from some degradation due to woodworm and wet rot in places not repaired.

House section slate barn concrete tile

The concrete tile and slates to be removed and discarded. The Stone tiles to be removed and saved for reuse although only small in quantity. Battens, rafters, purlins and kingpost truss to be carefully removed and stored for assessment and reuse. Roof window to be removed and discarded.

Roof to be reinstated on raised walls using original materials where appropriate. Constructing a insulated warm roof with felt/sarking. New larger roof window to be installed to rear and new large roof window on west elevation. Roof recovered with Sandstone roofing tiles in period with the character of the barn.

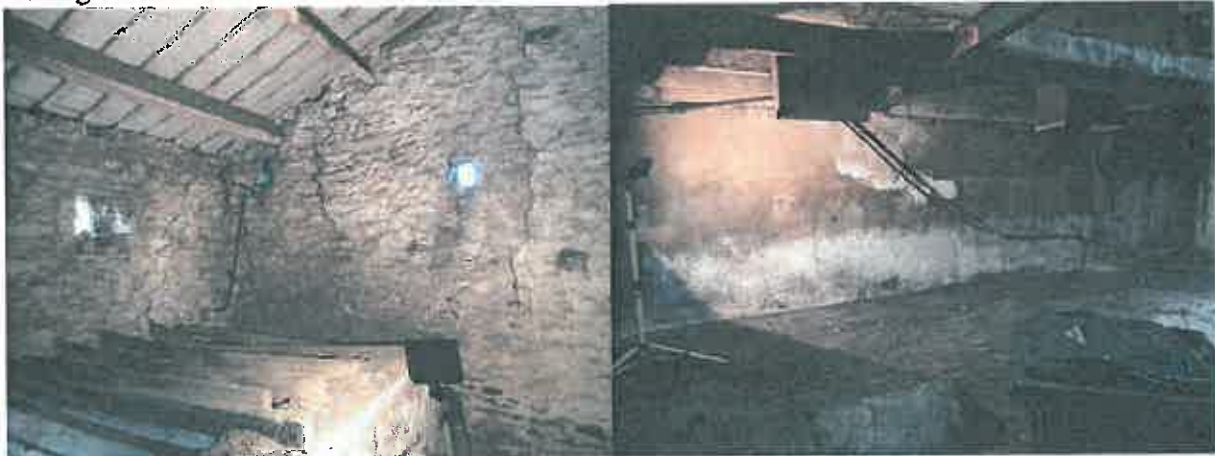
North elevation (gable end) has several cracks in the wall showing signs of movement particularly more relevant to the West side (road side) see photos. There are several small opening higher up on the wall as vents and some larger blocked up openings lower down. The wall is out of plumb and leaning outwards.

North barn wall showing cracks N/W corner

Barn gable from Milking parlour cement rendered

North gable wall: requires rebuild where it intersects to west wall (approx 3m in) and underpinning to stabilise movement. Four small openings at lower side to be reinstate allowing light through from milking parlour. Profile of wall to be lifted by 900mm to increase roof height by same in matching stone. Small opening at top of gable to be altered into a circular window approx 600mm diameter in traditional style with sandstone surround key stones. Cement render to be cleaned from wall. Mortar work to be raked out and repointed

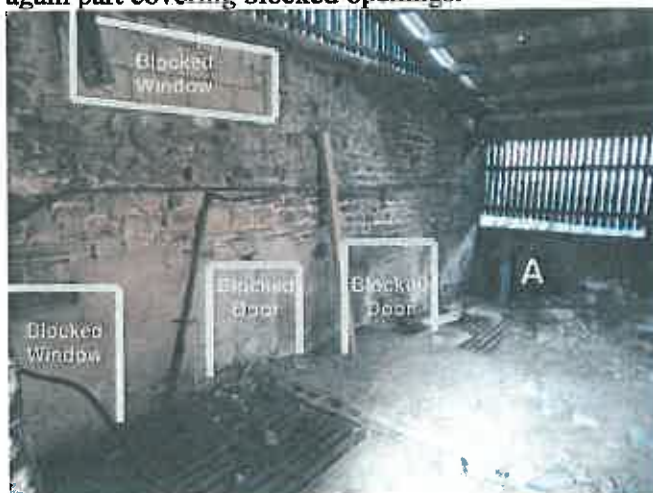
West Elevation Wall

Section left of post is house section.

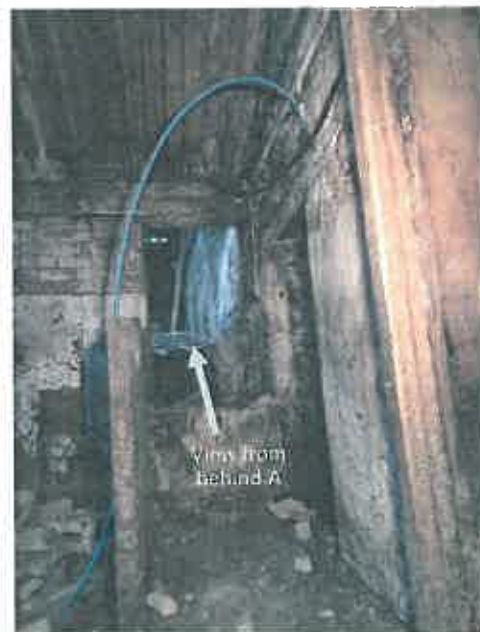
East Elevation (rear) there are several openings in this elevation windows and doorways that have been block off in a mixture of concrete block, brick and stone with sections of the wall inside and out rendered in cement. The ground level to the rear of the wall has been raised by approx 3 foot which part covers blocked openings. The internal floor was originally split level and has been filled in again part covering blocked openings.

This shows the difference in floor levels.

East wall: current floor level to rear to be lowered matching floor level in barn by removal of slurry channel/structure . Blocked out openings to be opened back out again and doors and windows installed. Cement render to be cleaned from stone. Wall profile to be lifted 900mm to increase roof height by same in matching stone. New opening for window at North end for upstairs bedroom and doorway to balcony partly accommodated in the 900mm lift. Current blocked opening to upstairs to be reinstated and enlarged with 900mm lift. Mortar work to be raked out and repointed

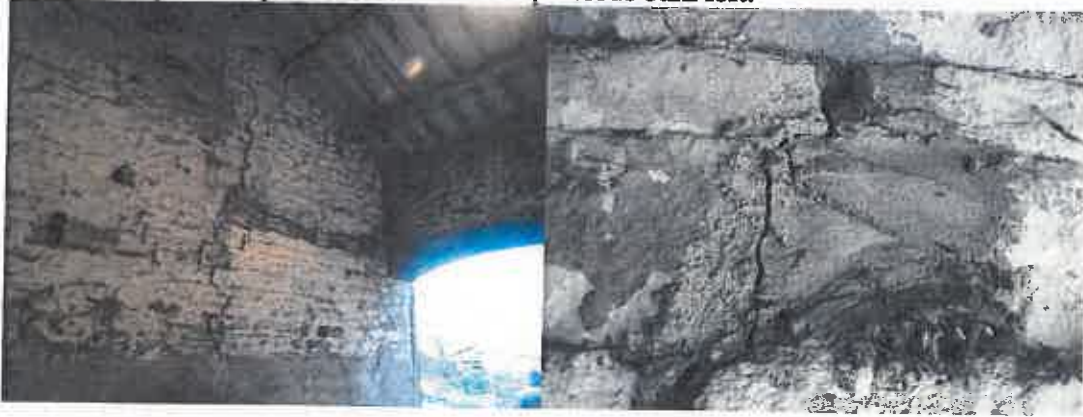
**South elevation (Inner gable)** Part sections covered in cement render, a pedestrian doorway that is blocked up. Several large cracks running up to 2/3 of the wall height, particularly more relevant to the west side (roadside). One section of the crack has recently been patched in cement which has subsequently cracked apart evident there is still movement, see photo. There is a section of support stones with pockets, possible evidence of a previous barn loft.

South inner gable: cement render to be cleaned. Blocked door opening to be reinstated to utility area. Wall profile lifted 900mm to increase roof height in matching stone. Underpinning on assessment to west part next to road approx 3m in and crack stitching to stabilise cracks. Mortar work to be raked out and repointed. New door opening created for first floor access through from upper landing.

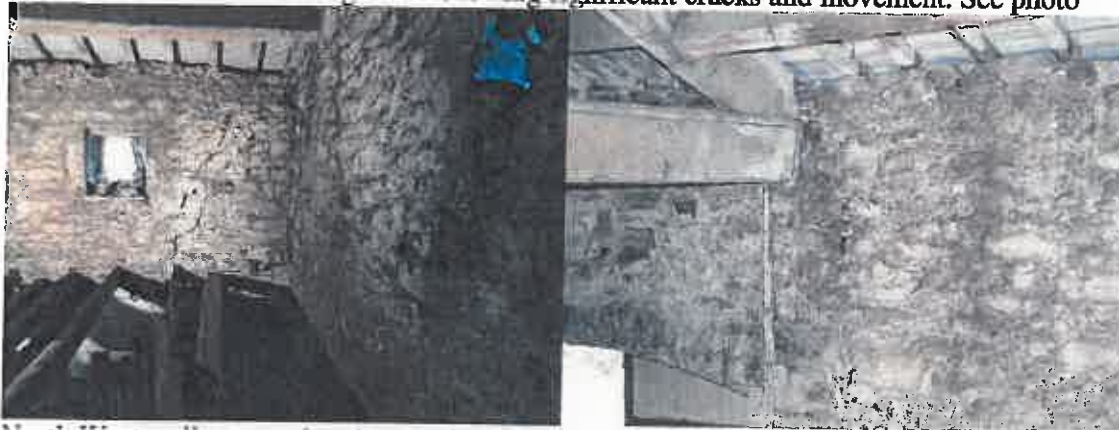
**West Elevation (roadside)** with barn door entrance pedestrian doorway to house and several window openings some blocked up. Wall is out of plumb leaning towards the road. The North part of the wall where it intersects with the gable is showing significant cracks and movement. See photo

**North West wall corner showing cracks**

**West wall mid section cracks next to kingpost**

West wall (road side): To be rebuilt on concrete foundations to stabilize movement, wall profile lifted 900mm to lift roof height in matching stone. Blocked out openings to be reinstated and concrete cills/mullions replaced in sandstone. Mortar work to be raked out and repointed. Sliding Barn door to be removed and large window sited in opening. Window to bedroom to be enlarged with wall lift.

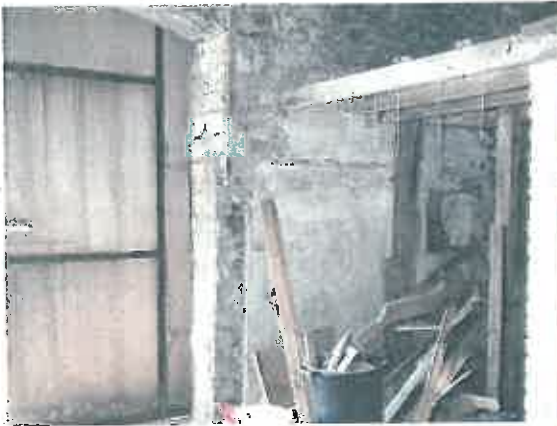
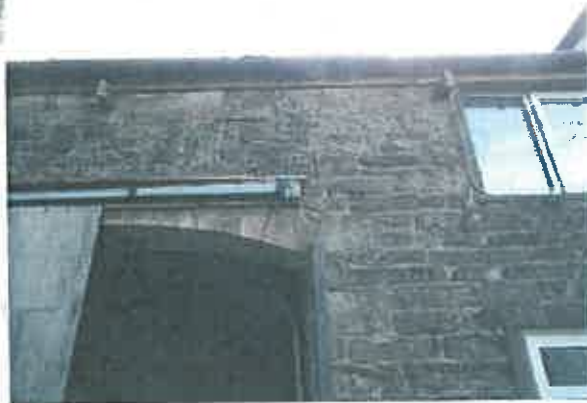
West wall showing part remove door support    West wall showing movement to stones above door

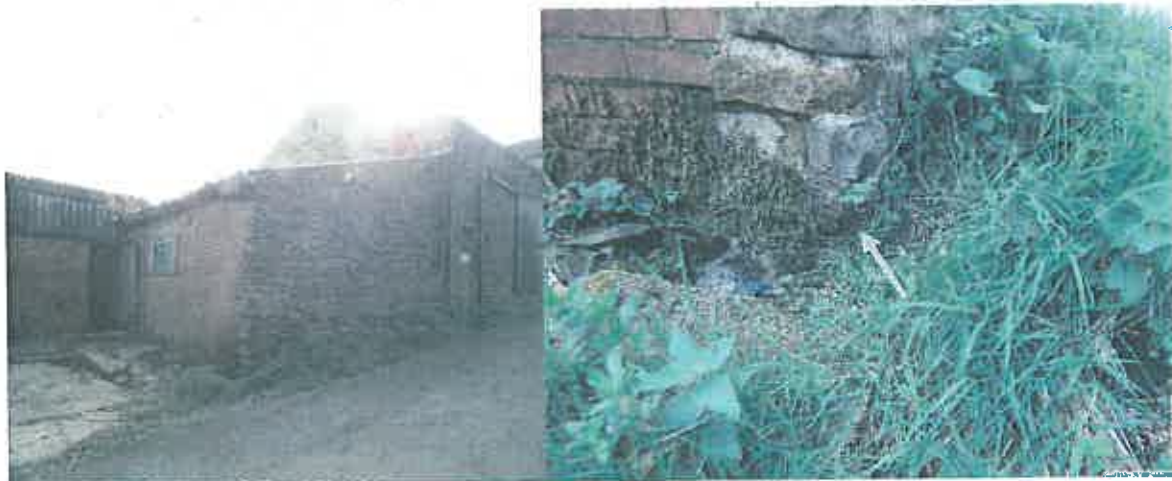
West wall (road side) constructed in rubble sandstone with evidence the wall was extended at some point. Wall is out of plumb with significant bulging and does not appear to have good footing at junction with south wall. See photo.

Milking parlour looking at north and west walls, Corner of wall has no under support.

North wall. Demolish and rebuild in matching sandstone 900mm higher to lift roof. Include losing door opening and enlargement of two windows.

West wall: Rebuild lifting 900mm higher.

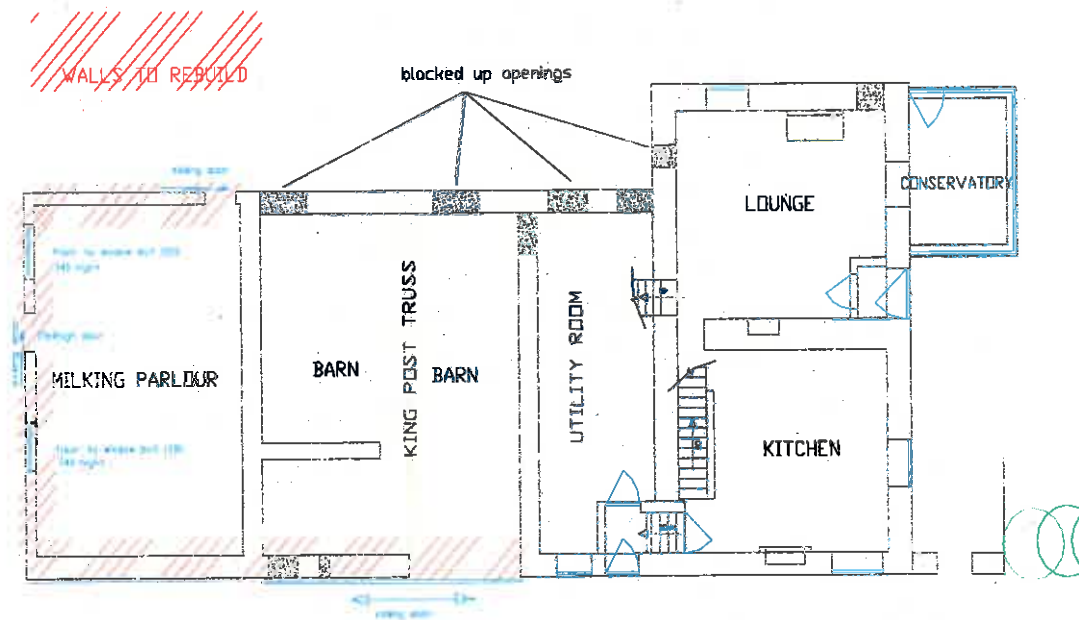
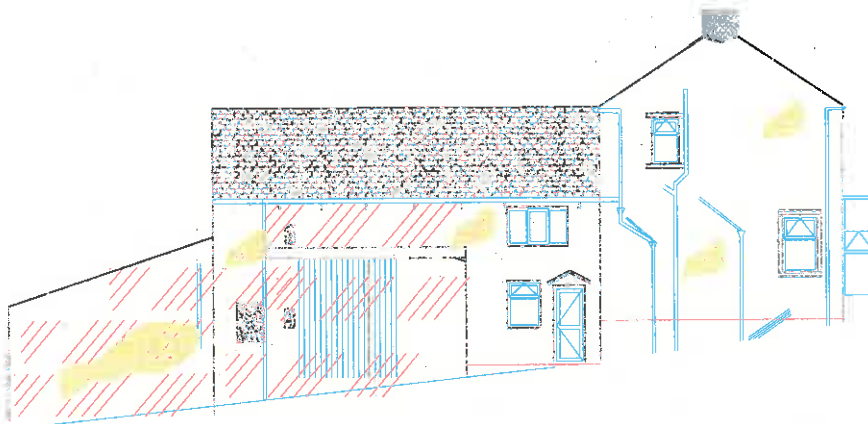
Walls for demolition and rebuild shown on plan and elevation hatched red.
