FAR LATHE BARN

HILL HOUSE FARM

GRINDLETON

PHOTOGRAPH SURVEY

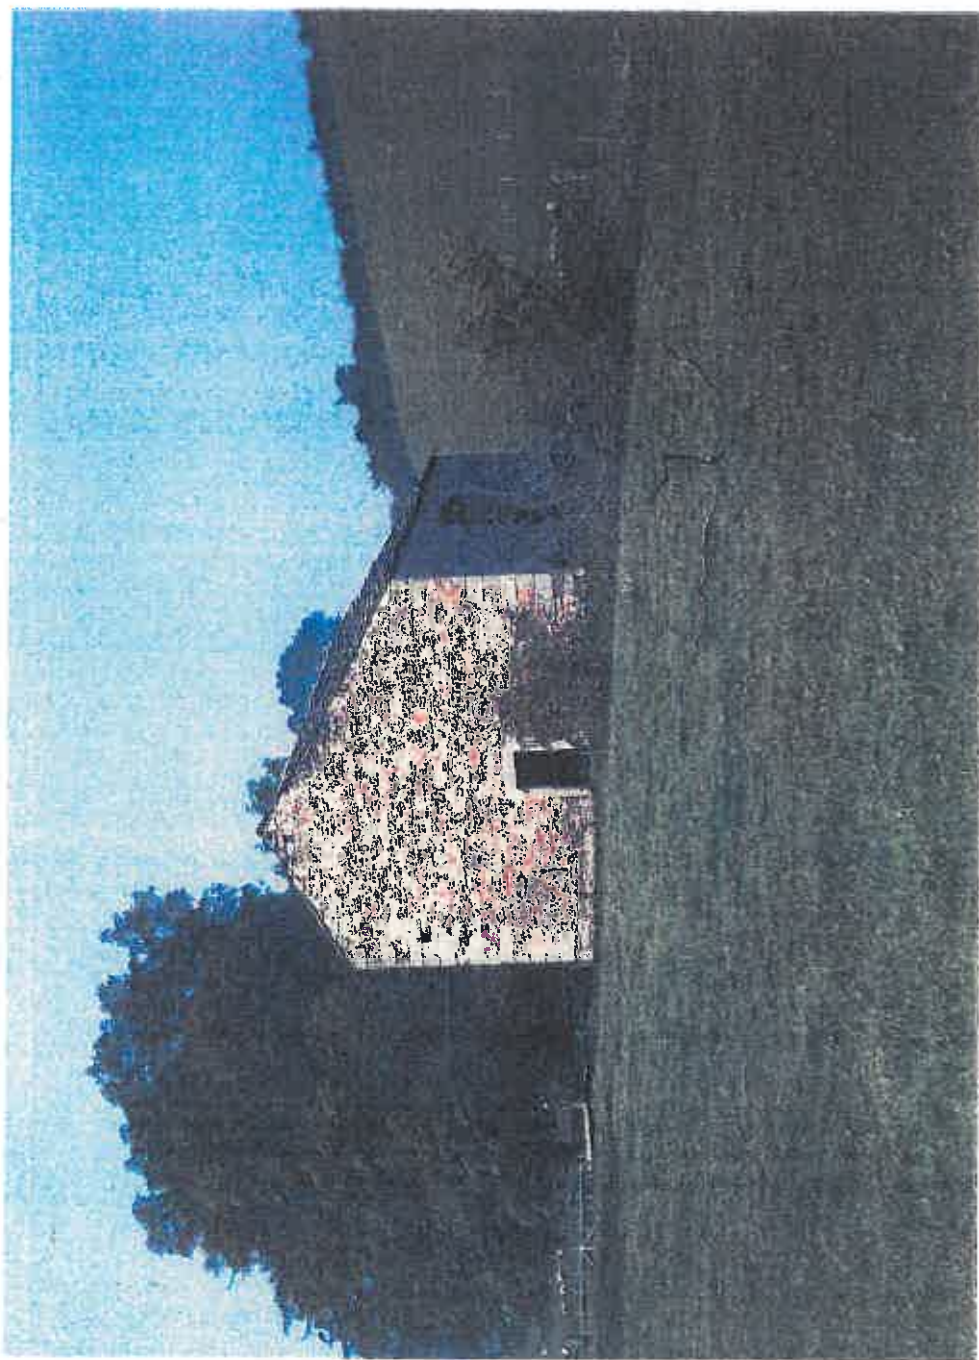
- P1 South – east view from a distance illustrating the undulating landscape
- P2 North – west view illustrating the robust sandstone quoins high window without cill and deterioration of roof on south west verge

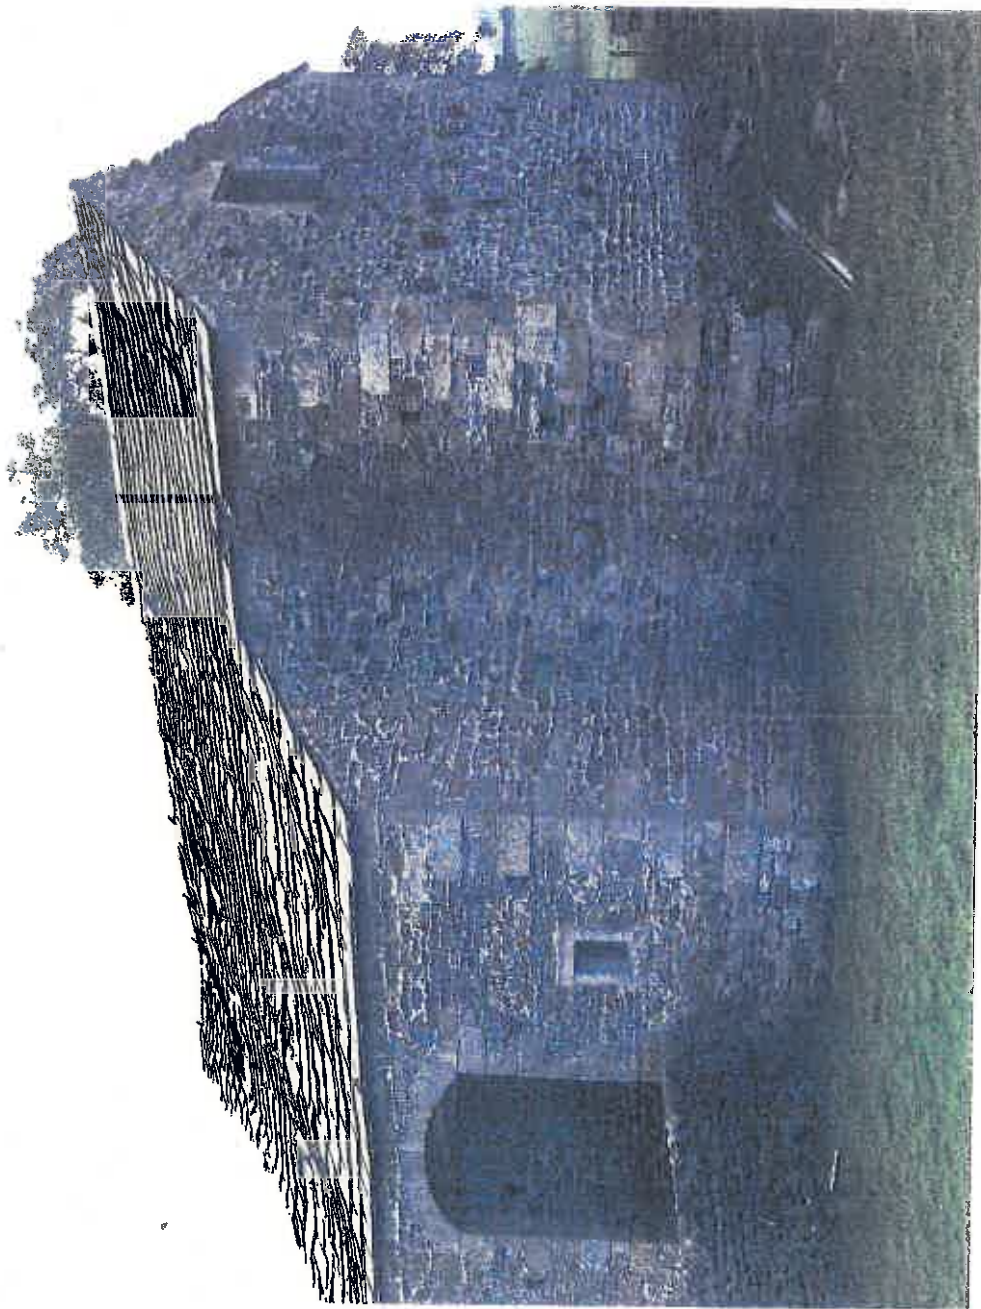
- P3 View from the north illustrating varying ground levels and stone wall separating the paddock from the open fields.
- P4 South – west elevation showing close up quality of sandstone quoins and elevation location of proposed roof
The floor cill shows the margin line defining two separate construction operations

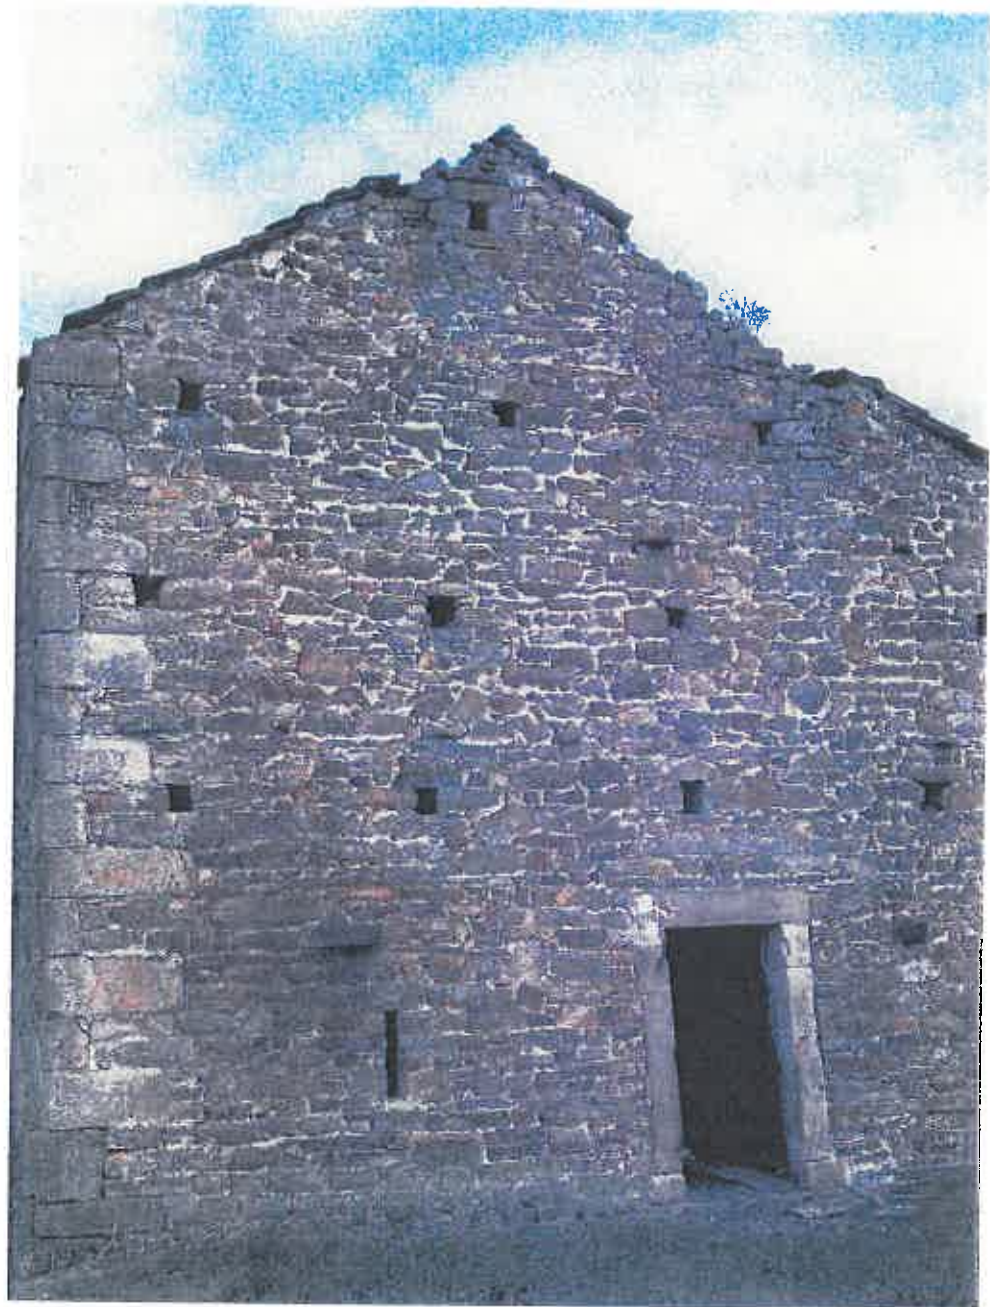
P 5

- P5 South – east gable elevation show breather putlog holes with slightly larger owl hole off centre of ridge line
- P6 North east view showing definitive base margin line of two separate construction methods

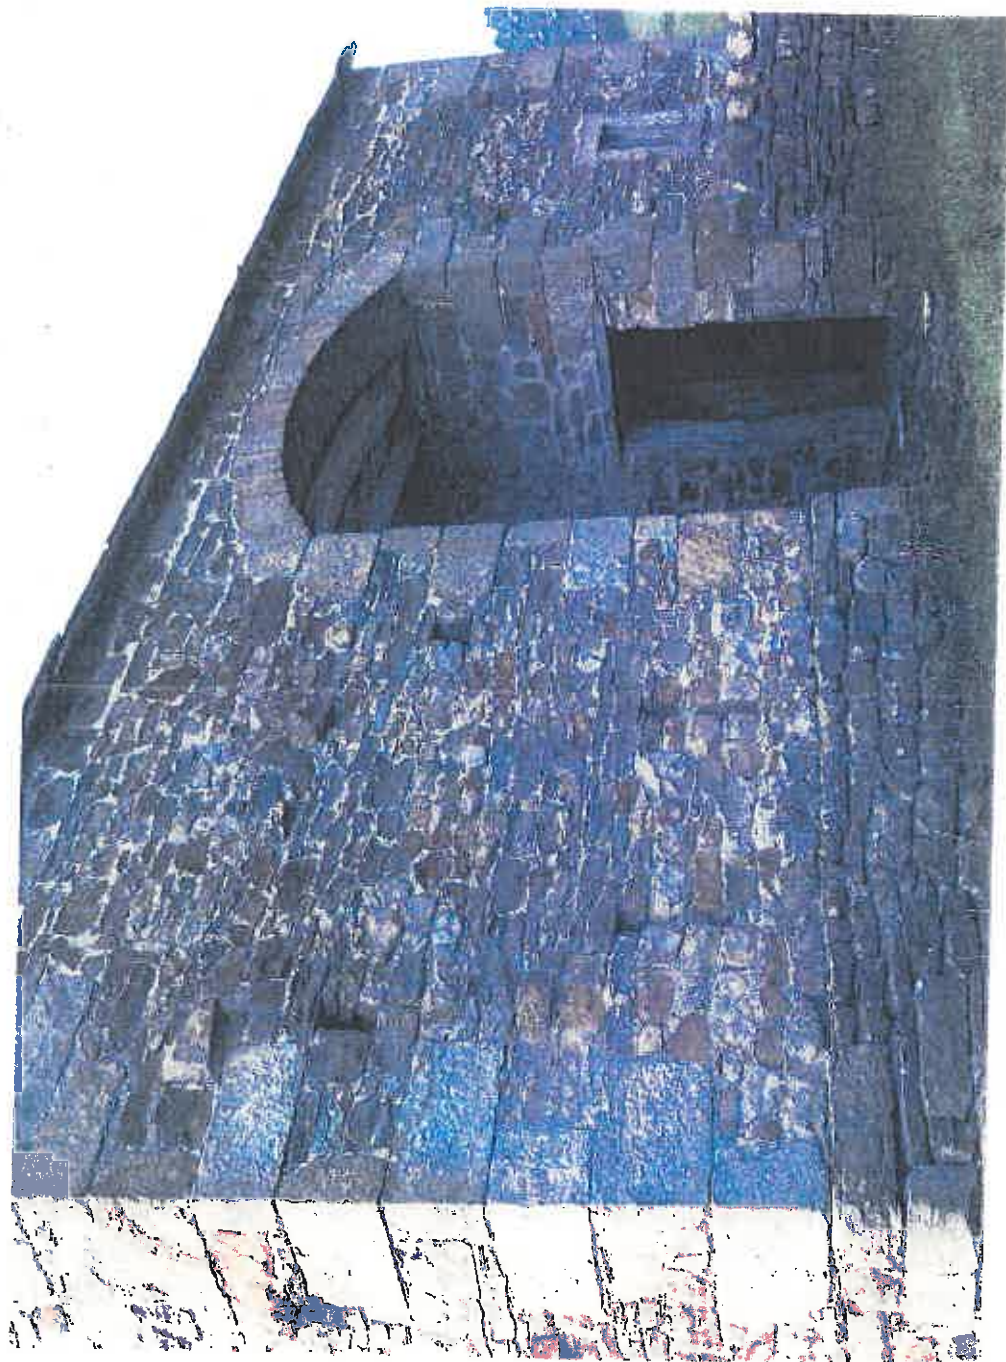
- Good quality quoins , and handsome stone arch to the wagon door
- Door to right hand side of wagon door without original sandstone Surrounds
- P7 Typical example of the Kingpost trusses with purlins and rafters all rift sawn

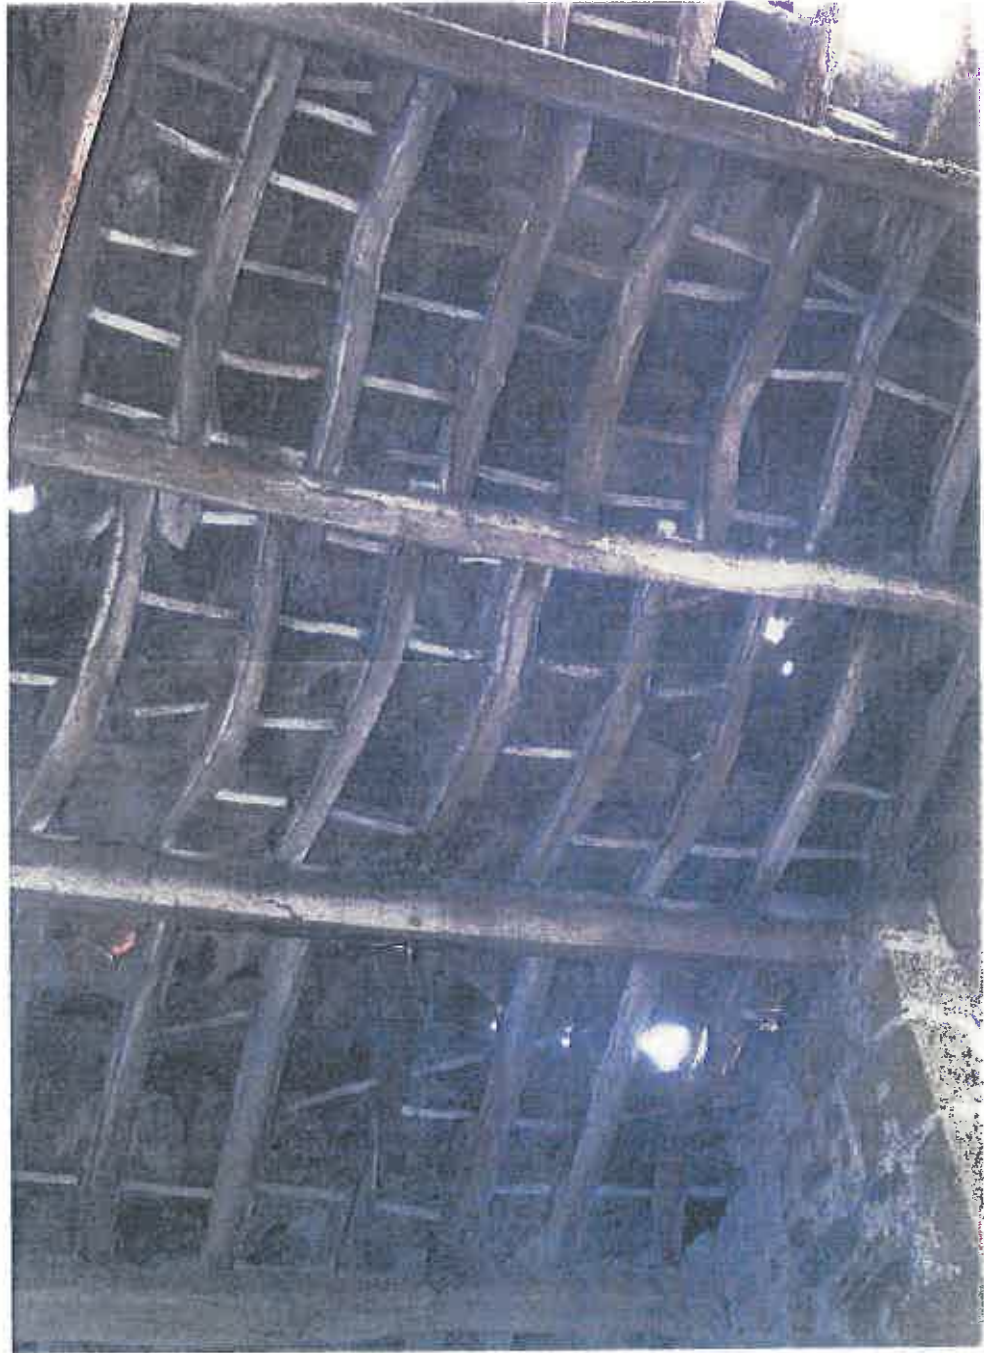
- P8 View of purlin section with rift sawn rafters over lapping the purlins
- P9 North – east view of the barn showing stone wall with gate forming the paddock to the right.
