PROPOSED
CONVERSION OF FAR LATHE BARN
AT
HILL HOUSE FARM
GRINDLETON

STRUCTURAL APPRAISAL

S.J. BIALECKI LIMITED

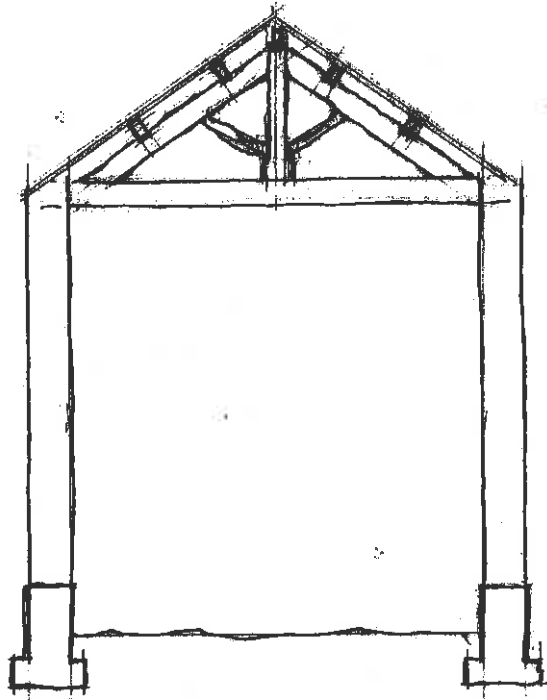
SKETCH 001

The structure (barn) which was originally constructed in two stages, because of the sloping nature of the land.

First stage construction comprising sub-structure and lower perimeter walls in a solid form to a level plane in preparation for principle super structure providing a "Setting Out" base

The level plane height 150mm above ground level to the north west gable and 750mm above ground level to the south east gable with a 650, average thickness.
