STRUCTURAL APPRAISAL

**OF
BARN
AT**

**STARTIFANTS FARM
LONGRIDGE ROAD
CHIPPING**

Project No.: 2014-203
Date: September 2014

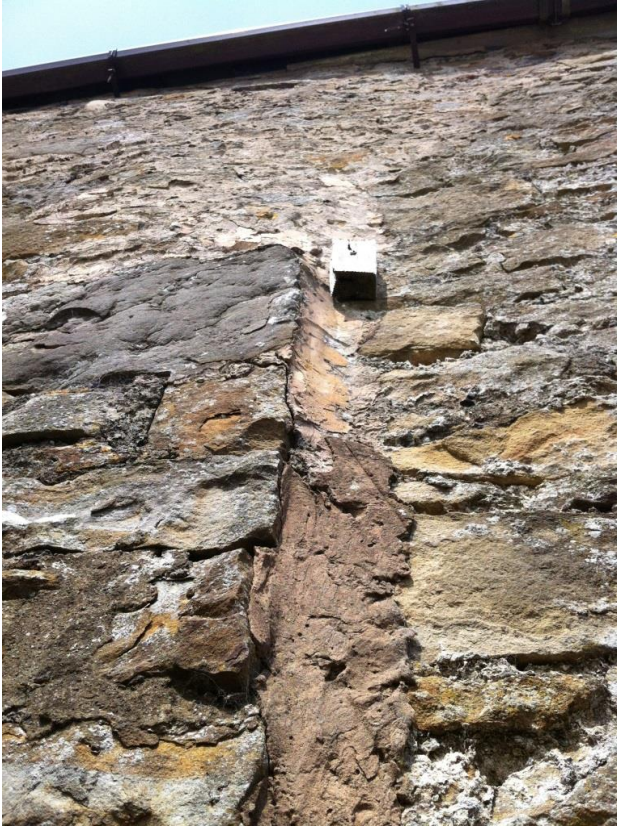
- 2.2.2 The barn is constructed of random rubble stonework, which although now weathered would originally have been flush pointed. The masonry to the west of the large barn door opening to the front elevation is very poor, having been badly weathered to the point of voids having developed across the stonework. An outward lean of this panel of masonry can also be detected, although being at its worst at high level, it is difficult to quantify accurately. It was estimated to be a maximum movement of 35mm in 1m, with the outward movement commencing at ground level. The barn door opening has been formed by a very shallow arch of stone voissours, which have a timber lintel below. The low level masonry to the eastern side of the barn door is in much better condition, although between the barn door and the pedestrian door at the eastern end of the elevation, evidence remains of what appears to be an old extension to the barn, with a visible step between the two panels of masonry of up to 50mm (see photograph 1). The quoins to what would have been the earlier barn to the west remain in place to approximately 2.5m above ground level, but the stonework above this level is continuous, with no quoins between. The high level masonry is again weathered, and that at eaves level bulges outwards.

Photo 1: Step in front elevation masonry

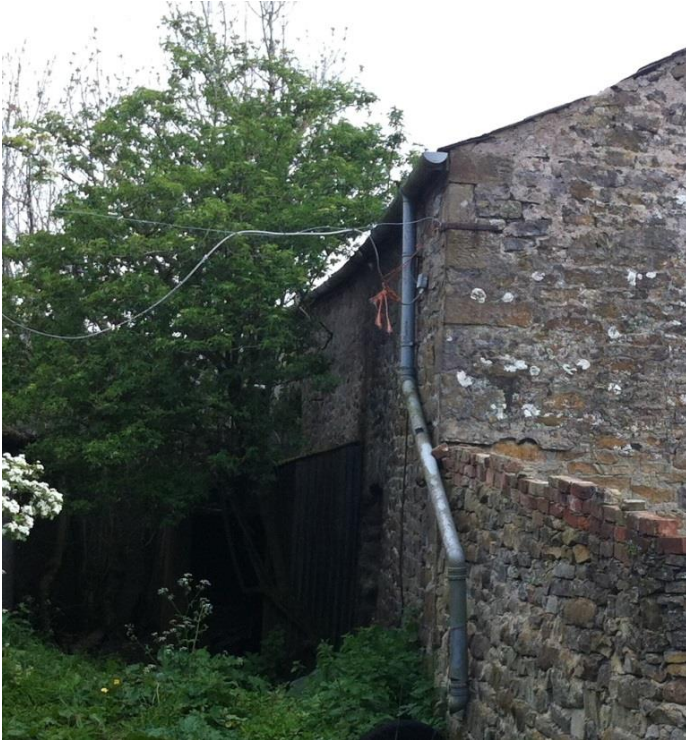
- 2.2.4 The eastern aspect of the rear elevation is difficult to assess in close detail as there is a dilapidated lean to and numerous semi-mature trees in close proximity to the wall. The centre of the rear elevation has noticeably distorted, with the upper part particularly having a significant inward lean (see photograph 2). Again, it was not possible to measure the movement accurately, but the masonry is estimated to be as much as 300mm out of line at the eaves. Although the joints have not deteriorated with the movement, the panel is generally weathered. The pedestrian door opening at ground floor level is formed by stone voissours which are free from any movement. There are localized and isolated voids around the quoin stones at the corner with the western gable, but there is no associated movement between the voids.

Photo 2: Inward lean to the rear elevation

- 3.19 As a final note, we would recommend in the short term that the saplings adjacent to the rear elevation are removed.

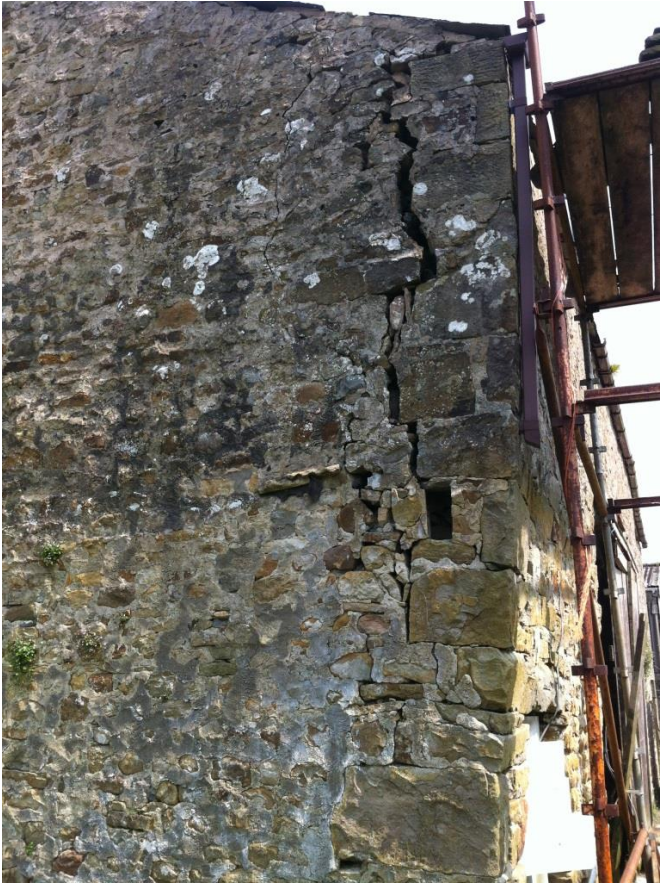
- 2.2.5 The western gable has no openings across the elevation and despite it being one of the more exposed aspects, the flush pointed masonry remains in reasonable condition. The gable is dominated by a crack close to the south elevation which extends from approximately 1.5m above ground level up the eaves, and is estimated to be, at its most severe, 75mm in magnitude (see photograph 3). The movement has occurred between the quoins and the remaining gable stonework, and even extends over the uppermost quoin suggesting that the movement is entirely limited to the front elevation. Pockets were noted in the stonework at approximately 2m above ground level, where timbers were previously seated to form a lean-to adjacent to the barn. Again, no fascia boards are present along the roof line, and the stonework below the missing slates to the front elevation is particularly uneven.

Photo 3: Movement to front elevation as observed from west gable.
