**UPDATED STRUCTURAL CONVERSION ASSESSMENT**  
**LITTLE DUDLANDS FARM, RIMINGTON LANE, RIMINGTON, BB7 4EA**

### **STRUCTURAL CONVERSION ASSESMENT AND METHOD STATEMENT LITTLE DUDLANDS FARM RIMINGTON LANE, RIMINGTON, BB7 4EA**

A structural inspection of the above property was carried out on 10 December, 2013, to examine and report on the current state and safety of an existing barn for conversion purposes.

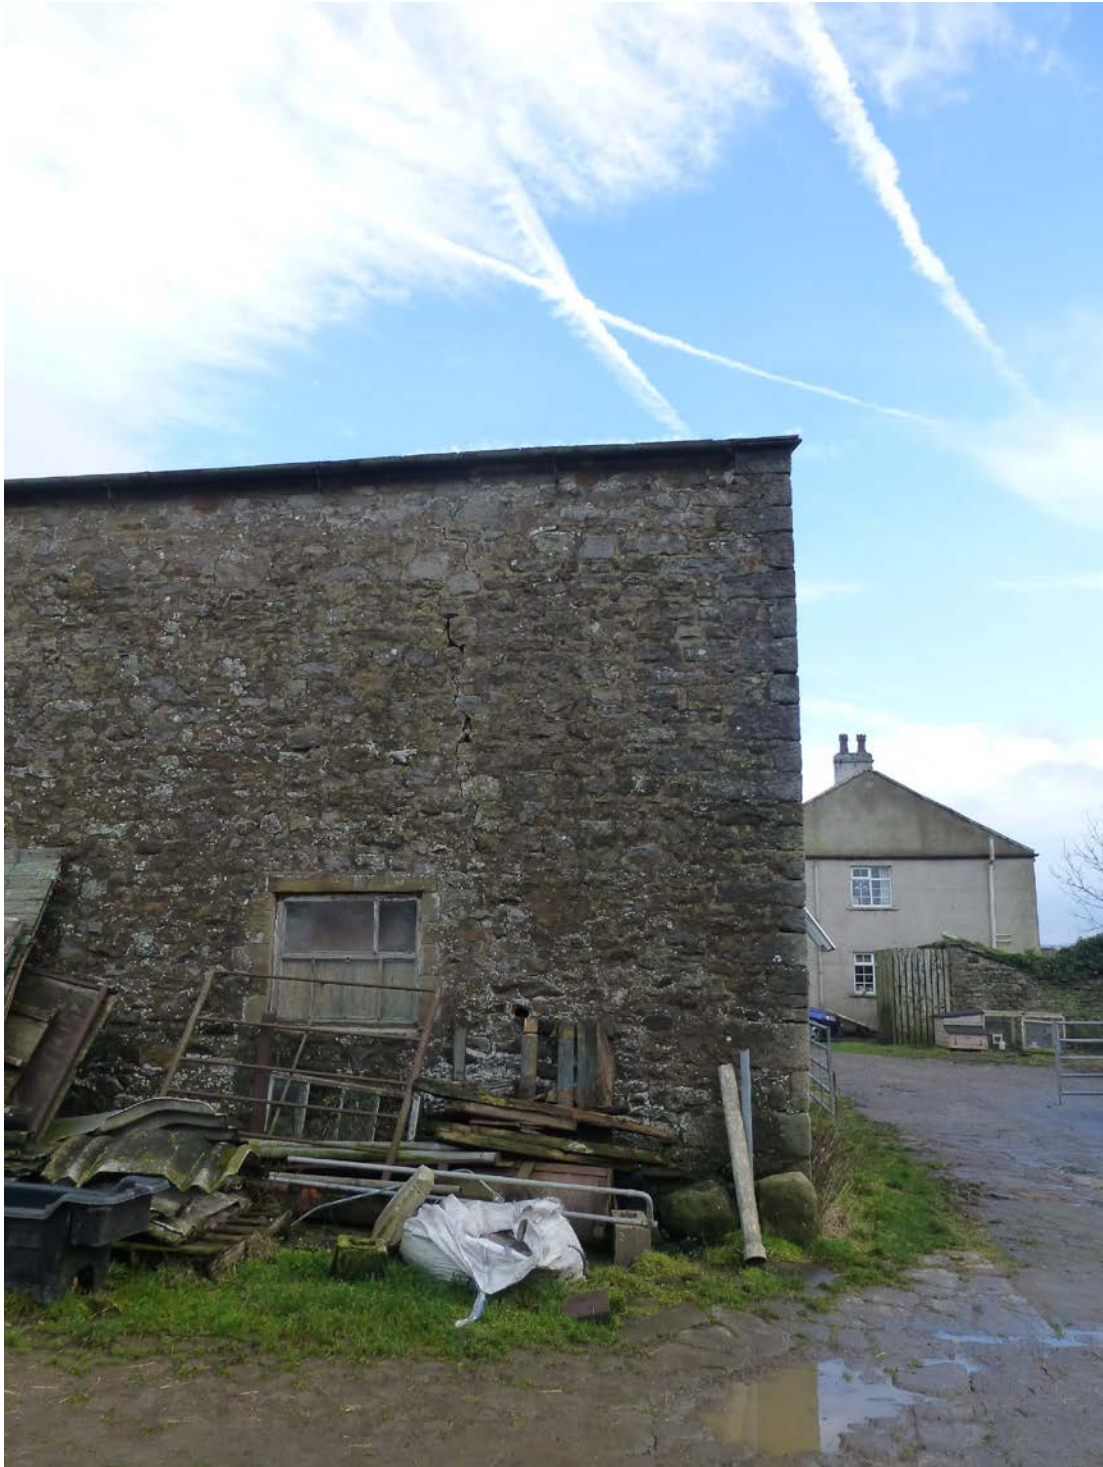
Photograph No. 9

The external wall shown on the plans as position 9 is reasonably plumb and in good condition showing no real signs of excessive movement or large cracking, except to one position near the corner. All the pointing however is in poor condition.

All areas require the existing pointing to be removed and replaced. Any loose stonework must also be replaced as necessary once the pointing has been removed with stone work to match; this should be carried out both externally and internally

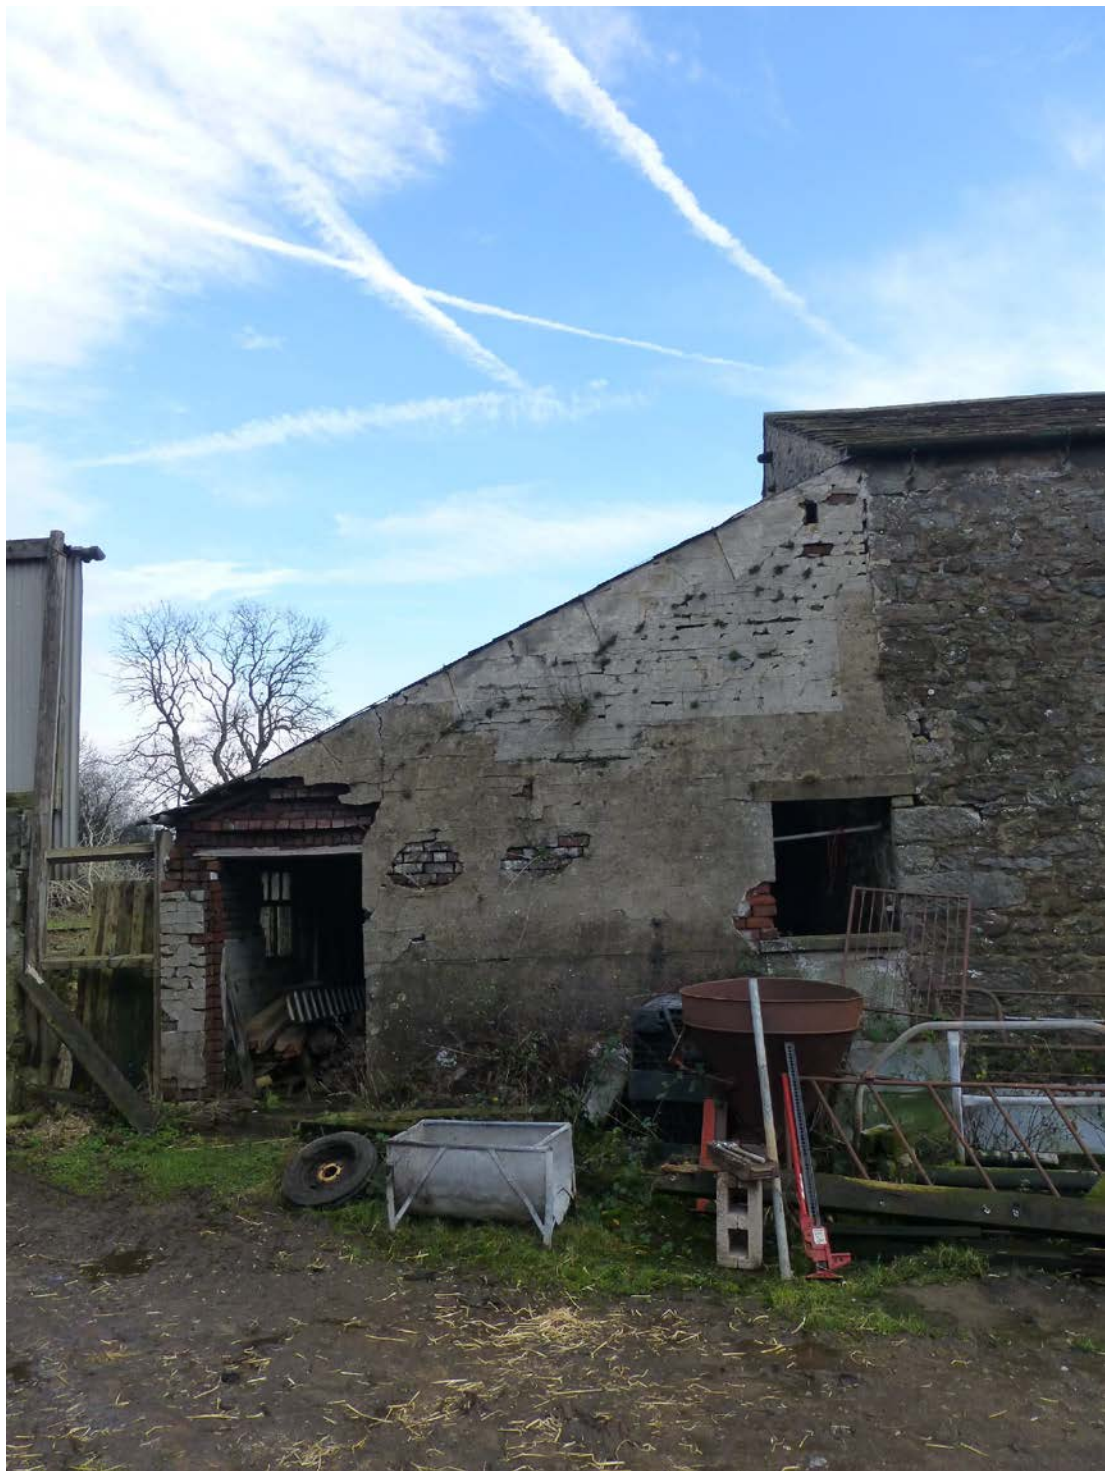
Photograph No. 10

The external wall construction that can be seen within photograph number 10 is in a poor state of condition and is only a red brick built lean too that was not built at the same time as the main barns.

The main barn wall (red brick section) as shown as position number 10 needs to be totally re-built off a new concrete strip footing. The wall construction will consist of an outer leaf of random stone with a 100mm thick concrete back blocking. This will be tied to an internal leaf of 140mm thick concrete block with ties as per the Architects details as supplied at the time of any Building Regulation application.

The size of the foundation required will be determined at the design stage.

The above wall should only be removed once adequate support has been provided to the existing roof and floor construction. The contractor must also provide lateral support to the existing barn flank walls whilst the wall in question is being re-built.
