**Structural Appraisal carried out on 12<sup>th</sup> March 2014**

**Cowley Brook Farm  
Higher Road  
Longridge**

**For the Proposed Barn Conversion to 2 Dwellings**

**Project Ref: BUTC/02**

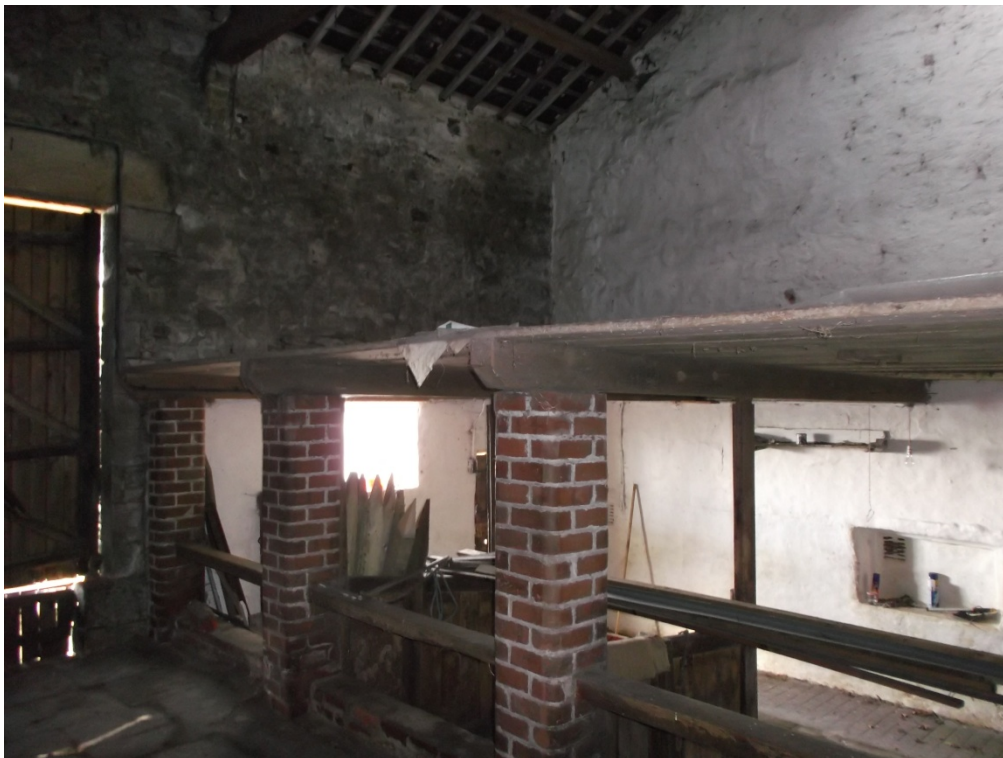
In the Mezzanine Areas the construction consists of flooring board, fixed to timber joists, spanning on to timber beams. The construction in general is of an adequate standard for its intended use but some of the flooring board is of poor quality. When the conversion works are carried out most of the floors will have to be upgraded to meet requirements in terms of loadings.

The existing Mezzanine Floors would have to be replaced/upgraded using appropriately sized timbers in accordance with TRADA.
