Proposed Conversion of Ancillary Agricultural Building at Windy Hill Farm, Chipping, Lancashire

Structural Appraisal Report

D1589 rev0

June 2012

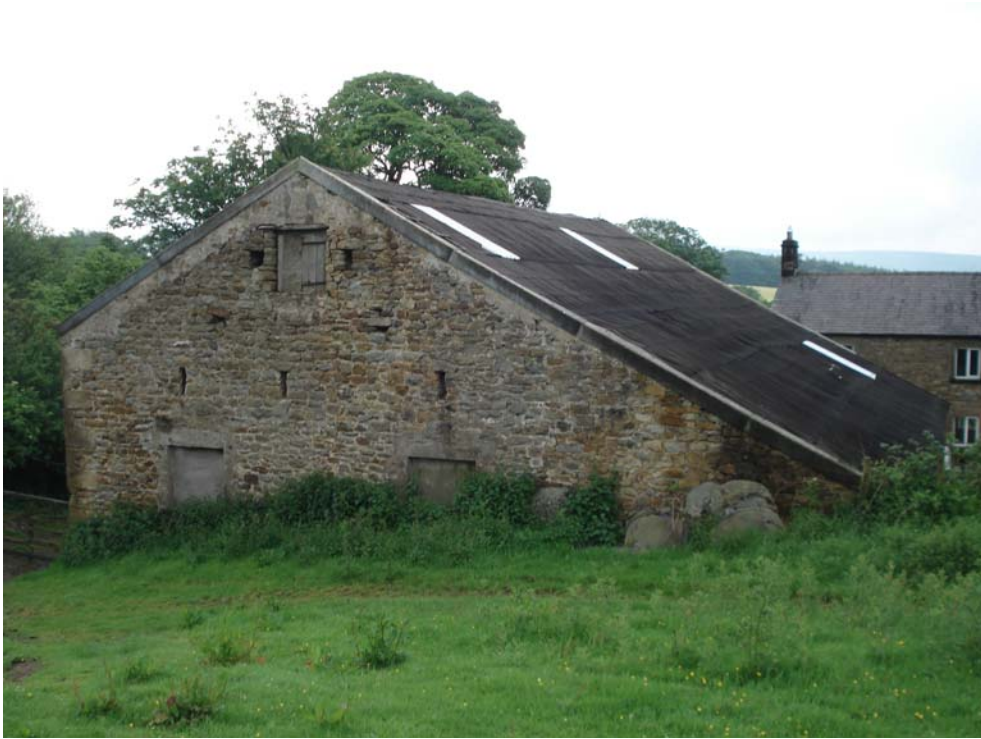
Gable Elevation (North facing); Plates 01-02 inclusive refers to the 450mm thick, coursed stone masonry, north facing gable elevation of the structure. The roofing felt finishes to the rear elevation roof pitch clearly exhibit evidence of previous historic deflection of underlying structural members.

The elevation holds four number infilled former window openings, now boarded, retaining adjacent agricultural land to a maximum approximate height of 1.0m adjacent to the west facing (rear) elevation.

The original elevation offers vertical misalignment of the order of 20mm from ground to 'hypothetical' first floor level adjacent to its junction with the east facing (front) elevation. The remaining elevation is vertically plumb. No lateral deviation of the elevation is noted.

Plate 1 – North facing gable Elevation

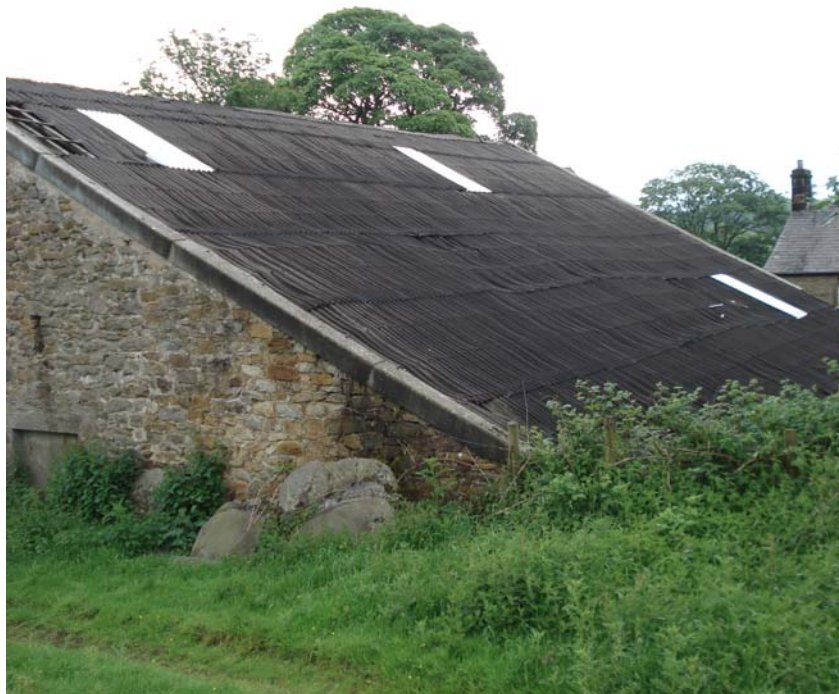
As noted within comments attributable to the north facing gable, the roof finishes accentuate the movement of the underlying structural timber members within the rear pitch. Where felt finishes are removed adjacent to the north gable junction exposing rafter members; these have been subject to historic moisture exposure, resulting in rot infestation.

Plate 2 – Undulating roof finishes to rear pitch

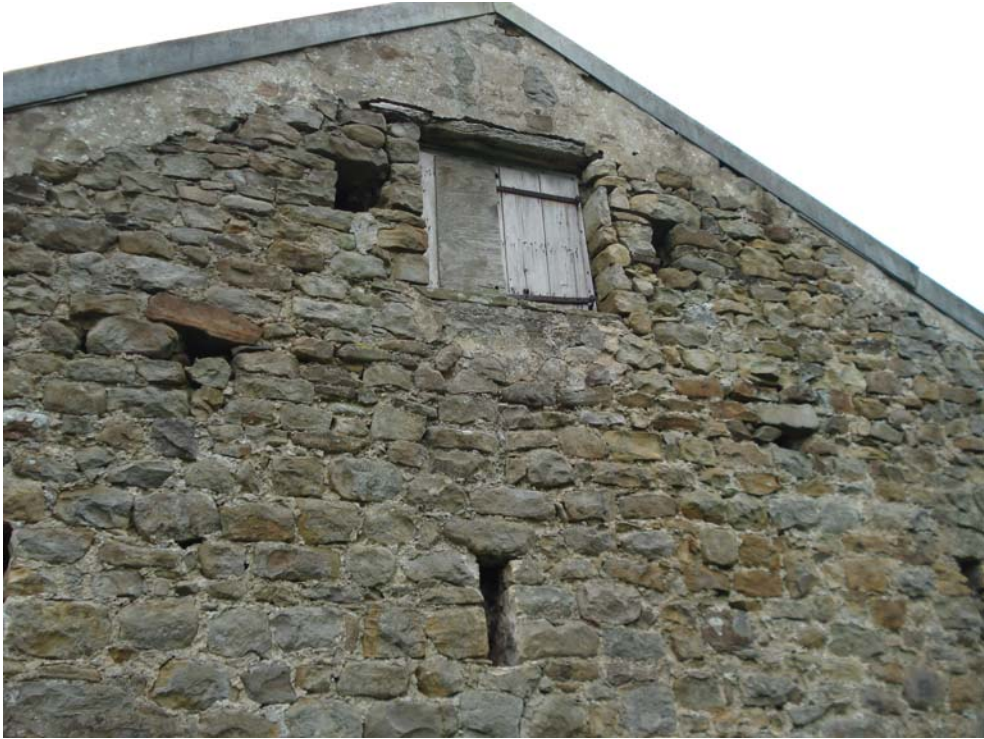
Evidence of historic weathering of the facade is clearly visible, particularly at the apex resulting in spalled mortar beds and perpendes (Plate 03), and adjacent to its junction with the rear elevation, obvious water ingress and 'staining' (Plate 04).

Plate 3 – Weathered mortar to North gable apex

- 3.0.1.6 Again, not of structural significance, we would recommend that in the interests of durability, all elevations of the proposed refurbished structures are re-pointed with respect to mortar beds and perpendes.

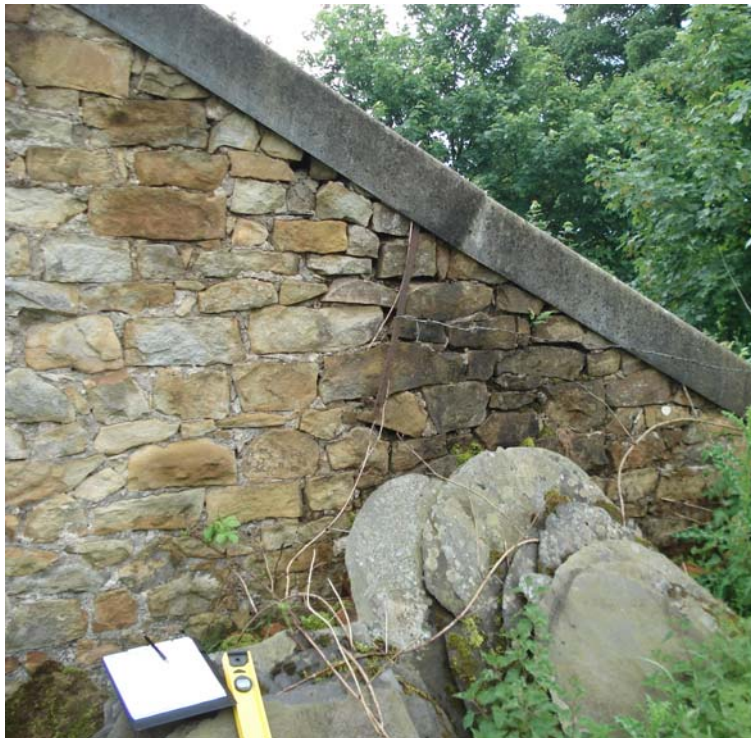
Plate 4 – Damp 'staining'

3.0.1.3 Whilst not of structural concern, we would recommend a "damp" survey be undertaken to all masonry elevations within the proposed area of refurbishment. If as expected, the level of the moisture within the wall elevations is excessive, remedial treatment solutions should be considered if necessary, particularly as proposals necessitate the 'physical connection/tie' to a blockwork lining wall.

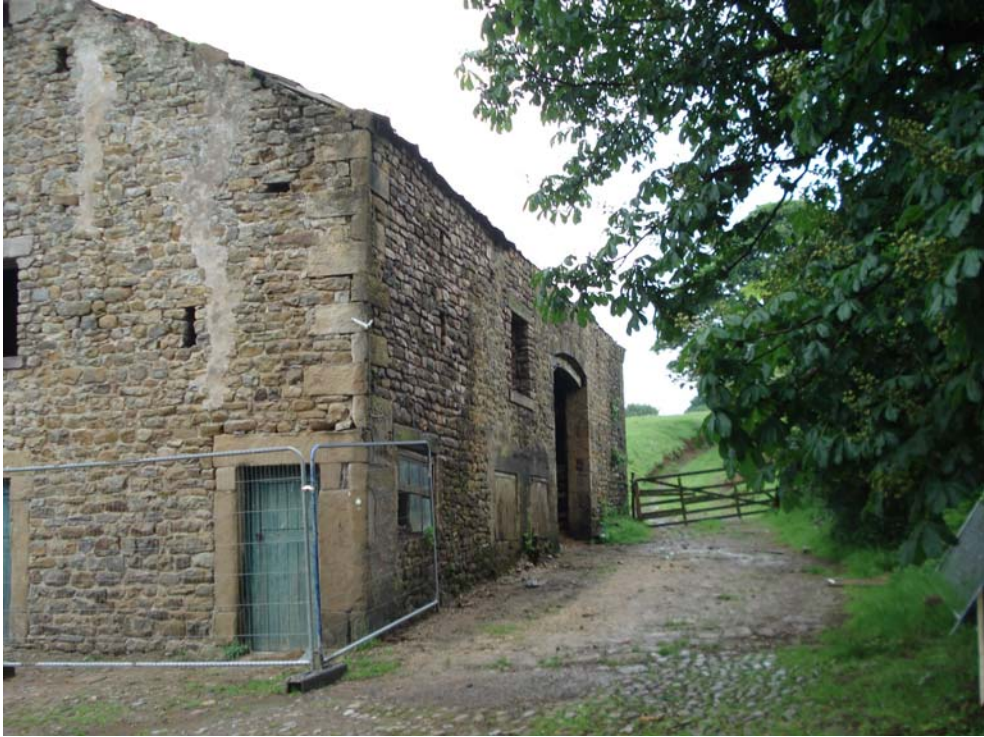
Front Elevation (East facing); Plate 05 provides record of the east facing front elevation general appearance. The elevation retains adjacent hardstanding to a maximum height of 300mm adjacent to its junction with the south facing gable elevation. A full height door forms the prominent feature to this elevation. The original masonry arch has been 'underdrawn' by the provision of a timber lintel (Plate 06), presumably remedially provided.

does not exhibit any noticeable lateral mis-alignment, however, vertical deformation was noted at 25mm and 20mm from ground to 'first floor' levels to the right and left side of the Barn door opening respectively.

Plate 5 – East facing (front) Elevation

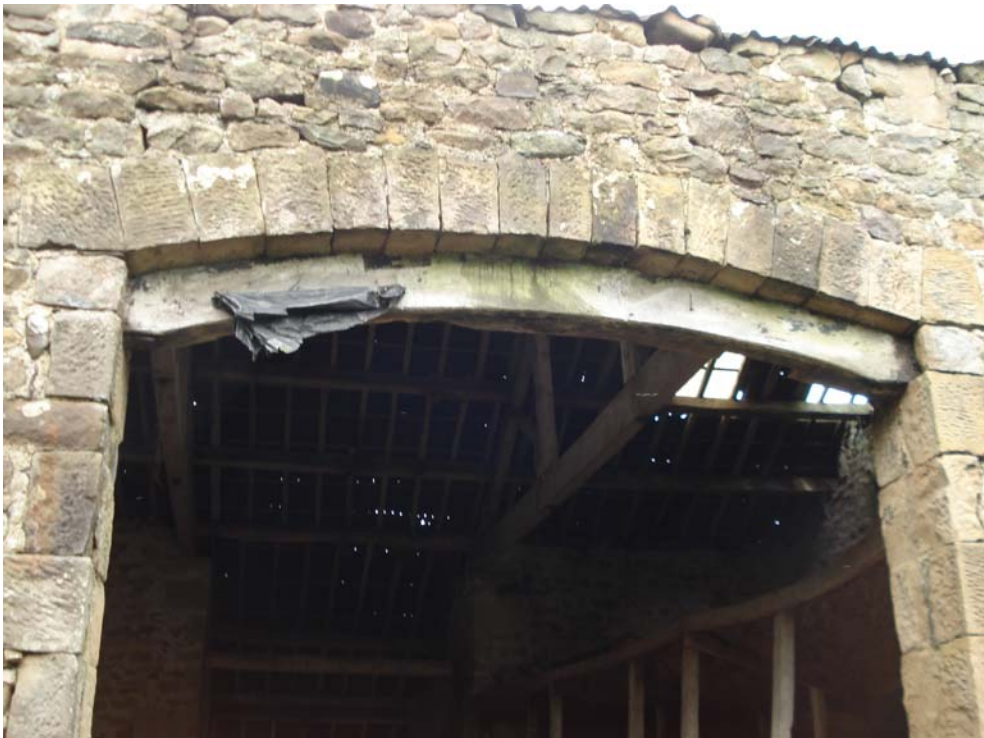
Plate 6 – Timber lintel beneath masonry arch

Additionally, we would recommend the replacement of all existing timber lintel members with suitably designed prestressed concrete replacement lintel members.

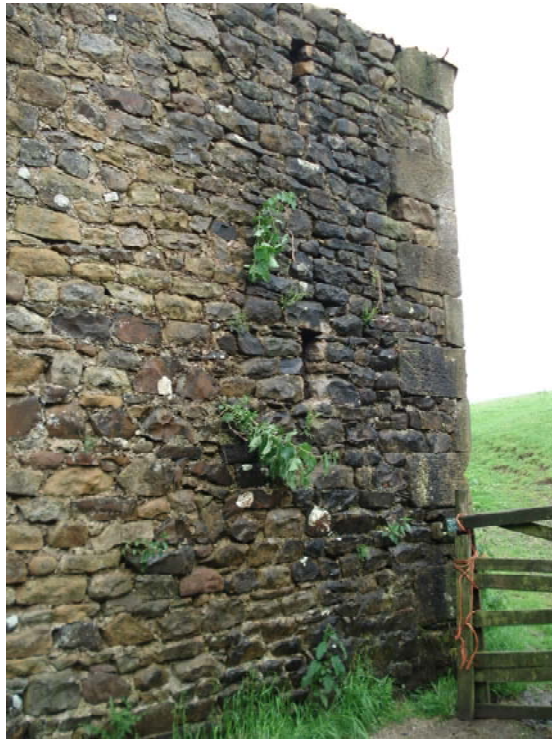
The elevation exhibits evidence of weathering, both in the appearance of mortar spalling and obvious remedial re-pointing works. Additionally, at its junction with the north gable elevation, the facade exhibits obvious water ingress staining, with vegetative growth (Plate 07).

Plate 7 – Water staining and vegetation growth

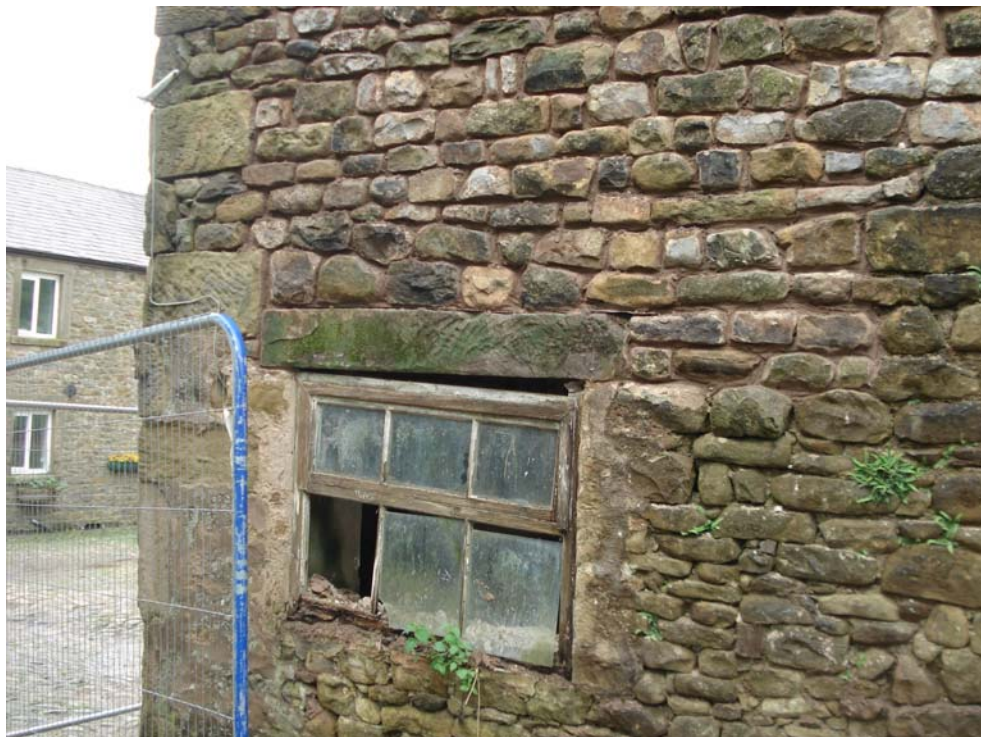
Historic movement of the elevation is noted. The window opening situated adjacent to the south facing gable junction has 'dropped' at its north bearing (Plate 08). The elevation

Plate 8 – Lintel bearing movement

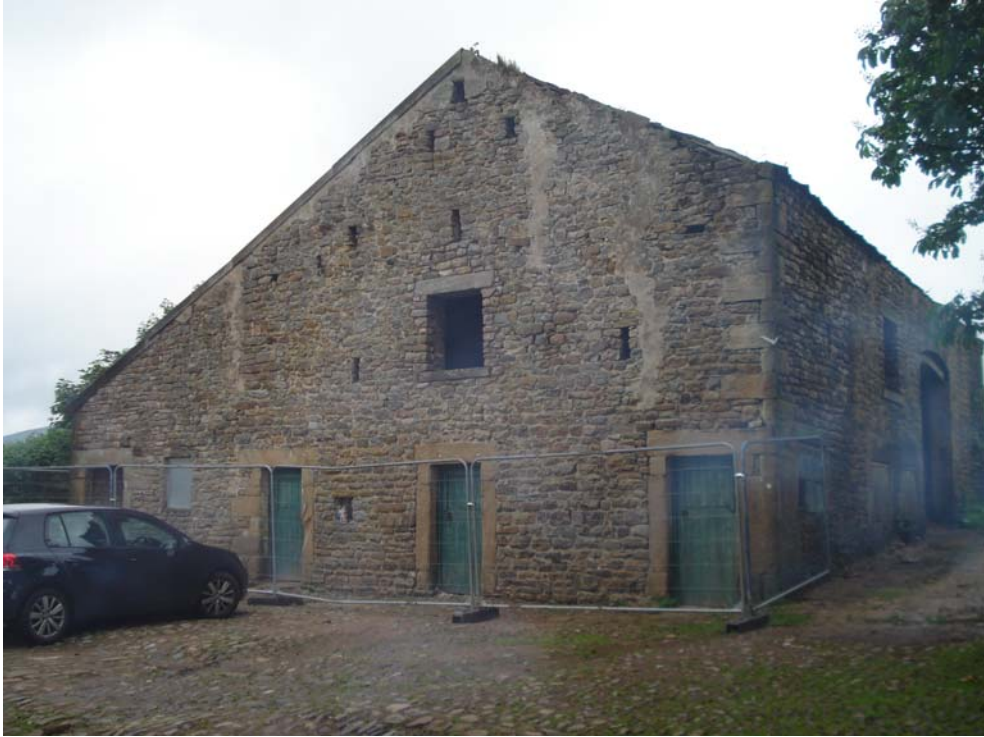
Gable Elevation(South facing); The south facing rear elevation of the structure is detailed within Plate 09. This depicts the postulated 'original' structure with a formatively constructed solid masonry 'Shippon' extended to the rear.

The facade would appear to have been the subject of recent remedial re-pointing.

Vegetative growth is noted emanating from apex and the front roof pitch eaves level.

The elevation exhibits no signs of lateral displacement, however, vertically displaced 20mm from ground to 'first floor' level.

Plate 9 – South facing gable Elevation

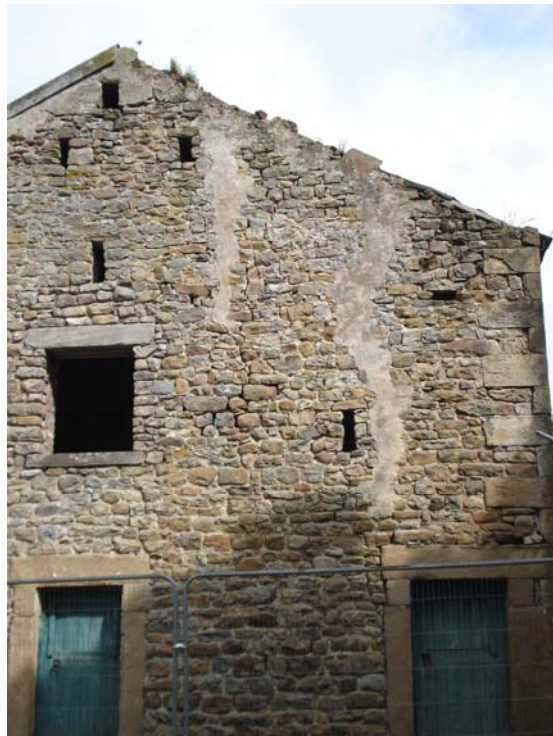
Two parallel, vertical cracks have been the subject of extensive mortar filling, emanating from eaves level of the front roof pitch to mid and ground floor door opening head height (Plate 10). Further cracking has also been subjected to a similar remedial process at the junction of the postulated 'Shippon' extension and the 'original' structure (Plate 11).

Plate 10 – 'Re-pointed' masonry cracking

3.0.2.1 Where vertical cracking is noted within the external and internal facade of the south facing gable elevation, remedial crack 'stitching' is required. The remedial works should take the form of helical reinforcement bars ('Twistfix' or approved equal) placed across the vertical crack location in accordance with the manufacturers guidance.

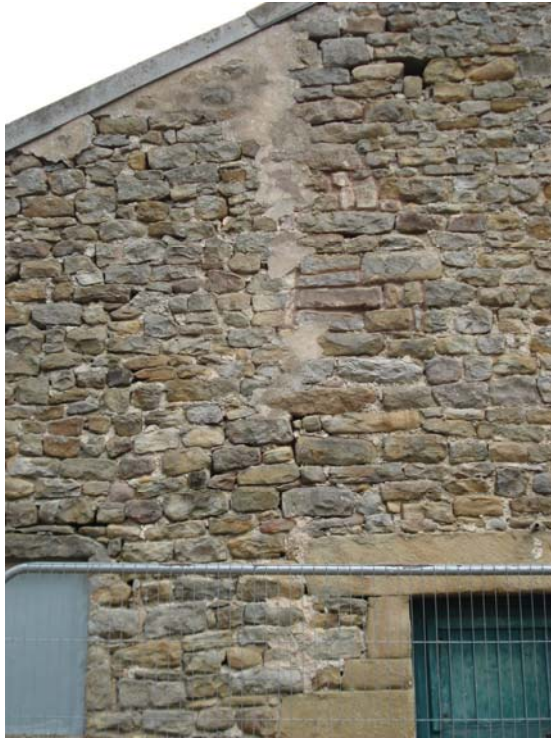
Plate 11 – ‘Re-pointed’ masonry cracking (‘Shippon’)

3.0.3.1 Where vertical cracking is noted at the junction of the internal rear elevation and the south facing gable elevation, remedial crack 'stitching' is required. The remedial works should take the form of helical reinforcement bars ('Twistfix' or approved equal) placed across the vertical crack location in accordance with the manufacturers guidance.

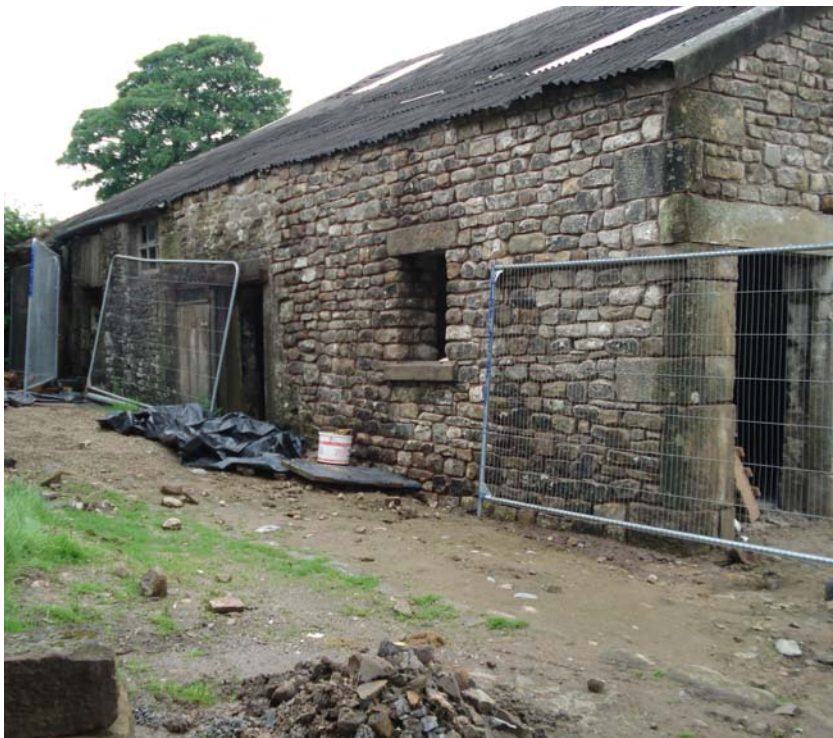
Rear Elevation (West facing); Plate 12 provides record of the west facing rear elevation general appearance. The elevation combines the rebuilt brickwork facade adjacent to the junction of the north facing gable (Plate 13) together with that of the original 'Shippon' stone facade.

Plate 12 – Rear (west facing) Elevation

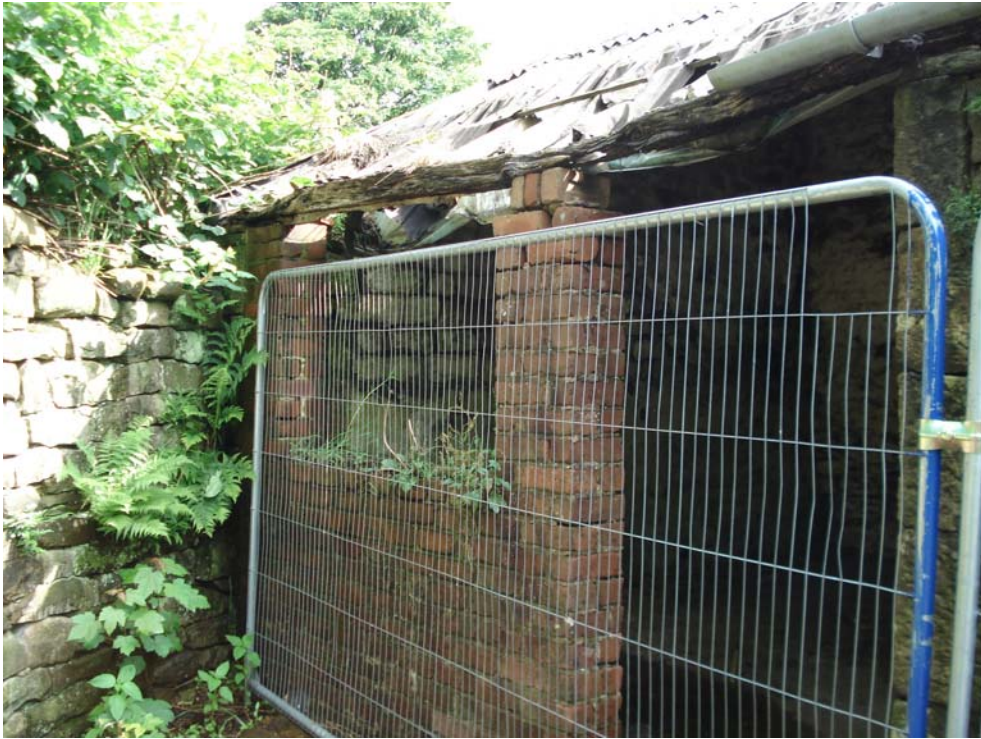
Plate 13 – Rebuilt brick facade adjacent to North Gable

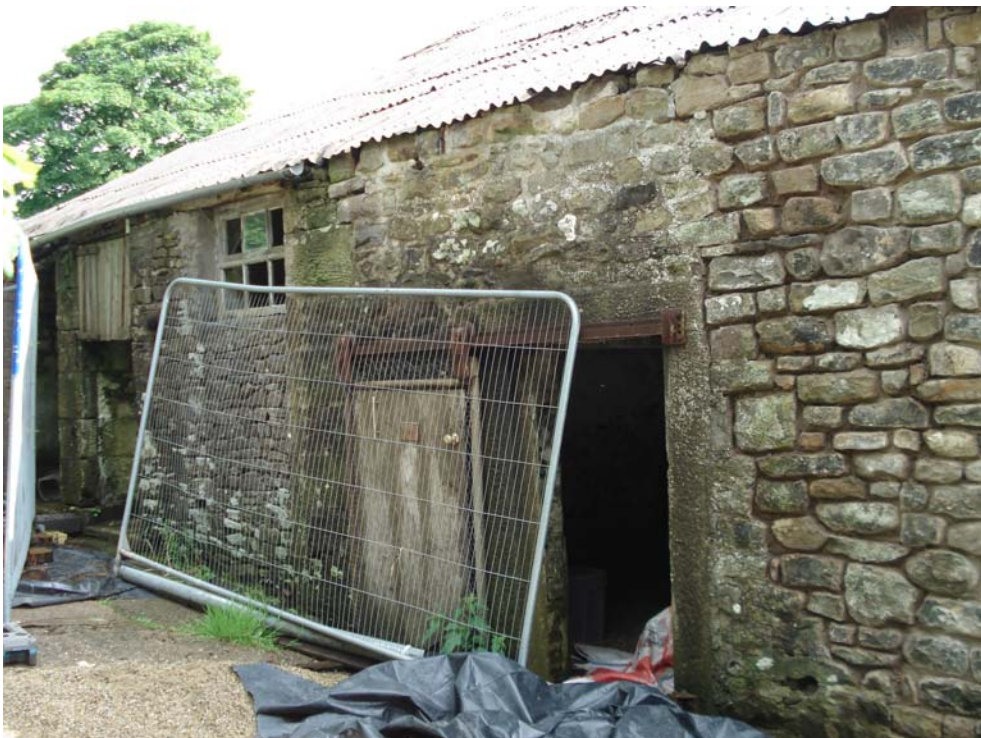
As expected of a west facing elevation, it exhibits considerable weathering, particularly within the more northerly areas (Plate 14). The elevation is laterally 'true', whilst vertical misalignment is noted within the central regions of the elevations, leaning 25mm from ground to eaves level.

Plate 14 – Weathering to West (rear) Elevation

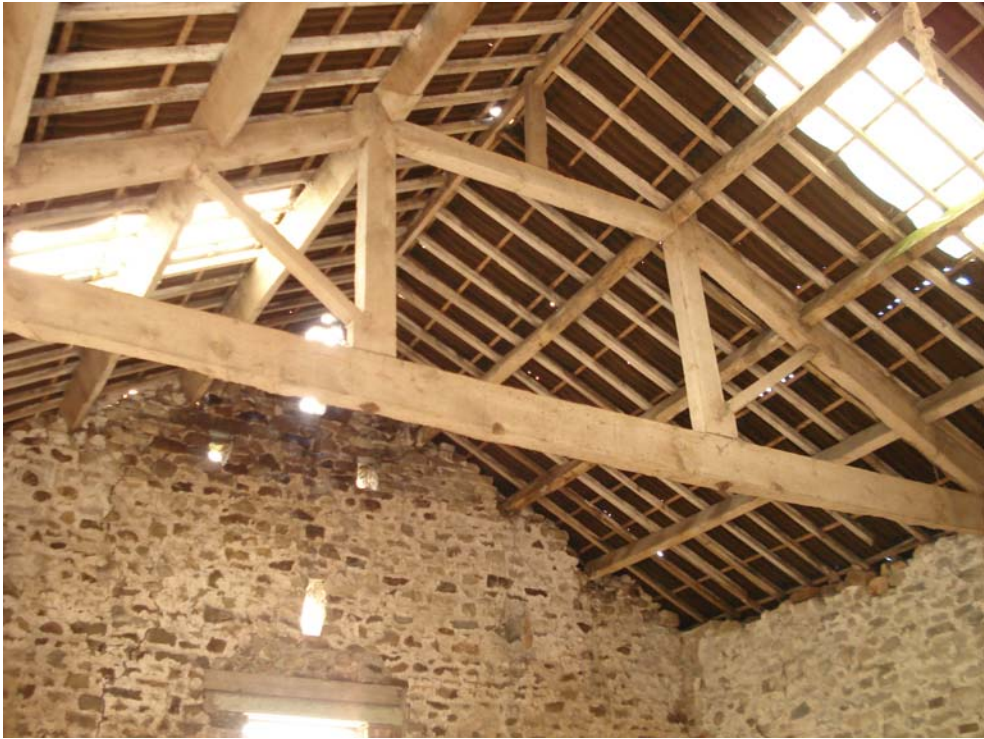
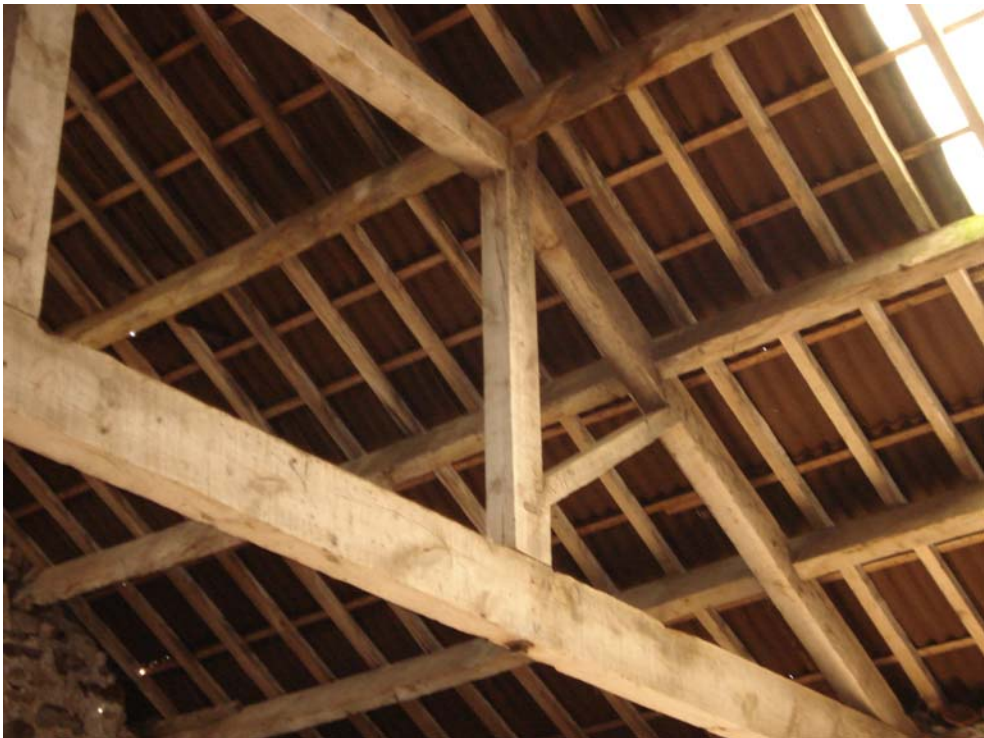
'Original' Barn Structure; Visual evidence would suggest the more formative replacement of all rafter members together with selected purlin members to both front and rear pitches. Where original purlin sections remain, these have depleted section size (Plates 15 & 16).

Plate 15 – Main Barn Roof

Plate 16 – Main Barn Roof

3.0.1.2 It is recommended that a "specialist" timber survey is undertaken upon the timber roof elements of the existing structures that are proposed to be retained in redevelopment, unless noted otherwise. Such a survey should identify the nature and extent of any wood boring insect infestation, dry/wet rot and fungal attack and recommend the extent of remedial works necessary to arrest such and maintain the structural member strength to continue to provide necessary support.

Should remedial treatment solutions be a viable option, we would recommend structural design assessment of the existing truss and purlin members be undertaken to verify, or otherwise, their suitability to provide adequate support to the roof structure if required.

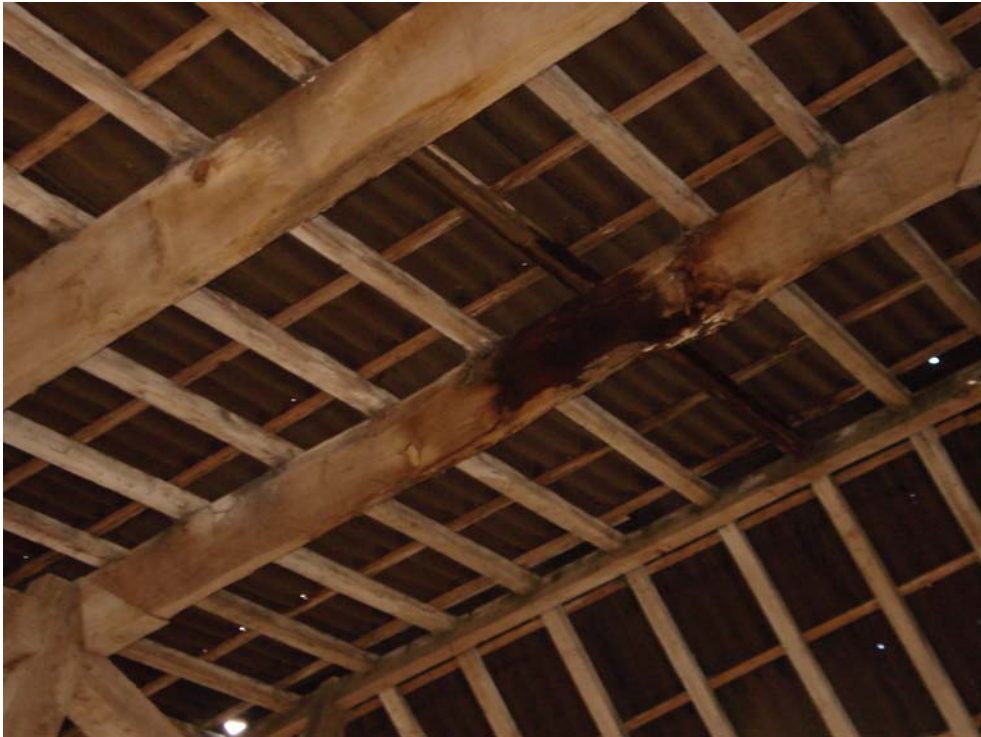
When viewed from ground level, there is evidence that all structural members have been subjected to wood boring insect infestation. Significant moisture and rot impregnation is visible within the central span of the uppermost front pitch purlin located within the central plan area of the structure (Plate 17).

Plate 17 – Damp and rot to purlin

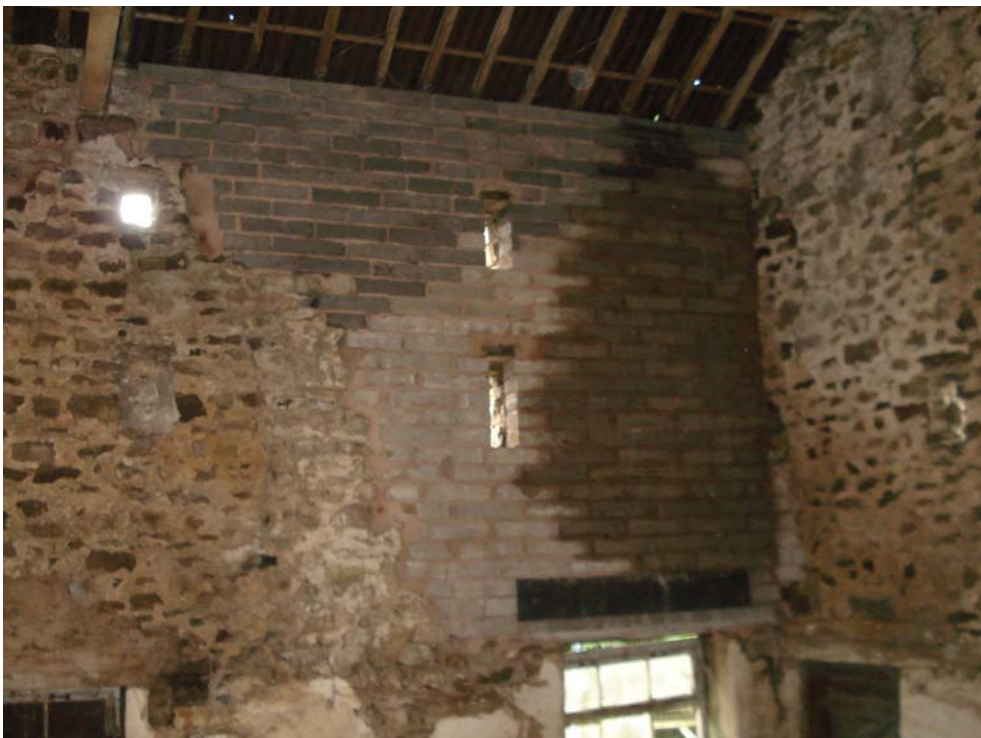
All internal walls are of solid construction and of uniform thickness. At the junction of the front and south facing elevations, the exposed internal leaf has been rebuilt in concrete block (Plate 18), however not bonded/tied. The external vertical cracking noted within the south facing gable elevation is reciprocated on the inner leaf (Plate 19). Where external cracking was noted at the rear barn/Shippon junction, visual evidence would suggest remedial rebuilding works to have been undertaken in this area previously however, the junction of the elevations remains untied/unbounded (Plate 20).

Plate 18 – Re-built inner leaf

- 3.0.1.5 We are of the considered opinion that the building would benefit from 'tying' at their corresponding elevations. Remedial action may comprise of the staggered placement of helical wall ties applied externally at corner junctions. A more feasible alternative would be the introduction of internal mild steel restraint strapping at 450mm vertical centres for the full height of the corner junctions across adjacent internal leaves.

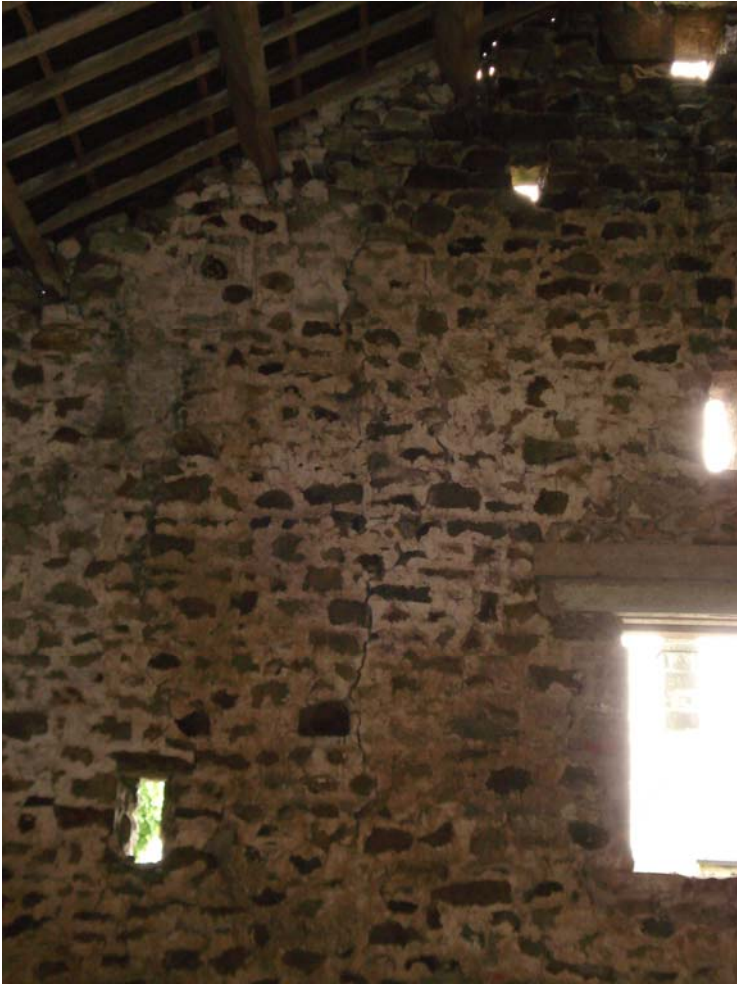
Plate 19 – Vertical cracking to inner leaf (South Gable)

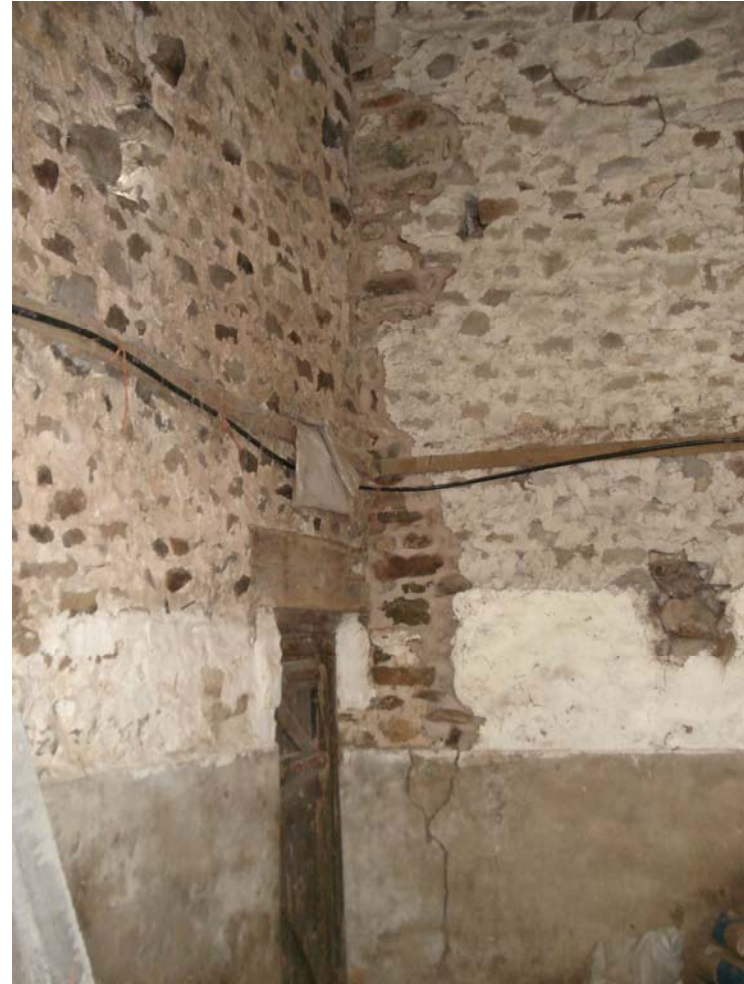
Plate 20 – South gable / Rear barn junction

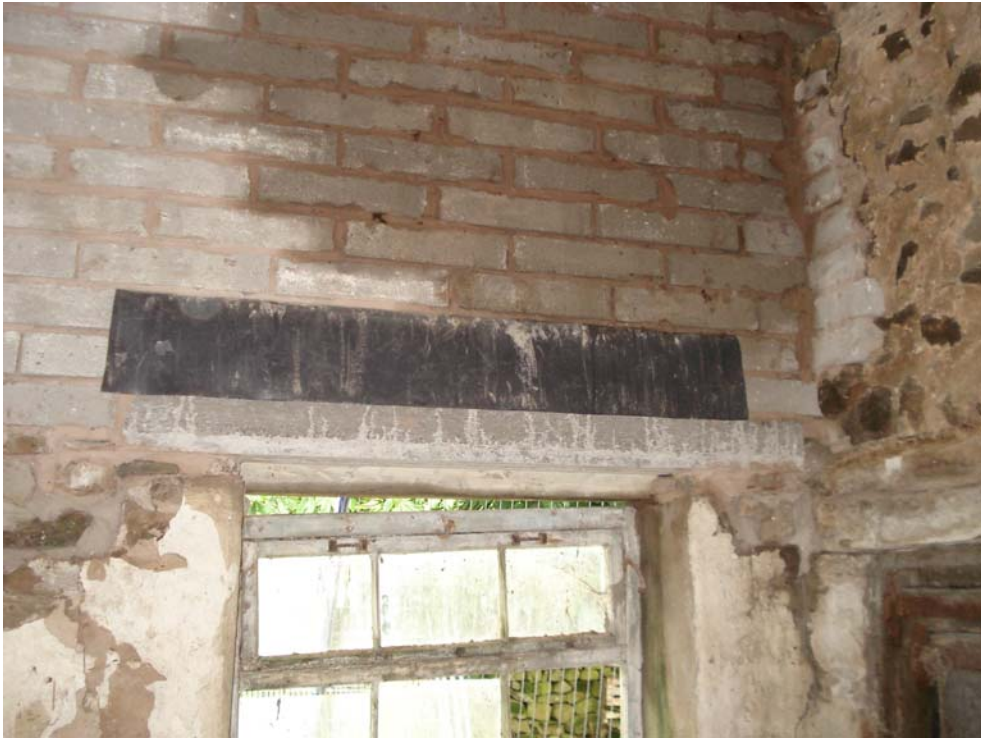
A number of internal lintel members have been replaced by prestressed concrete members (Plate 21). Where original members remain (Plate 22), these offer visual evidence of section depletion and historic wood boring insect infestation.

Plate 21 – Pre-stressed concrete lintel replacement

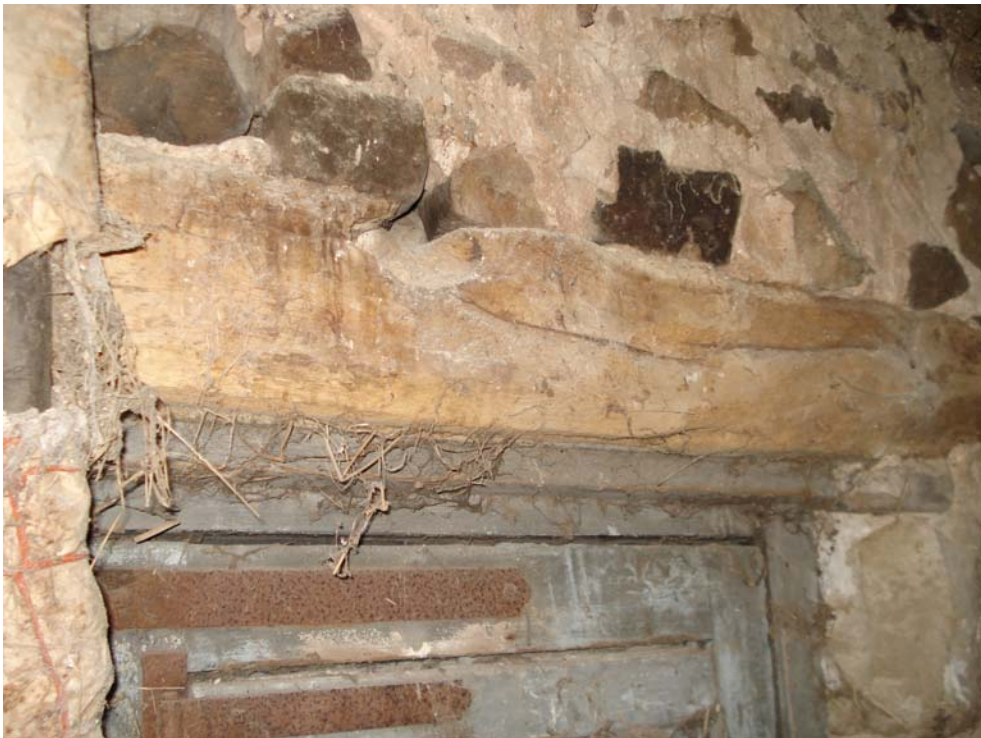
Plate 22 – Existing timber lintel (Barn – internal)

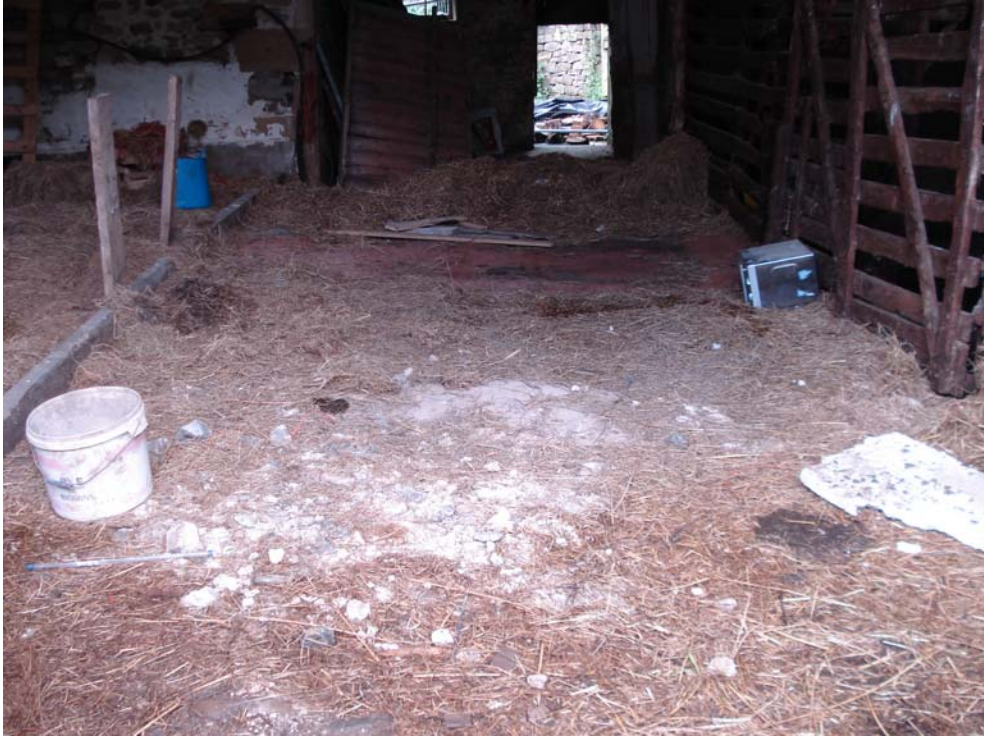
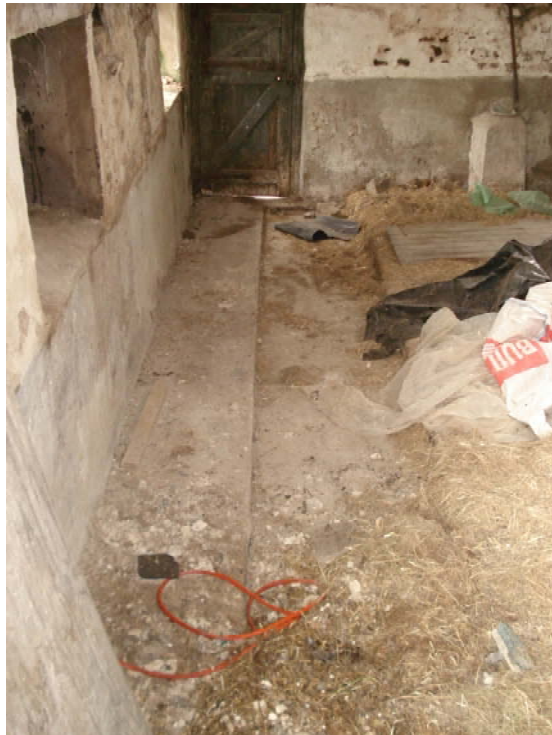
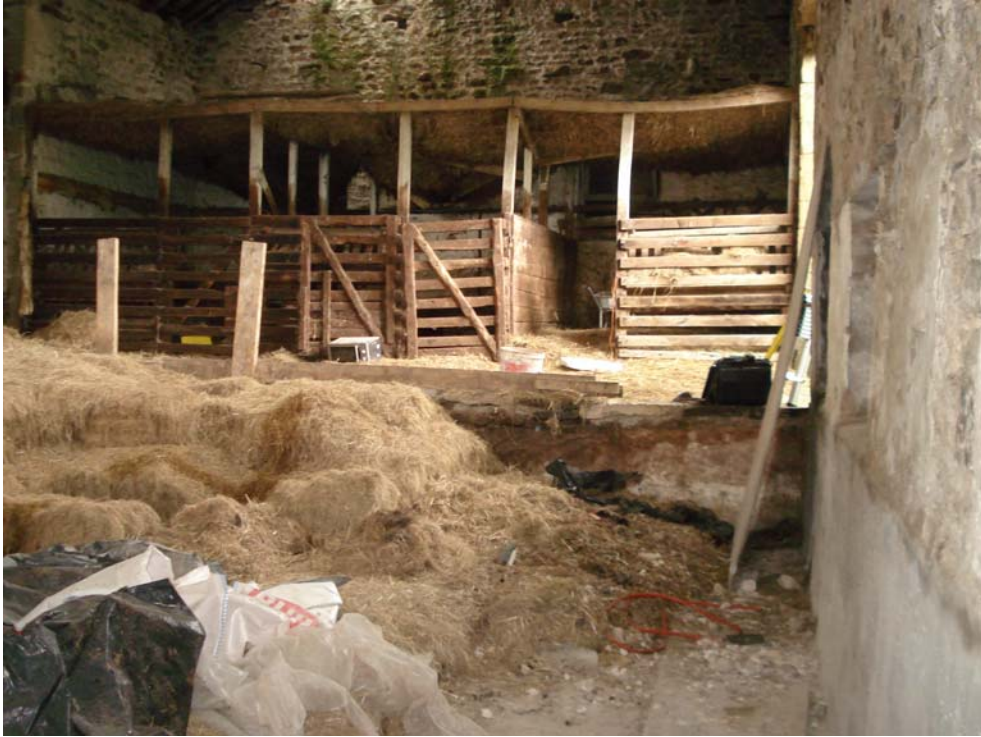
Plate's 23-25 inclusive detail the split-level ground floor construction of the main barn area. A more formatively replaced concrete ground bearing slab lies 850mm below entrance level, with adjacent ground retained by a masonry dwarf wall. The upper lying ground floor

comprises a combination of stone setts, flagging and hardstanding. Throughout the area, stockpiled haylage restricts inspection however, where visible there is no visual evidence of excessive ground movement. All areas of the ground floor plan slopes noticeably from north to south.

Plate 23 – Floor adjacent to Main Door

Plate 24 – Lower lying concrete ground bearing slab

Plate 25 – Ground floor viewed from south-east corner

- 3.0.1.7 Based upon redevelopment proposals raising the existing ground floor slab level, the provision for a replacement ground floor slab should comprise of a 150mm thick, ground bearing concrete slab, laid upon suitably compacted hardcore and a single layer of 1200 gauge damp proof membrane ("Visqueen" or approved equal), formed upon approved competent sub-base strata, or alternatively if competent bearing strata is proven beneath the existing slab, directly off such. Nominal mesh type reinforcement (A193) to the top of the slab should be provided with 25mm cover. Adjacent to external wall elevations, and where requirement necessitates the provision of foundation for internal load bearing wall elevations, the requirement of a thickening/downstand should be accommodated upon which formation of the proposed blockwork internal leaf can be made.

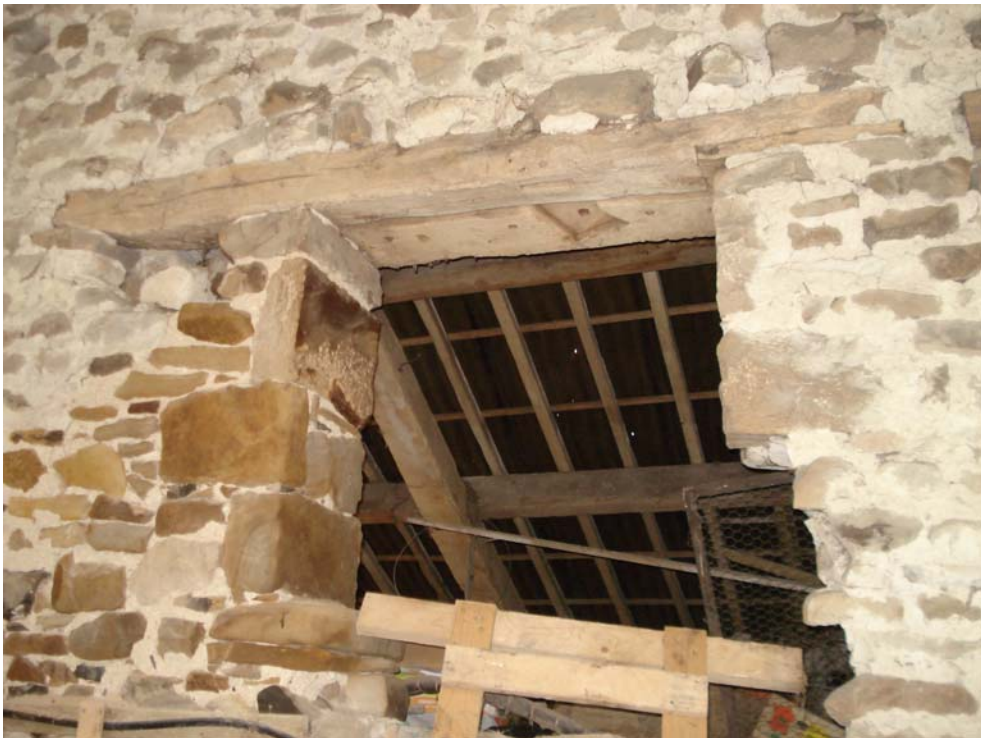
Plate 26 – Opening within rear elevation of barn to roof void of Shippon

Shippon; With access gained to the first floor area/roof void via an opening formed within the rear elevation of the barn (Plate 26), visual inspection of structural timber purlin and truss roof members revealed historic wood boring insect infestation and section depletion (Plates 27-29 inclusive). Exposed roof members to the remaining northern area of the Shippon are consistent with the defects noted however, purlin end damp penetration is clearly visible at the bearing with the north facing gable (Plates 30 & 31).

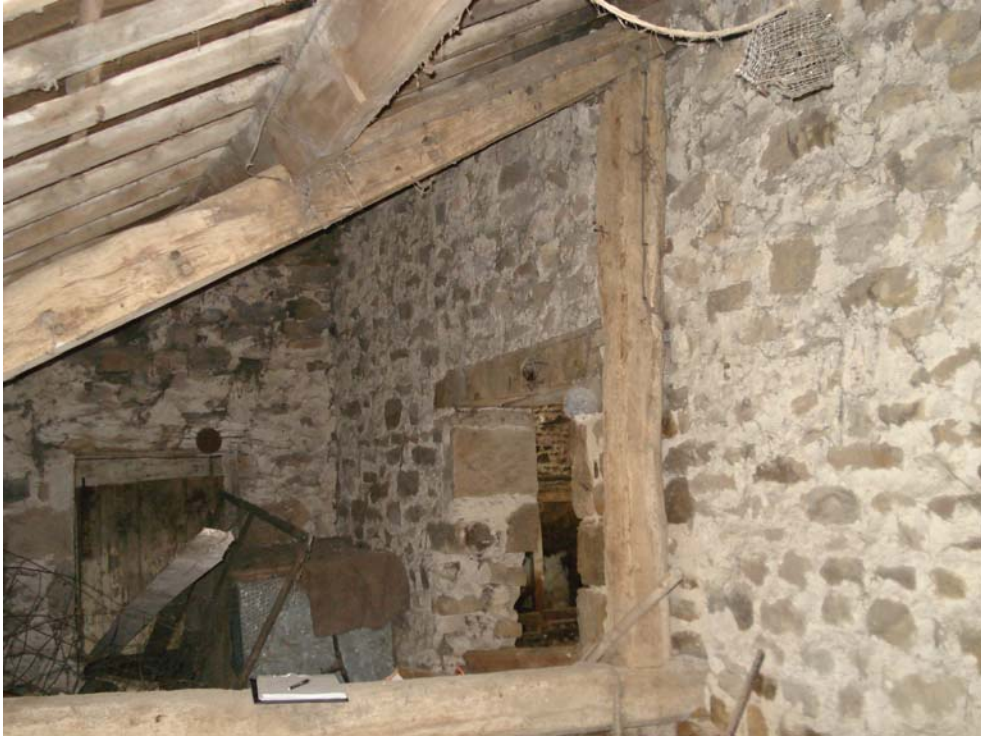
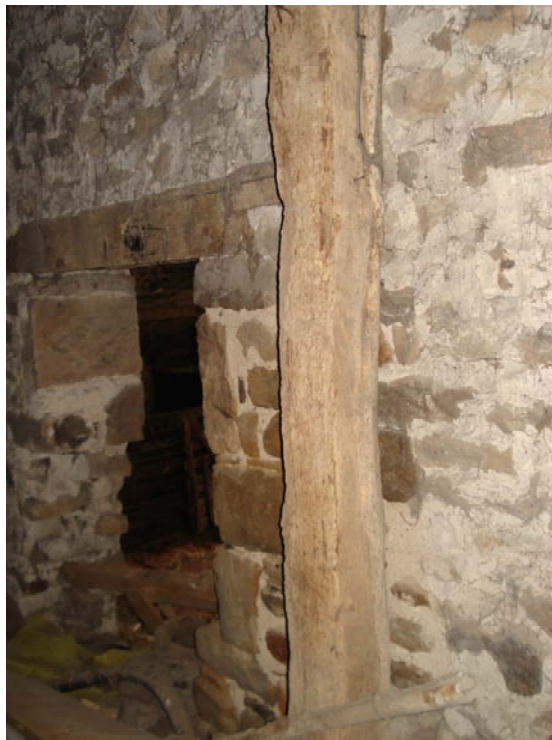
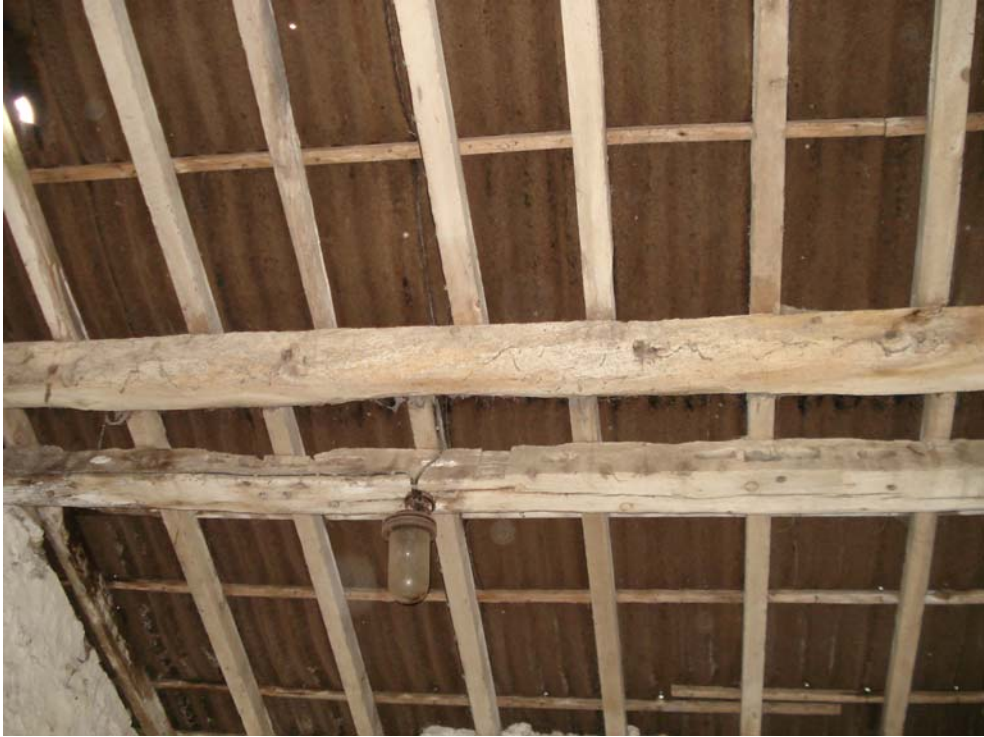
Plate 27 – Shippon roof (truss in foreground)

Plate 28 – Vertical post of mono pitch truss

Plate 29 – Purlin section depletion (Shippon)
