Proposed Conversion of Ancillary Agricultural Building at Windy Hill Farm, Chipping, Lancashire

Structural Appraisal Report

D1589 rev0

June 2012

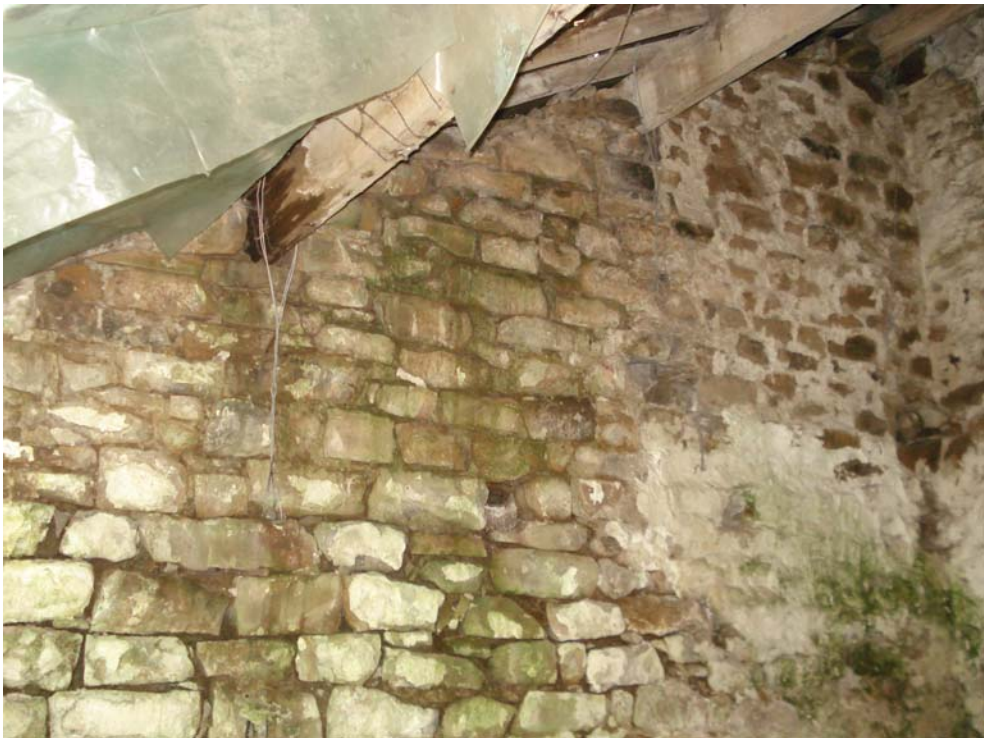
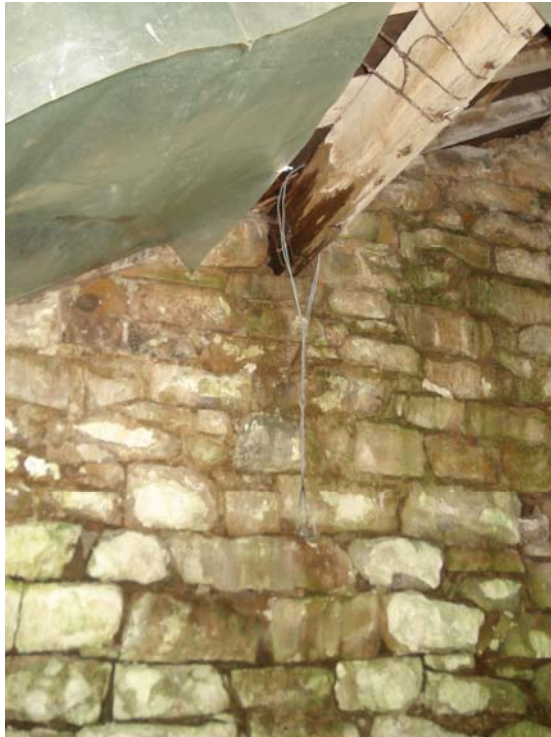
Shippon; With access gained to the first floor area/roof void via an opening formed within the rear elevation of the barn (Plate 26), visual inspection of structural timber purlin and truss roof members revealed historic wood boring insect infestation and section depletion (Plates 27-29 inclusive). Exposed roof members to the remaining northern area of the Shippon are consistent with the defects noted however, purlin end damp penetration is clearly visible at the bearing with the north facing gable (Plates 30 & 31).

Plate 30 – Damp penetration to purlin bearing and North gable (Shippon)

Plate 31 – Damp penetration to purlin bearing at North gable (Shippon)

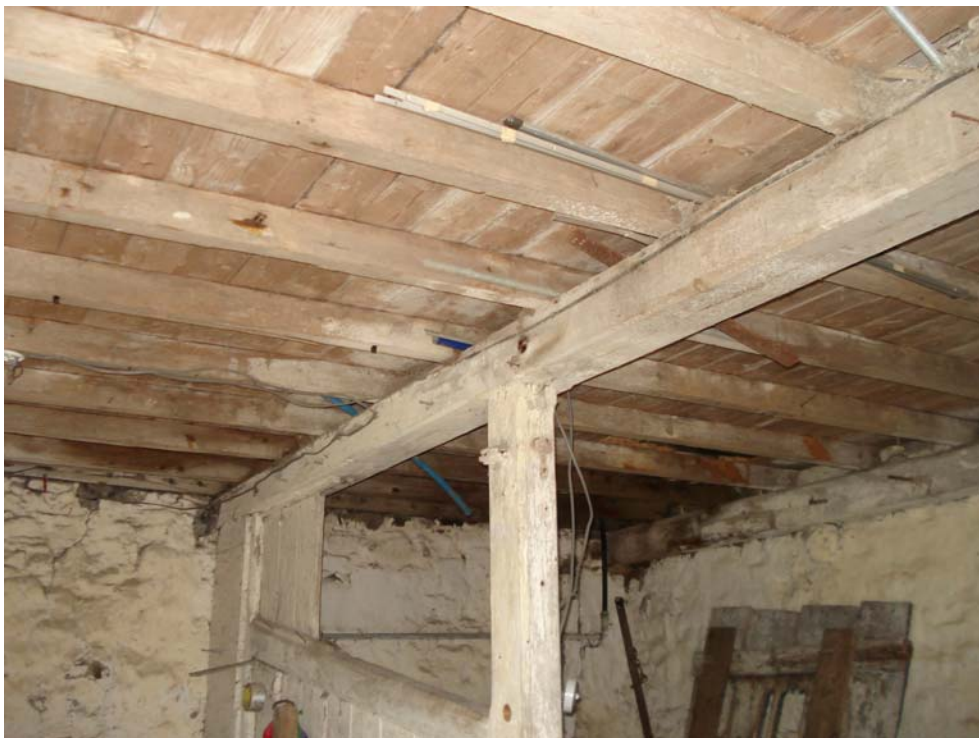
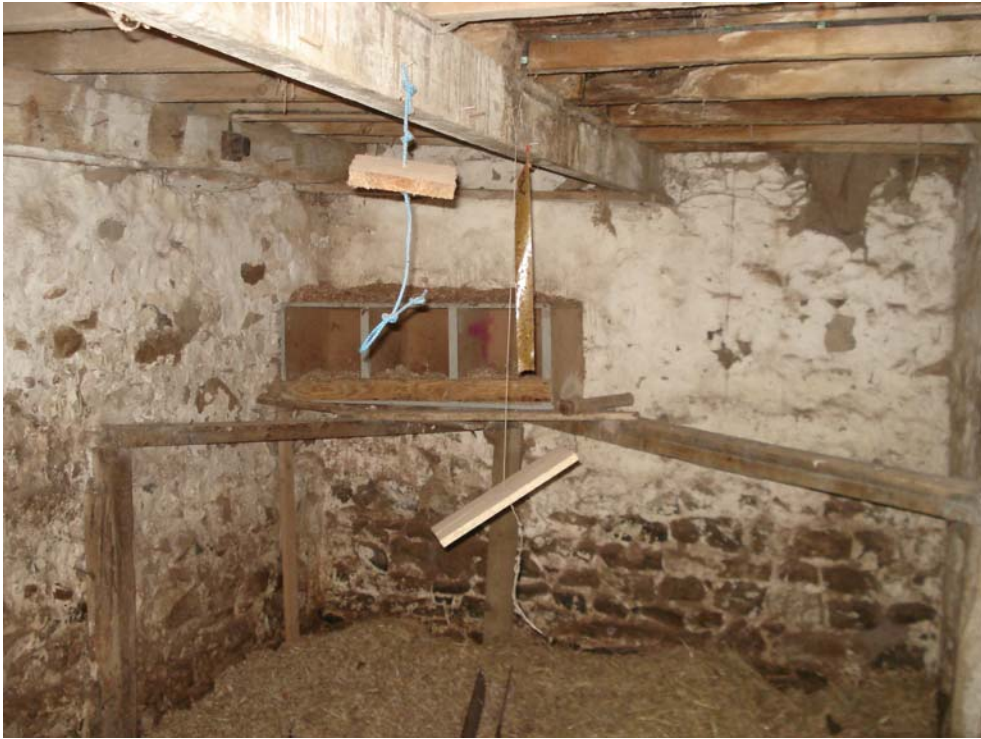
Visual inspection of the first floor boarding did not offer any evidence of excessive damp penetration, or 'springing' when walked across. When viewed from corresponding ground level, the supporting timber joists, beams and stall partitions do not suggest historic structural overstress based upon previous loading scenarios (Plates 32 & 33).

Plate 32 – 1st floor joists supported on stall partition

Plate 33 – 1st floor supporting beam

It is our considered opinion that where insitu, the existing timber first floor elements **are not** adequate to sustain the proposed loading, and as a result, be replaced by structurally competent, designed supporting members.

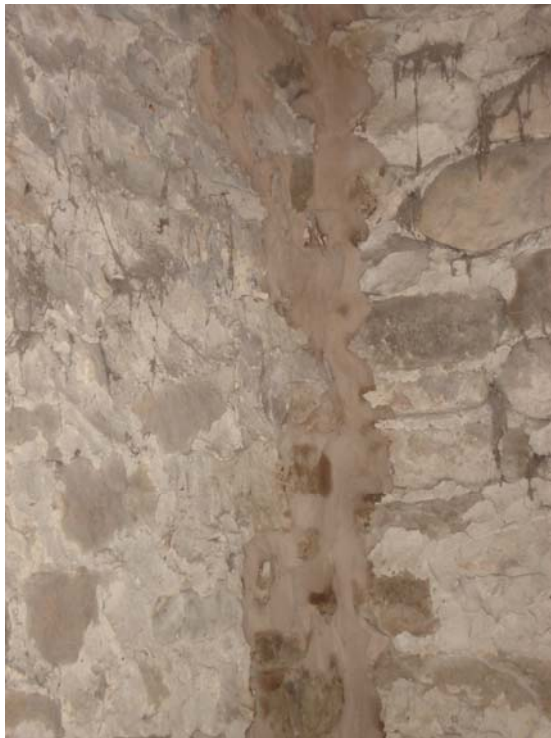
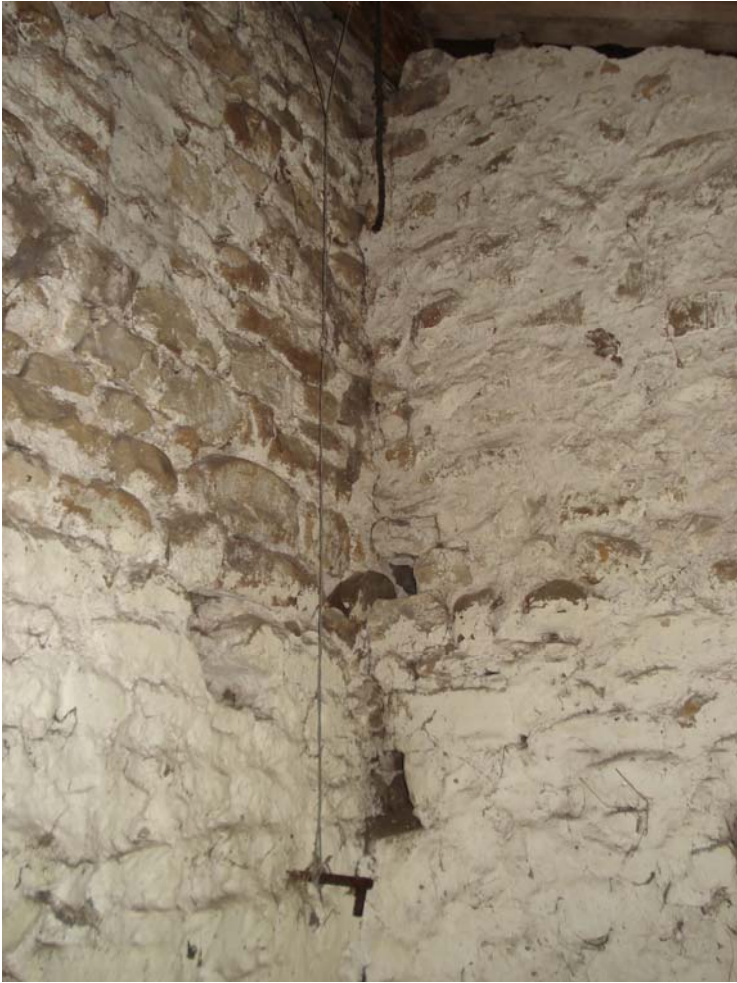
Throughout the Shippon, visual evidence clearly reinforces the assumption that this area was a more formative extension, with vertical 'butt' joints visible at the junction with the main barn masonry elements. (Plates 34 & 35). Additionally, a vertical crack is noted at the rear elevation of the Shippon with that out the south gable, corresponding to the location noted within the main barn (Plate 36).

Plate 34 – Butt joint at Shippon / Barn

Plate 35 – Butt joint at Shippon rear elevation and spine wall

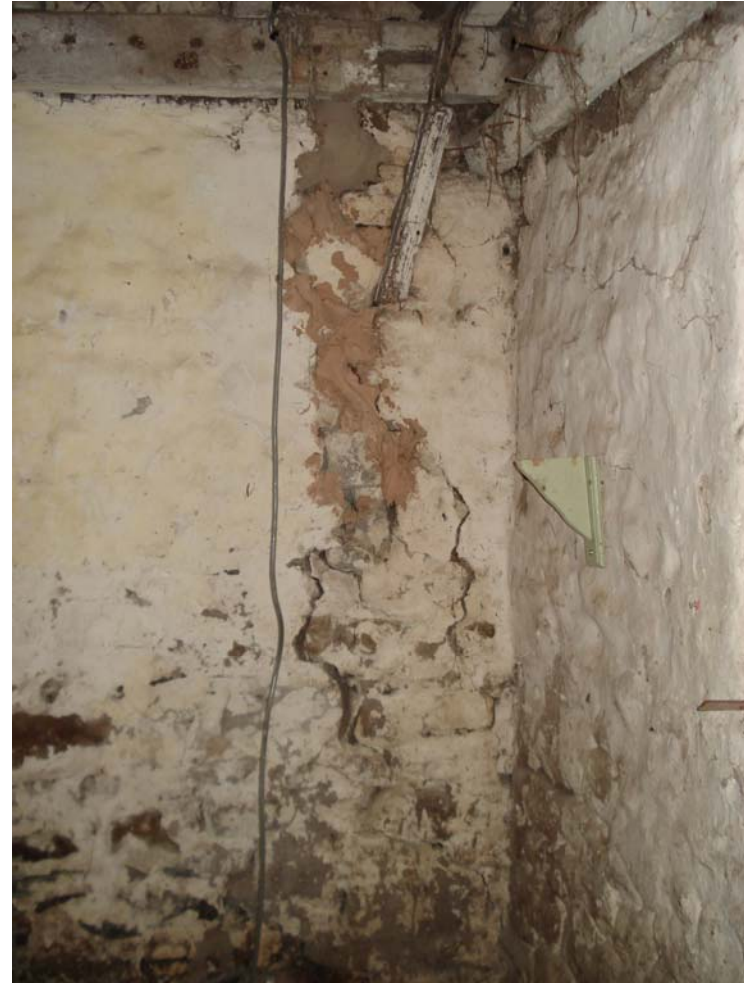
Throughout, evidence of damp ingress to all wall elevations is noted (Plate 36). At the junction of the rear external elevation and south facing Shippon gable, evidence would suggest that this area has been more formatively re-pointed/rebuilt. More obviously, directly adjacent to the north gable, the elevation has obviously been re-built utilising standard format brickwork (Plate 37).

Plate 36 – Vertical crack, damp penetration to applied Shippon wall finishes

3.0.3.1 Where vertical cracking is noted at the junction of the internal rear elevation and the south facing gable elevation, remedial crack 'stitching' is required. The remedial works should take the form of helical reinforcement bars ('Twistfix' or approved equal) placed across the vertical crack location in accordance with the manufacturers guidance.

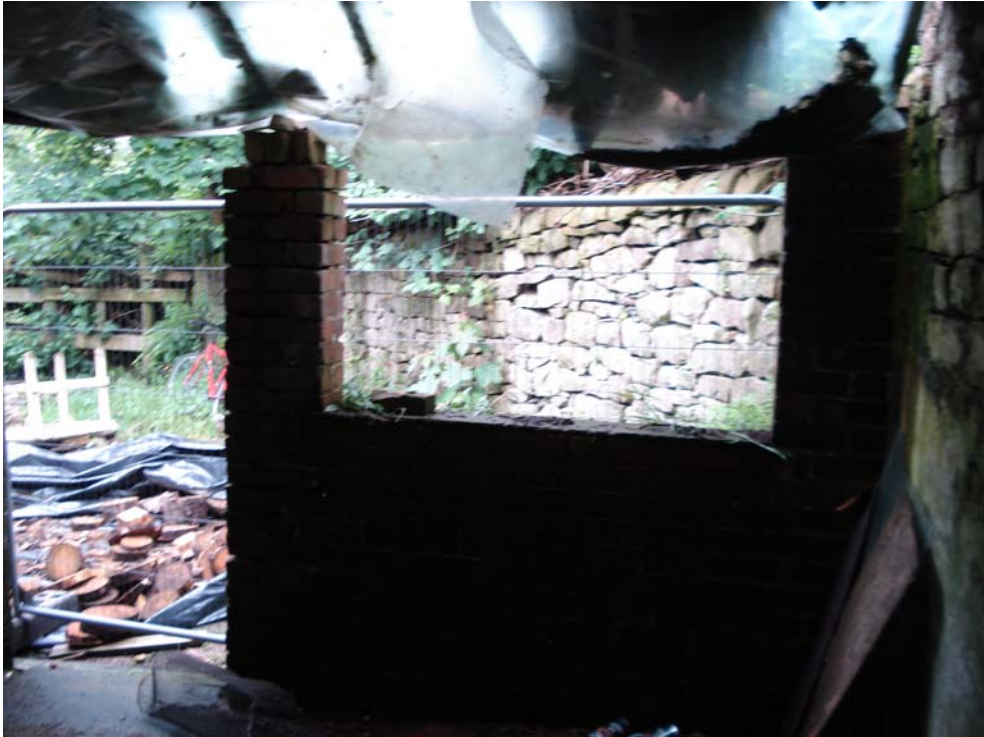
Plate 37 – Re-built brickwork elevation
