BAT SURVEY

**19 SPRINGDALE ROAD
LANGHO**

**DATE AND TIME OF VISIT
26th March 2015 3.30pm**

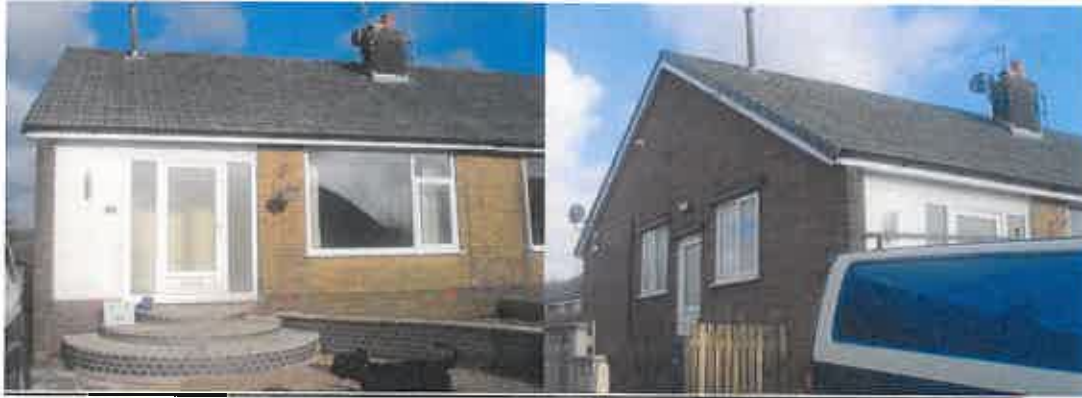
Front elevation West

Side elevation North

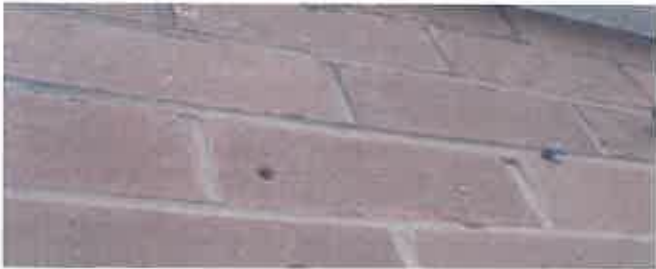
The walls are brick.

The walls are in good condition as is the pointing there are no access points or crevices suitable for bats.

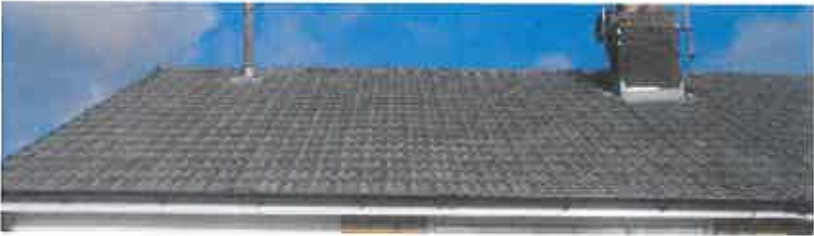
The roof is a double pitched roof with profile tile finish. There is a slight overhang at the eaves the soffits are upvc

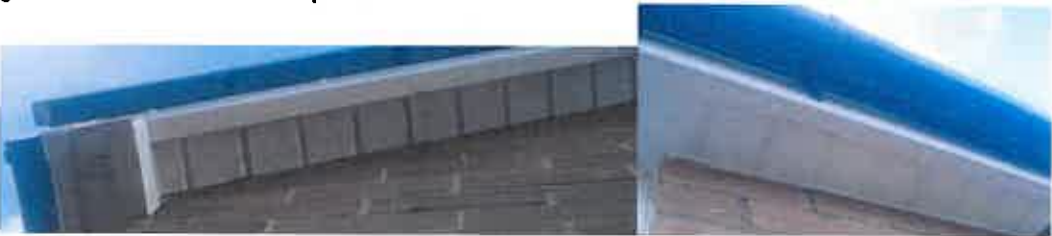
The roof tiles are in reasonable condition with no significant cracks or loose tiles. The soffits are tight fitting and in good condition with no access points.

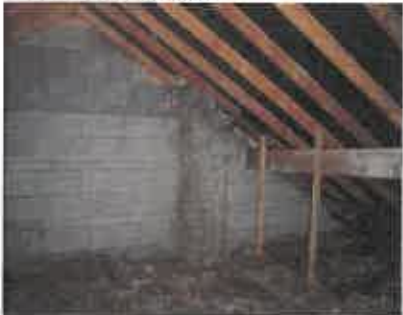
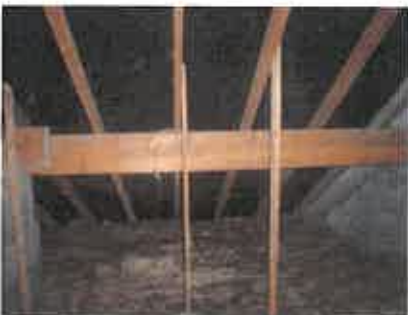
COMMENTS: The roof is rafters and felt over timber purlins with hangers for the ceiling joists. Between the joists is insulated with quilt. The timbers are in good condition and the felt is in reasonable condition. This space is considered low potential for roosting bats due to the lack of potential access points and no evidence of current hibernation was found.
