**Higher Lickhurst Farm**

**ChippingJob No. 1735Schedule of Repairs to Windows and Doors**

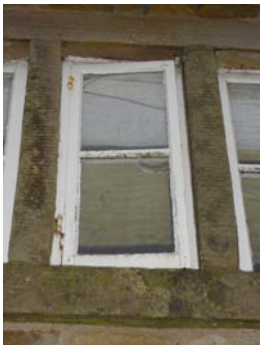
Master Bedroom (South Elevation)	Existing painted softwood framed, single-glazed, casement side opening light window, (two-panes). Due to the proportions of the frames, this window is believed to be one of the oldest in the property and if not original to the house, would appear to have been replaced many years ago to match an original type.  Structural opening size – 365mm (w) x 915mm (h)	The outer window frame appears sound and decay free, except for the cill. However the flush opening light has swollen and cannot be closed. The glazing putty has also deteriorated. The top glazing pane is broken and the paintwork is tired.	The proposal is to remove the opening light intact, to allow it to be stripped of paint, planed and sanded, then preservative treated and re-glazed with new non-linseed based putty. New outer frame to be fabricated in hardwood, to exactly match original, with new draught / weather seals installed. Fix in existing stone surround and mastic seal to edges. Frames to be preservative treated and finished in 1 coat of primer, 2 coats undercoat and 1 exterior gloss coat. Original refurbished opening light to be re-fitted into new outer frame on new flush hinges. New wrought iron opening handles and casement stays to match period of property.

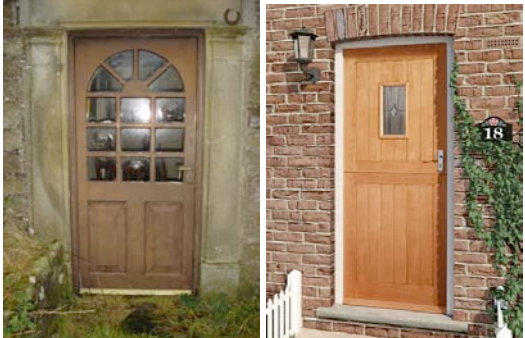
EDG.2

Existing door.      Proposed door type (Illustrative only).	Rear Door on to Garden (South Elevation)	Existing matt painted softwood framed raised and fielded panel door with multiple glazed panels to top half. (This appears to be a non-original door replaced within the last twenty years and is not appropriate to the period of the property).  Structural opening size – 1060mm (w) x 1955mm (h)	The door and frame are generally in fair condition, with little sign of decay, but the paint has almost completely faded and worn away. The glazing is unbroken.	The proposal is to replace the existing door with a bespoke made vertical T & G boarded door, with a small eye-level vision panel, more in character with the period of the property. It is to be preservative treated and finished in 1 coat of primer, 2 coats undercoat and 1 exterior gloss coat. New wrought iron opening handles to match period of property.

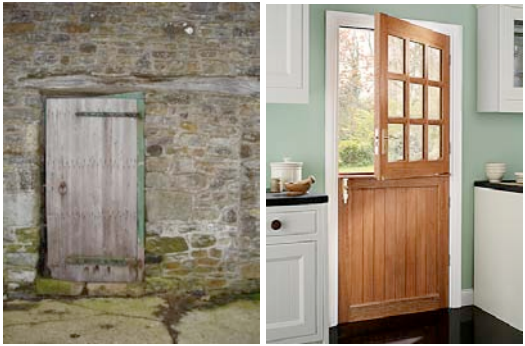
<p>EDG.4</p>

<p>Existing door. Proposed door type (illustrative only).</p>	<p>Kitchen Side Door (East Elevation)</p>	<p>New stained hardwood frame and split 'stable' door with glazed upper leaf in existing opening, with original vertical boarded door fixed in the open position flat against the external wall alongside as a 'shutter'.</p> <p>Structural opening size – 1215mm (w) x 2115mm (h)</p>	<p>The condition of the existing door and frame is poor, with the frame itself rotten and broken away from the opening.</p>	<p>The proposal is to preservative treat the existing door leaf and apply a 2-coat exterior stain finish; clean up the hinges, apply rust converter to arrest further corrosion and paint with black metal 'hammer-effect' finish paint. Original frame to be repaired, with rotten timber cut out and replaced. Door to then be opened fully back, flat against the external wall, alongside the opening to act as a decorative 'shutter', secured in place with 'hook and eye' fixings top and bottom.</p> <p>New hardwood frame and split 'stable' door with glazed upper leaf to be preservative treated and finished with 2 coats of exterior stain. New wrought iron opening handles to match period of property.</p>

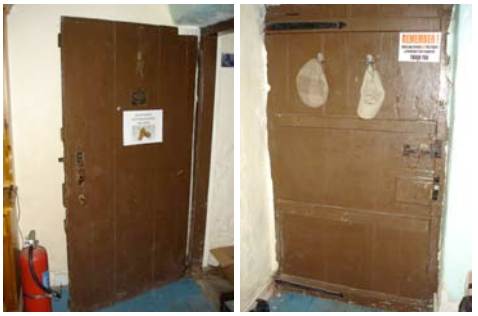
Porch side.      Hall side.	Porch to Hall	Existing painted, broad vertical boarded and railed internal door, with black finish, metal strap hinges and Suffolk latch ironmongery. Door also fitted with a mortice deadlock.	The door and frame are structurally sound, but cosmetically / decoratively poor. The ironmongery is in good working condition.	The proposal is to retain the door in it's frame, with the existing paint finish stripped off. The bare wood is to be sanded lightly, with badly damaged areas filled and smoothed. The timber is to be finished with 1 coat of primer, 2 undercoats and 1 coat of either gloss or eggshell paint in white (as other doors); the ironmongery is to be cleaned up and repainted with black metal 'hammered-effect' paint finish. Deadlock to be retained and serviced as required. Additional signage and fixtures to be left in place and cleaned as required.

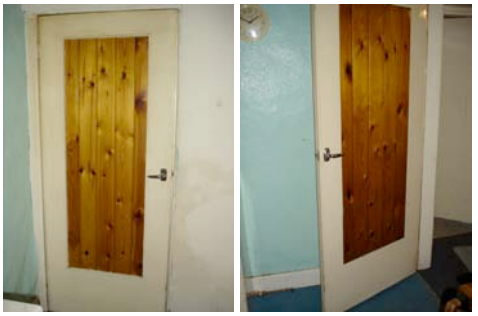
Hall side.      Stairs side.	Hall to Stairs	Existing modern (approx. 30 years old) plain, painted panel door, with a stained knotty pine vertical boarded inner panel (possibly originally glazed).	The door and frame are in fair condition, but not period to the property.	The proposal is to replace this door with a broad vertical boarded and railed timber (pine) door, which matches others in the property and is more in keeping with it's period. The timber is to be finished with 1 coat of primer, 2 undercoats and 1 coat of either gloss or eggshell paint in white (as other doors); the matching 'Suffolk latch' and strap hinge ironmongery is to be painted with black metal 'hammered-effect' paint finish.
DG.3

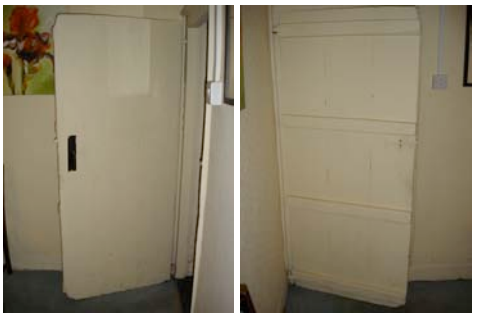
Stairs side.      Lounge side.	Stairs to Lounge	Existing painted, broad vertical boarded and railed internal door, with metal strap hinges and Suffolk latch ironmongery.	The timber of the door is generally sound with minimal damage to the corners, due to wear and tear.	The proposal is to retain the door in it's frame, with the existing paint finish stripped off. The bare wood is to be sanded lightly, with badly damaged areas filled and smoothed, whilst preserving the character of the door. The timber is to be finished with 1 coat of primer, 2 undercoats and 1 coat of either gloss or eggshell paint in white (as other doors); the ironmongery is to be cleaned up and repainted with black metal 'hammered-effect' paint finish.

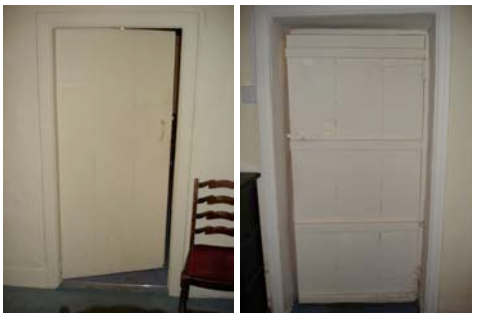
DG.4

Lounge side.      Dining Room side.	Lounge to Dining Room	Existing painted, broad vertical boarded and railed internal door, with metal strap hinges and Suffolk latch ironmongery.	The timber of the door is generally sound with minimal damage to the corners, due to wear and tear.	The proposal is to retain the door in it's frame, with the existing paint finish stripped off. The bare wood is to be sanded lightly, with badly damaged areas filled and smoothed, whilst preserving the character of the door. The timber is to be finished with 1 coat of primer, 2 undercoats and 1 coat of either gloss or eggshell paint in white (as other doors); the ironmongery is to be cleaned up and repainted with black metal 'hammered-effect' paint finish.

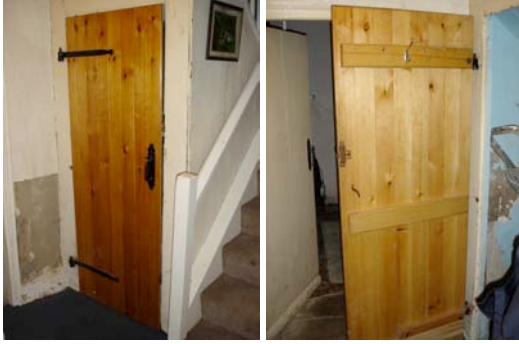
Stairs side.      Cupboard side.	Stairs Cupboard	Existing modern stained, knotty pine, vertical boarded and railed internal door on black painted metal strap hinges and fitted with a 'Suffolk latch'.	This door looks fairly new and has no condition issues.	The proposal is to retain this door, but paint it with primer, 2 undercoats and 1 coat gloss or eggshell paint to match other doors in the property.
DG.6

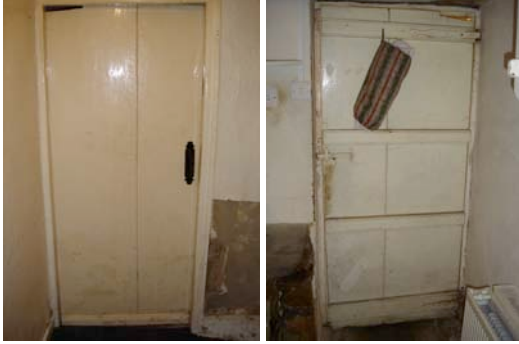
Stairs side.      Utility Room side.	Stairs to Utility Room	Existing painted, broad vertical boarded and railed internal door, with metal strap hinges and Suffolk latch ironmongery.	The timber of the door is generally sound with minimal damage to the corners, due to wear and tear.	The proposal is to retain the door in it's frame, with the existing paint finish stripped off. The bare wood is to be sanded lightly, with badly damaged areas filled and smoothed, whilst preserving the character of the door. The timber is to be finished with 1 coat of primer, 2 undercoats and 1 coat of either gloss or eggshell paint in white (as other doors); the ironmongery is to be cleaned up and repainted with black metal 'hammered-effect' paint finish.

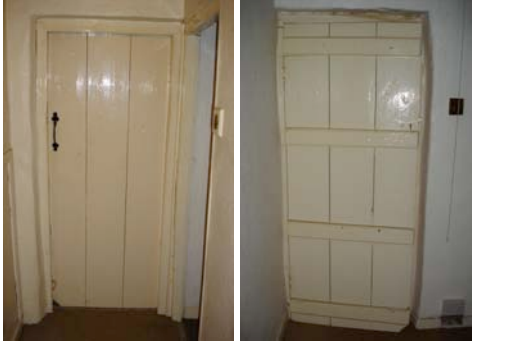
DF.1

Landing side.      Bathroom side.	Landing to Bathroom (Formerly Bedroom)	Existing painted, broad vertical boarded and railed internal door, with metal strap hinges and Suffolk latch ironmongery.	The timber of the door is generally sound with minimal damage to the corners, due to wear and tear.	The proposal is to retain the door in it's frame, with the existing paint finish stripped off. The bare wood is to be sanded lightly, with badly damaged areas filled and smoothed, whilst preserving the character of the door. The timber is to be finished with 1 coat of primer, 2 undercoats and 1 coat of either gloss or eggshell paint in white (as other doors); the ironmongery is to be cleaned up and repainted with black metal 'hammered-effect' paint finish.
DF.2

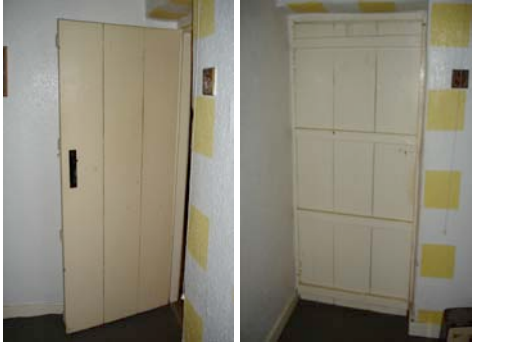
Landing side.      Master Bed side.	Landing to Master Bedroom	Existing painted, broad vertical boarded and railed internal door, with metal strap hinges and Suffolk latch ironmongery.	The timber of the door is generally sound with minimal damage to the corners, due to wear and tear.	The proposal is to retain the door in it's frame, with the existing paint finish stripped off. The bare wood is to be sanded lightly, with badly damaged areas filled and smoothed, whilst preserving the character of the door. The timber is to be finished with 1 coat of primer, 2 undercoats and 1 coat of either gloss or eggshell paint in white (as other doors); the ironmongery is to be cleaned up and repainted with black metal 'hammered-effect' paint finish.

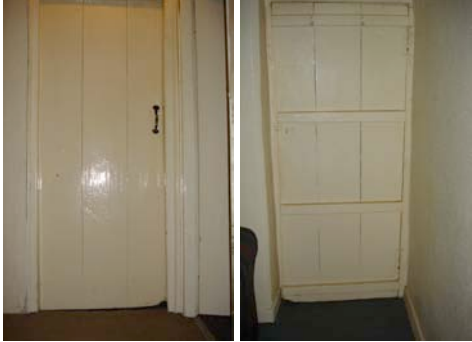
Landing side. Bedroom 2 side.	Landing to Bedroom 2	Existing painted, broad vertical boarded and railed internal door, with metal strap hinges and Suffolk latch ironmongery.	The timber of the door is generally sound with minimal damage to the corners, due to wear and tear.	The proposal is to retain the door in it's frame, with the existing paint finish stripped off. The bare wood is to be sanded lightly, with badly damaged areas filled and smoothed, whilst preserving the character of the door. The timber is to be finished with 1 coat of primer, 2 undercoats and 1 coat of either gloss or eggshell paint in white (as other doors); the ironmongery is to be cleaned up and repainted with black metal 'hammered-effect' paint finish.

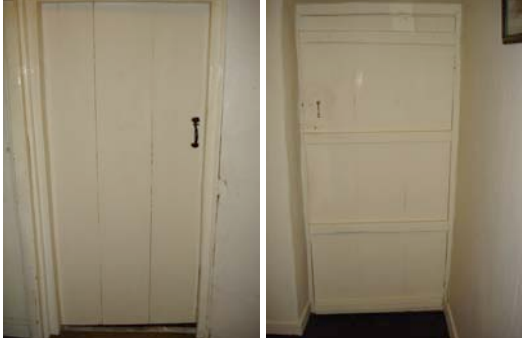
DF.5

Landing side. Bedroom 3 side.	Landing to Bedroom 3 (Formerly Bathroom)	Existing painted, broad vertical boarded and railed internal door, with metal strap hinges and Suffolk latch ironmongery.	The timber of the door is generally sound with minimal damage to the corners, due to wear and tear.	The proposal is to retain the door in it's frame, with the existing paint finish stripped off. The bare wood is to be sanded lightly, with badly damaged areas filled and smoothed, whilst preserving the character of the door. The timber is to be finished with 1 coat of primer, 2 undercoats and 1 coat of either gloss or eggshell paint in white (as other doors); the ironmongery is to be cleaned up and repainted with black metal 'hammered-effect' paint finish.
