BAT SURVEY

AT  
THORN COTTAGE  
KNOWSLEY ROAD  
WILPSHIRE

DATE AND TIME OF VISIT  
6<sup>TH</sup> MARCH 2015 9.30 AM

REFERENCE NO. 4733

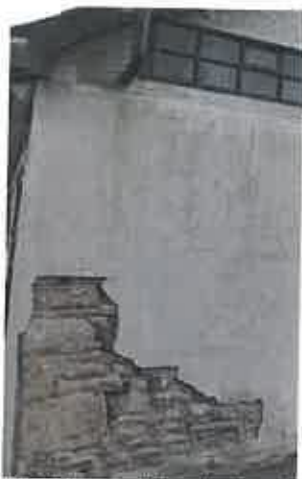
Workshop gable wall showing stone render and Painted brick.

**COMMENTS:** House / workshop, generally there are no access points in the walls, the render is in reasonable condition with the exception of the gable wall of workshop which has exposed stone this does not provide access however crevices are evident in the stone work. There is a potential access point through a timber grille on the east elevation of the rear workshop.

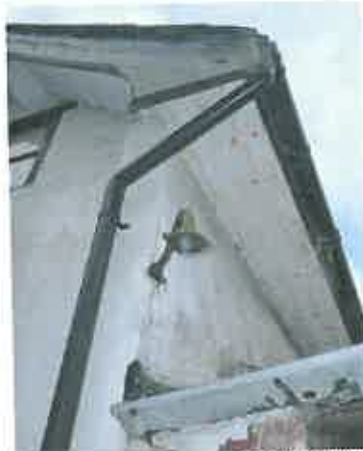
workshop gable and soffit (south)

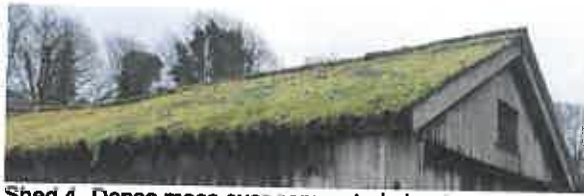
Shed 4- Dense moss over corrugated sheet.

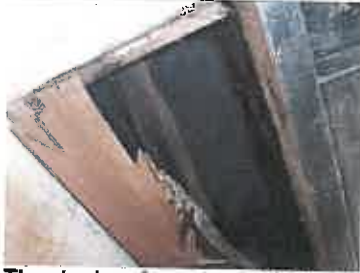
**COMMENTS:** The main roof slate is in reasonable condition the soffits are tight fitting with the exception of the cottage north east corner timber soffit which has a large access opening.

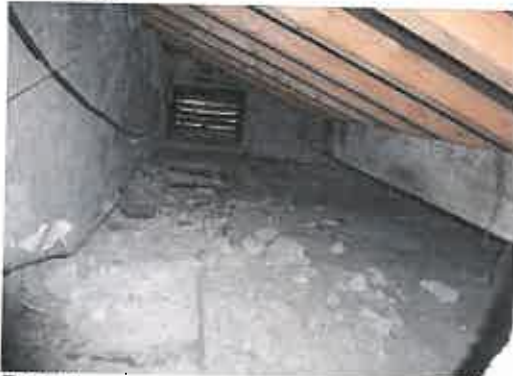
Rear workshop roof void showing potential grille access

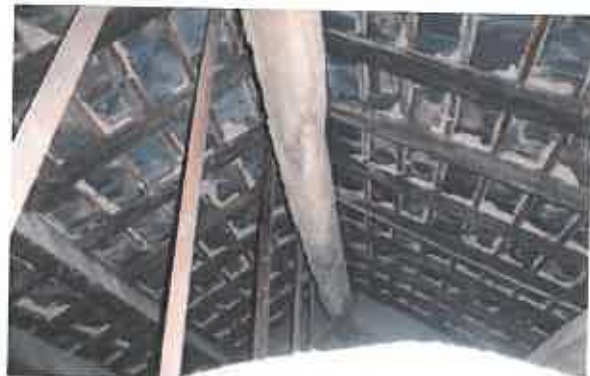
**COMMENTS:** The cottage roof void was accessible via a ceiling hatch however it was not safe to enter. The slate is bedded on to the battens with mortar. The timbers are in good condition with no cracks or crevices the ceiling is covered with fine rubble and in generally dusty. It has low potential for supporting roosting bats. The roof space over the rear workshop was partially accessible, the rafters appear to be quite new and the ceiling was covered with mortar debris probably from when the original rafters were replaced. The space is draughty and although accessible there were no signs ie. Feeding or dropping evidence that bats have entered the space. The remainder of the workshop roof had boarding to the underside, any possible voids behind were not accessible.

Cottage roof void

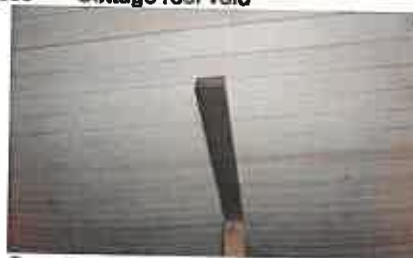
Boarding to the u/s of workshop roof
