STRUCTURAL INSPECTION

NEW HALL BARN, RIBCHESTER

STANTON ANDREWS ARCHITECTS

August 2015
Project No P2531

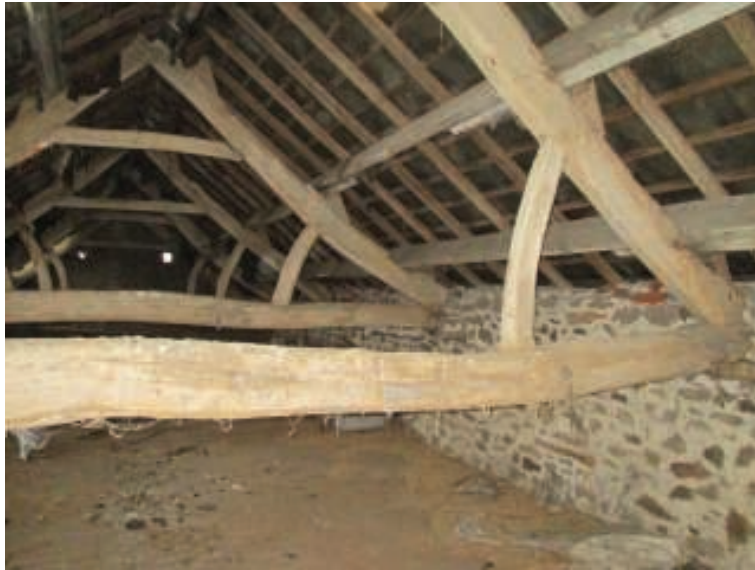
- There are five timber trusses in the main part of the barn. All appear to be the original oak trusses, and all show signs of serious insect infestation and damage (**photos 3-10**). The bottom tie beams are bowed, and one has a serious split (**photo 6**). On one truss the high-level collar tie is loose and ineffective (**photo 8**). On another, the principal rafter exhibits a serious bow (**photo 9**). On a third, the internal bracing strut is missing (**photo 10**).

Photo 3 – View of Barn Roof Trusses from First Floor

The roof trusses in the main barn are in very poor condition. If they are to be retained as features in the new scheme, they will require lifting to ground level and sand-blasting to remove all decayed material. Members with insufficient residual cross section should be replaced or strengthened.

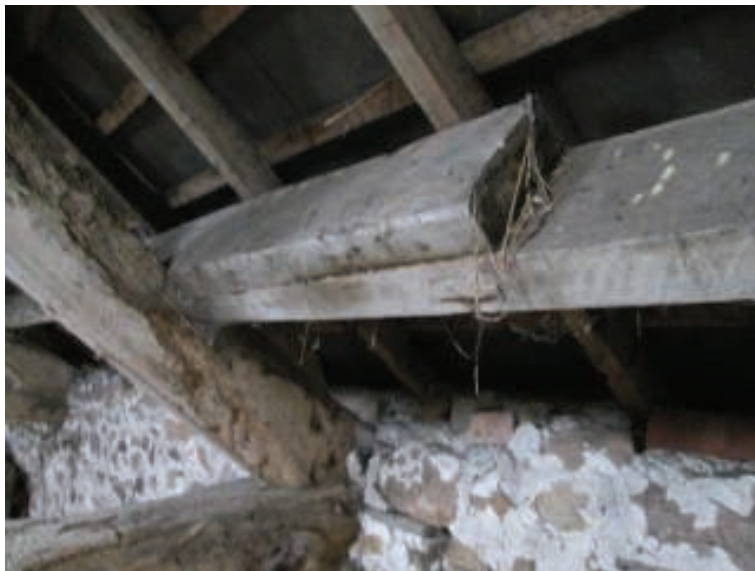
relatively recent past, and new sawn timber rafters, purlins and slating battens provided (**photo 4**). These items are all in reasonable structural condition.

Photo 4 – Sawn Timber Rafters and Purlins

The timber rafters and purlins are in reasonable condition. The rafters are however of limited depth, and may need to be replaced with deeper sections able to accommodate the required depth of new insulation. The conversion will require a new plasterboard ceiling fixed to the underside of the rafters. The purlins will most likely prove inadequate to take the increased weight.

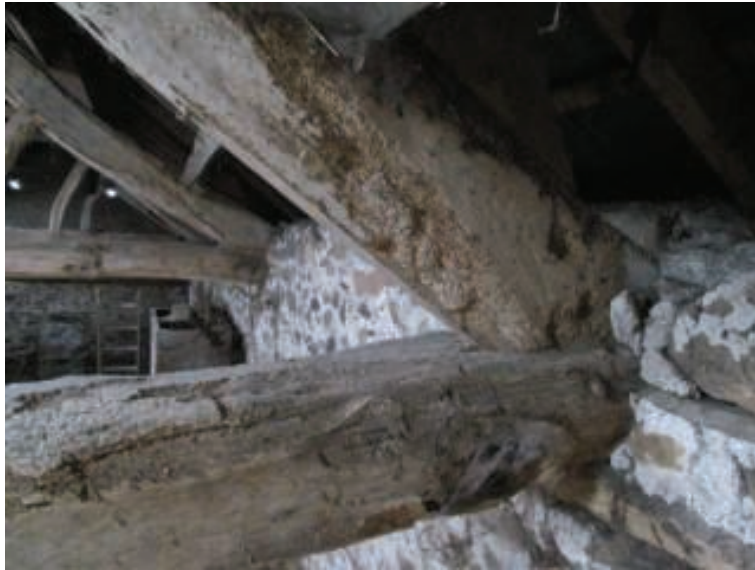
Photo 5 – Insect Decay at Truss Bearing

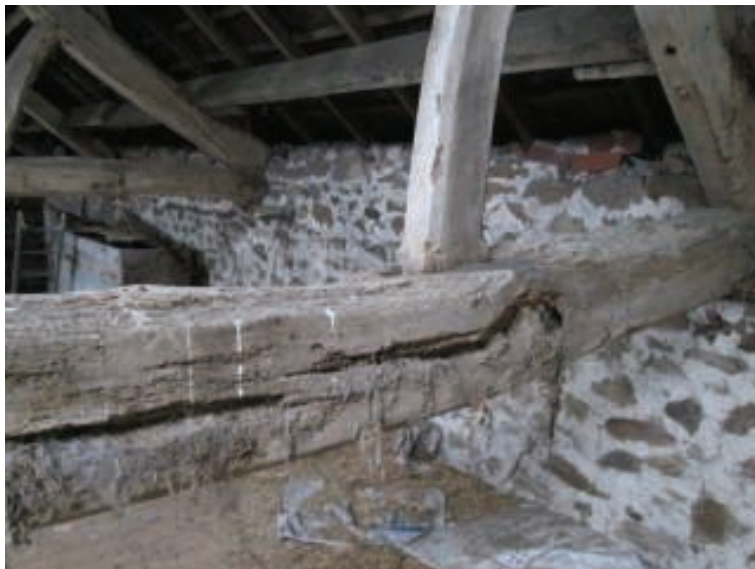
Photo 6 – Insect Damaged and Split Truss Bottom Tie

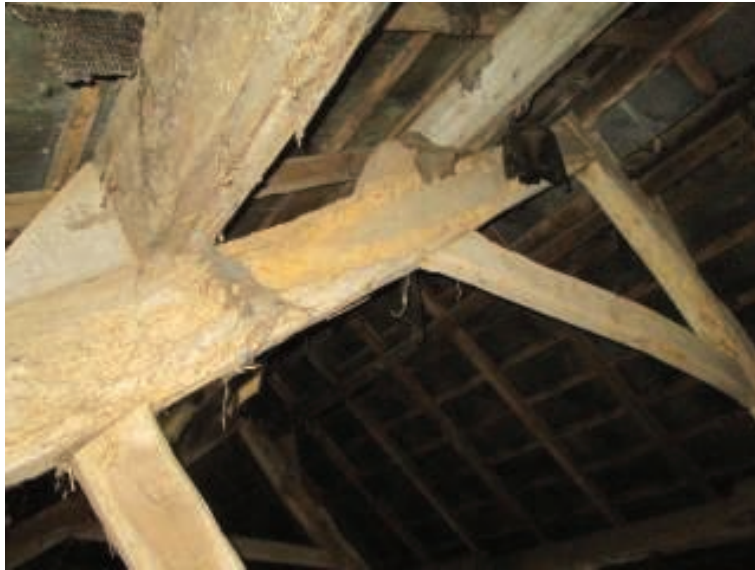
Photo 7 – Insect-Damaged Truss Principal Rafter

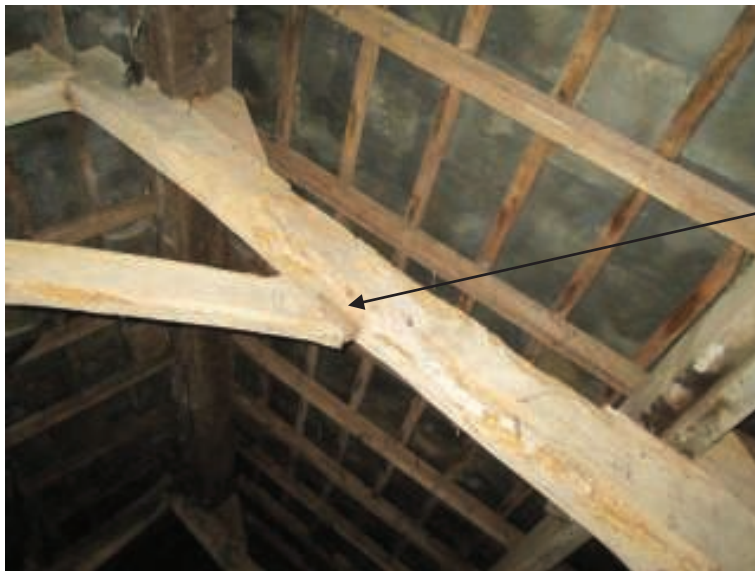
Photo 8 – Loose Truss Collar Tie

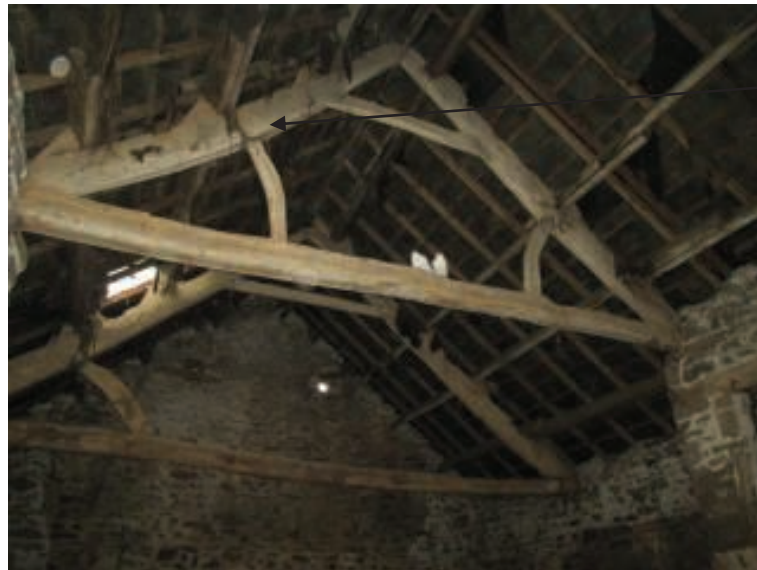
Bowed Rafter

Photo 9 – Bowed Truss Principal Rafter.

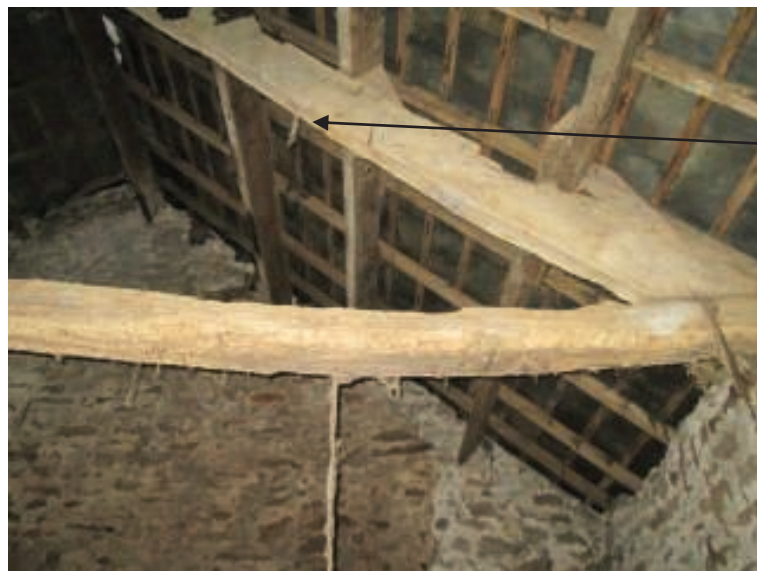
Missing Bracing Strut

Photo 10 – Severe Bow and Insect Damage to Bottom Tie Beam. Missing Strut

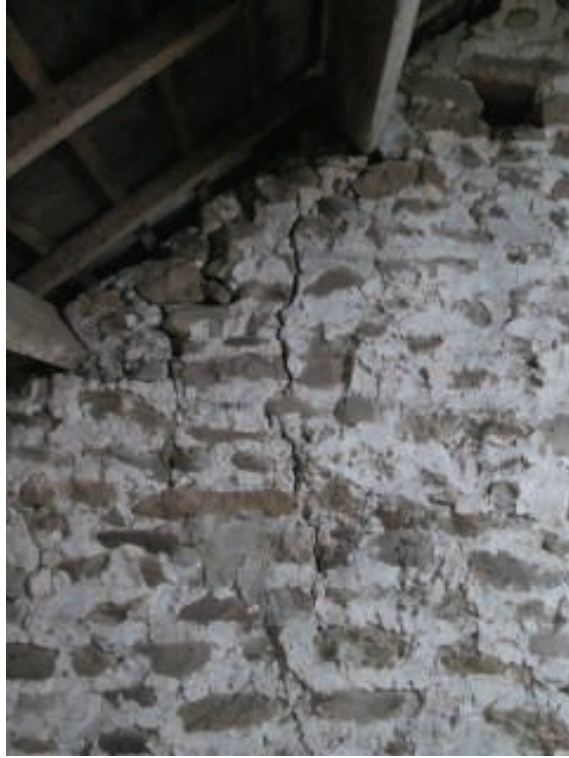
- Vertical cracks were noted in the crosswall, on the side facing the larger loft (**photo 11**), and at some truss bearing positions, where timber sections have been used as spreader beams (**photo 12**).

Photo 11 – Vertical Crack in Central Wall

There are a number of vertical cracks on the inside face of the external walls, most likely the result of continual thermal and moisture movement. They should be repaired by stitching with steel bars or installing new bonding stones across the cracks. The significant crack near the door in the rear wall has been caused by water entry through the failed shippon roof and flashings. It should be stitched in a similar manner. A vertical gap has formed where the internal cross wall meets the front wall.

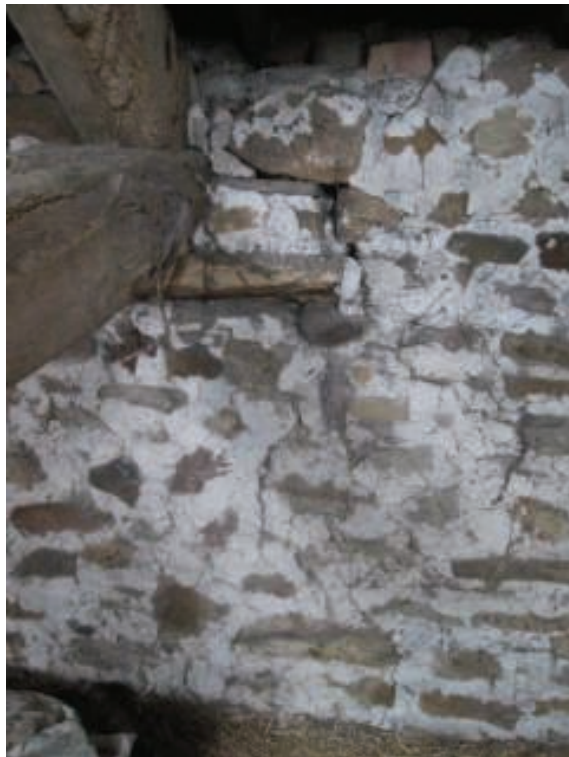
Photo 12 – Vertical Crack at Truss Bearing

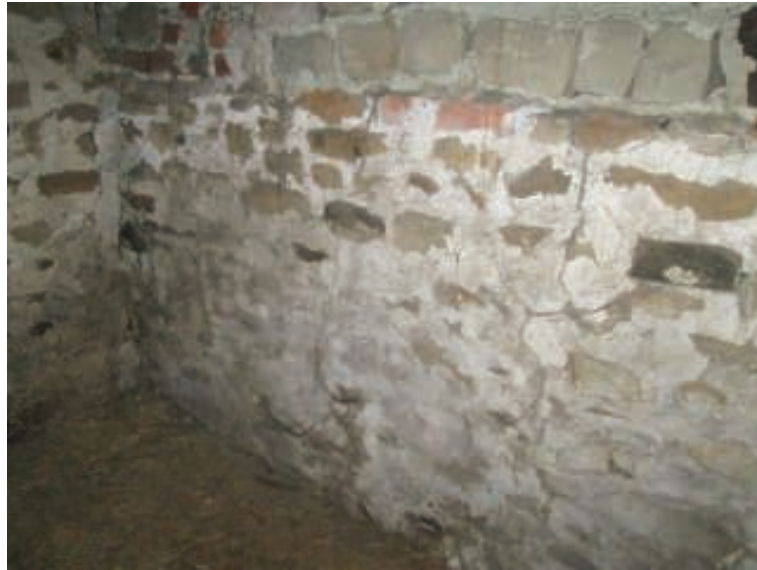
- The small hayloft was accessed via a ladder through an opening in the floor. A number of vertical cracks on the inside face of the walls were noted (**photos 13&14**). There is a vertical crack where the crosswall meets the front wall (**photo 14**).

Photo 13 – Small Loft - Vertical Cracks in Rear Wall

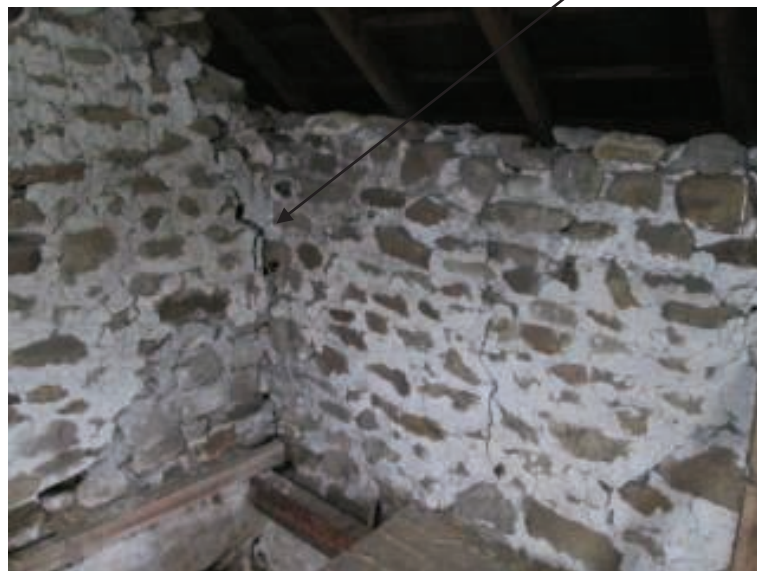
Separation at Wall Junction

Photo 14 – Small Loft – Separation at Internal Wall / Front Wall Junction

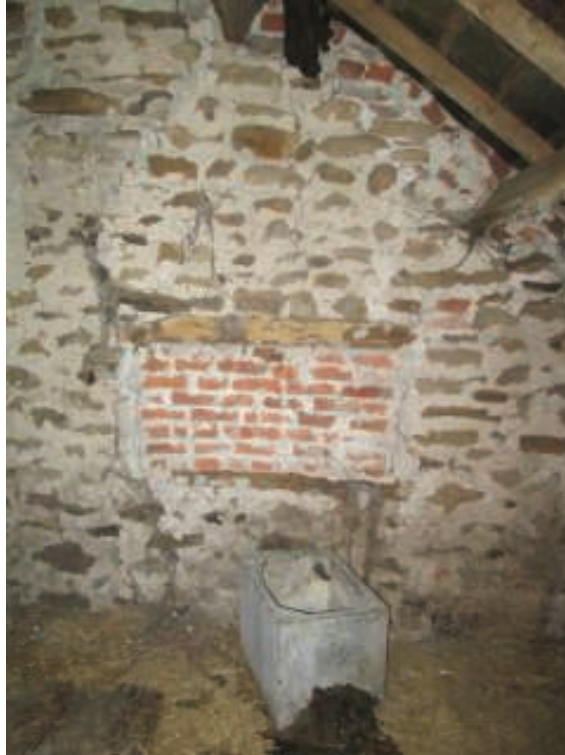
- In the small hay loft, a window opening in the left-hand gable wall has been in-filled with brickwork (**photo 15**). A crack of some 30mm in width has formed at the top left-hand side of the opening (**photo 16**) and the wall is generally quite distorted in this area.

Photo 15 – Small Loft - Left Gable Wall – In-filled Opening

The front wall of the barn leans out significantly at the left-hand corner. This area should be re-built (see marked-up plans in Appendix B), or otherwise stabilised with new steel posts or framing. The left-hand gable wall is distorted, cracked and bulging near the in-filled first floor window. This area should be re-built (see Appendix B). The right-hand gable wall is reasonably straight and vertical. The architectural proposals show that a large part of this wall will be removed over its full height. A rigid steel frame will be needed to support the roof and to give overall lateral stability to the barn. The rear wall of the barn is reasonably straight and vertical.

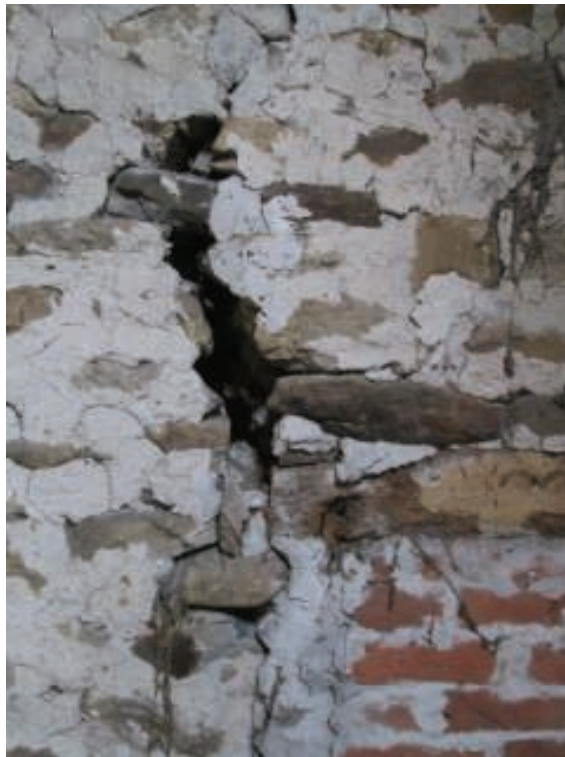
Photo 16 – Small Loft - Left Gable Wall – Wide Crack

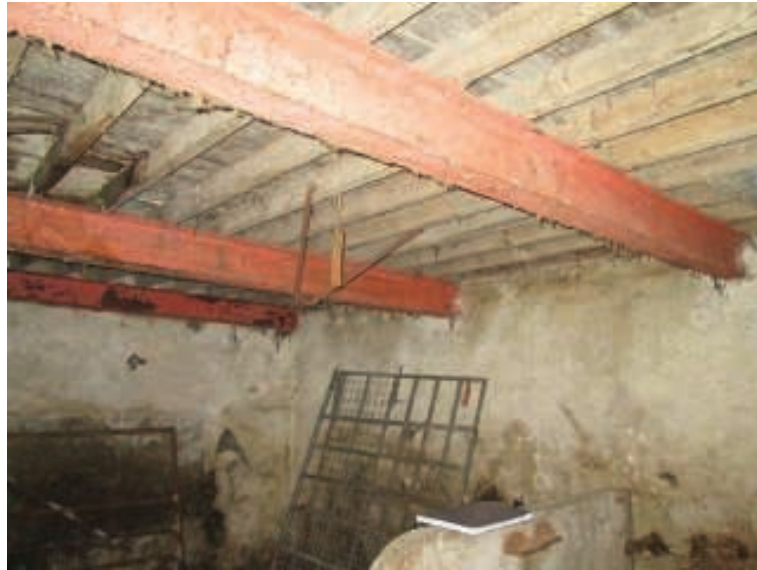
- The floor joists and steel beams forming both hay lofts were inspected. No significant defects were noted (**photo 17**).
- In the byre below the smaller hay loft, the window has been reduced in height to include a ventilation opening. The original timber lintel remains in place (**photo 18**).

Photo 17 – Steel Beams Supporting Floor of Small Loft

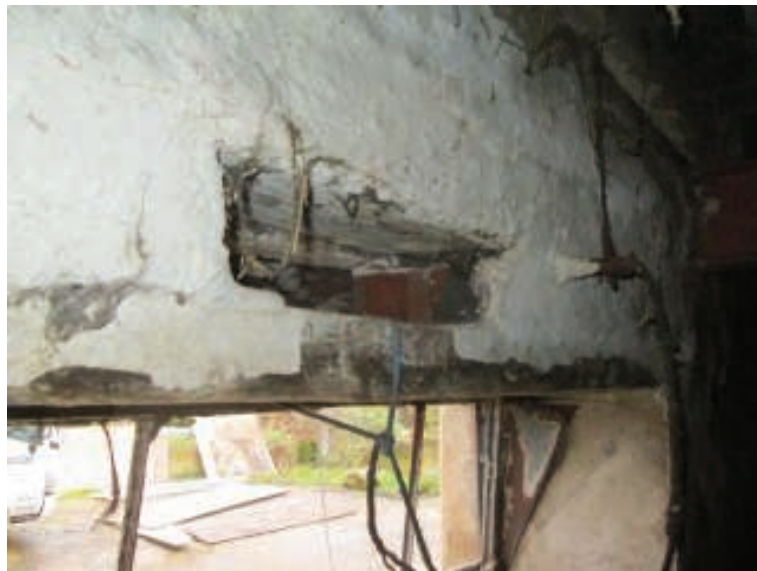
Photo 18 – Timber Lintel – Left Hand Gable Wall, Ground Floor

Elsewhere, timber lintels should be removed and replaced with concrete or steel items.

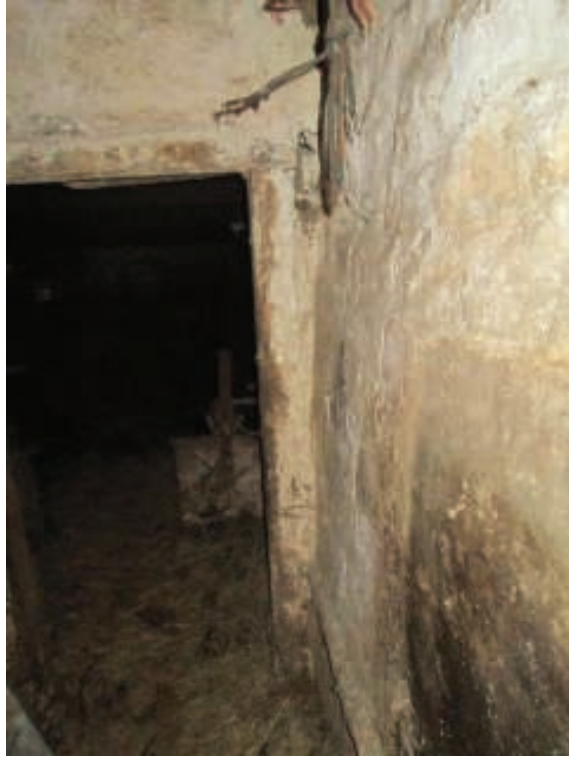
- Severe outward leaning of the front wall at the front left-hand corner was noted (**photo 19**). The lean is approximately 100mm over the height of a 1200mm spirit level (**photo 20**).

Photo 19 –Leaning Front Wall

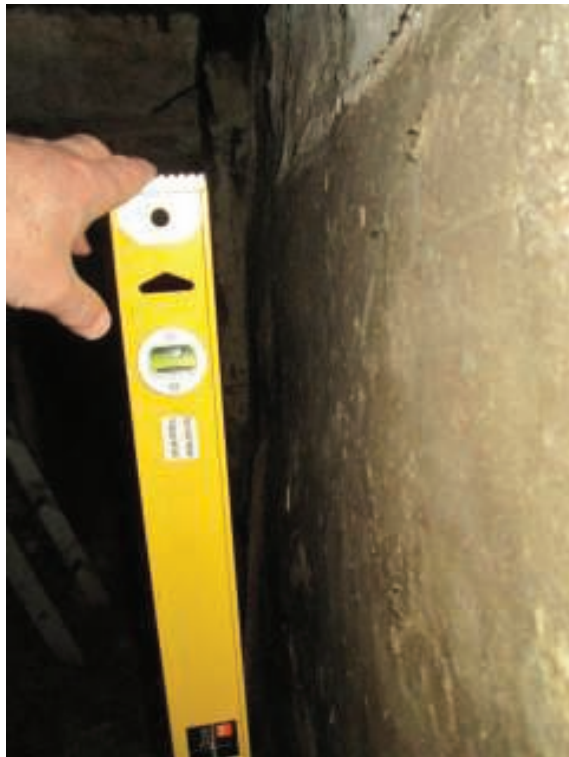
Photo 20 – Leaning Front Wall

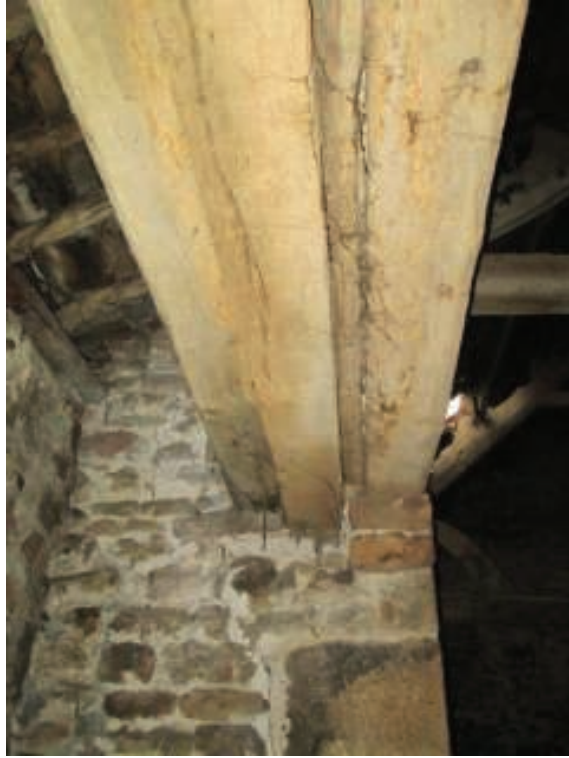
- Timber lintels have been provided over all window and door openings, including the former rear entrance door (**photos 21,22&23**). The timber shows signs of decay due to insect infestation.

Photo 21 – Timber Beams over Main Barn Doors

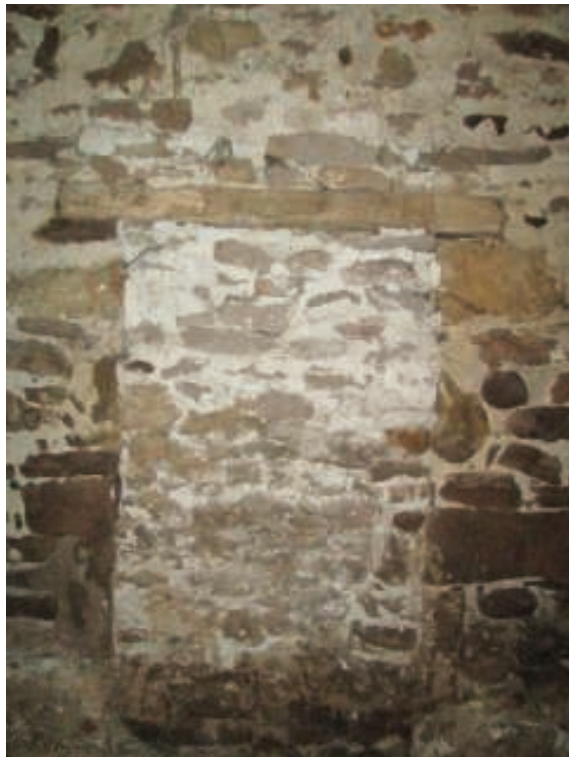
Photo 22 – Right-Hand Gable Wall – In-filled Door Opening

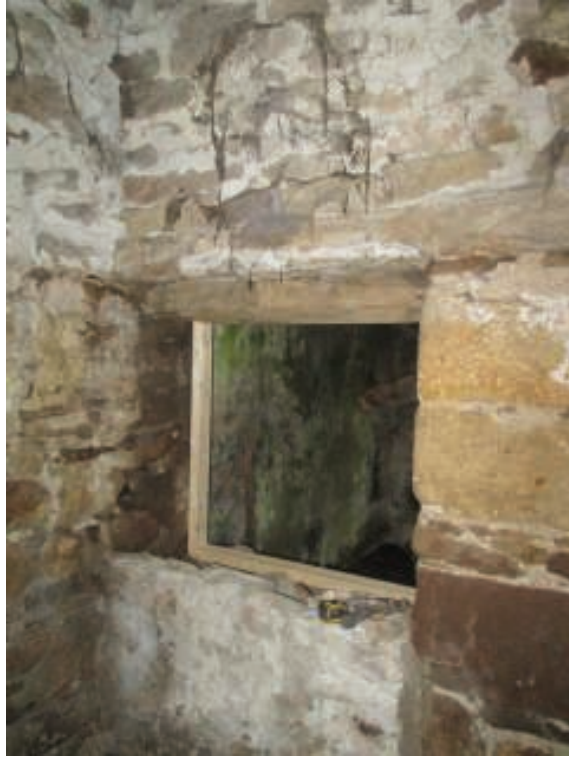
Photo 23 – Right-Hand gable Wall – Timber Lintels above Door / Window Opening

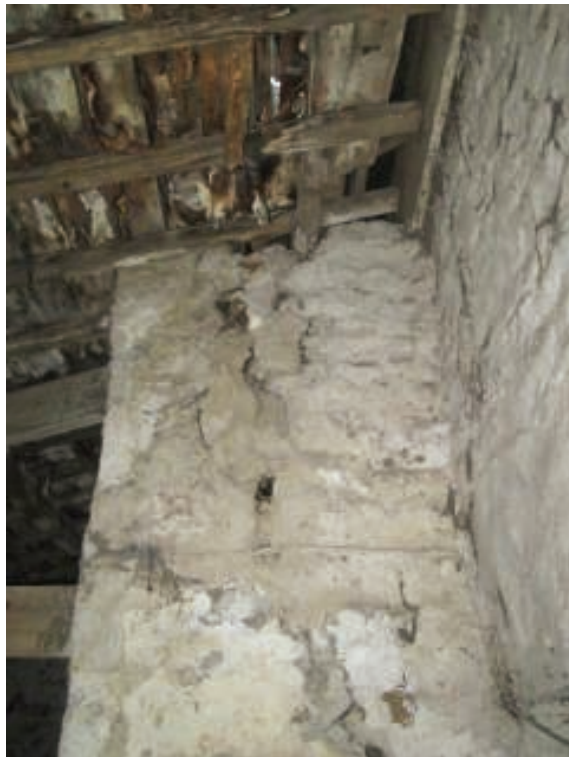
- There is a vertical crack of width up to 25mm over the full height of the rear wall near the door leading to the shippon (**photos 24&25**).
- Three trial pits had been excavated, alongside the inside face of the external walls. Trial pit 1 was located at the left-hand gable (**photo 26**), trial pit 2 at the right-hand gable (**photo 27**), and trial pit 3 at the front wall in the double-height barn space. All three revealed that the walls are founded in stiff clay and extend no deeper than approximately 150mm below the floor.

Photo 24 – Rear Wall of Barn – Vertical Crack (1)

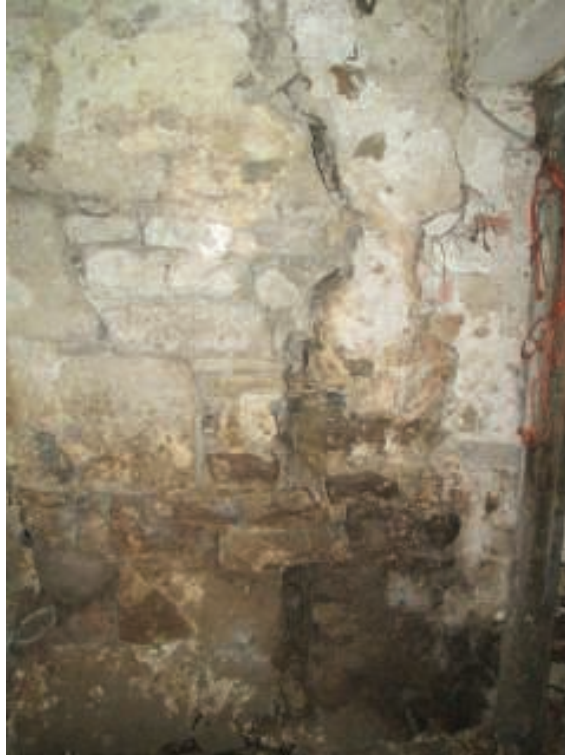
Photo 25 – Rear Wall of Barn – Vertical Crack (2)

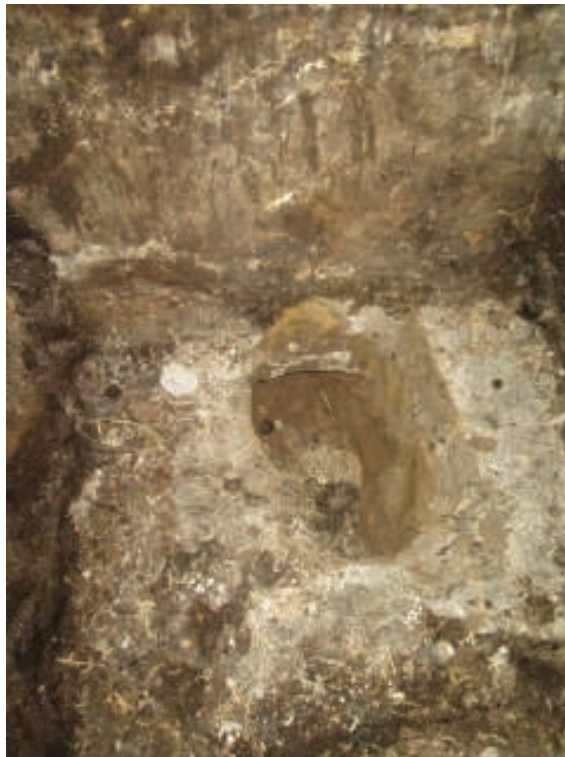
Photo 26 – Trial Pit 1 – Left Hand Gable Wall

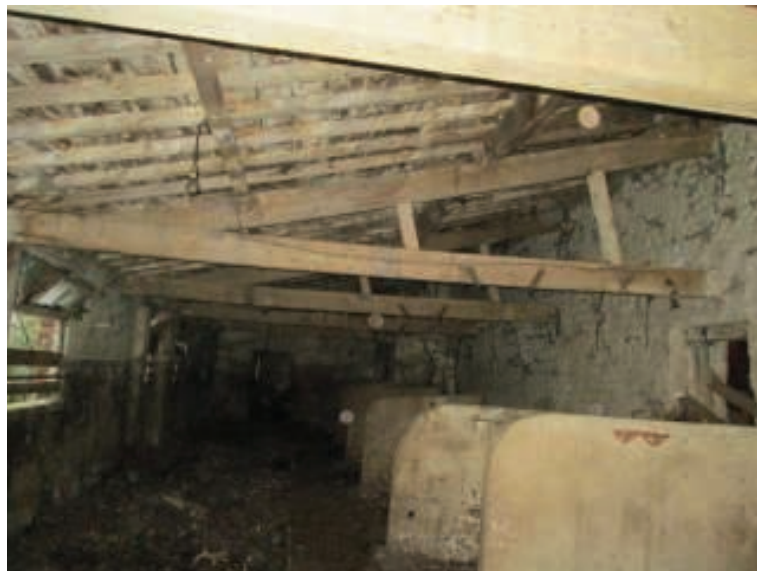
- The roof trusses appeared to be free of defect (**photo 28**).
- There are signs of serious water damage to the rafters and sarking boards near the door between the barn and shippon (**photo 29**). Minor water damage to the boarding was noted at several other locations.
- Cracking in the stonework of the rear barn wall was noted at the left-hand gable end (**photo 30**) and right-hand gable end (**photo 31**).

Photo 28 – Internal View of Shippon

The roof trusses in the shippon appear to be reasonably sound but should be inspected by a timber preservation specialist if they are to be re-used. The trusses may need to be raised above their existing height to increase headroom below the bottom tie beams.

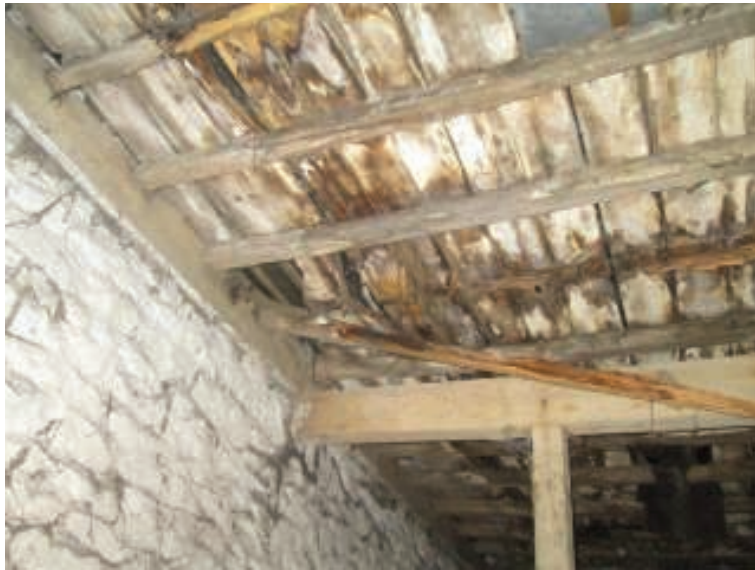
Photo 29 – Water Damage to Shippon Roof

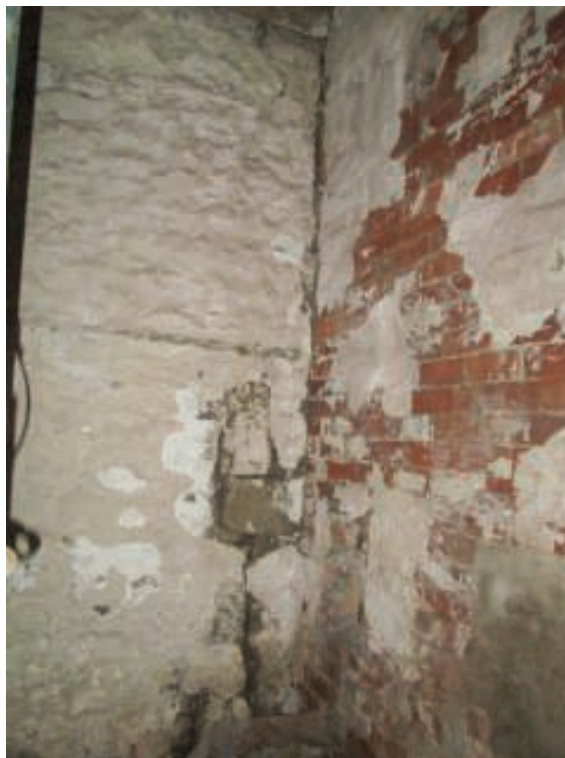
Photo 30 – Junction of Shippon Wall and Barn Wall at Left-Hand Gable

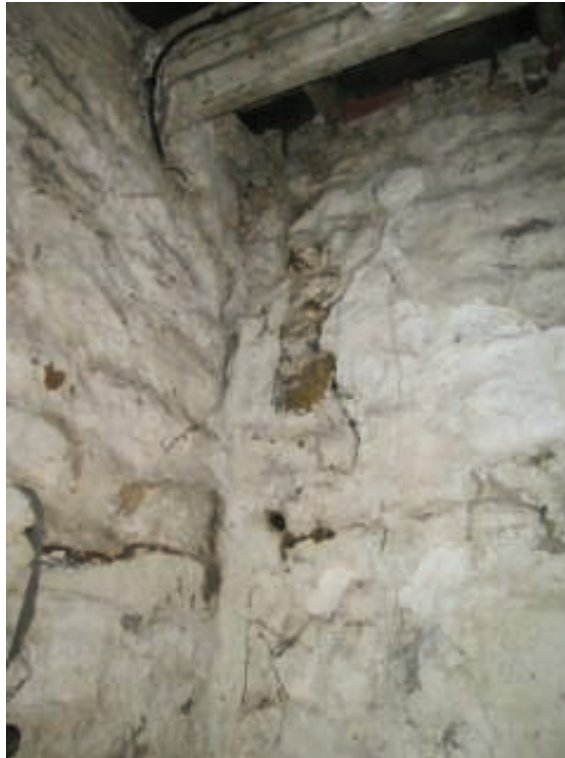
Photo 31 –Cracking in Rear Wall of Barn at Right-Hand Gable

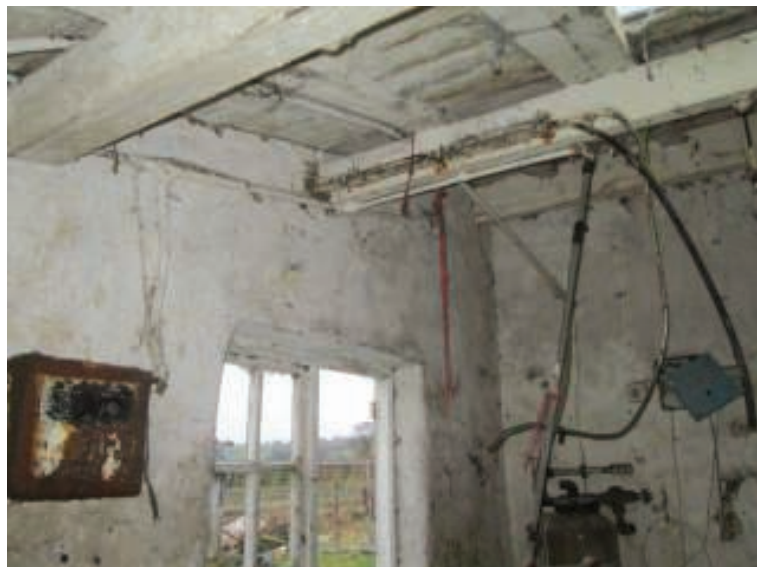
- The roof structure is of timber boarding, rafters and purlins (**photo 32**). It is in poor condition, and has collapsed above the rearmost outhouse (**photo 36**).
- The walls have been constructed from concrete, cast in-situ, possibly using aggregate dredged from the adjoining river bed (**photo 33**).

Photo 32 – Internal View of Outhouses at Right-Hand Gable

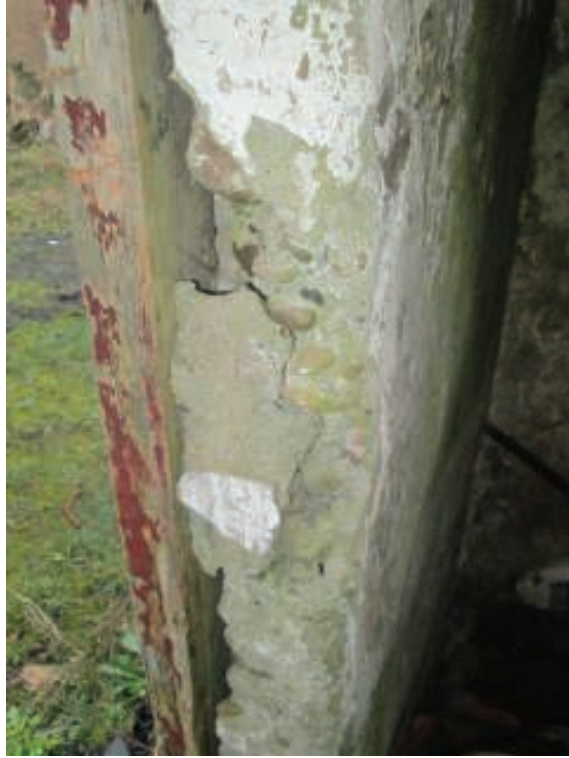
Photo 33 – Outhouse Wall Construction

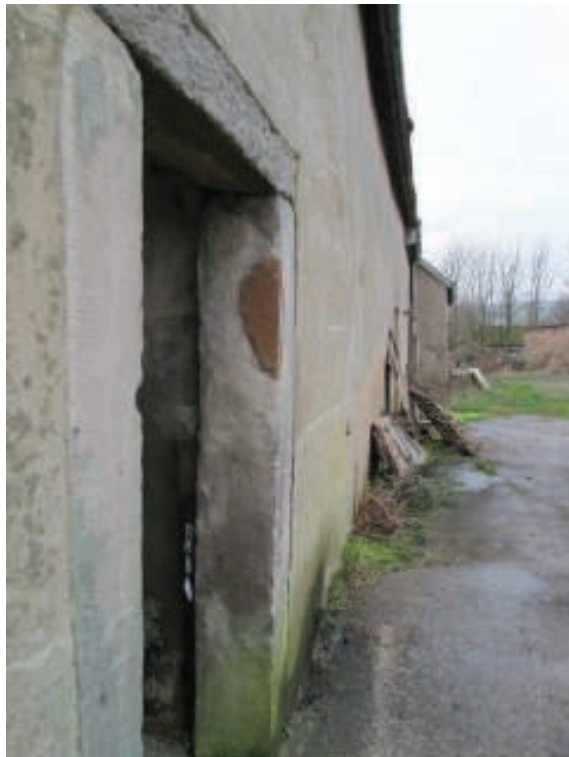
- The slating on the main barn and most of the shippon is good, reflecting the fact that they have recently been re-slatted. The roof over the outhouses on the right-hand side is poor.
- The front wall of the barn shows the significant outward lean at the left-hand corner as noted internally (**photo 34**). The wall leans inward at the main entrance door (**photo 35**).
- The right-hand gable wall of the barn is reasonably straight and vertical. There is some cracking where the rear outbuilding joins the main barn (**photo 36**).
- The rear wall of the shippon is reasonably straight and vertical (**photo 37**). The timber lintels over the windows have decayed (**photo 38**).
- The gable wall of the shippon has been partially demolished and the gap closed with plywood sheeting (**photo 37**). A gap has opened where the brick gable wall of the shippon joins the main barn (**photo 39**).

Photo 34 – Leaning Front Wall near Left-Hand Gable

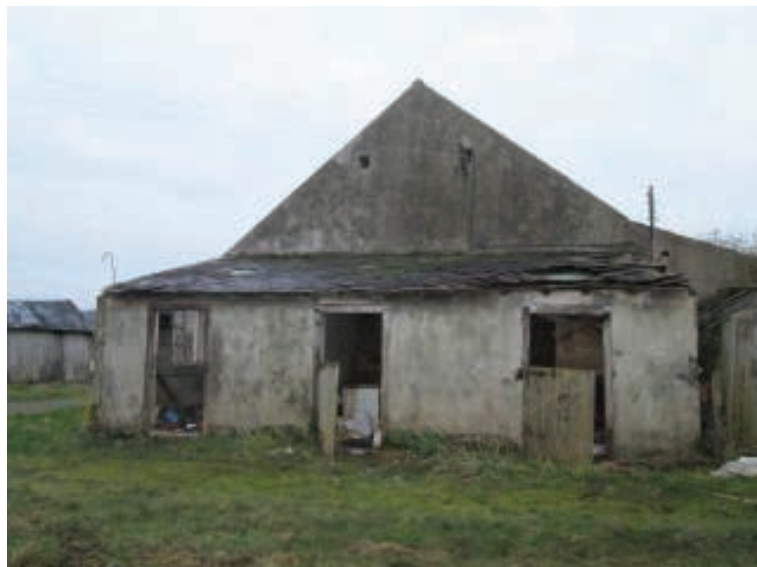
Photo 36 –Right-Hand Gable and Outhouses

Current architectural proposals involve converting the main part of the barn and the attached rear outbuilding to residential accommodation. The outbuildings attached to the right-hand gable wall will be demolished. The shippon will be demolished and re-built.

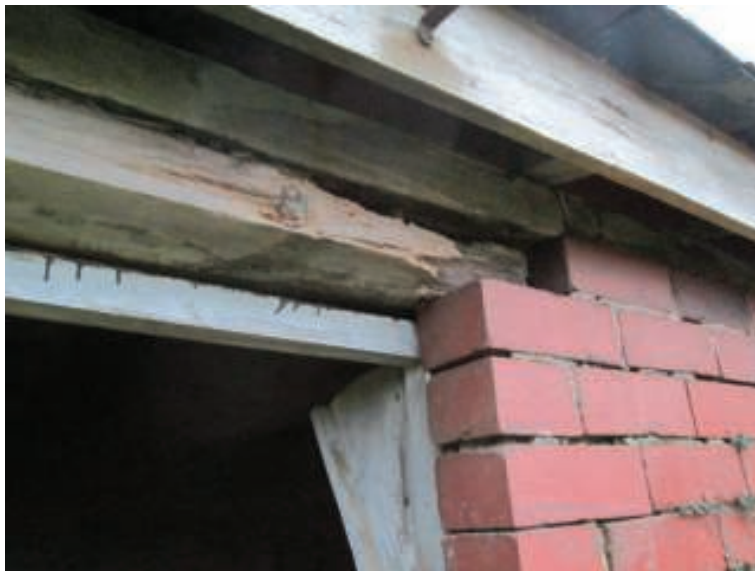
Photo 38 – Decayed Timber Lintels - Shippon

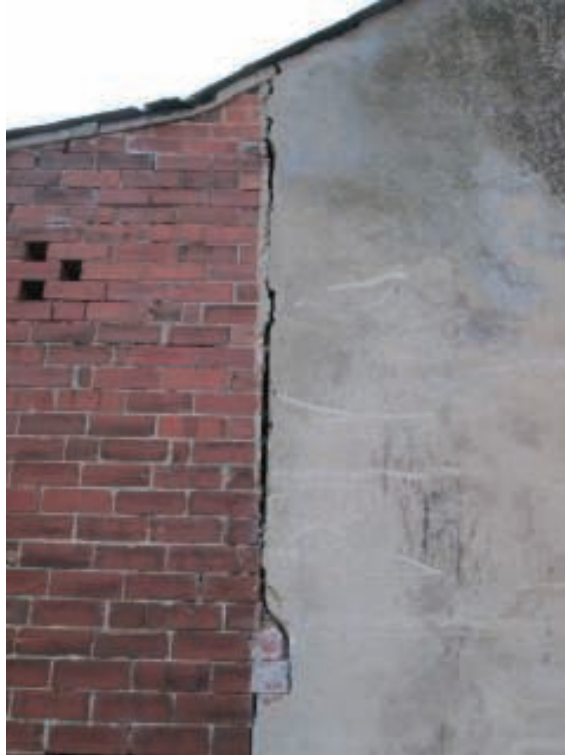
Photo 39 – Gap between Shippon and Barn - Left-Hand Gable Wall

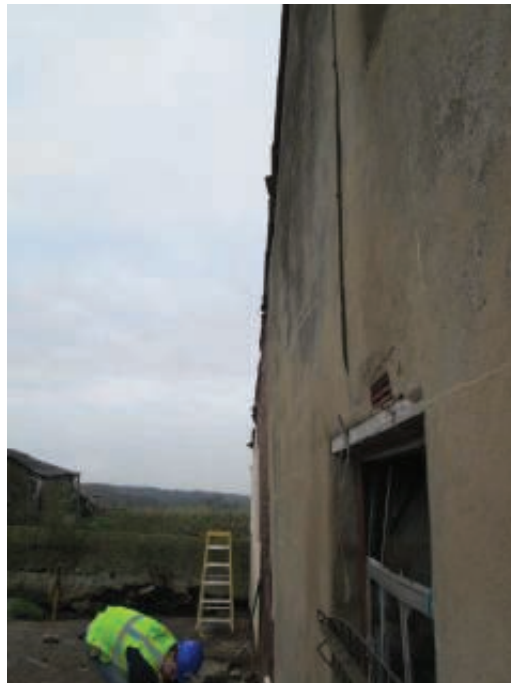
Photo 40 –Bulging Left-Hand Gable Wall
