BUILDING (STRUCTURAL) CONDITION SURVEY
IN CONNECTION WITH
BARN AT HIGHER BOYCE FARM,
RIBCHESTER

MR M. SELLS AND MISS M. HOWORTH,
HIGHER BOYCE FARM,
STONEYGATE LANE, RIBCHESTER, PR3 3YN

JOB REF: 4874, DATED: 23/09/2015, VERSION: 1.00.

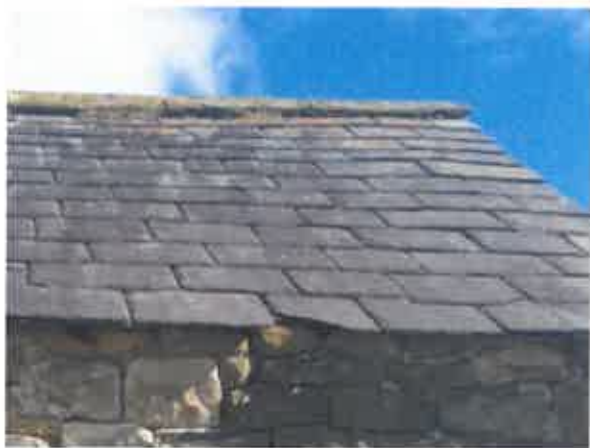
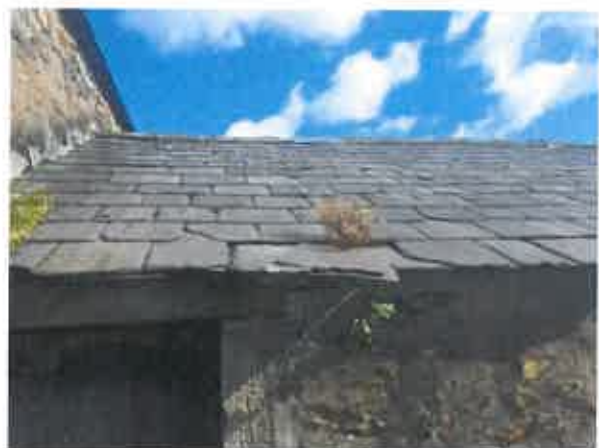
The natural slate covering to the roof is in an average condition and is showing signs of weathering with a number of chipped and cracked slates throughout. There are also a number of loose / dislodged and missing slates as well as an ad-hoc repair to the roof covering to the west elevation of the south section of the barn. All of which is to be expected given the age of the barn. All ridge tiles appeared to be present at the time of construction however they appeared to be in poor condition throughout along with the mortar pointing which was degraded and missing in places. Moss and vegetation growth was also present at roof level. These issues have the potential to allow for unwanted water ingress into the barn.

PL2 (Left) and PL3 (Right) showing cracked, chipped and dislodged slates along with vegetation growth.

- All timber wall plates should be replaced throughout.
- All degraded ridge files should be removed and replaced with new ridge files throughout.
- Damaged areas of the roof covering should be repaired and all damaged slates should be replaced whilst ensuring that the roof is water tight.

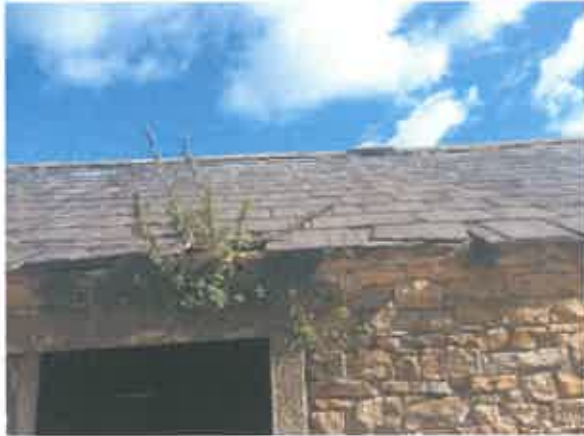
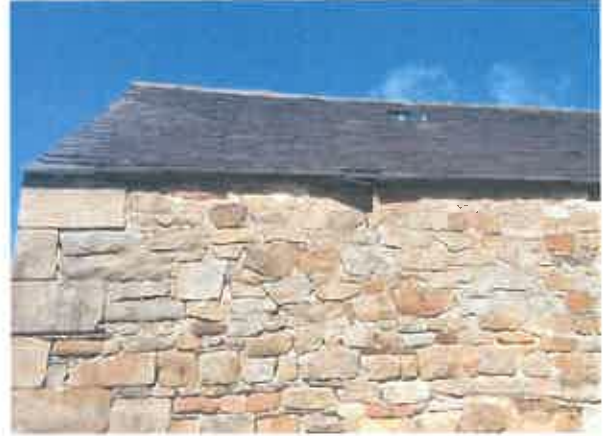
PL4 (Left) and PL5 (Right) showing cracked, chipped and dislodged slates along with vegetation growth.

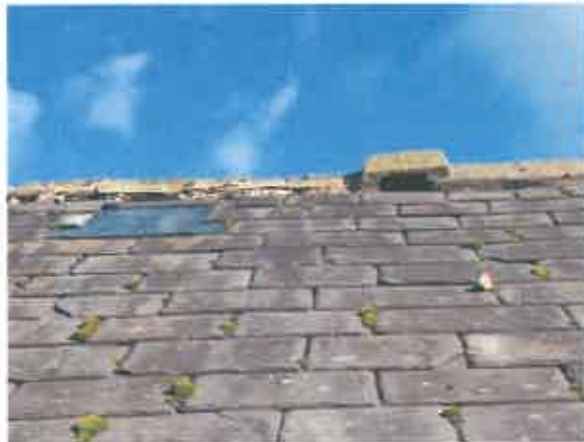
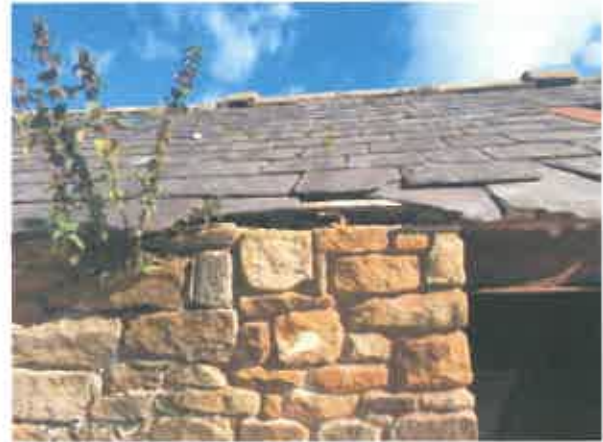
PL4 (Left) and PL5 (Right) showing degradation to ridge tiles and pointing as well as cracked, chipped and dislodged slates with vegetation growth.

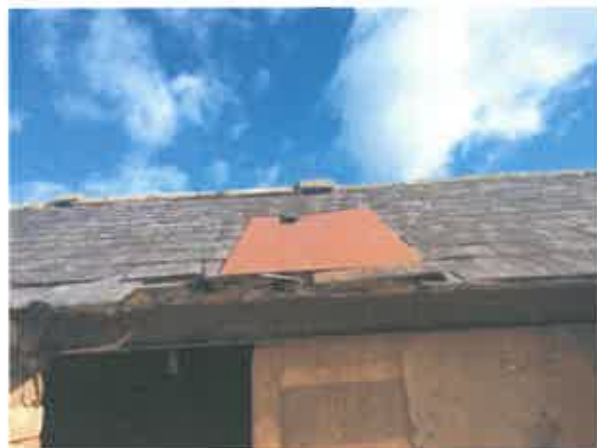
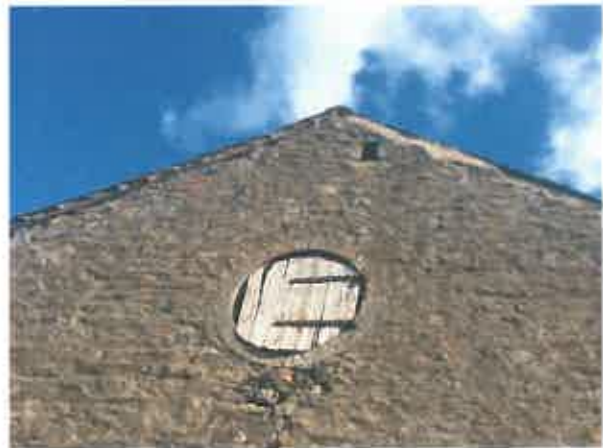
The verges to the main roofs were in poor condition due to mortar degradation and areas of missing mortar pointing. Areas of exposed timber wall plates were also exposed due to the degradation and lack of mortar pointing.

PL6 (Left) and PL7 (Right) showing cracked, chipped and dislodged slates with ad-hoc roofing repair. Degradation and missing mortar pointing noted to roof verges.

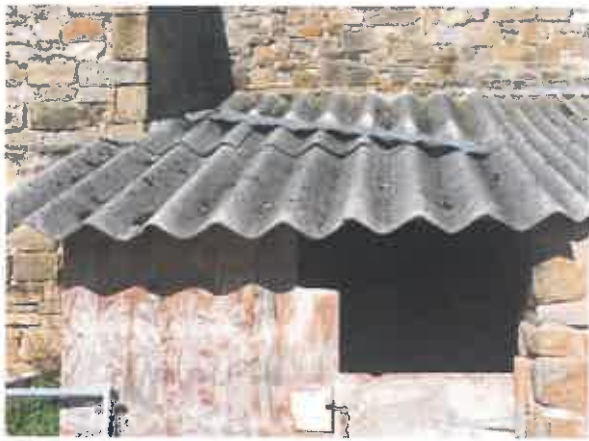
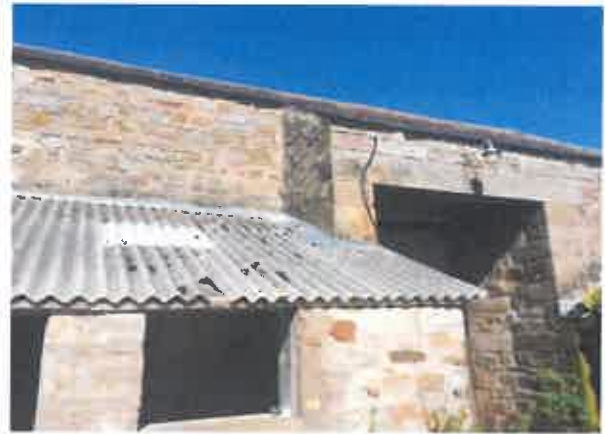
The asbestos roof covering to the south elevation of the north section of the barn was in poor condition with cracked and damaged asbestos sheets as well as vegetation growth and weathering visible to the surface of the covering. All asbestos sheets were present at the time of inspection with no dislodgements or breaches present at the time of inspection. In accordance with this application, this area of the barn is to be demolished. This said, suspected Asbestos Containing Material (ACMs) were highlighted during the inspection and subsequently a full demolition and alteration asbestos survey will need commissioning and undertaking by the client prior to any works commencing. In addition, any ACM will require removing in full by a specialist asbestos removal contractor and Clean Air Certificate authorised prior to conversion works commencing.

The lead work that is present at the junction between the north and south buildings of the barn is in average to poor condition with no obvious breaches, dislodgements or missing sections of flashing however the flashing had become discoloured. The lead work to the asbestos roof was in average condition at the time of inspection; however a large section of the lead flashing had become completely dislodged from the roof and wall junction.

PL8 (Left) and PL9 (Right) showing the condition of the asbestos roof covering and the section of dislodged lead flashing (this particular area is to be demolished).

- All asbestos containing materials should be fully removed from site and disposed of by a licenced specialist contractor. (See also Section 1.1 - ACMs note).

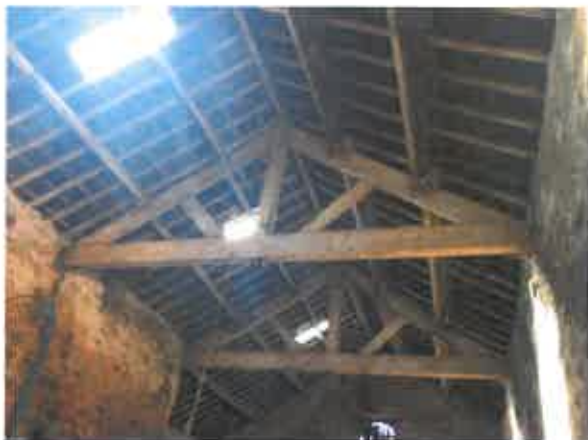
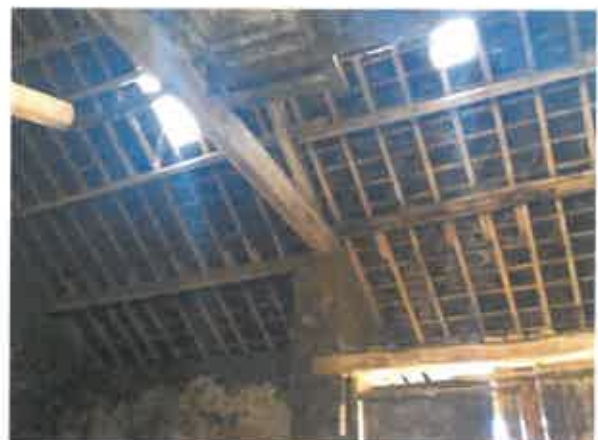
The trusses throughout are beginning to dilapidate and on visual inspection of the trusses; they appear to be suffering from decay. This could have occurred over time as a result of the breaches within the roof covering which could have allowed for water ingress to occur. Evidence of possible insect attack is also present. However, these issues would need to be fully confirmed with a closer visual inspection of the trusses.

PL10 (Left) and PL11 (Right) showing internal roof structure to north section of the barn.

- Remedial works should be carried out to the timber roof structure where required. This may consist of the treating of all timber components that are to be retained i.e. trusses, to protect against rot and insect attack.

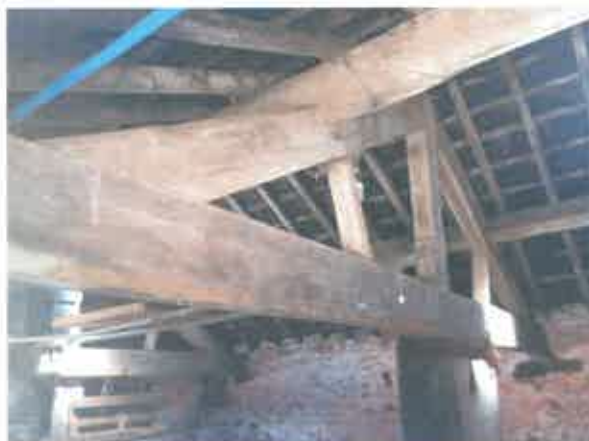
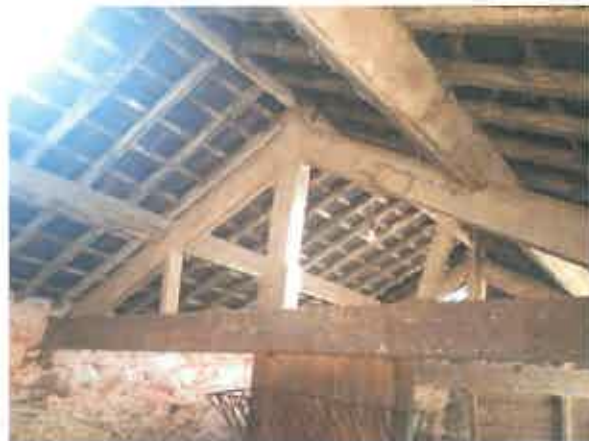
PL12 (Left) and PL13 (Right) showing internal roof structure to south section of the barn.

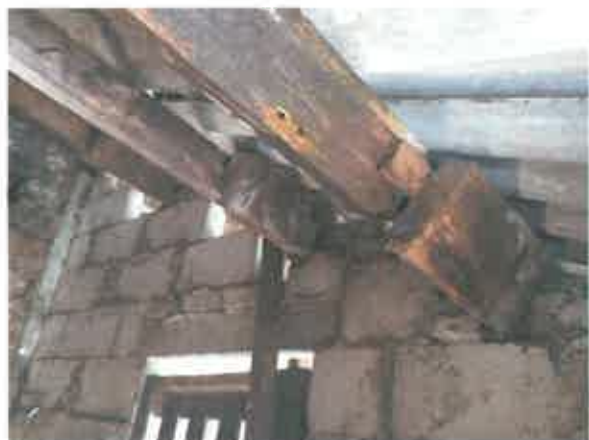
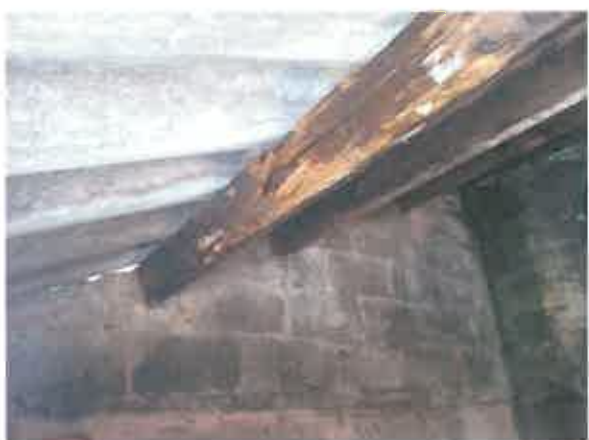
The purlins which supported the asbestos roof covering to the south elevation, where in poor condition, with clear evidence of decay and rot visible at the time of inspection.

PL14 (Left) and PL15 (Right) showing internal roof structure to lean to roof on the south elevation of the north section of the barn building.

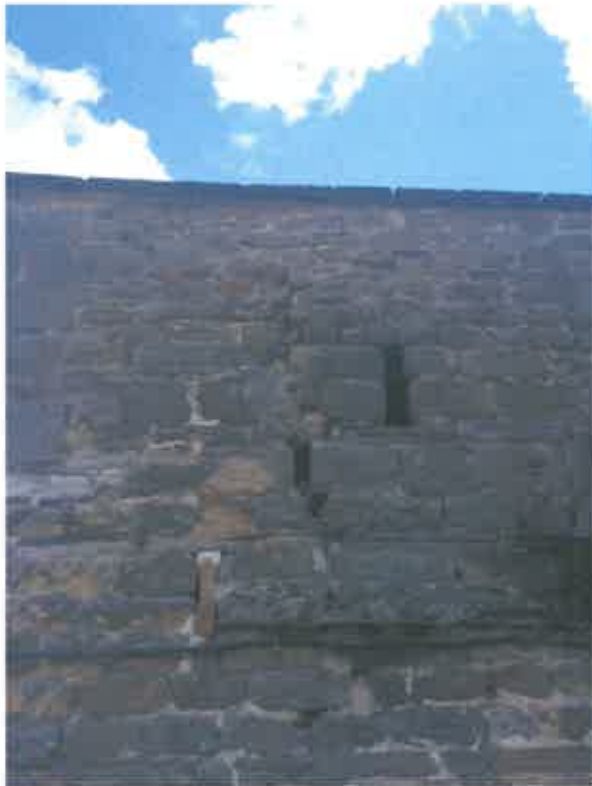
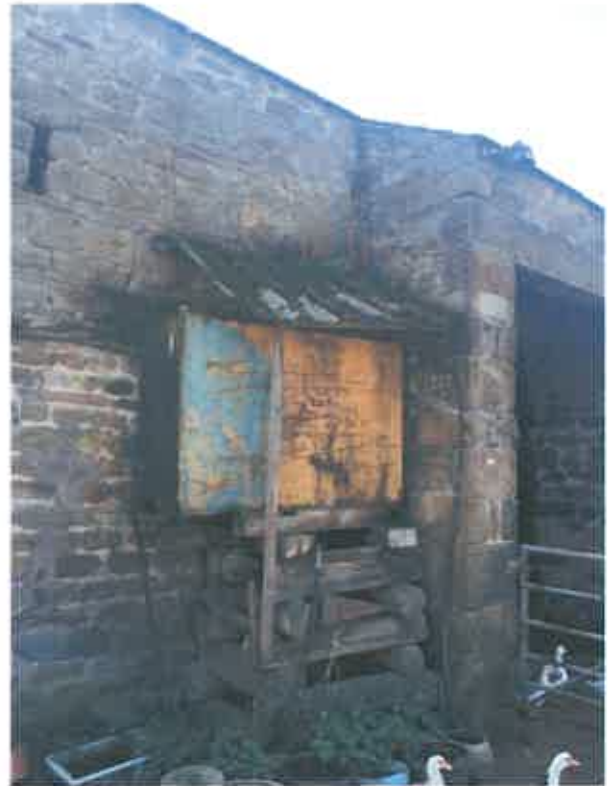
The condition of the external walls to the barn is that of average condition throughout with no obvious structural cracking and breaches. However this is with the exception of the presence of ventilation holes and vertical wall cracking to the north and east elevations with associated patch mortar repairs. Potential minor, isolated areas of remedial crack stitching / lateral restraints required at these points. Mortar degradation and missing mortar pointing was prevalent throughout particularly to the base of the walls where the mortar is more susceptible to decay through the splashback of rainwater. Hairline cracking of the mortar joints was also evident throughout. Mortar cracking was also noted to the right hand side face of the stone lintel over the barn entrance to the north elevation.

PL17 (Left) showing area of cracking to eastern side of north elevation. PL18 (Right) showing dilapidated ad-hoc structure, used to store water tank, which is to be demolished.

- Remedial works should be carried out to the external walls where required. This will involve the raking out of the degraded mortar and repointing the affected areas with a suitable lime mortar. Stone replacements may also be required in order to replace any degraded / damaged / missing stones. Crack stitching to take place in order to repair wall cracking to the north and east elevation walls.

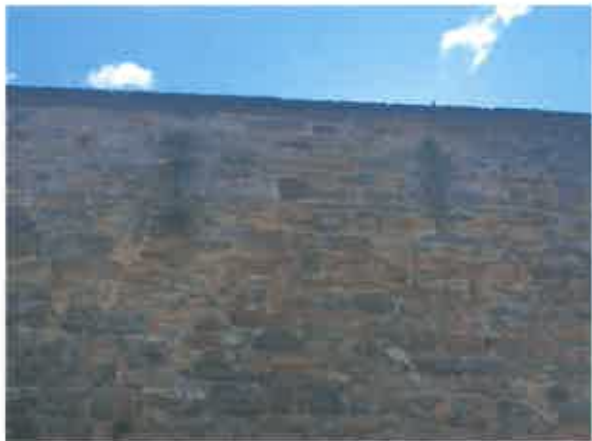
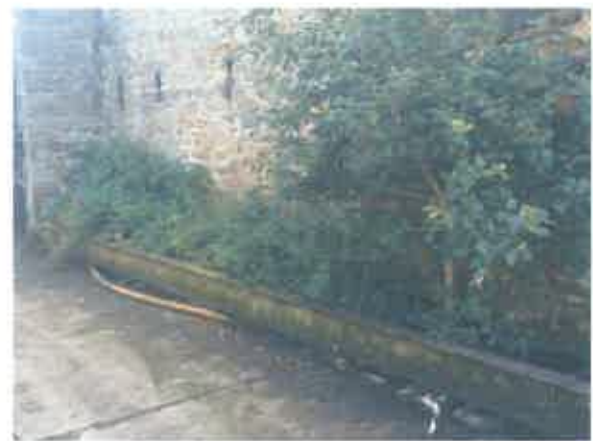
Vegetation / weed growth was noted to the bases of all elevations and should be removed prior to commencement of any proposed works. An area of ad-hoc construction for the storage of a water tank was noted to the left hand side of the barn entrance to the north elevation and was in poor condition and dilapidated and is also to be removed in line with the proposals. Minor rust staining was also noted to the top of the north elevation and is caused by the corrosion of the metal fixtures that are fixed at eaves level.

PL19 (Left) showing rust staining to below metal fixtures. PL20 (Right) showing significant vegetation growth to the base of the elevation.

- All vegetation growth is to be removed from the base of all walls and also from the affected areas of the roof structure / covering.

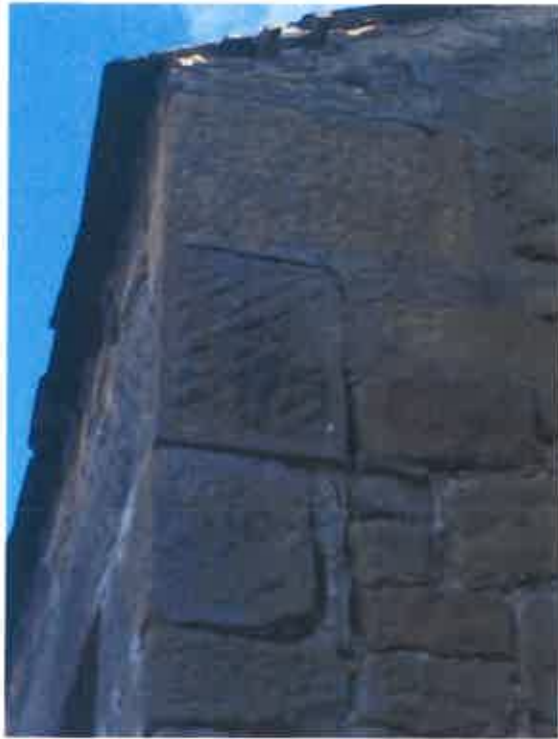
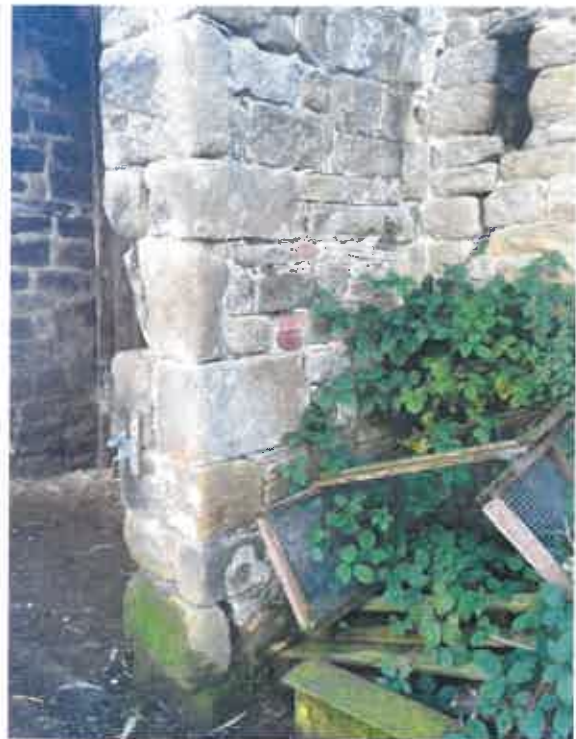
PL21 (Left) showing mortar crack to right hand side of stone lintel to barn entrance. PL22 (Right) showing condition of stonework and degradation to base of wall.

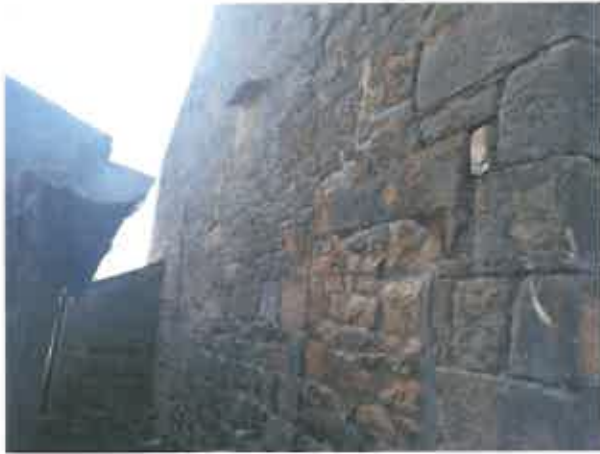
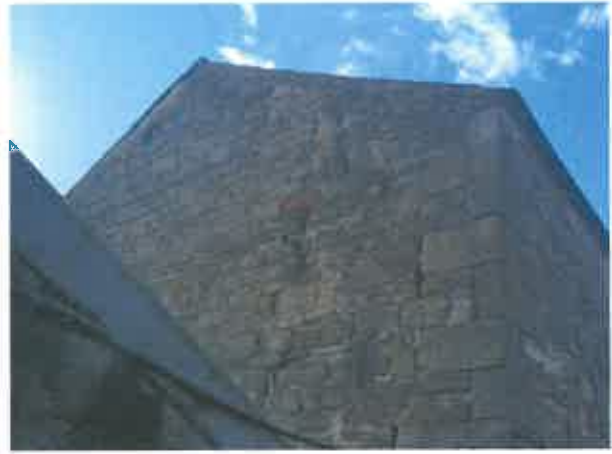
PL25 (Left) showing condition of the east elevation gable wall with degraded mortar and patch repairs. PL26 (Right) showing cracking to east elevation gable wall.

Another issue was the presence of cracks within the walls of the building both internally and externally. The possible cause of this could be down to a number of contributing factors. It is likely that the building has shallow foundations which are inadequate for the loading requirements that have been placed on them. In turn this has resulted in movement of the building. Further investigations would be required to fully determine the cause of movement and whether or not further movement is likely and the extent of any remedial action required.

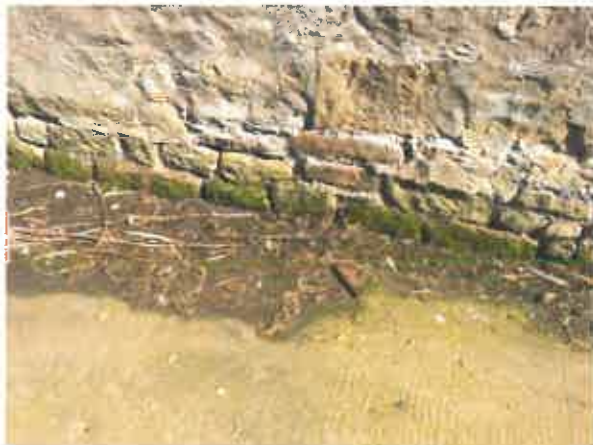
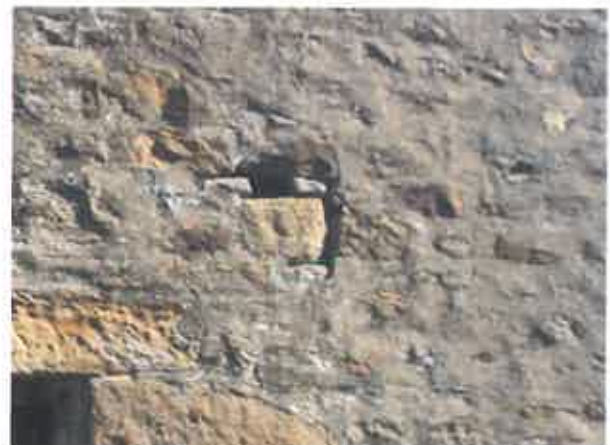
PL33 (Left) showing mortar degradation to base of wall. PL34 (Right) showing hole damage and hairline cracking to west elevation.

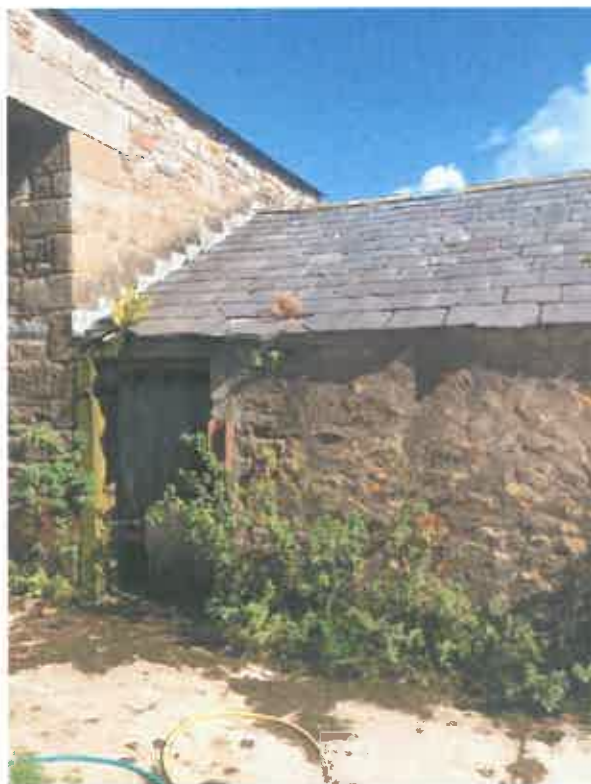
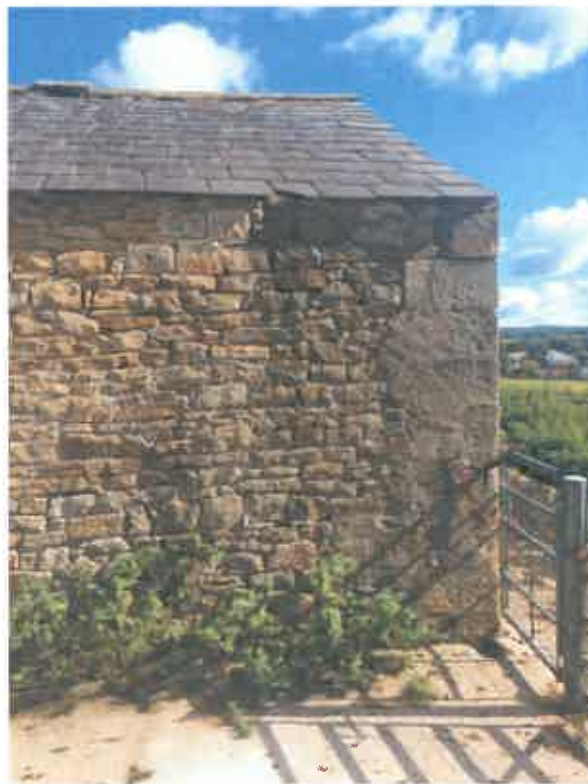
PL35 (Left) shows mortar repairs to stone joints and significant plant / weed growth to base of wall. PL36 (Right) showing mortar patch repairs, mortar degradation and plant / weed growth.

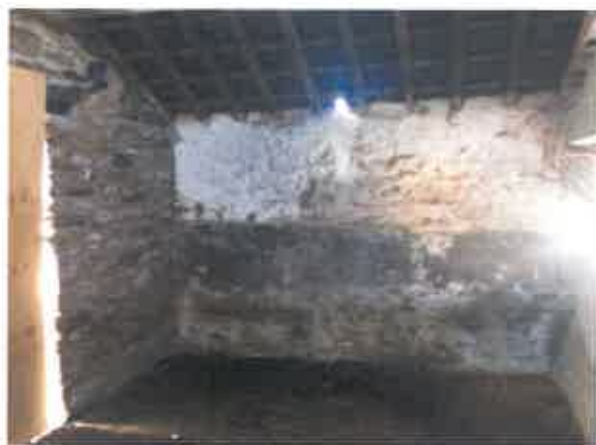
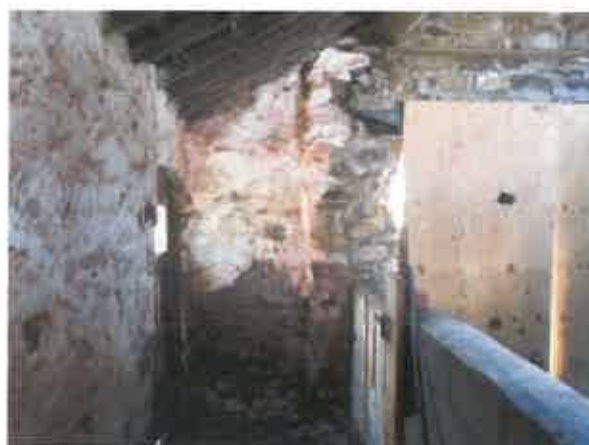
Internally throughout, the internal walls were in average to poor condition. The internal white washes and renders were degraded with areas of stonework being exposed beneath the white wash. The white wash was also stained, soiled and discoloured throughout. Hairline cracking was also present to the areas of cement render. The blockwork walls were in average condition with some soiling and patch mortar repairs present however, the dwarf walls are to be removed as part

PL38 (Left) and PL39 (Right) shows difference in internal wall finishes and also condition.

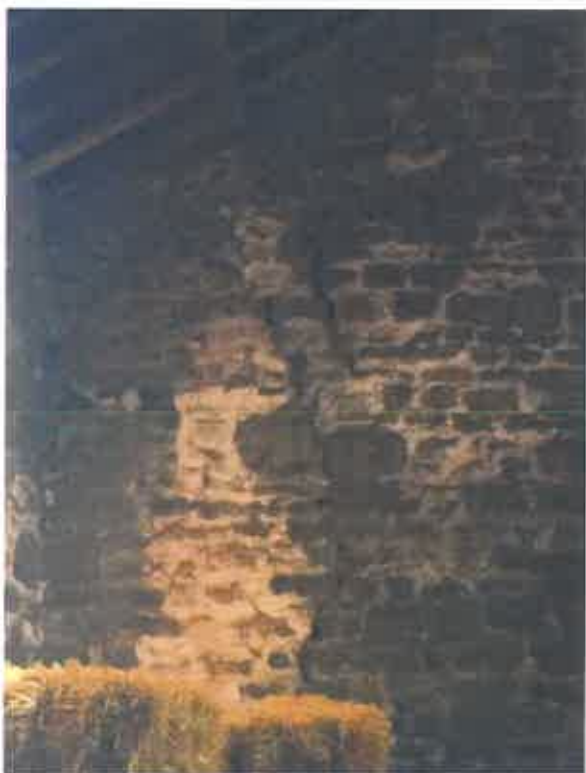
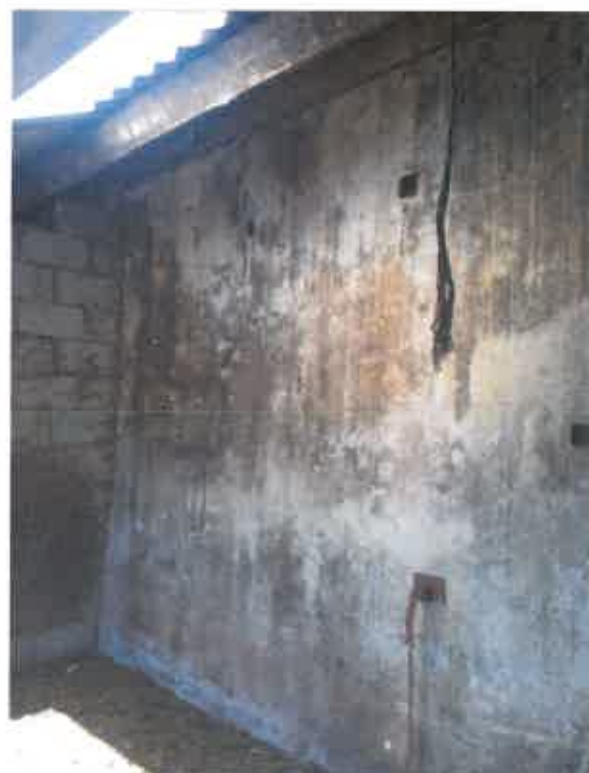
An area of wall cracking was present to the internal face of the east external gable wall. This crack was reflective of what also occurred on the external face of the wall in the same location.

PL40 (Left) shows wall cracking to the internal face of the east gable wall within the north section of the barn and is in the same location as the external wall cracking. Minor isolated crack stitching / lateral restraint ties potentially required at this point. PL41 (Right) shows soiling and staining to internal walls.

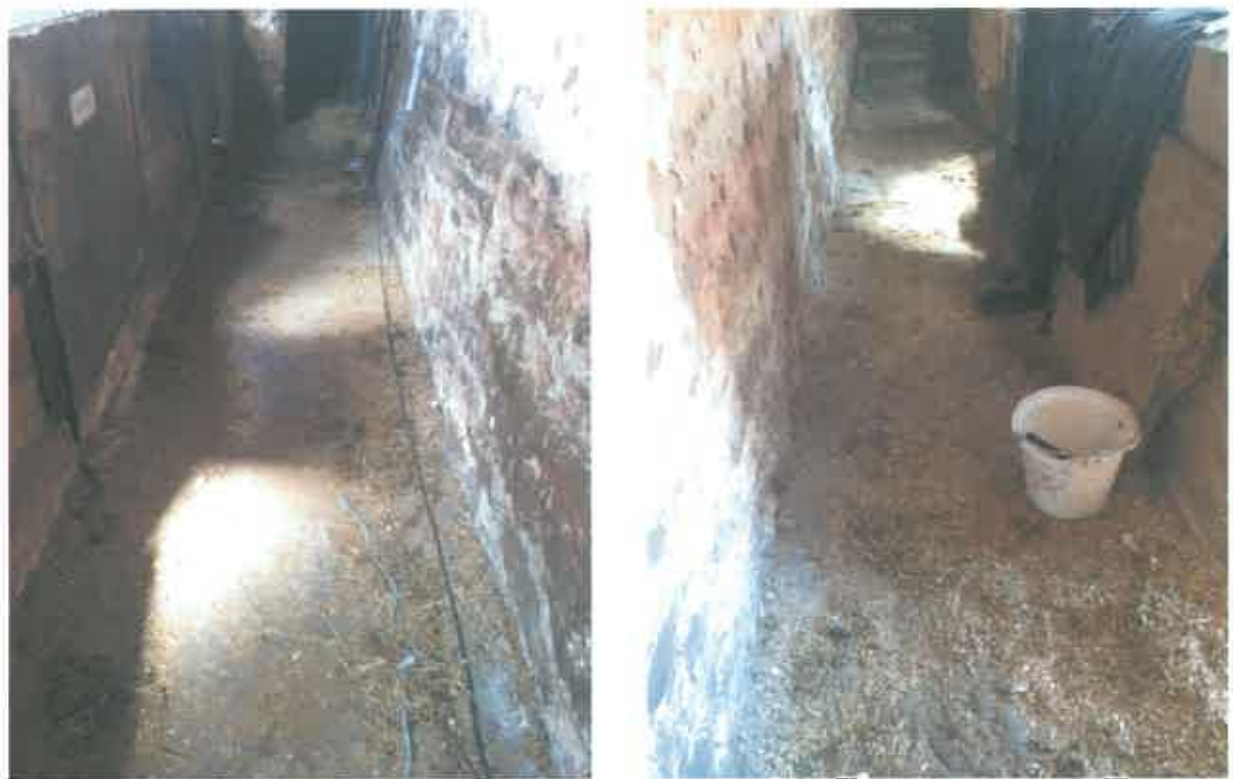
The concrete ground floor appeared to be in moderate condition with no obvious signs of substantial cracking and appeared to be relatively level. However the finished surface was rough and contained various areas of staining and surface blemishes, however it is fit for its intended purpose at present.

PL42 (Left) and PL43 (Right) showing the internal concrete floor of the south section of the barn building.

- Existing concrete ground floor should be grubbed up and replaced with a new insulated concrete ground floor structure incorporating DPMs with DPCs lapped up to new internal block lining walls.

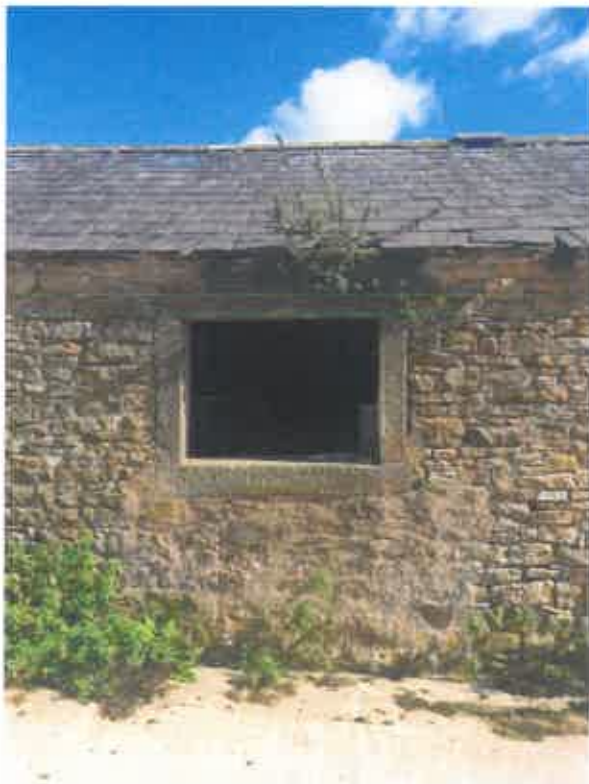
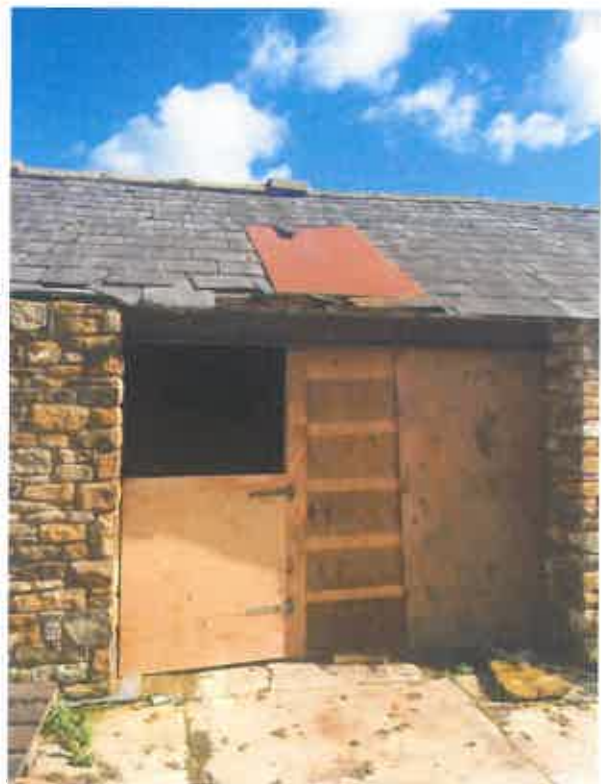
All windows and doors, including frames, were in poor condition and dilapidated with graining of the surface and virtually no paint finish visible at the time of inspection. A number of the doors had been repaired in an ad-hoc nature, through which they had also become unsightly. Many of the timber components were also showing signs of timber decay.

PL44 (Left) showing empty structural opening. PL45 (Right) showing ad – hoc gate / door arrangement.

- Existing timber windows and doors should be removed and replaced with new double glazed uPVC or timber units to ensure water tightness from wind driven rain at these points.

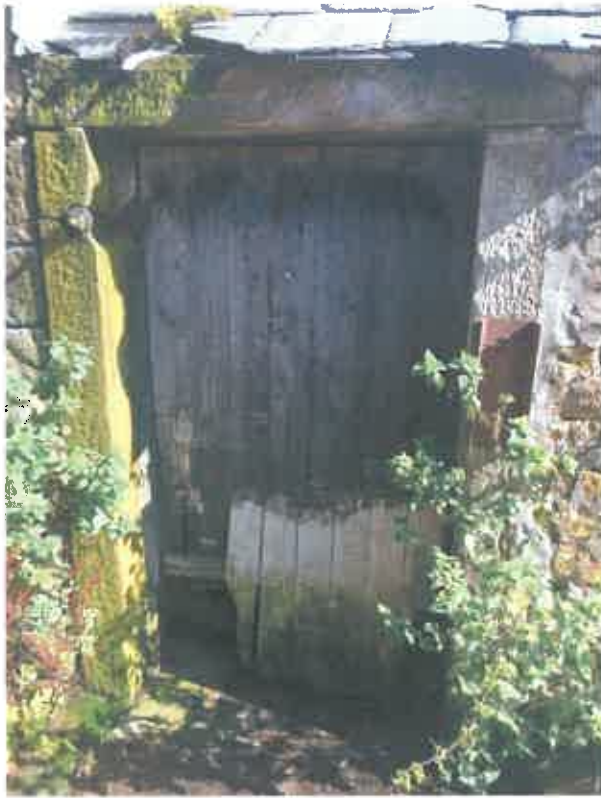
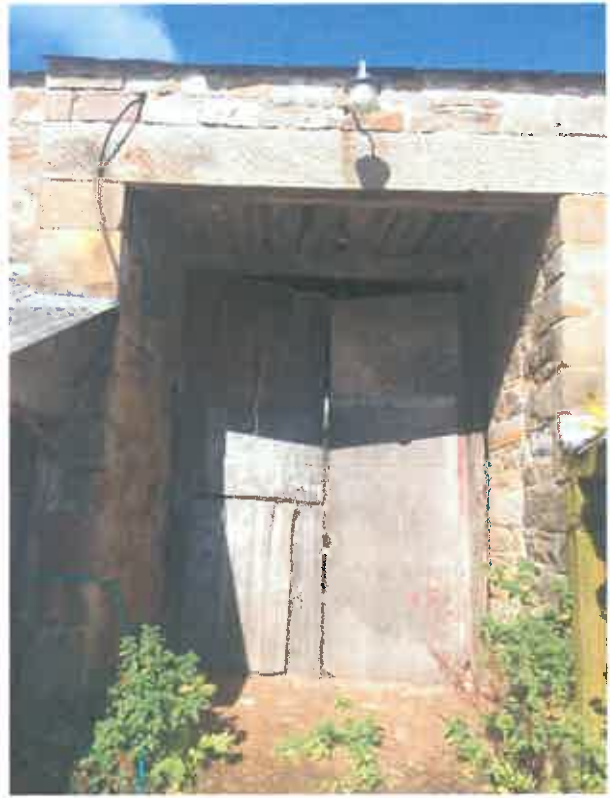
PL46 (Left) and PL47 (Right) showing dilapidated and damaged external doors.

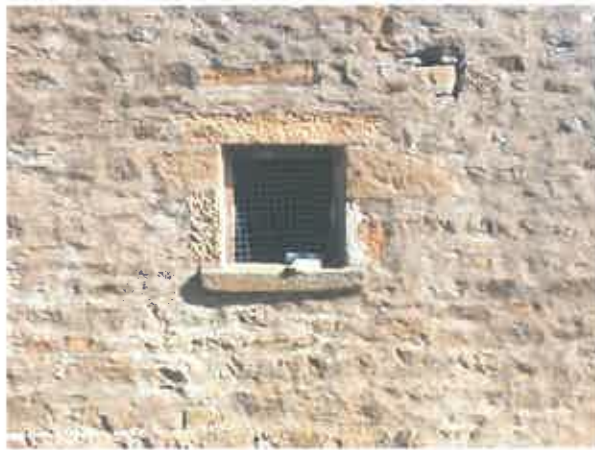
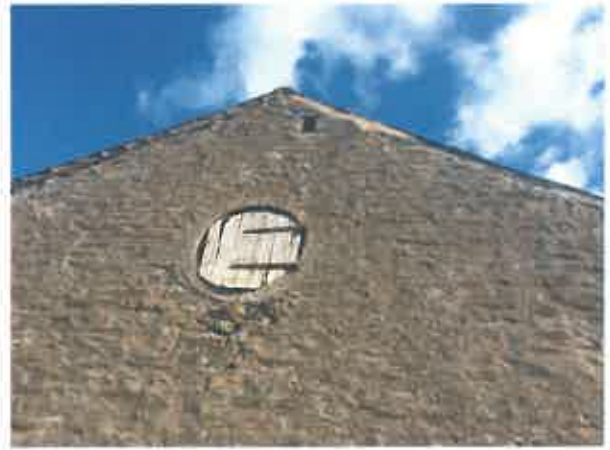
PL48 (left) showing dilapidated window frame with wire mesh infill. PL49 (Right) showing poor condition of pitching hole door and rusting hinges.

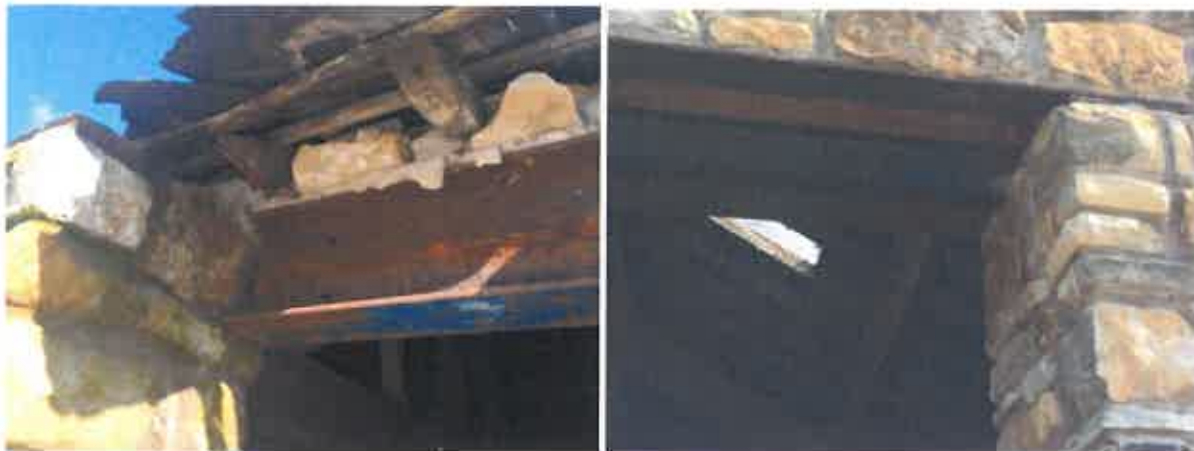
PL50 (left) and PL51 (Right) showing rust and corrosion to steel lintels above openings.
