**STRUCTURAL APPRAISAL**

**GABLE WALL**

**DOWER HOUSE**  
**Park Road**  
**Gisburn**

**W/15/113**

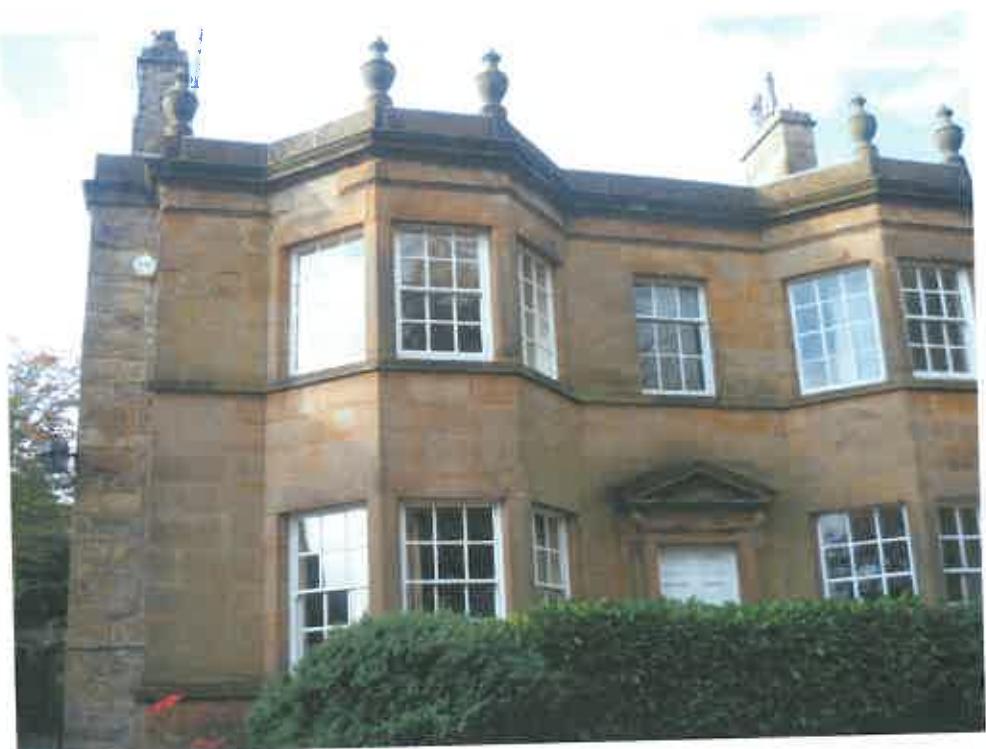
Front Elevation

This elevation is stonework.

The wall adjacent to the gable is generally virtually plumb.

The window cill is virtually level.

The stone work coursing is virtually level.

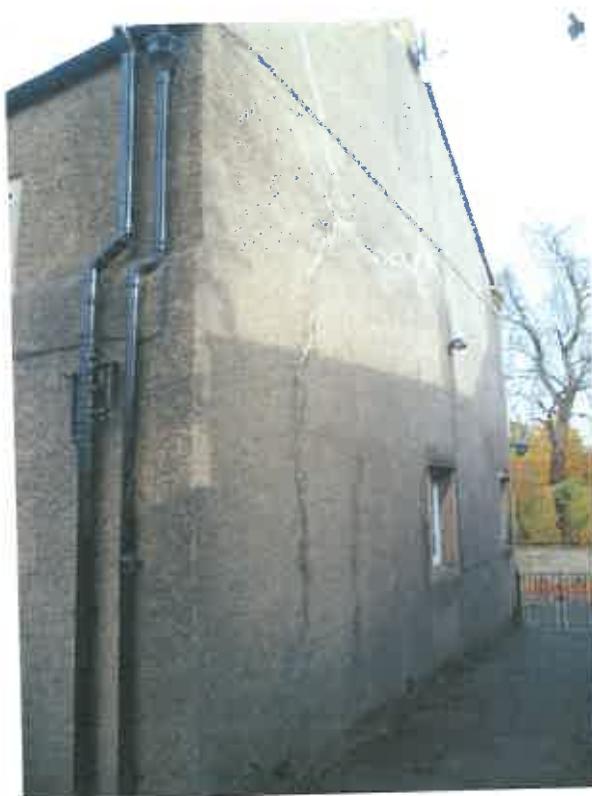
Left Hand Gable

This elevation is pebble dashed.

At first floor level there is a significant bulge.

The wall to the rear of the rear window leans out at 25 in 1000.

There is cracking in the pebble dashed elevation.

There is a near vertical crack above the rear of the front window head.

There is a crack near to the rear elevation spreading up to roof and turning to the front.

These cracks have been pointed and display no obvious recent significant cracking.

There is a near vertical crack in the pebble dash to the front of the rear crack.

This has not been pointed.

- 3.02 The gable wall displays a significant bulge and cracking in the pebbledash render externally.
- 3.03 Internally there is no obvious indications of significant lateral movement. The walls checked in the vicinity of the left hand gable are virtually plumb.

- 3.04 Additionally the cracking observed externally appears to be associated with the positions of the chimney flues.
- 3.05 This would suggest that the outer stonework has separated from the inner at the position of the chimney flues.

- 3.06 Whilst ideally the externally skin should be taken down and re-built, the outer stonework may be tied back to the existing internal stonework.
- 3.07 This may be achieved by, initially erecting scaffolding against the gable wall prior to the following work:-

- 3.08 Install threaded steel ties through the wall in and around the bulge position. The steel ties may then be resin fixed into the inner stone work. The ties would penetrate the outer skin and be bolted through steel plates to restrain the outer stonework.

- 3.09 We have noted this recommendation on our sketch no W/15/113/SK01
- 3.10 The final positions for the wall restraints are to be agreed on site.

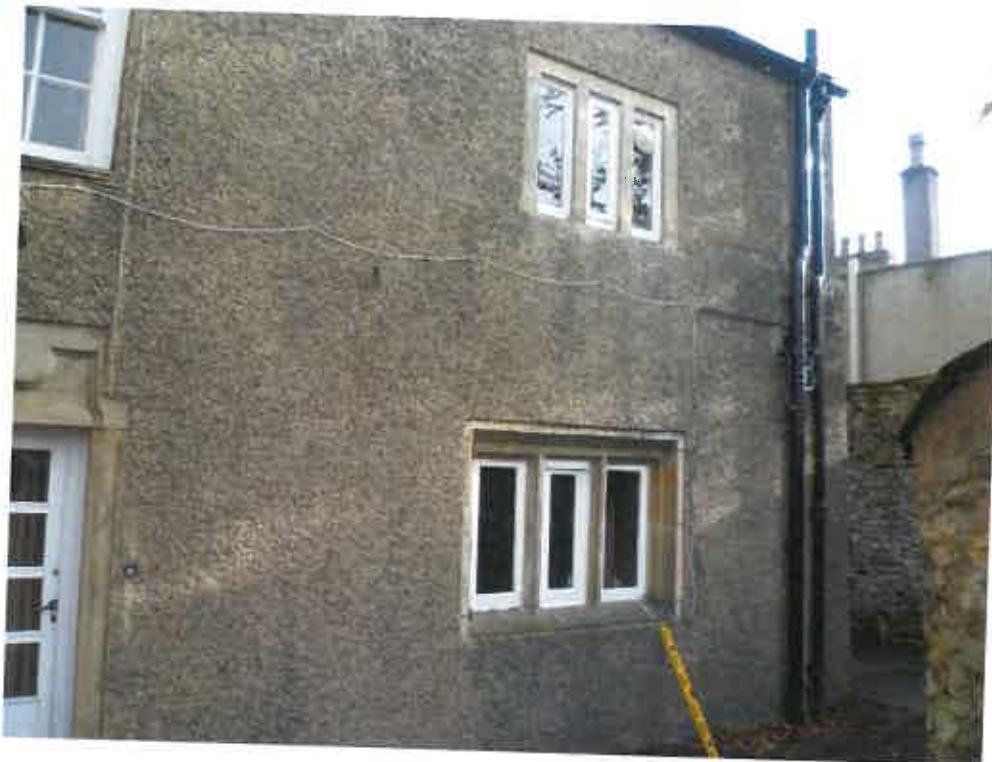
Rear Elevation

This elevation is pebbled dashed.

Adjacent to the left hand gable the wall is virtually plumb.

The window sill is virtually level/

leans out at 15 in 1000;

There is a slight bulge at first floor level; above the left hand ground floor window head.

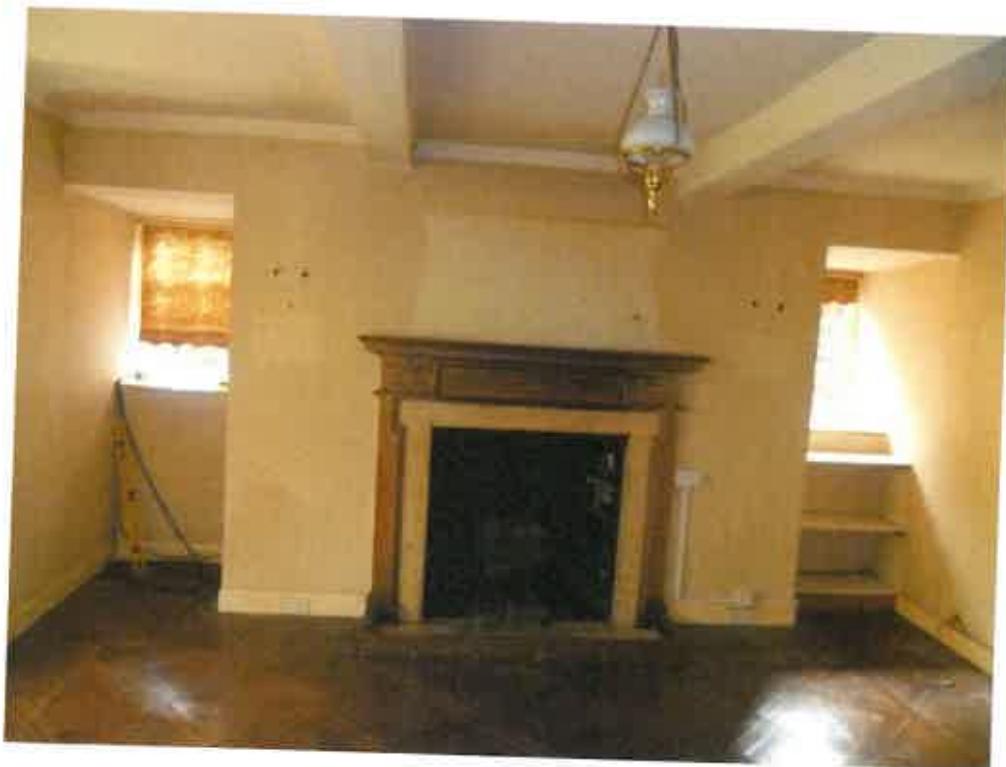
Internal – Ground Floor Front Room

The floor is virtually level

The window cills are virtually level.

The left hand wall (chimney breast), front and rear walls are virtually plumb.

Within the cupboard immediately adjacent to the front there is a crack at high level on the left hand wall spreading up to the rear.
