TREVOR A. HARLING

**SPECIALIST INDEPENDENT SURVEYOR OF DAMP,
STRUCTURAL TIMBER AND BUILDING FABRIC**

THE DOWER HOUSE
PARK ROAD
GISBURN
CLITHEROE
BB7 4HT

Survey/Inspection Report

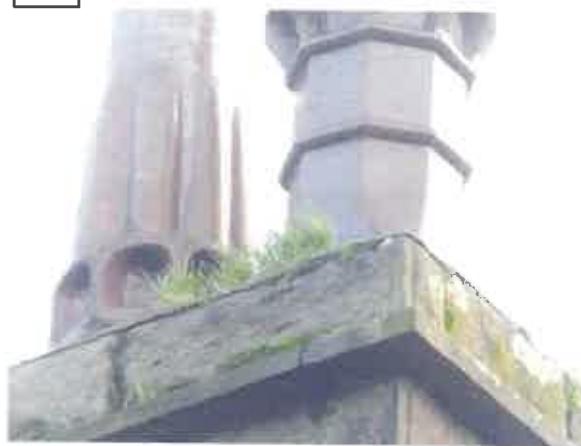
1

1.	Condition of central chimney stack – water staining in the roof void
2.	External wall above the breakfast room - internal high level damp staining and blocked guttering

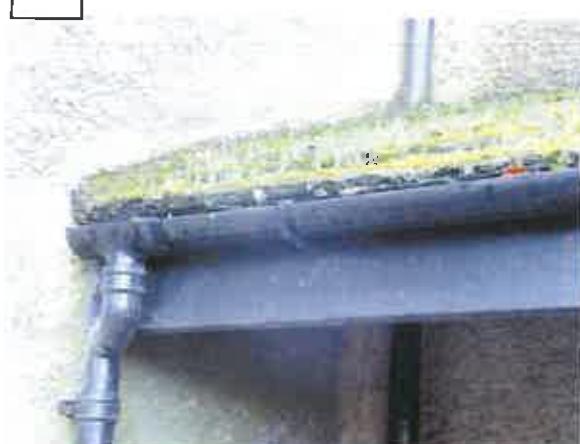
3

3.	Lower roof abutting the breakfast room – internal high level damp staining
4.	Truss and roof configuration – far left area
5.	Truss and roof configuration – far left area

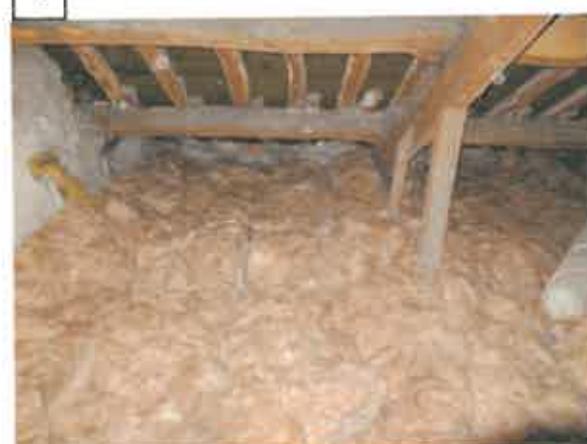
9

Most types of quilt insulation allows moisture laden air to travel through but not dry warm air, thus a build-up of moisture laden air occurs, in particular during the winter months.

6.	Roof configuration – middle area
7.	Roof configuration -- middle area
8.	Roof configuration – middle area
9.	Insulation over ceiling rafters
10.	Rainwater staining – chimney breast middle area

I would recommend that the existing insulation is removed and replaced using a material that does not allow the passage of moisture laden air into the roof void.

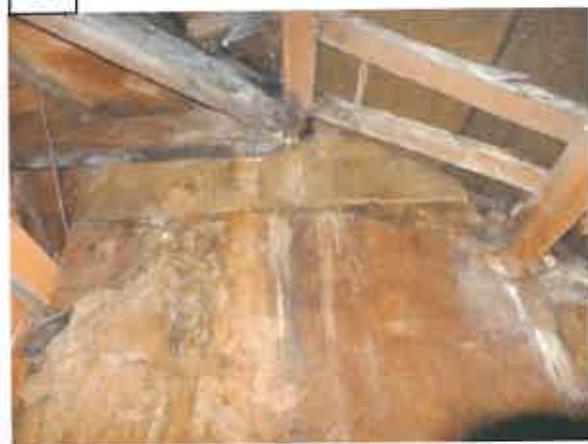
10

Areas of inactive historic wood borer infestation damage was observed to a number of the large dimensioned timbers such as purlins and elements of the trusses mainly to the wane element. It was noted during the inspection that there is rainwater ingress staining to the wall structure that divides the second bedroom (from the left front) and the 3rd bedroom front (from the left). Water could be seen at low level running out from the wall, this may be a chimney breast as indicated in the report. Deep insulation over the ceiling rafters restricted safe movement and prevented close inspection.

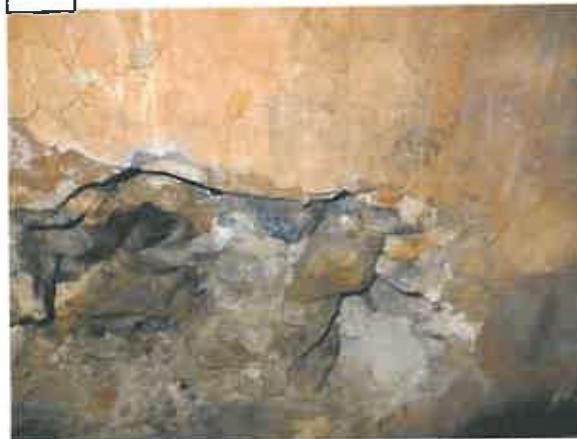
11

11.	Rainwater ingress – chimney breast middle area
12.	Roof configuration over the master bedroom
13.	Roof configuration over the master bedroom
14.	Far right roof void area

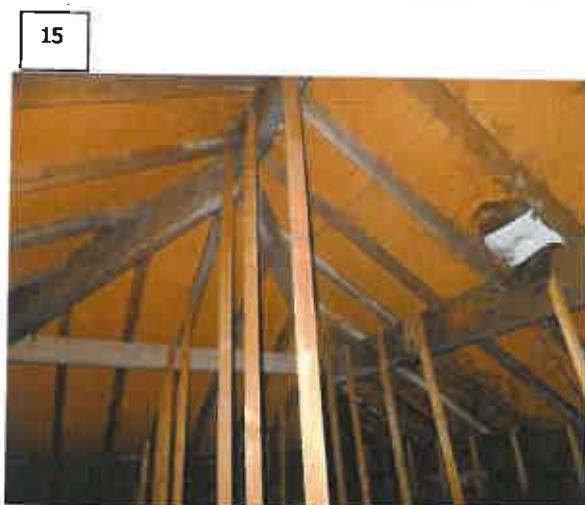
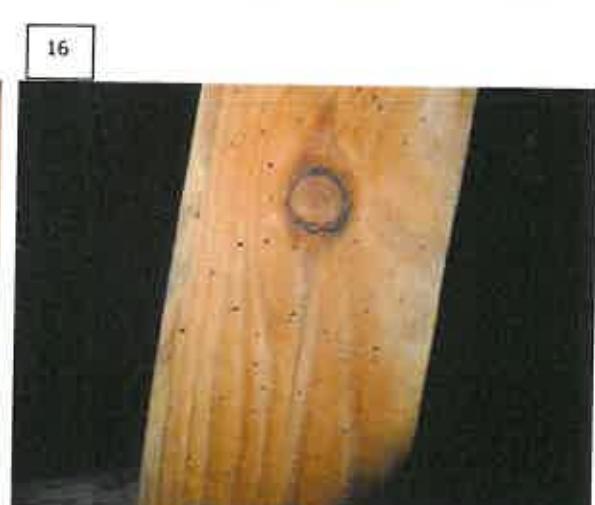
There is inactive historic wood borer damage to the undersides of the purlin timbers and sporadically to the common spars, mainly to the wane element.

15.	Historic inactive wood borer damage – rear mid purlin
16.	Historic inactive wood borer damage – rear mid purlin
17.	Exposed flooring – first floor
18.	Exposed flooring – first floor

No recommendations regarding preservative treatments.

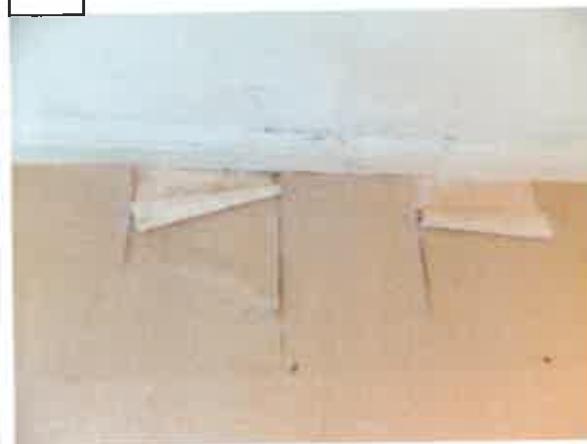
22

19.	Exposed flooring – first floor
20.	Exposed flooring – first floor
21.	Exposed flooring – first floor
22.	Damp staining below the chimney breast in the roof void

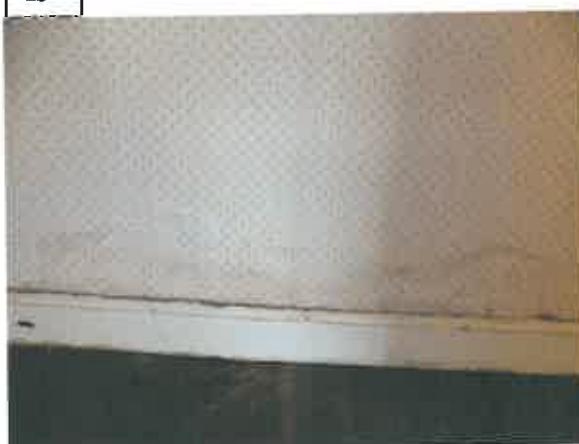
23

The readings obtained from the profiling techniques indicated that of rising damp at low level to most of the affected walls and sporadically located throughout the ground floor areas, further suggested by the sharp cut off between wet and dry at the head of the rise.

23.	Damp staining – ground floor
24.	Damp staining – ground floor
25.	Damp staining – sitting room chimney breast
26.	Damp staining – ground floor
27.	Damp staining – ground floor

After consideration I could only advise that the only type of damp proof course I would install would be an electro osmosis type. This could either be installed from the outside once the rough cast render is removed or internally once the damp affected areas of plaster are removed along with the skirting boards to allow installation (only remove the visually damp and disrupted areas of wall plaster).

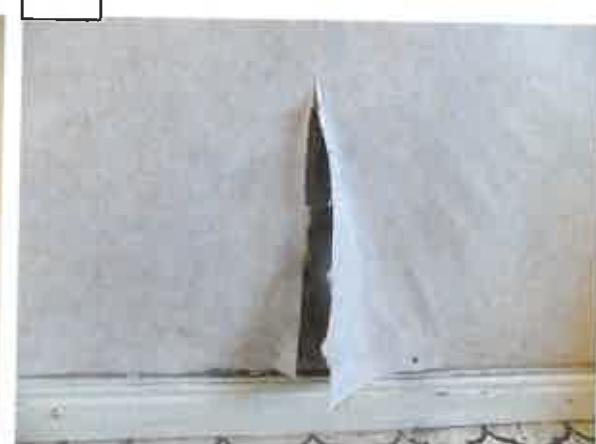
28

28.	Damp staining and disruption to wall finishes
29.	Damp staining and disruption to wall finishes
30.	Damp staining and disruption to wall finishes
31.	Planter to the rear elevation

Ideally, this should be undertaken using a natural lime product (likely NHL 3.5) depending on the strength of the background material, in particular to external wall areas. If not considered practical to use traditional lime plaster, consider/investigate the use of Limelite or Tilcon Hardwall incorporating a water proofer (i.e. Brunolene PS).

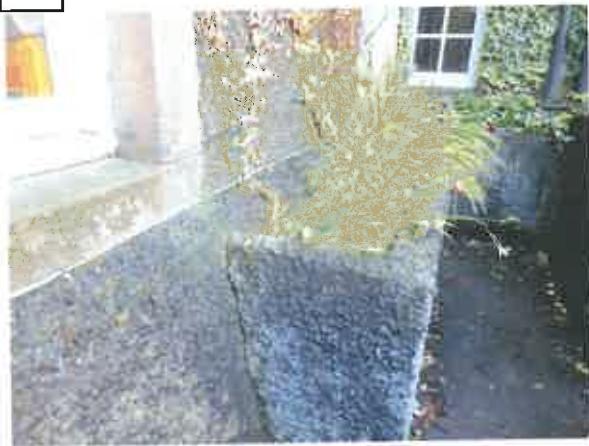
31

1. The rough cast render is directly in contact with the ground. The render appears to be cement rich and this would prevent any evaporation of moisture, in particular at low level; damp/moisture entering the wall structure would be forced higher to evaporate. The render may be 'drawing' moisture from the ground.
2. Ground/path levels to the left gable and rear are high in relation to the internal floor position.
3. High ground levels to the immediate left of the boiler room between the rear wall of the store area and greenhouse/boiler room dividing wall.
4. Planters to the rear main external wall to the right of the pantry are holding damp/wet soil against the rear elevation.

1. I would recommend that the cement rich rough cast render coat is cut back from the ground to one metre and replaced like for like using a lime based render (NHL5) the replacement rough cast render ideally should be terminated 150mm above the ground levels to further allow evaporation of moisture at low level. The patina of the new rough cast render could be, if desired, toned down using a natural dye.
2. Ideally reduce ground levels where feasible or maintain them at their present levels; avoid any further increase in height. Consider if allowed, the removal of the planters to the rear elevation.

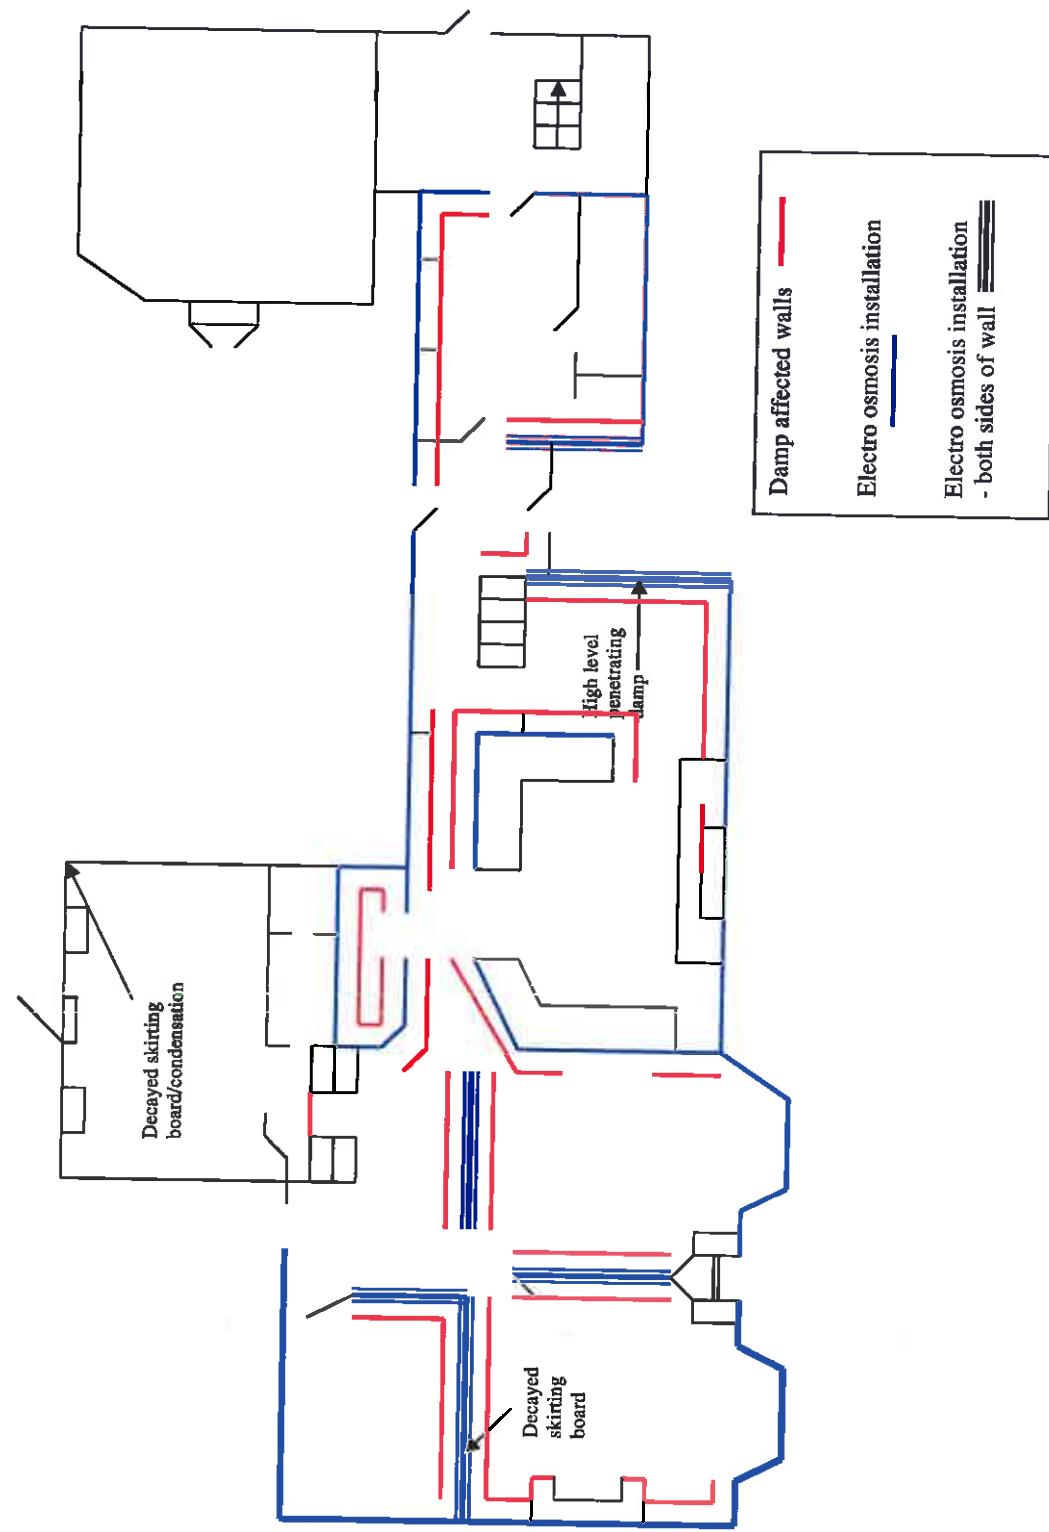
GROUND FLOOR SKETCH PLAN - Not to Scale
The Dower House, Park Road, Gisburn

The affected areas are indicated on the floor plan provided.

The area/extent of the installation is indicated on the floor plan provided.
