**STRUCTURAL APPRAISAL**

**GABLE WALL**

**DOWER HOUSE  
Park Road  
Gisburn**

**W/15/113**

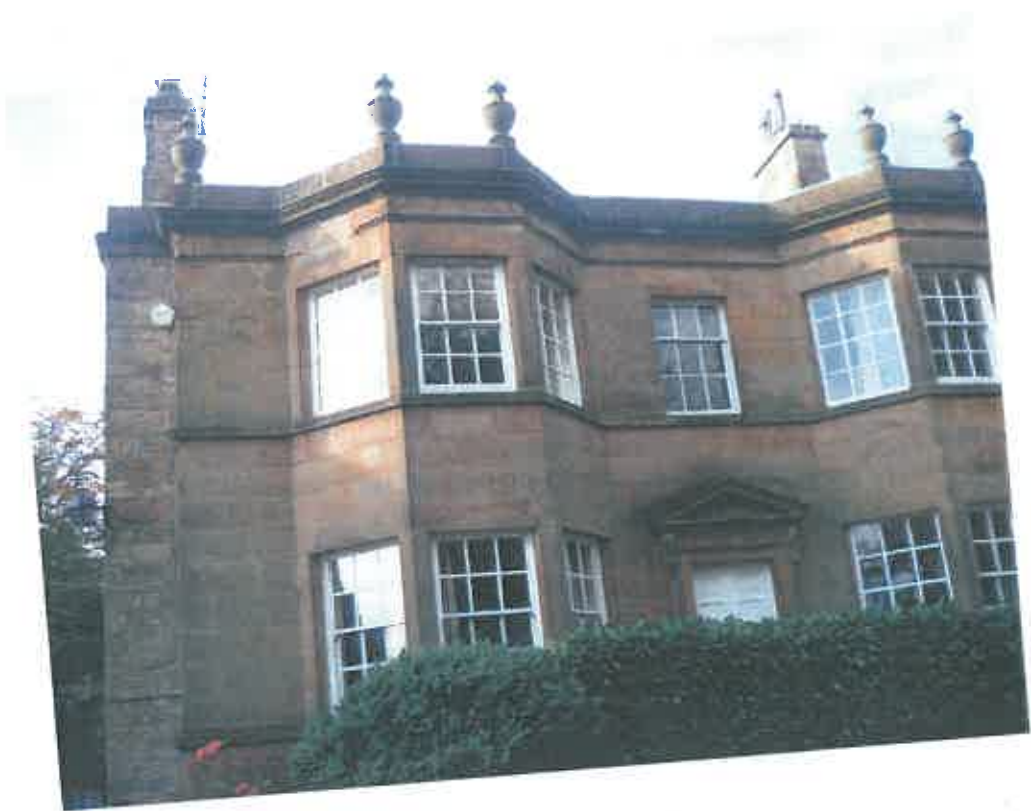
Front Elevation

This elevation is stonework.

The wall adjacent to the gable is generally virtually plumb.

The window cill is virtually level.

The stone work coursing is virtually level.

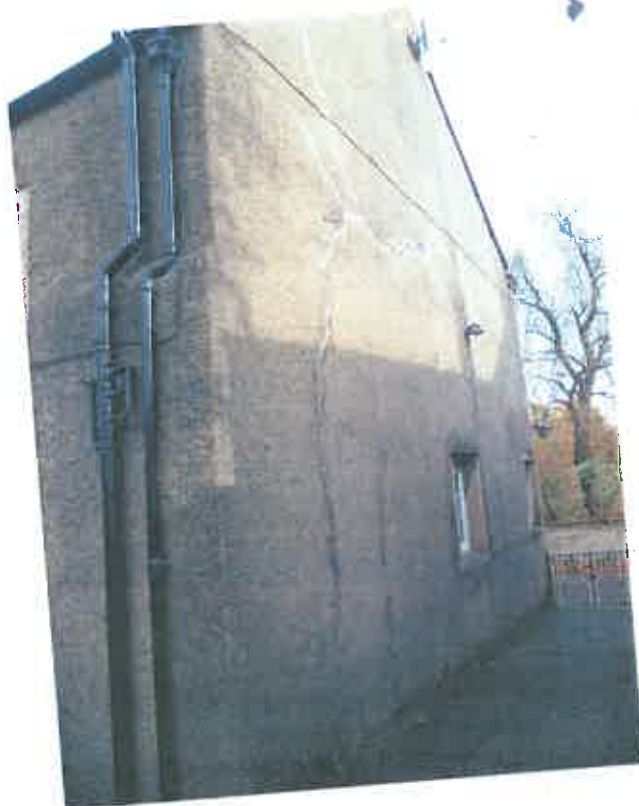
Left Hand Gable

At first floor level there is a significant bulge.

The wall to the rear of the rear window leans out at 25 in 1000.

There is cracking in the pebble dashed elevation.

There is a near vertical crack above the rear of the front window head.

There is a crack near to the rear elevation spreading up to roof and turning to the front.

These cracks have been pointed and display no obvious recent significant cracking.

There is a near vertical crack in the pebble dash to the front of the rear crack.

This has not been pointed.

- 3.02 The gable wall displays a significant bulge and cracking in the pebbledash render externally.
- 3.03 Internally there is no obvious indications of significant lateral movement. The walls checked in the vicinity of the left hand gable are virtually plumb.

- 3.04 Additionally the cracking observed externally appears to be associated with the positions of the chimney flues.
- 3.05 This would suggest that the outer stonework has separated from the inner at the position of the chimney flues.

- 3.06 Whilst ideally the externally skin should be taken down and re-built, the outer stonework may be tied back to the existing internal stonework.
- 3.07 This may be achieved by, initially erecting scaffolding against the gable wall prior to the following work:-

- 3.08 Install threaded steel ties through the wall in and around the bulge position. The steel ties may then be resin fixed into the inner stone work. The ties would penetrate the outer skin and be bolted through steel plates to restrain the outer stonework.

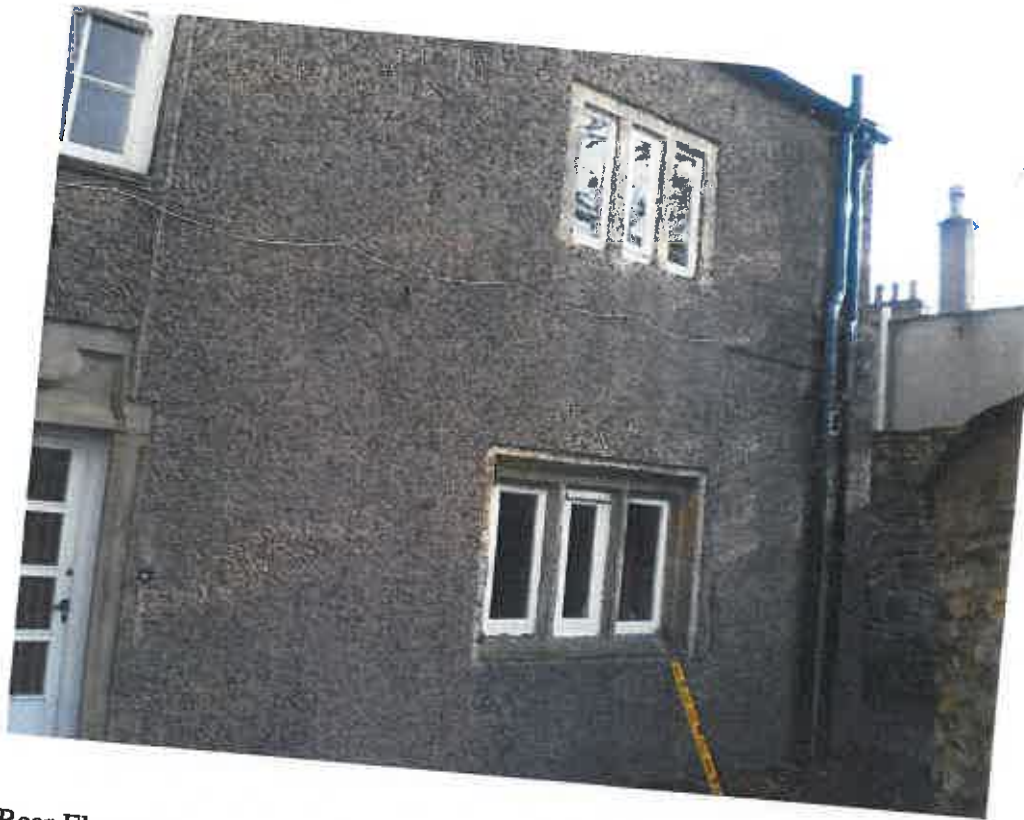
Rear Elevation

Adjacent to the left hand gable the wall is virtually plumb.

leans out at 15 in 1000;

There is a slight bulge at first floor level; above the left hand ground floor window head.

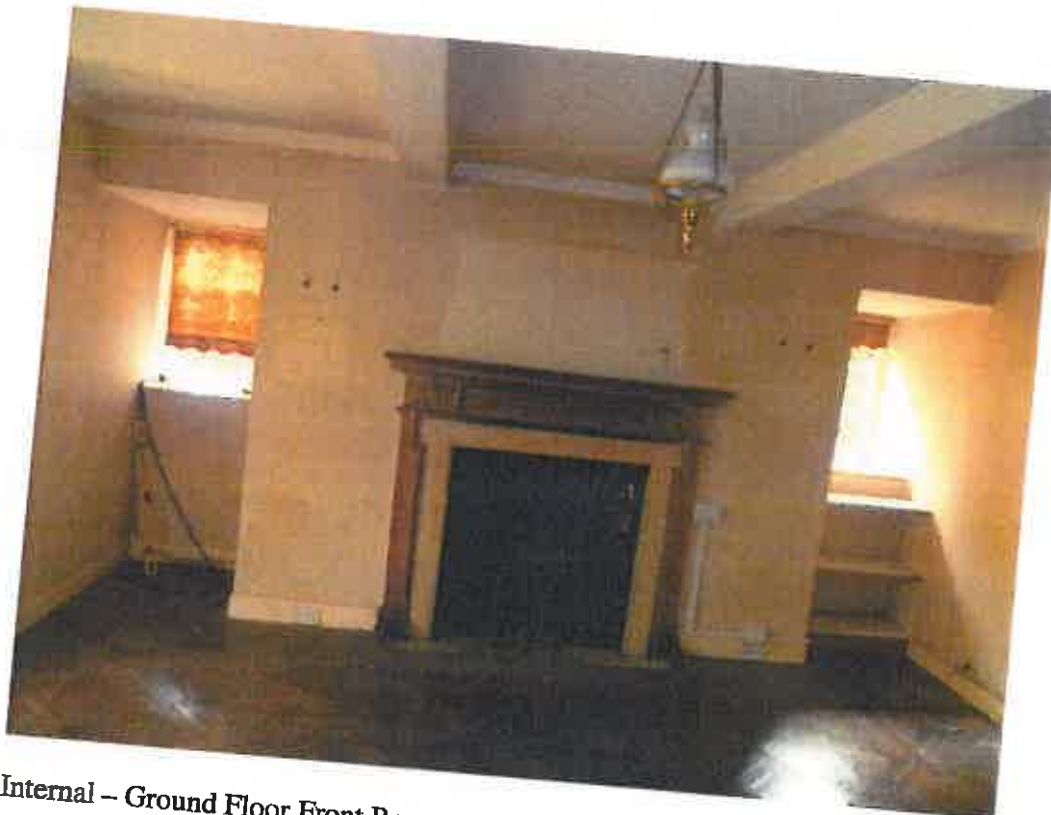
Internal – Ground Floor Front Room

The floor is virtually level

The window cills are virtually level.

The left hand wall (chimney breast), front and rear walls are virtually plumb.

Within the cupboard immediately adjacent to the front there is a crack at high level on the left hand wall spreading up to the rear.
