# TREVOR A. HARLING

**SPECIALIST INDEPENDENT SURVEYOR OF DAMP,  
STRUCTURAL TIMBER AND BUILDING FABRIC**

| NAME AND ADDRESS OF CLIENT | ADDRESS OF PROPERTY TO BE SURVEYED |
|---|---|
| MR. & MRS. JOHN COOLEY<br>16 SKIPTON ROAD<br>BARNOLDWICK<br>BB18 6PX | THE DOWER HOUSE<br>PARK ROAD<br>GISBURN<br>CLITHEROE<br>BB7 4HT |

## Survey/Inspection Report

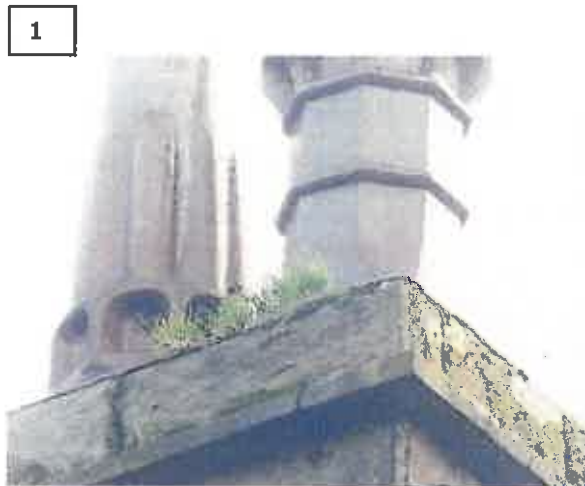
| 1. | Condition of central chimney stack – water staining in the roof void |

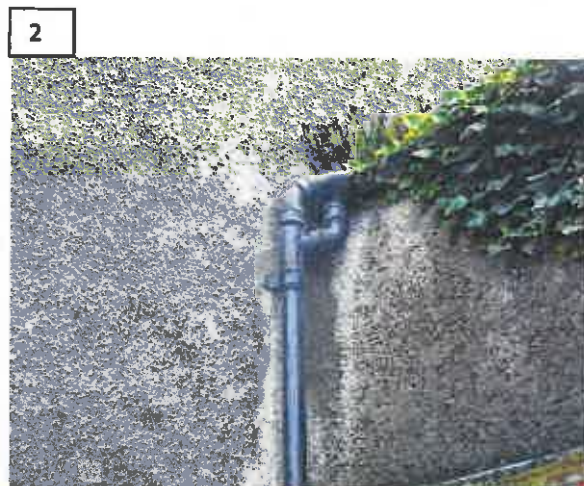
| 2. | External wall above the breakfast room - internal high level damp staining and blocked guttering |

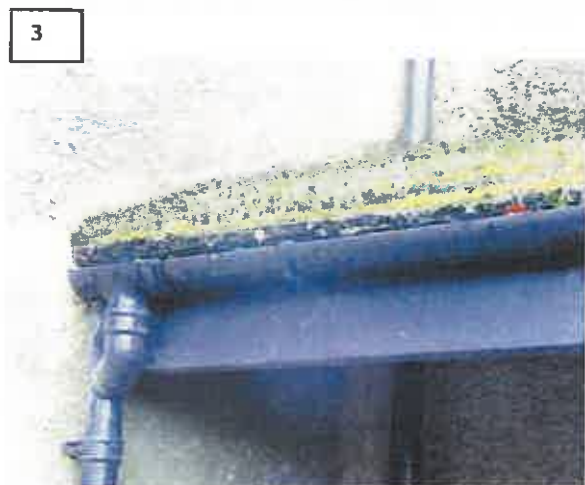
| 3. | Lower roof abutting the breakfast room – internal high level damp staining |

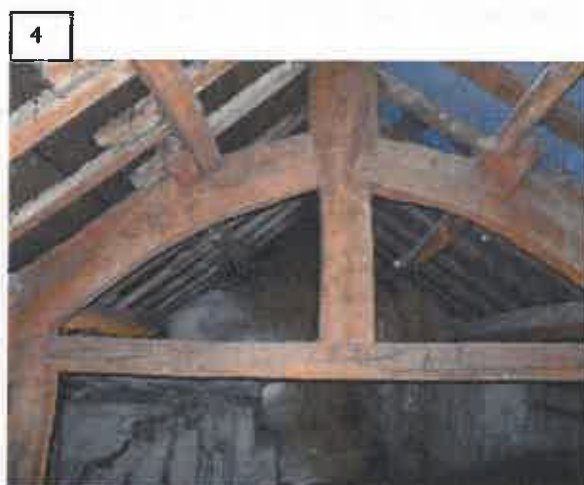
| 4. | Truss and roof configuration – far left area |

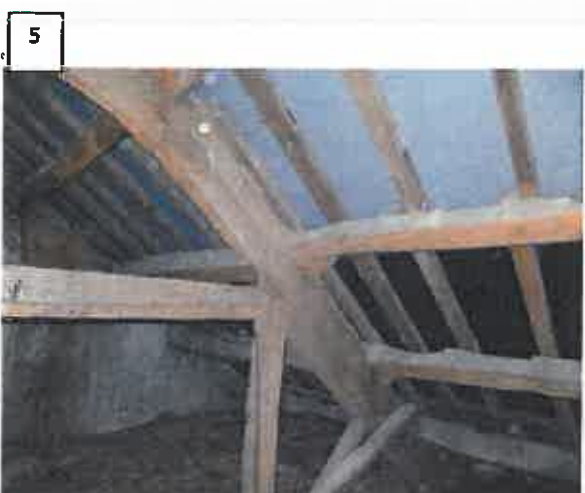
| 5. | Truss and roof configuration – far left area |

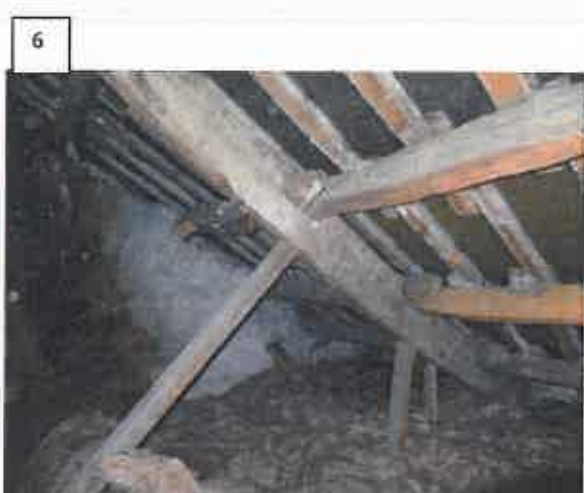
| 6. | Roof configuration – middle area |

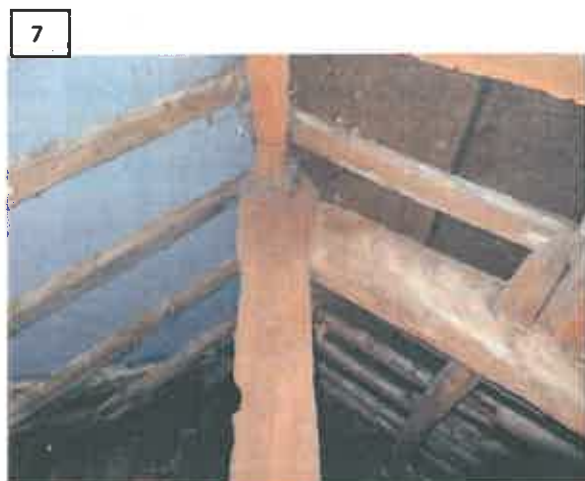
| 7. | Roof configuration – middle area |

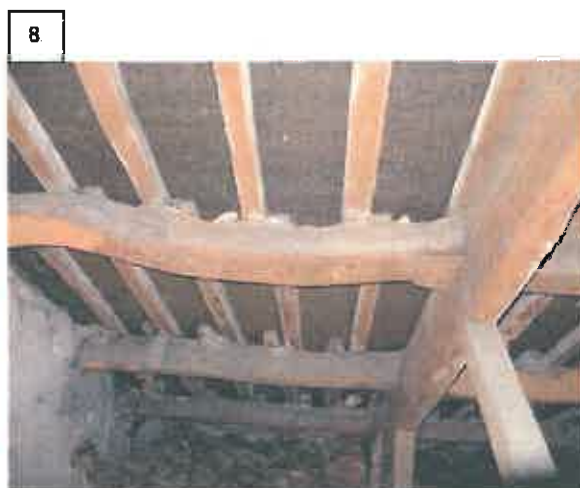
| 8. | Roof configuration – middle area |

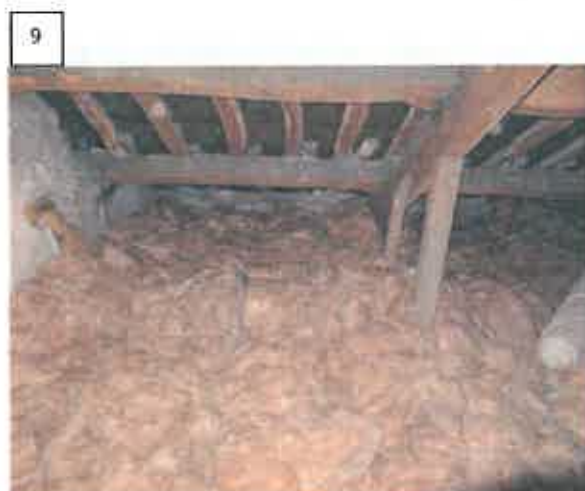
Most types of quilt insulation allows moisture laden air to travel through but not dry warm air, thus a build-up of moisture laden air occurs, in particular during the winter months.

| 9. | Insulation over ceiling rafters |

I would recommend that the existing insulation is removed and replaced using a material that does not allow the passage of moisture laden air into the roof void.

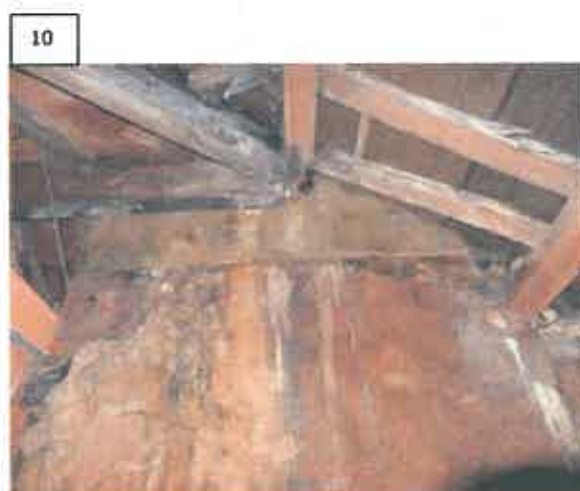
| 10. | Rainwater staining – chimney breast middle area |

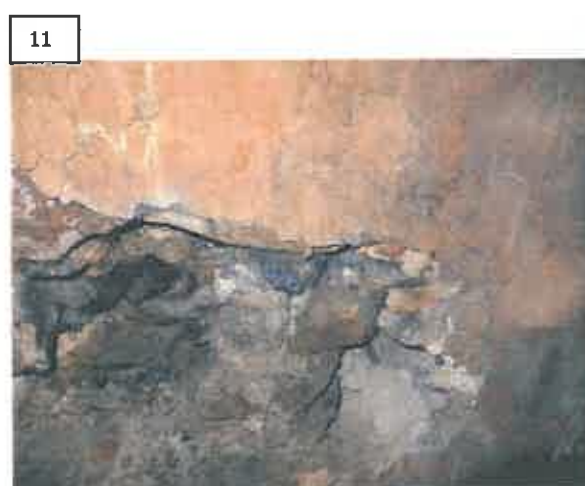
Areas of inactive historic wood borer infestation damage was observed to a number of the large dimensioned timbers such as purlins and elements of the trusses mainly to the wane element. It was noted during the inspection that there is rainwater ingress staining to the wall structure that divides the second bedroom (from the left front) and the 3<sup>rd</sup> bedroom front (from the left). Water could be seen at low level running out from the wall, this may be a chimney breast as indicated in the report. Deep insulation over the ceiling rafters restricted safe movement and prevented close inspection.

| 11. | Rainwater ingress – chimney breast middle area |

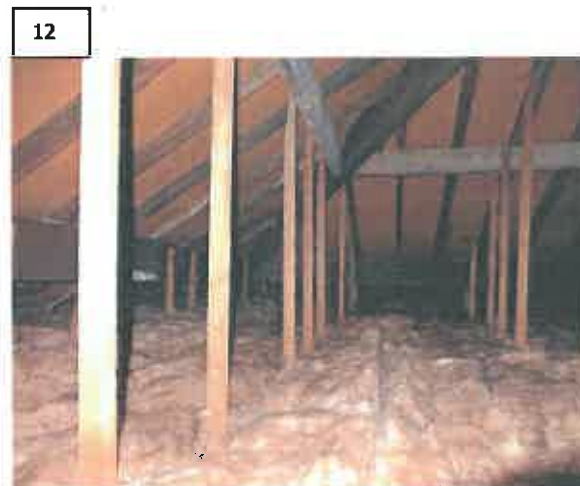
| 12. | Roof configuration over the master bedroom |

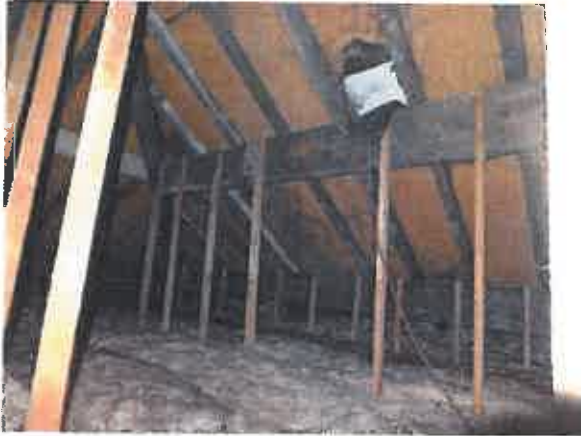
13

| 13. | Roof configuration over the master bedroom |

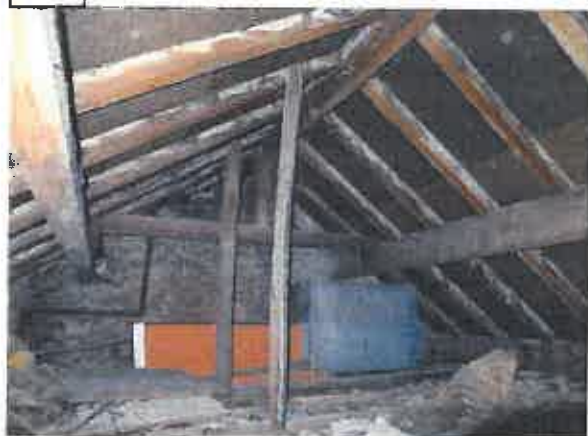
14

| 14. | Far right roof void area |

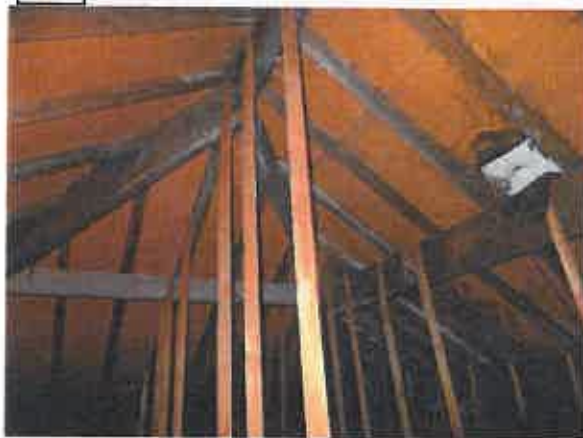
15

| 15. | Historic inactive wood borer damage – rear mid purlin |

No recommendations regarding preservative treatments.

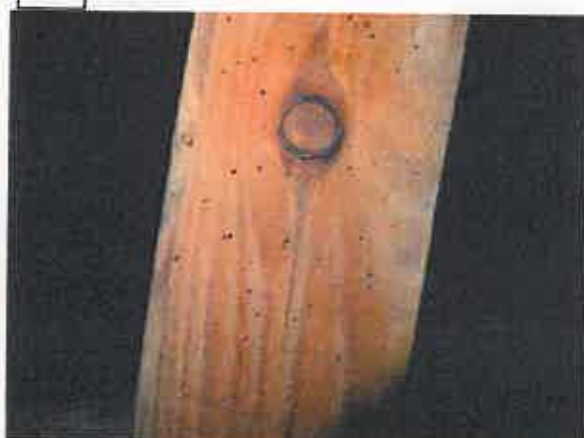
16

| 16. | Historic inactive wood borer damage – rear mid purlin |

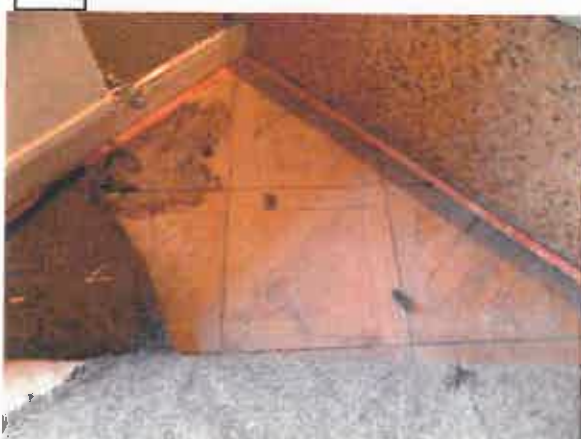
17

| 17. | Exposed flooring – first floor |

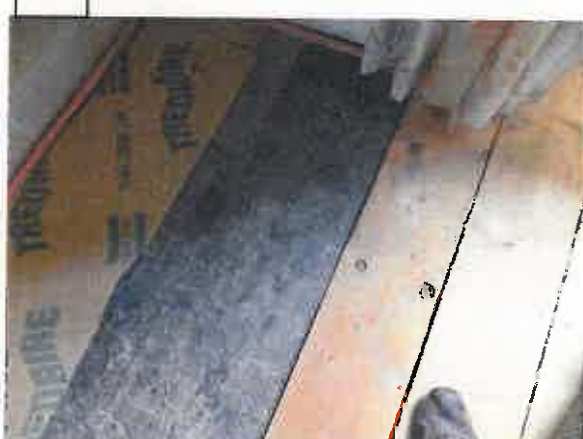
18

| 18. | Exposed flooring – first floor |

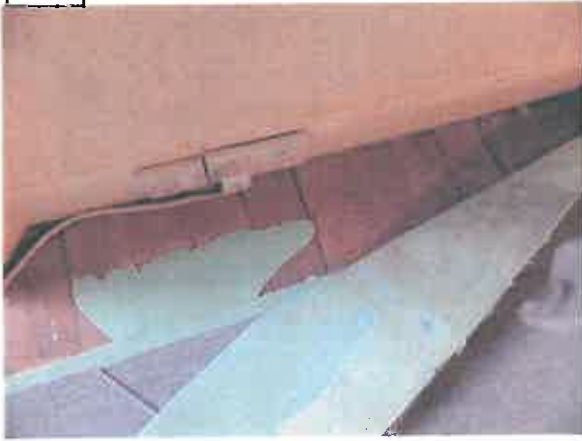
19

| 19. | Exposed flooring – first floor |

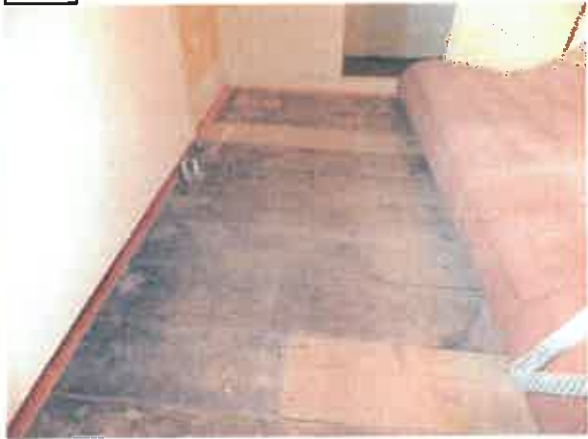
20

| 20. | Exposed flooring – first floor |

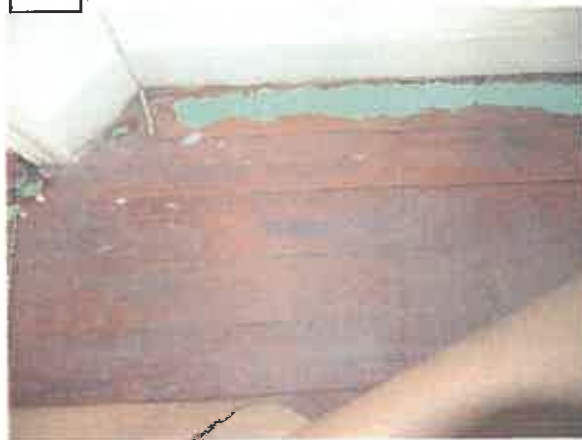
21

| 21. | Exposed flooring – first floor |

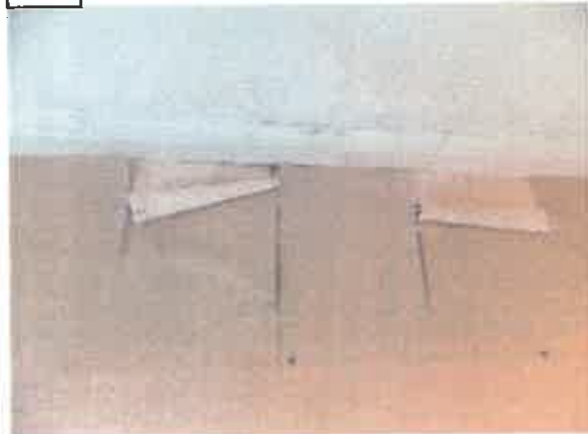
22

| 22. | Damp staining below the chimney breast in the roof void |

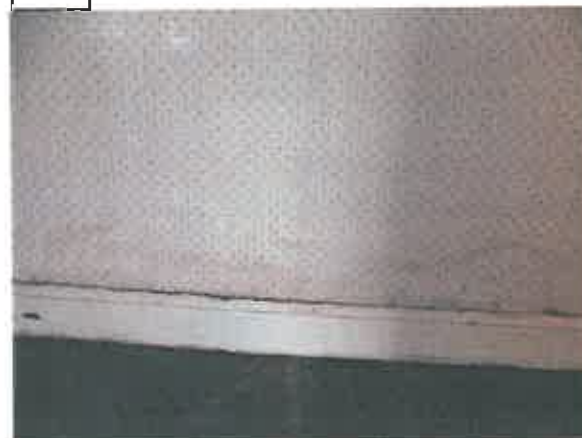
23

The readings obtained from the profiling techniques indicated that of rising damp at low level to most of the affected walls and sporadically located throughout the ground floor areas, further suggested by the sharp cut off between wet and dry at the head of the rise.

| 23. | Damp staining – ground floor |

After consideration I could only advise that the only type of damp proof course I would install would be an electro osmosis type. This could either be installed from the outside once the rough cast render is removed or internally once the damp affected areas of plaster are removed along with the skirting boards to allow installation (only remove the visually damp and disrupted areas of wall plaster).

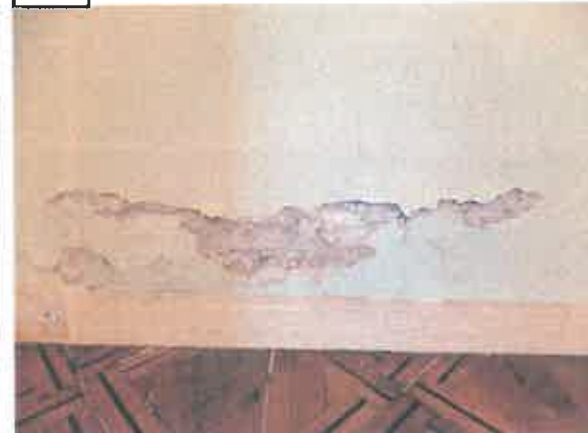
24

| 24. | Damp staining – ground floor |

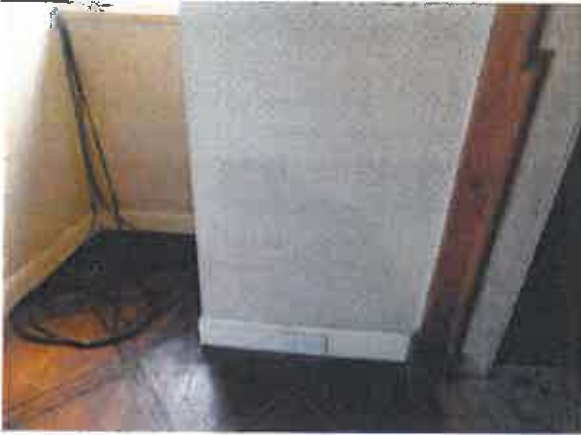
25

| 25. | Damp staining – sitting room chimney breast |

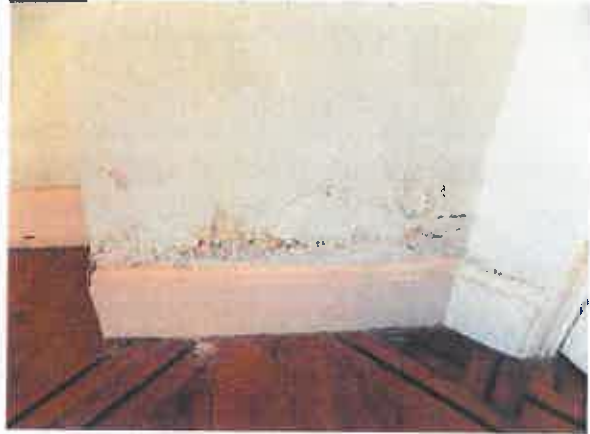
26

| 26. | Damp staining – ground floor |

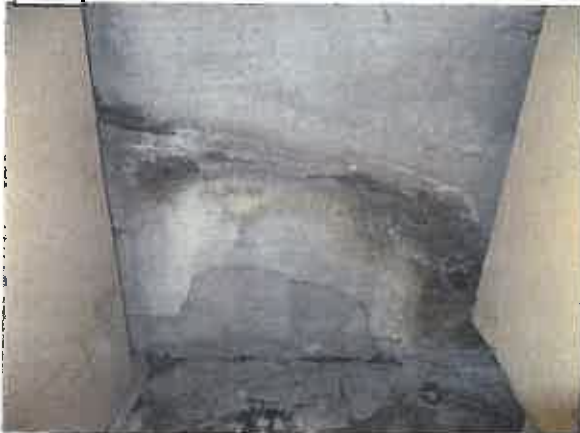
27

| 27. | Damp staining – ground floor |

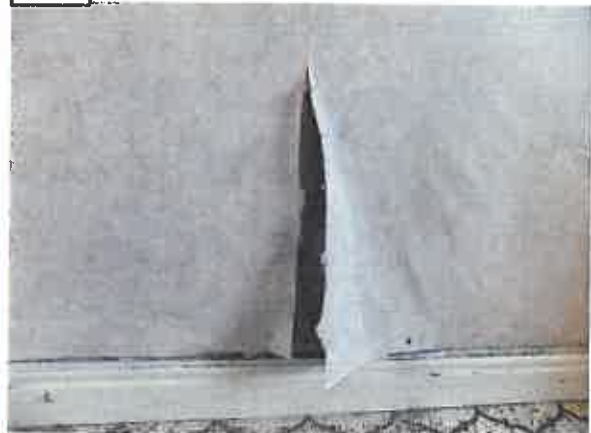
28

| 28. | Damp staining and disruption to wall finishes |

Ideally, this should be undertaken using a natural lime product (likely NHL 3.5) depending on the strength of the background material, in particular to external wall areas. If not considered practical to use traditional lime plaster, consider/investigate the use of Limelite or Tilcon Hardwall incorporating a water proofer (i.e. Brunolene PS).

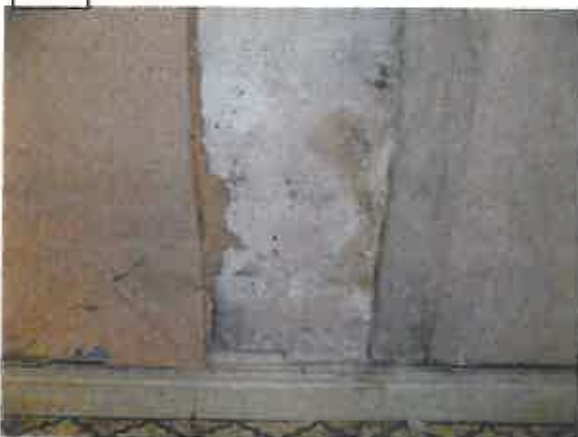
29

| 29. | Damp staining and disruption to wall finishes |

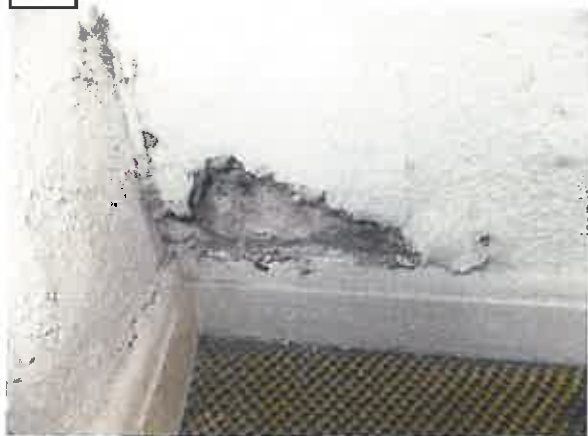
30

| 30. | Damp staining and disruption to wall finishes |

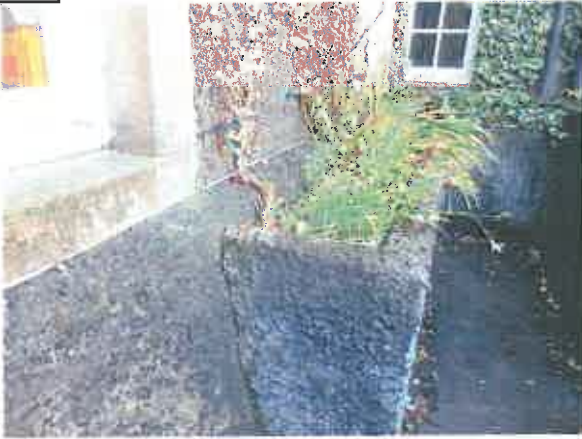
31

1. The rough cast render is directly in contact with the ground. The render appears to be cement rich and this would prevent any evaporation of moisture, in particular at low level; damp/moisture entering the wall structure would be forced higher to evaporate.  
The render may be 'drawing' moisture from the ground.
2. Ground/path levels to the left gable and rear are high in relation to the internal floor position.
3. High ground levels to the immediate left of the boiler room between the rear wall of the store area and greenhouse/boiler room dividing wall.
4. Planters to the rear main external wall to the right of the pantry are holding damp/wet soil against the rear elevation.

| 31. | Planter to the rear elevation |

1. I would recommend that the cement rich rough cast render coat is cut back from the ground to one metre and replaced like for like using a lime based render (NHL5) the replacement rough cast render ideally should be terminated 150mm above the ground levels to further allow evaporation of moisture at low level. The patina of the new rough cast render could be, if desired, toned down using a natural dye.
2. Ideally reduce ground levels where feasible or maintain them at their present levels; avoid any further increase in height. Consider if allowed, the removal of the planters to the rear elevation.

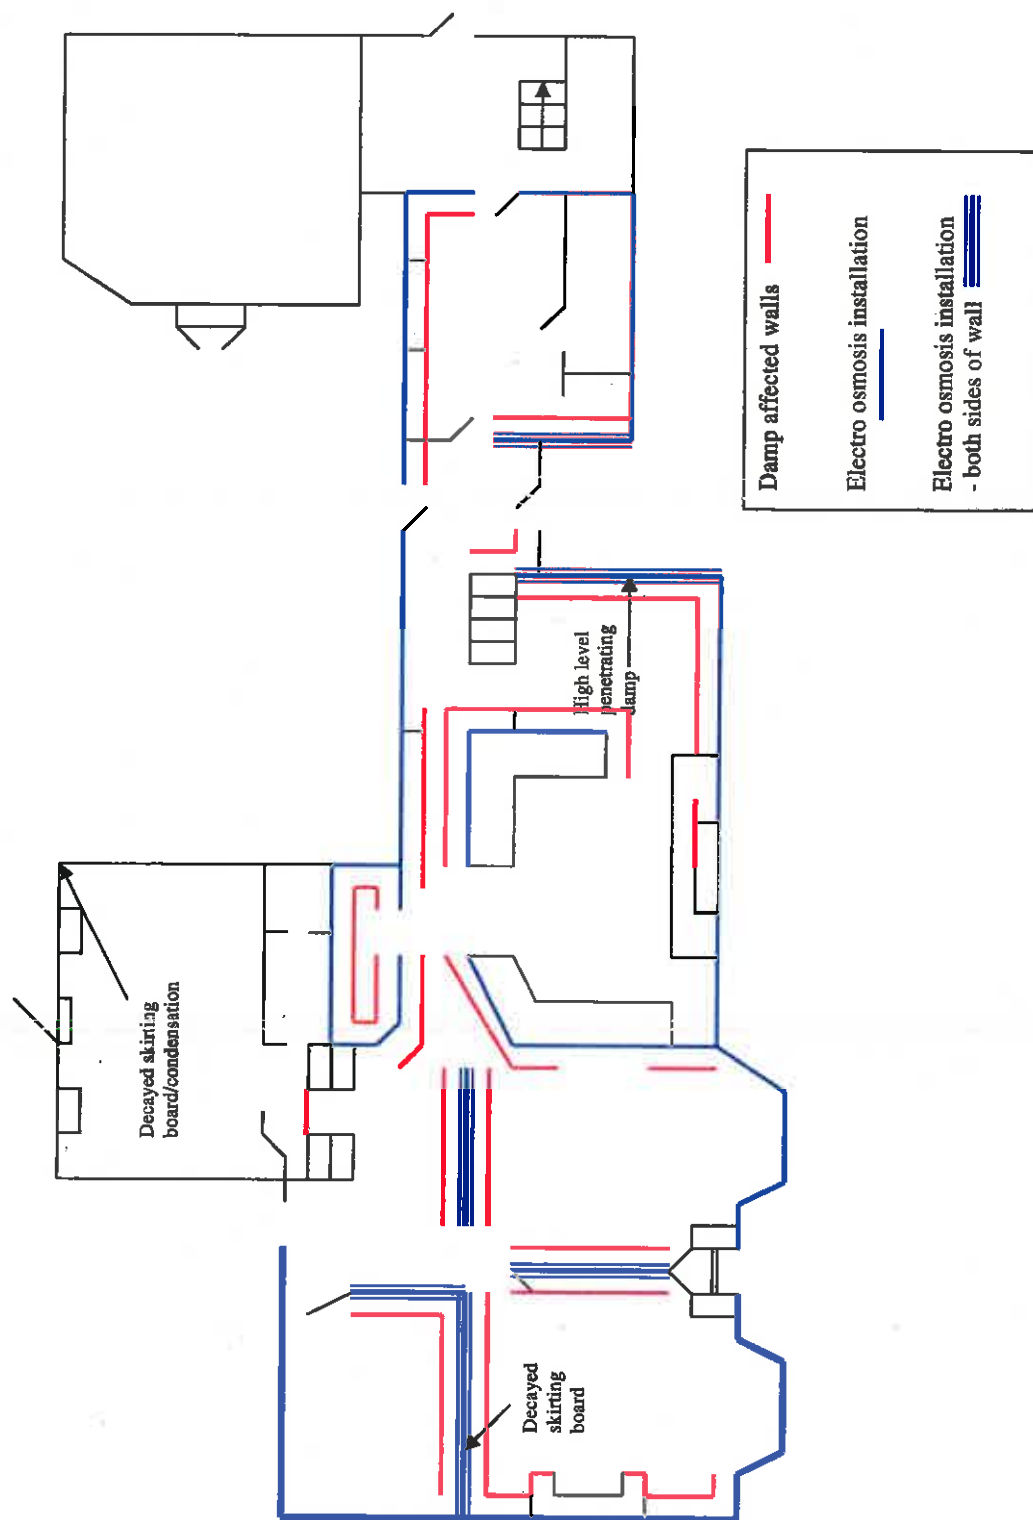
**GROUND FLOOR SKETCH PLAN – Not to Scale**  
**The Dower House, Park Road, Gisburn**

The affected areas are indicated on the floor plan provided.

The area/extent of the installation is indicated on the floor plan provided.
