BUILDING (STRUCTURAL) CONDITION SURVEY
IN CONNECTION WITH
BARN AT HIGHER BOYCE FARM,
RIBCHESTER

MR M. SELLS AND MISS M. HOWORTH,
HIGHER BOYCE FARM,
STONEYGATE LANE, RIBCHESTER, PR3 3YN

JOB REF: 4874, DATED: 23/09/2015, VERSION: 1.00.

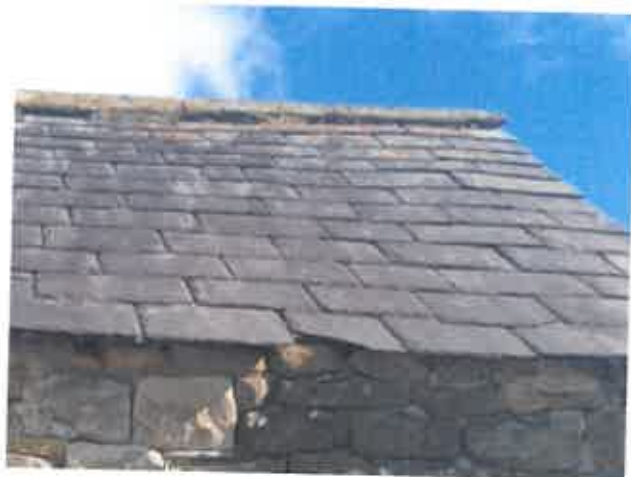
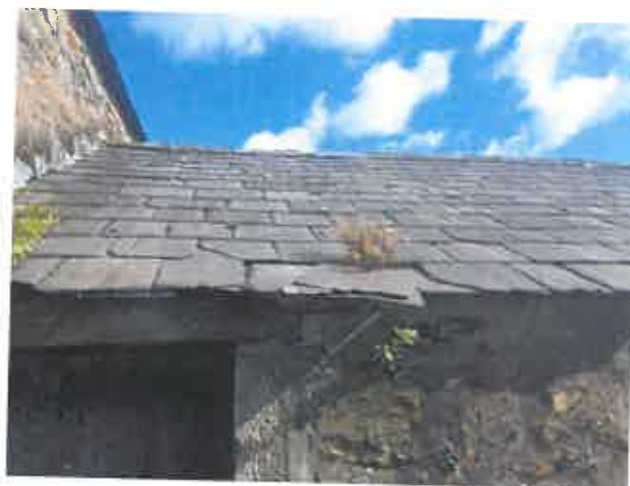
The natural slate covering to the roof is in an average condition and is showing signs of weathering with a number of chipped and cracked slates throughout. There are also a number of loose / dislodged and missing slates as well as an ad-hoc repair to the roof covering to the west elevation of the south section of the barn. All of which is to be expected given the age of the barn. All ridge tiles appeared to be present at the time of construction however they appeared to be in poor condition throughout along with the mortar pointing which was degraded and missing in places. Moss and vegetation growth was also present at roof level. These issues have the potential to allow for unwanted water ingress into the barn.

PL2 (Left) and PL3 (Right) showing cracked, chipped and dislodged slates along with vegetation growth.

- All timber wall plates should be replaced throughout.
- All degraded ridge tiles should be removed and replaced with new ridge tiles throughout.
- Damaged areas of the roof covering should be repaired and all damaged slates should be replaced whilst ensuring that the roof is water tight.

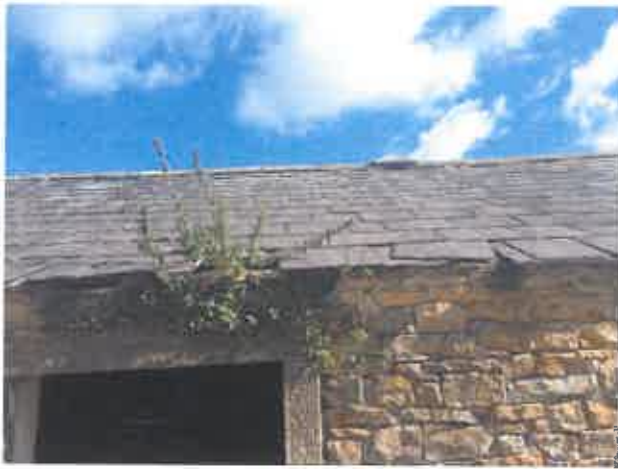
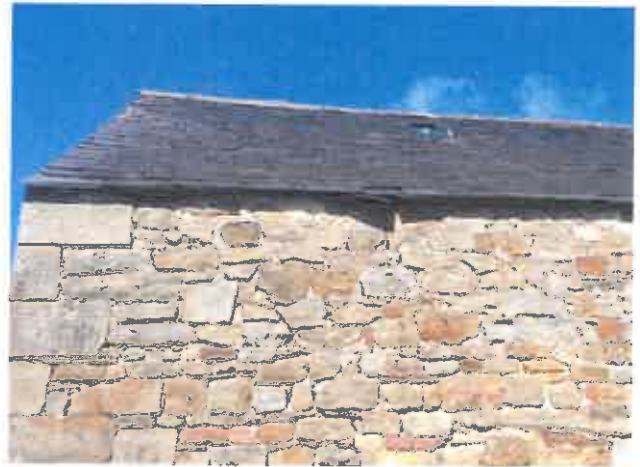
PL4 (Left) and PL5 (Right) showing cracked, chipped and dislodged slates along with vegetation growth.

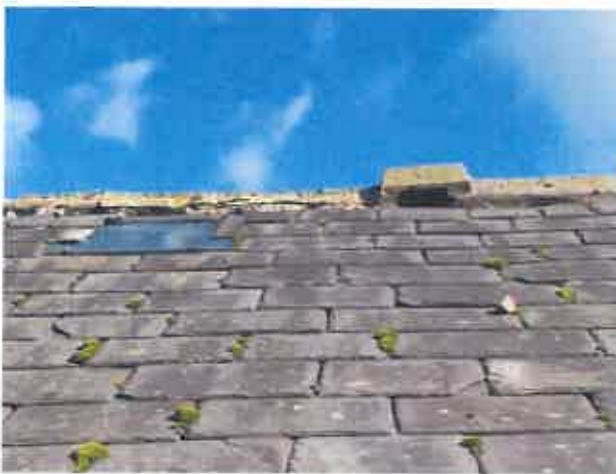
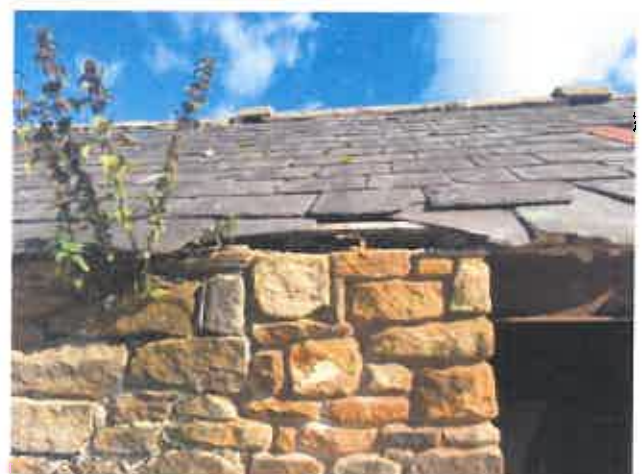
PL4 (Left) and PL5 (Right) showing degradation to ridge tiles and pointing as well as cracked, chipped and dislodged slates with vegetation growth.

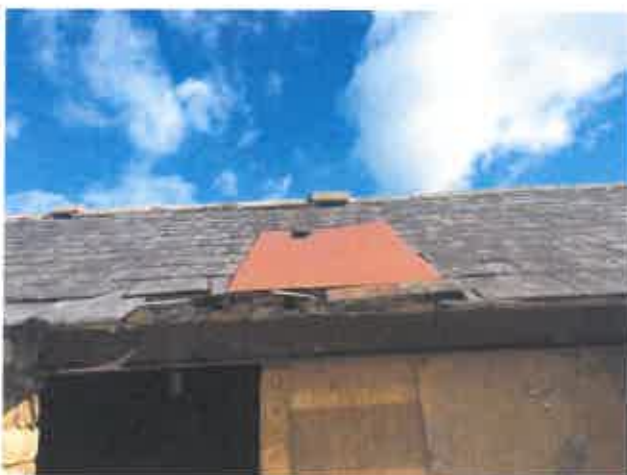
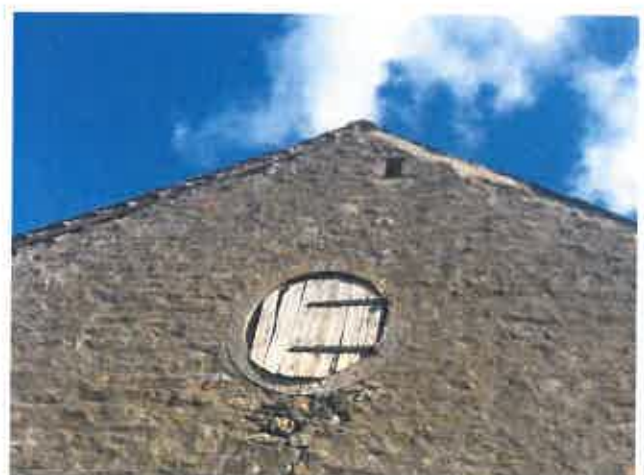
The verges to the main roofs were in poor condition due to mortar degradation and areas of missing mortar pointing. Areas of exposed timber wall plates were also exposed due to the degradation and lack of mortar pointing.

PL6 (Left) and PL7 (Right) showing cracked, chipped and dislodged slates with ad-hoc roofing repair. Degradation and missing mortar pointing noted to roof verges.

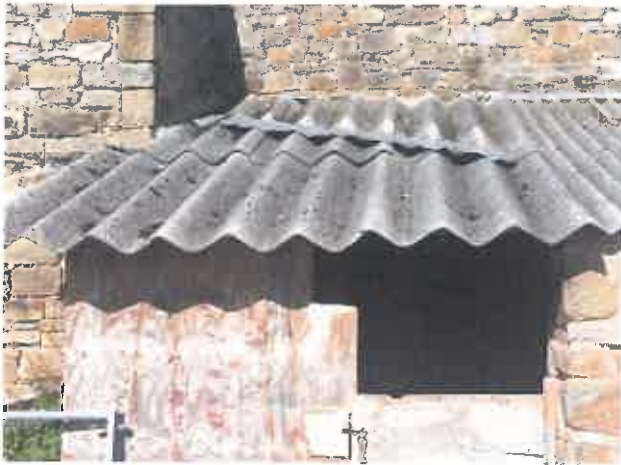
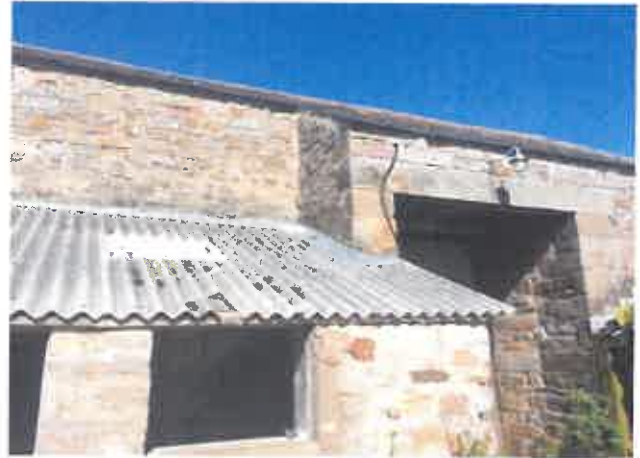
The asbestos roof covering to the south elevation of the north section of the barn was in poor condition with cracked and damaged asbestos sheets as well as vegetation growth and weathering visible to the surface of the covering. All asbestos sheets were present at the time of inspection with no dislodgements or breaches present at the time of inspection. In accordance with this application, this area of the barn is to be demolished. This said, suspected Asbestos Containing Material (ACMs) were highlighted during the inspection and subsequently a full demolition and alteration asbestos survey will need commissioning and undertaking by the client prior to any works commencing. In addition, any ACM will require removing in full by a specialist asbestos removal contractor and Clean Air Certificate authorised prior to conversion works commencing.

The lead work that is present at the junction between the north and south buildings of the barn is in average to poor condition with no obvious breaches, dislodgements or missing sections of flashing however the flashing had become discoloured. The lead work to the asbestos roof was in average condition at the time of inspection; however a large section of the lead flashing had become completely dislodged from the roof and wall junction.

PL8 (Left) and PL9 (Right) showing the condition of the asbestos roof covering and the section of dislodged lead flashing (this particular area is to be demolished).

- All asbestos containing materials should be fully removed from site and disposed of by a licenced specialist contractor. (See also Section 1.1 - ACMs note).

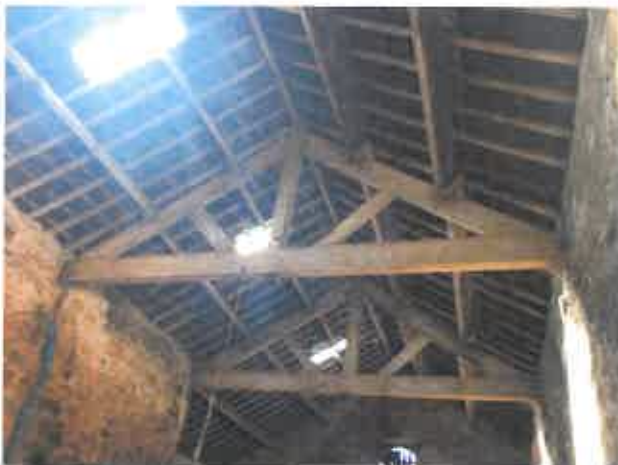
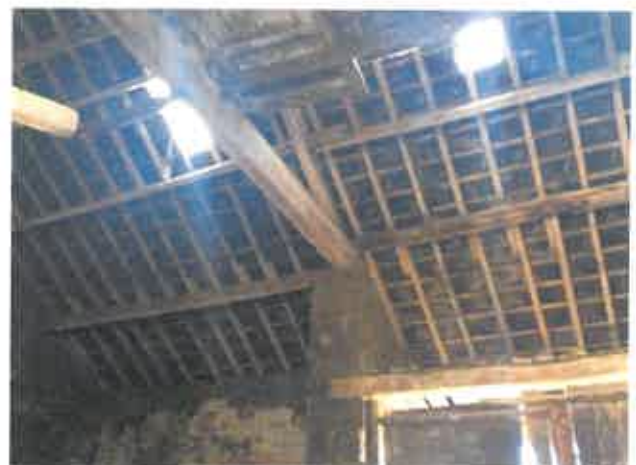
The trusses throughout are beginning to dilapidate and on visual inspection of the trusses; they appear to be suffering from decay. This could have occurred over time as a result of the breaches within the roof covering which could have allowed for water ingress to occur. Evidence of possible insect attack is also present. However, these issues would need to be fully confirmed with a closer visual inspection of the trusses.

PL10 (Left) and PL11 (Right) showing internal roof structure to north section of the barn.

- Remedial works should be carried out to the timber roof structure where required. This may consist of the treating of all timber components that are to be retained i.e. trusses, to protect against rot and insect attack.

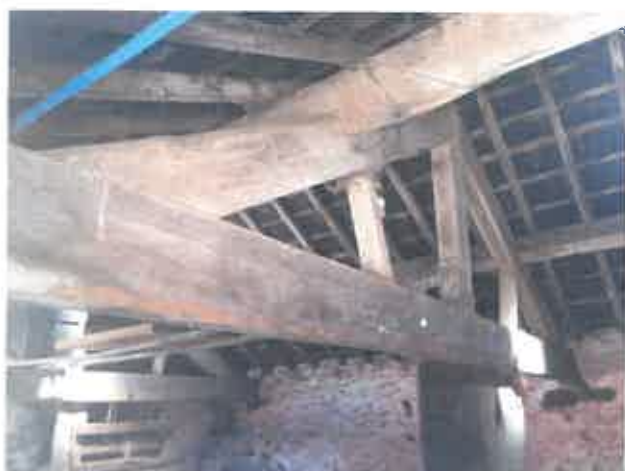
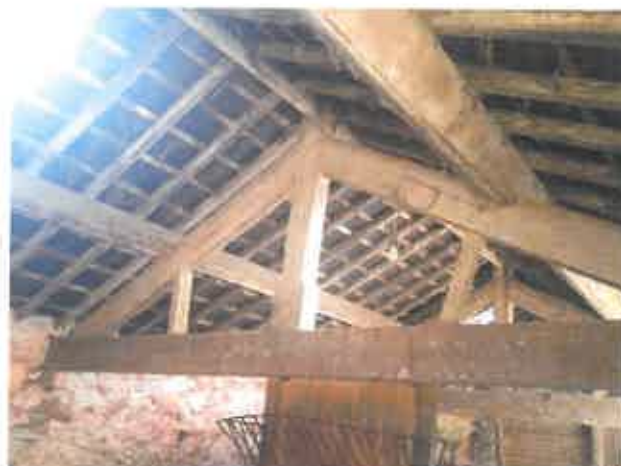
PL12 (Left) and PL13 (Right) showing internal roof structure to south section of the barn.

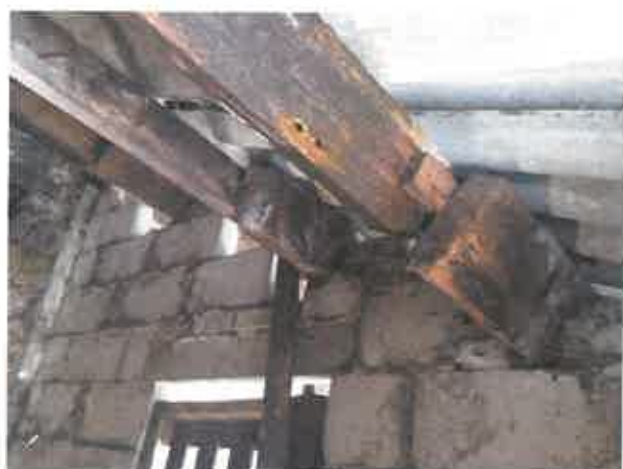
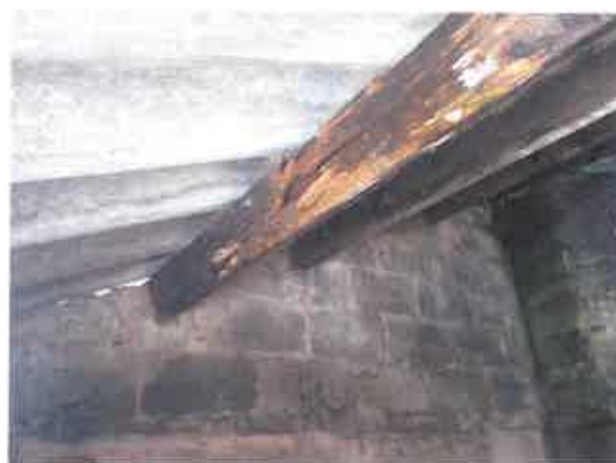
The purlins which supported the asbestos roof covering to the south elevation, where in poor condition, with clear evidence of decay and rot visible at the time of inspection.

PL14 (Left) and PL15 (Right) showing internal roof structure to lean to roof on the south elevation of the north section of the barn building.

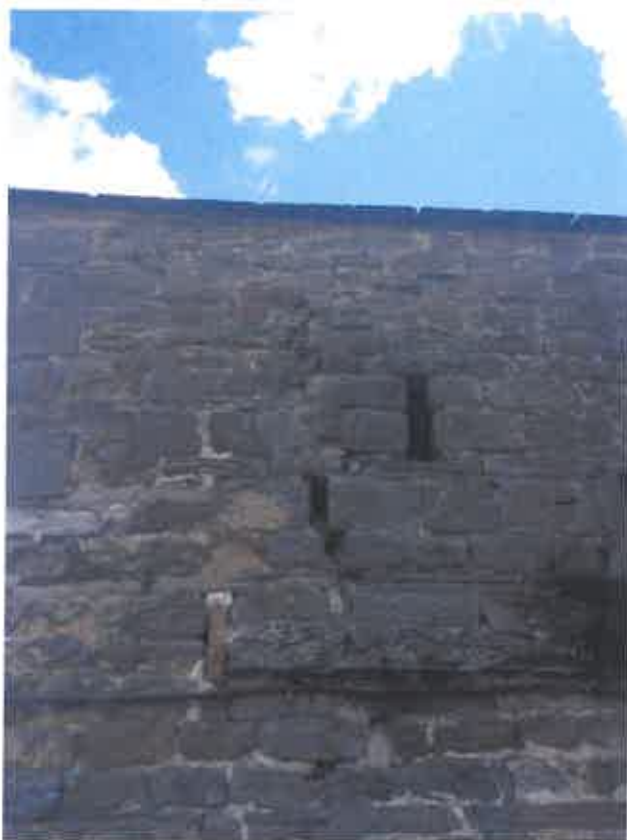
PL17 (Left) showing area of cracking to eastern side of north elevation. PL18 (Right) showing dilapidated ad-hoc structure, used to store water tank, which is to be demolished.

Another issue was the presence of cracks within the walls of the building both internally and externally. The possible cause of this could be down to a number of contributing factors. It is likely that the building has shallow foundations which are inadequate for the loading requirements that have been placed on them. In turn this has resulted in movement of the building. Further investigations would be required to fully determine the cause of movement and whether or not further movement is likely and the extent of any remedial action required.

- Remedial works should be carried out to the external walls where required. This will involve the raking out of the degraded mortar and repointing the affected areas with a suitable lime mortar. Stone replacements may also be required in order to replace any degraded / damaged / missing stones. Crack stitching to take place in order to repair wall cracking to the north and east elevation walls.

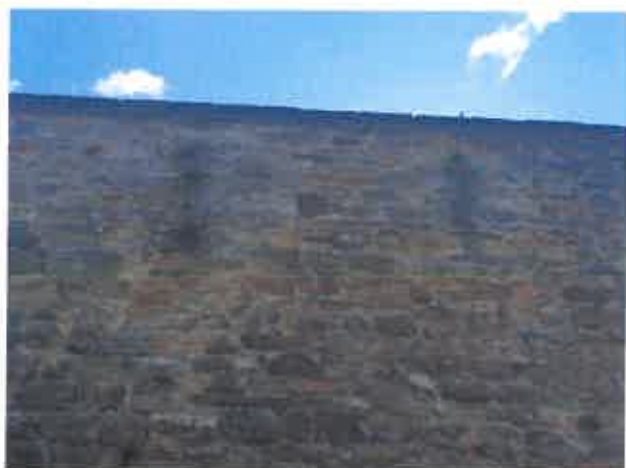
PL19 (Left) showing rust staining to below metal fixtures. PL20 (Right) showing significant vegetation growth to the base of the elevation.

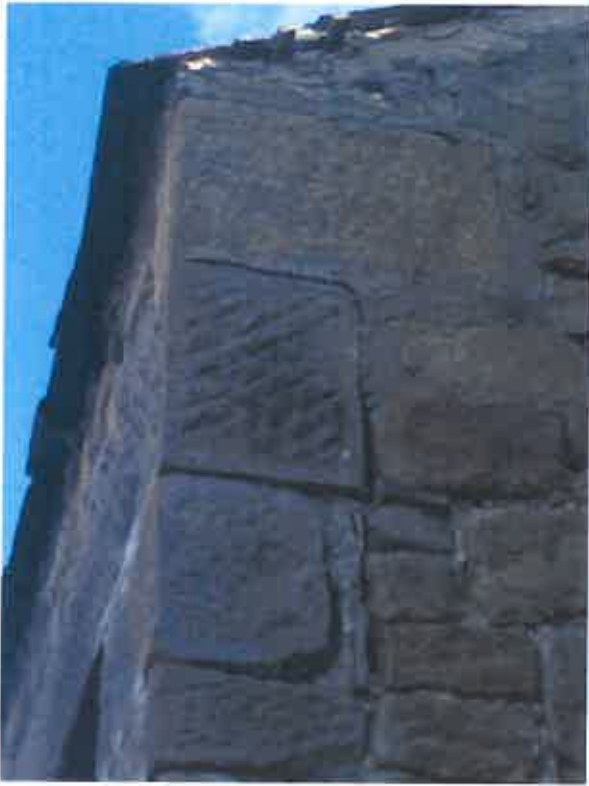
PL21 (Left) showing mortar crack to right hand side of stone lintel to barn entrance. PL22 (Right) showing condition of stonework and degradation to base of wall.

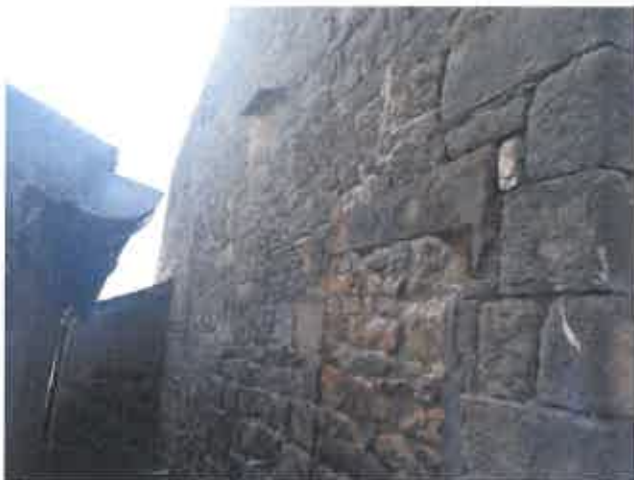
PL25 (Left) showing condition of the east elevation gable wall with degraded mortar and patch repairs. PL26 (Right) showing cracking to east elevation gable wall.

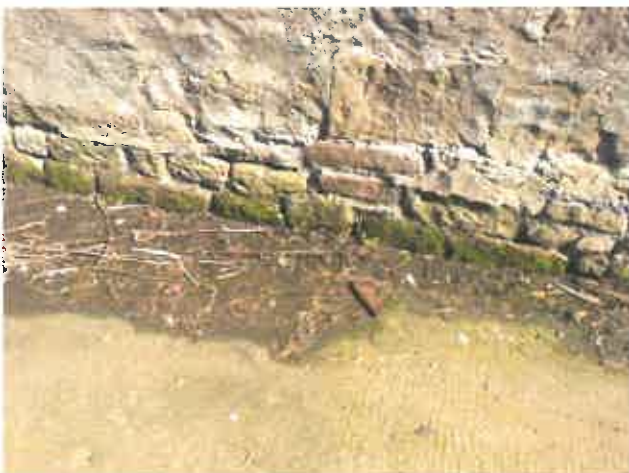
PL33 (Left) showing mortar degradation to base of wall. PL34 (Right) showing hole damage and hairline cracking to west elevation.

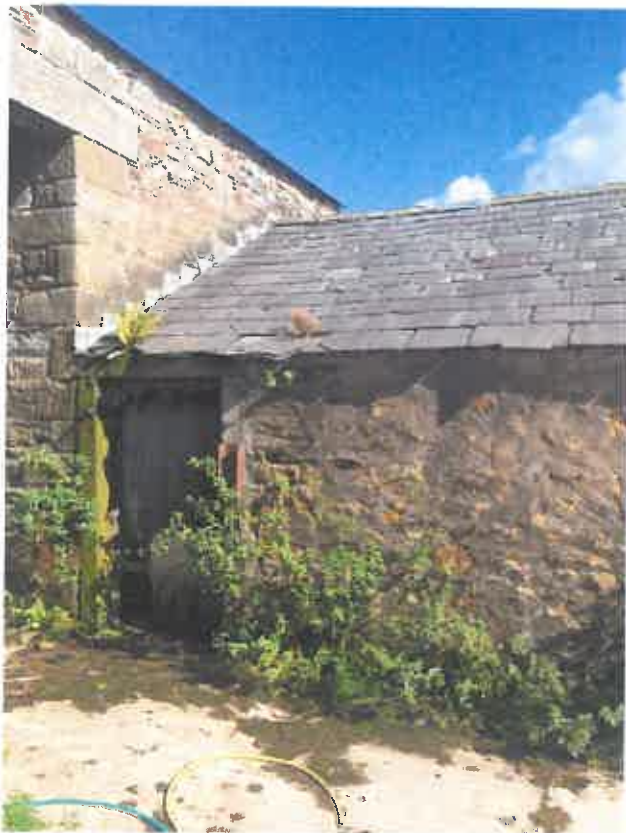
PL35 (Left) shows mortar repairs to stone joints and significant plant / weed growth to base of wall. PL36 (Right) showing mortar patch repairs, mortar degradation and plant / weed growth.

- All vegetation growth is to be removed from the base of all walls and also from the affected areas of the roof structure / covering.

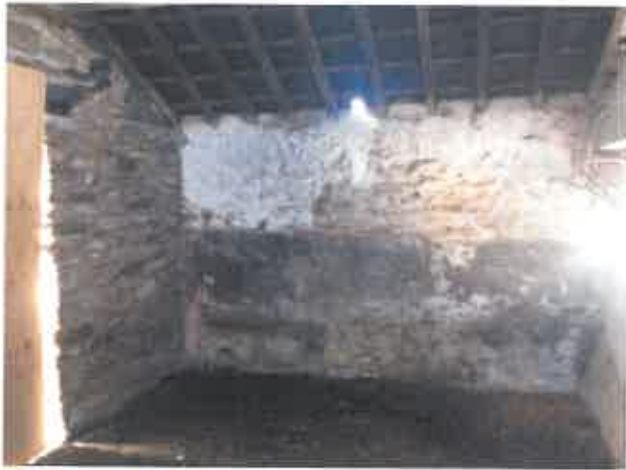
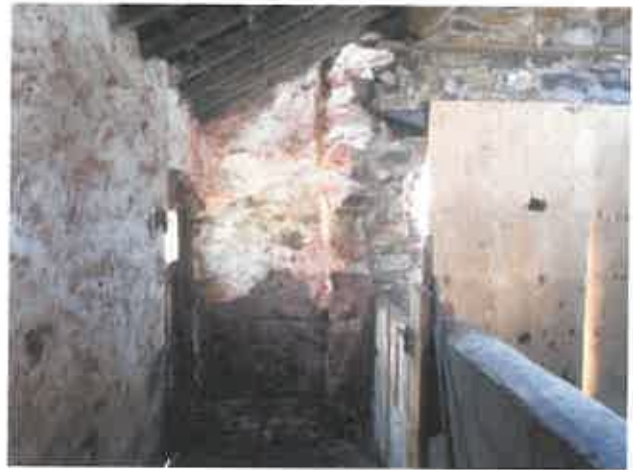
Internally throughout, the internal walls where in average to poor condition. The internal white washes and renders were degraded with areas of stonework being exposed beneath the white wash. The white wash was also stained, soiled and discoloured throughout. Hairline cracking was also present to the areas of cement render. The blockwork walls where in average condition with some soiling and patch mortar repairs present however, the dwarf walls are to be removed as part

PL38 (Left) and PL39 (Right) shows difference in internal wall finishes and also condition.

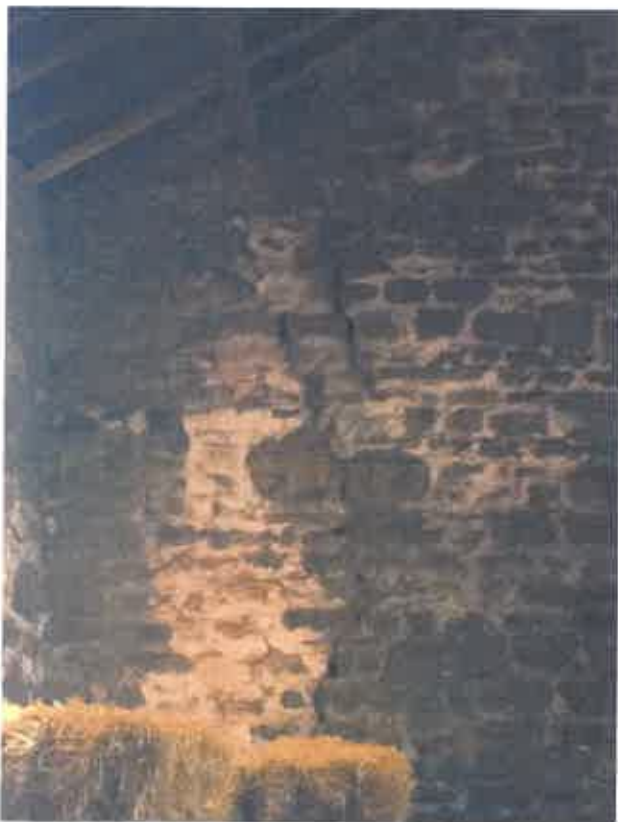
An area of wall cracking was present to the internal face of the east external gable wall. This crack was reflective of what also occurred on the external face of the wall in the same location.

PL40 (Left) shows wall cracking to the internal face of the east gable wall within the north section of the barn and is in the same location as the external wall cracking. Minor isolated crack stitching / lateral restraint ties potentially required at this point. PL41 (Right) shows soiling and staining to internal walls.

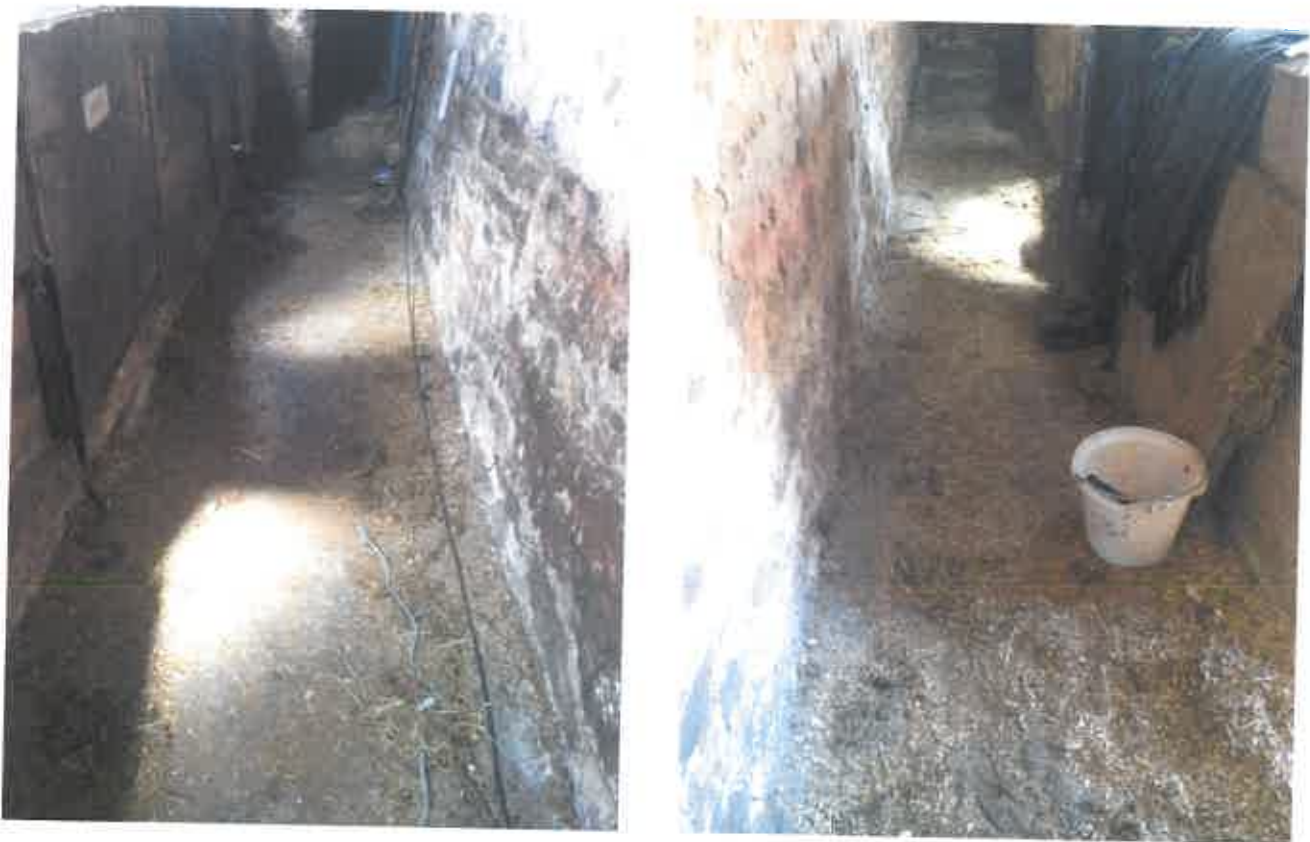
The concrete ground floor appeared to be in moderate condition with no obvious signs of substantial cracking and appeared to be relatively level. However the finished surface was rough and contained various areas of staining and surface blemishes, however it is fit for its intended purpose at present.

PL42 (Left) and PL43 (Right) showing the internal concrete floor of the south section of the barn building.

- Existing concrete ground floor should be grubbed up and replaced with a new insulated concrete ground floor structure incorporating DPMs with DPCs lapped up to new internal block lining walls.

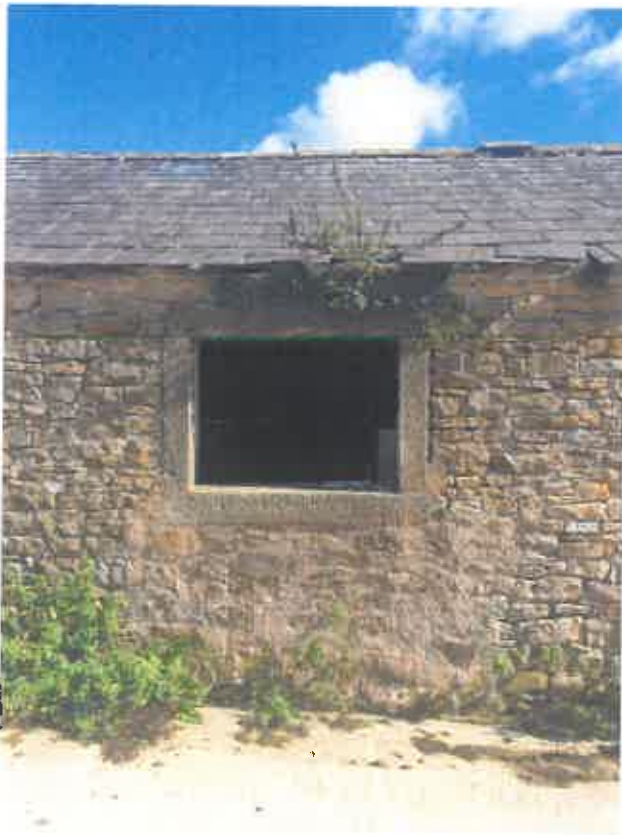
PL44 (Left) showing empty structural opening. PL45 (Right) showing ad – hoc gate / door arrangement.

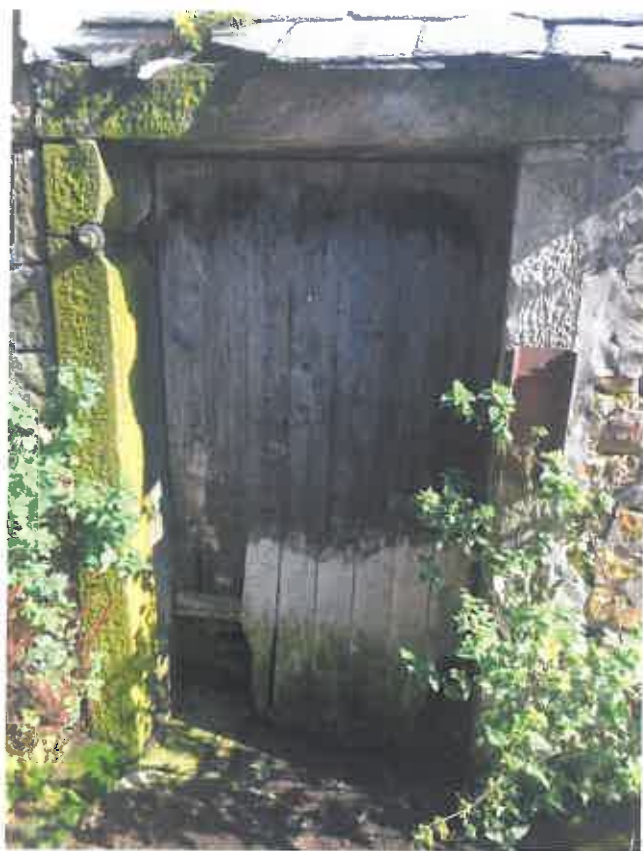
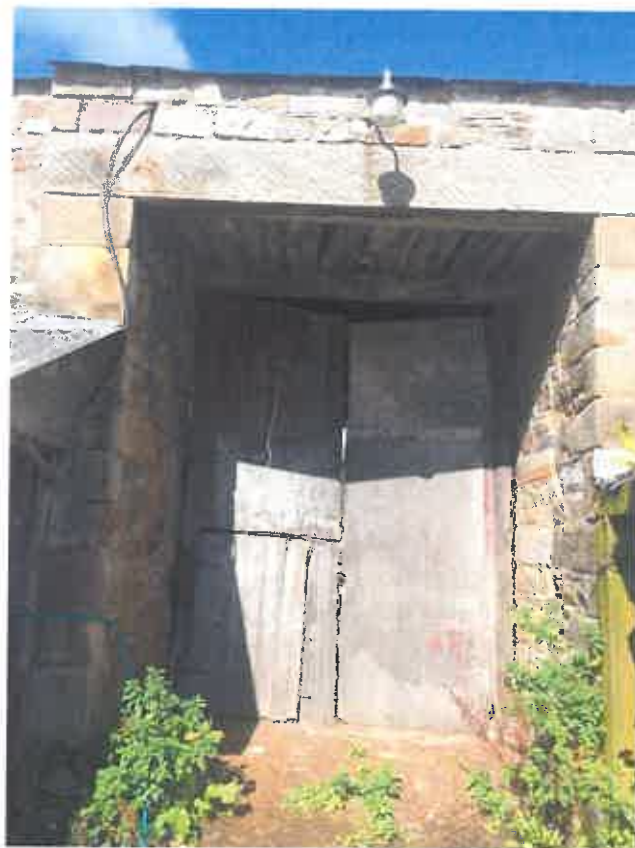
All windows and doors, including frames, were in poor condition and dilapidated with graining of the surface and virtually no paint finish visible at the time of inspection. A number of the doors had been repaired in an ad-hoc nature, through which they had also become unsightly. Many of the timber components were also showing signs of timber decay.

PL46 (Left) and PL47 (Right) showing dilapidated and damaged external doors.

- Existing timber windows and doors should be removed and replaced with new double glazed uPVC or timber units to ensure water tightness from wind driven rain at these points.

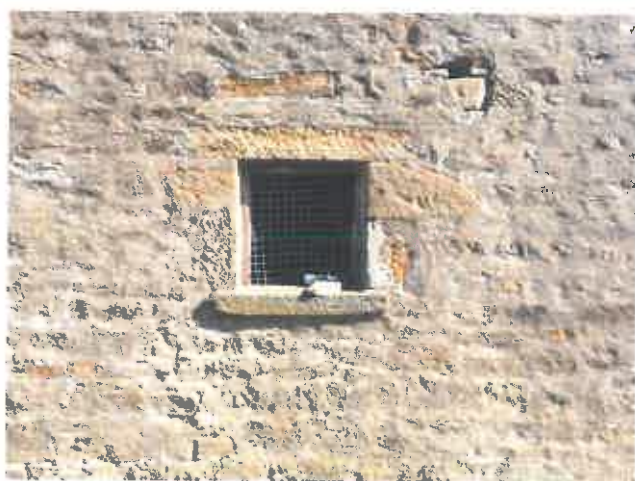
PL48 (left) showing dilapidated window frame with wire mesh infill. PL49 (Right) showing poor condition of pitching hole door and rusting hinges.

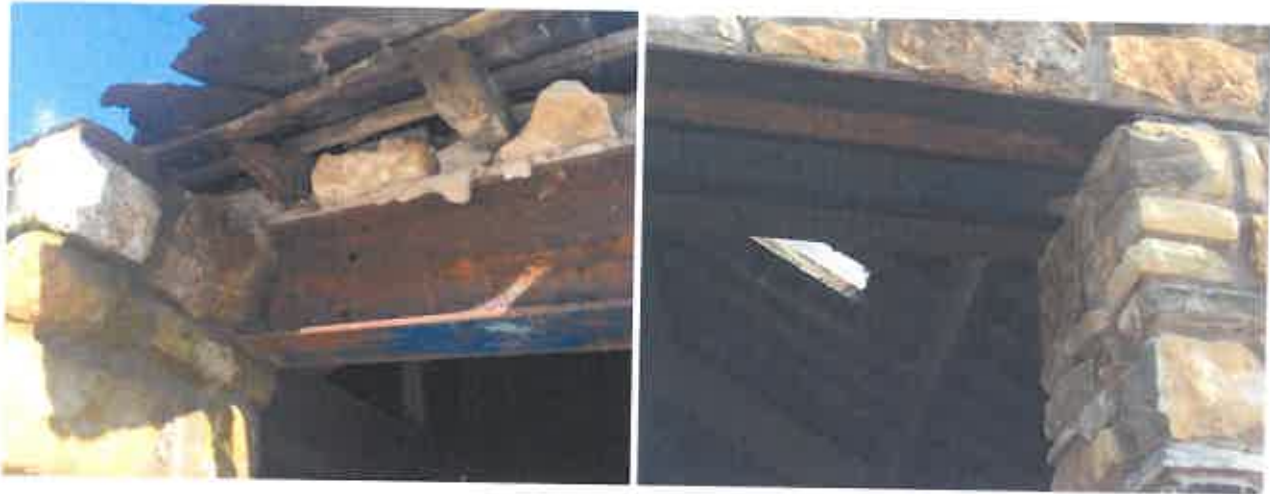
PL50 (left) and PL51 (Right) showing rust and corrosion to steel lintels above openings.
