**UPDATED STRUCTURAL CONVERSION ASSESSMENT**  
**LITTLE DUDLANDS FARM, RIMINGTON LANE, RIMINGTON, BB7 4EA**

### **STRUCTURAL CONVERSION ASSESMENT AND METHOD STATEMENT LITTLE DUDLANDS FARM RIMINGTON LANE, RIMINGTON, BB7 4EA**

A structural inspection of the above property was carried out on 10 December, 2013, to examine and report on the current state and safety of an existing barn for conversion purposes.

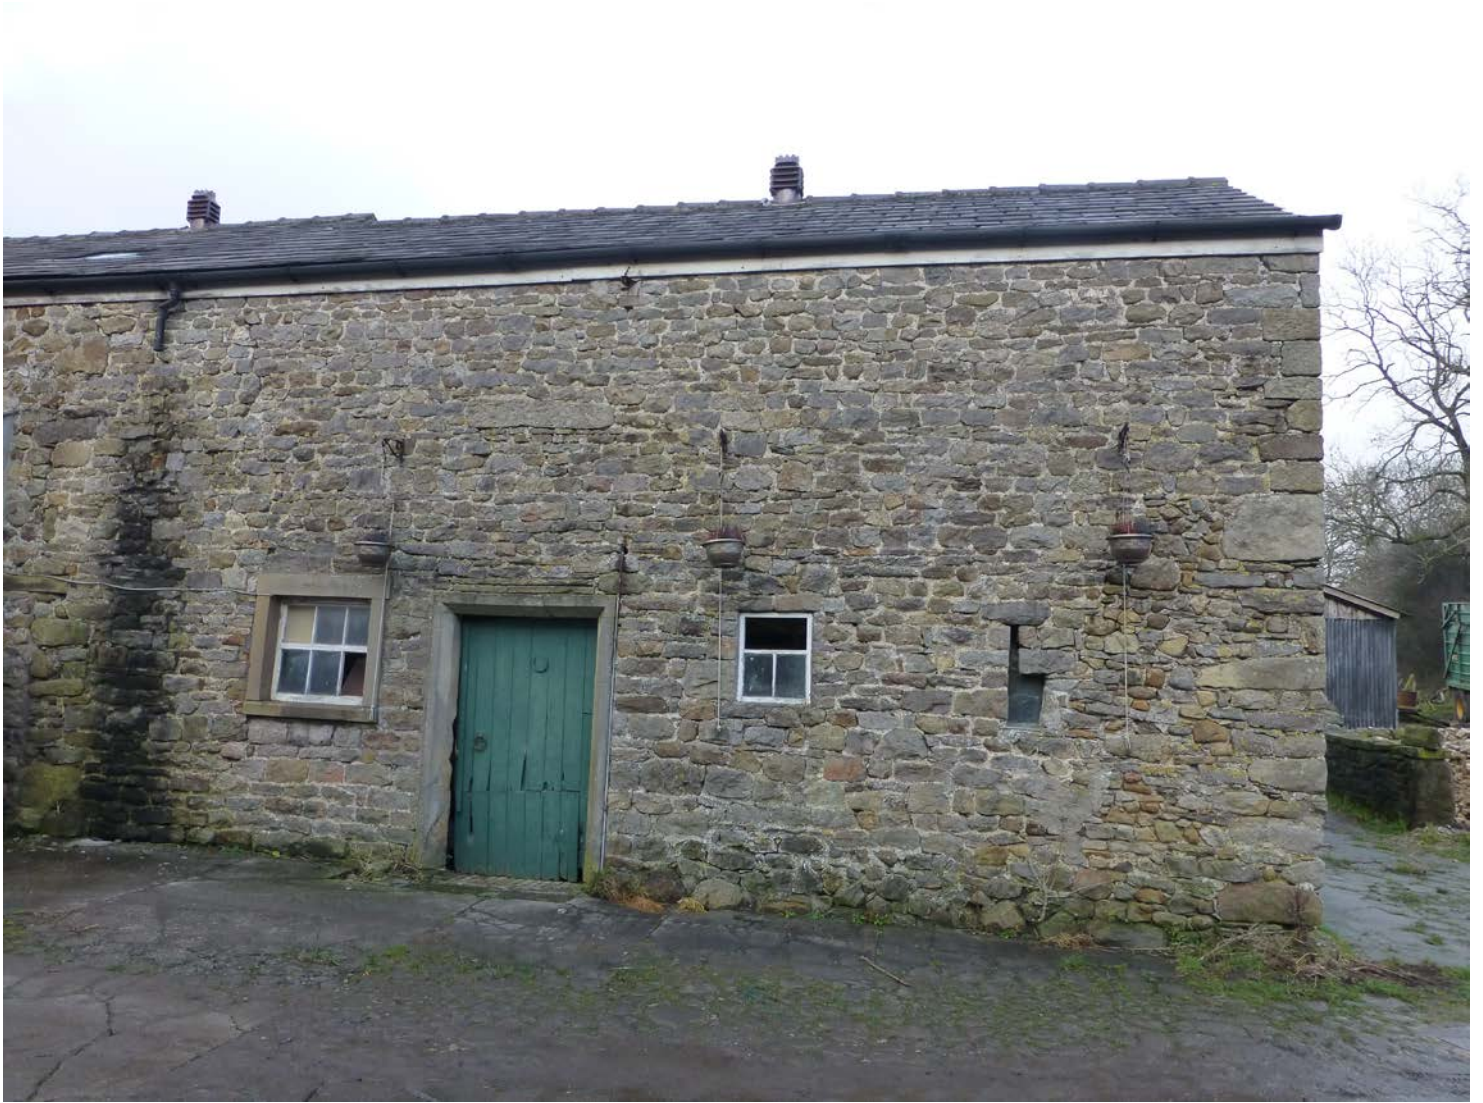
Photograph No. 3

The two external walls shown on the plans as positions 3, 5 & 8 are reasonably plumb and in good condition showing no real signs of excessive movement or large cracking. All the pointing however is in poor condition. Cracking to the walls internally could also be seen in numerous areas to the plan positions 5.

All areas require the existing pointing to be removed and replaced. Any loose stonework must also be replaced as necessary once the pointing has been removed with stone work to match; this should be carried out both externally and internally

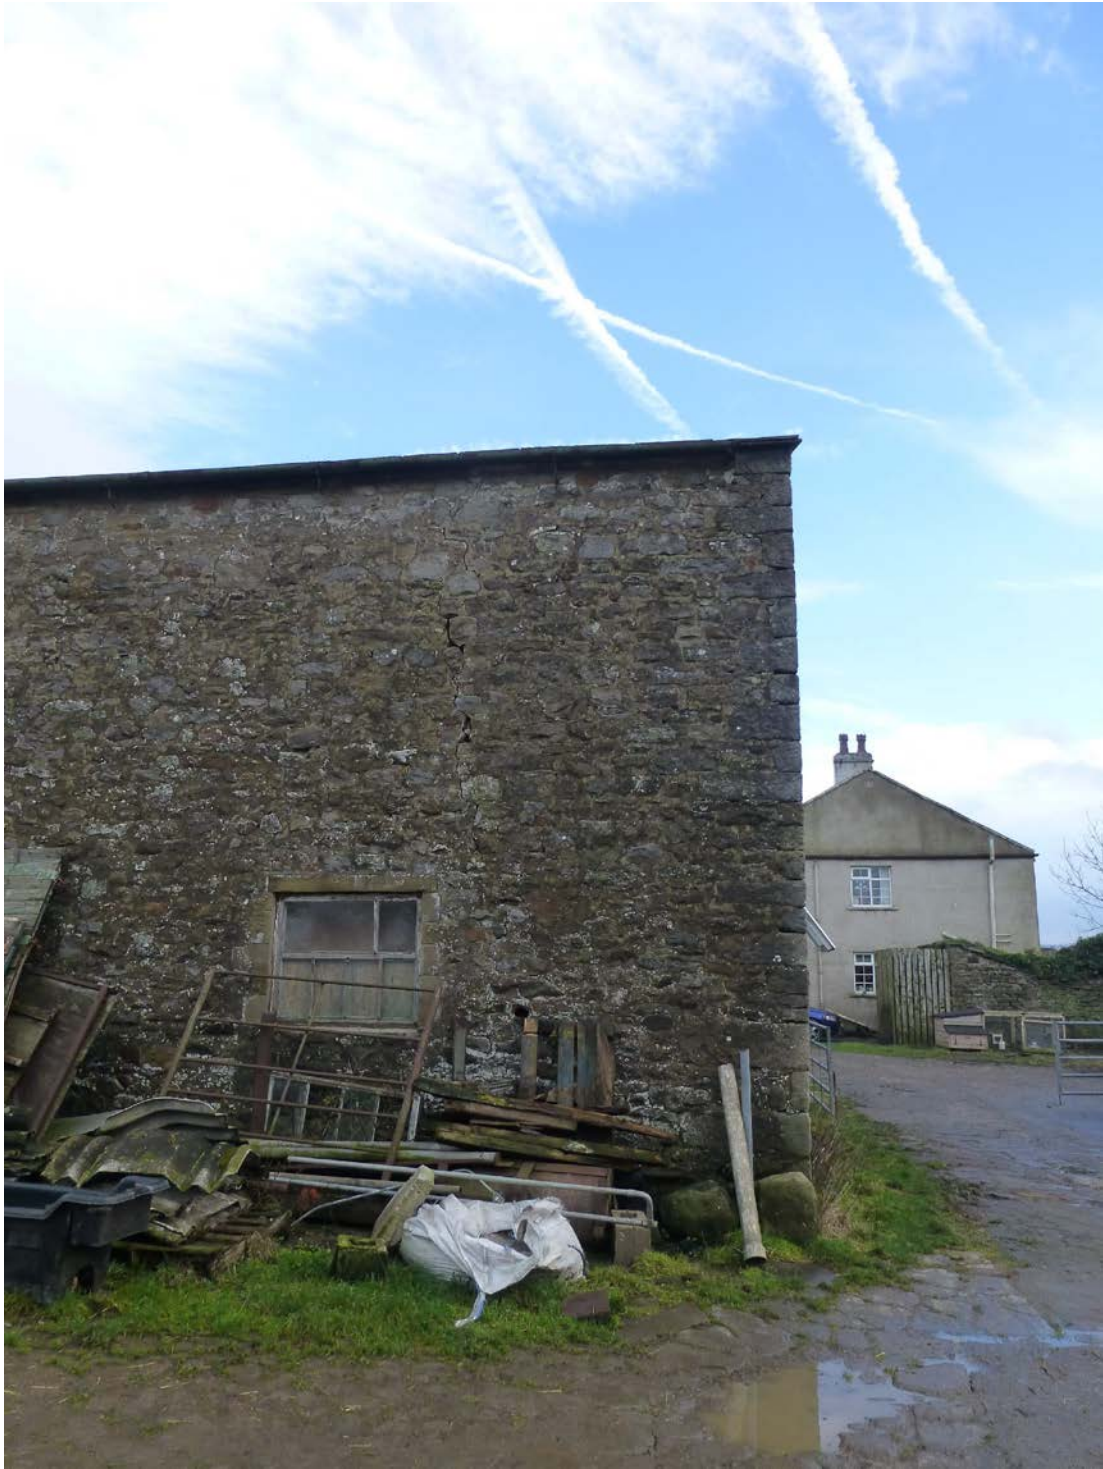
Photograph No. 9

The external wall shown on the plans as position 9 is reasonably plumb and in good condition showing no real signs of excessive movement or large cracking, except to one position near the corner. All the pointing however is in poor condition.

All areas require the existing pointing to be removed and replaced. Any loose stonework must also be replaced as necessary once the pointing has been removed with stone work to match; this should be carried out both externally and internally

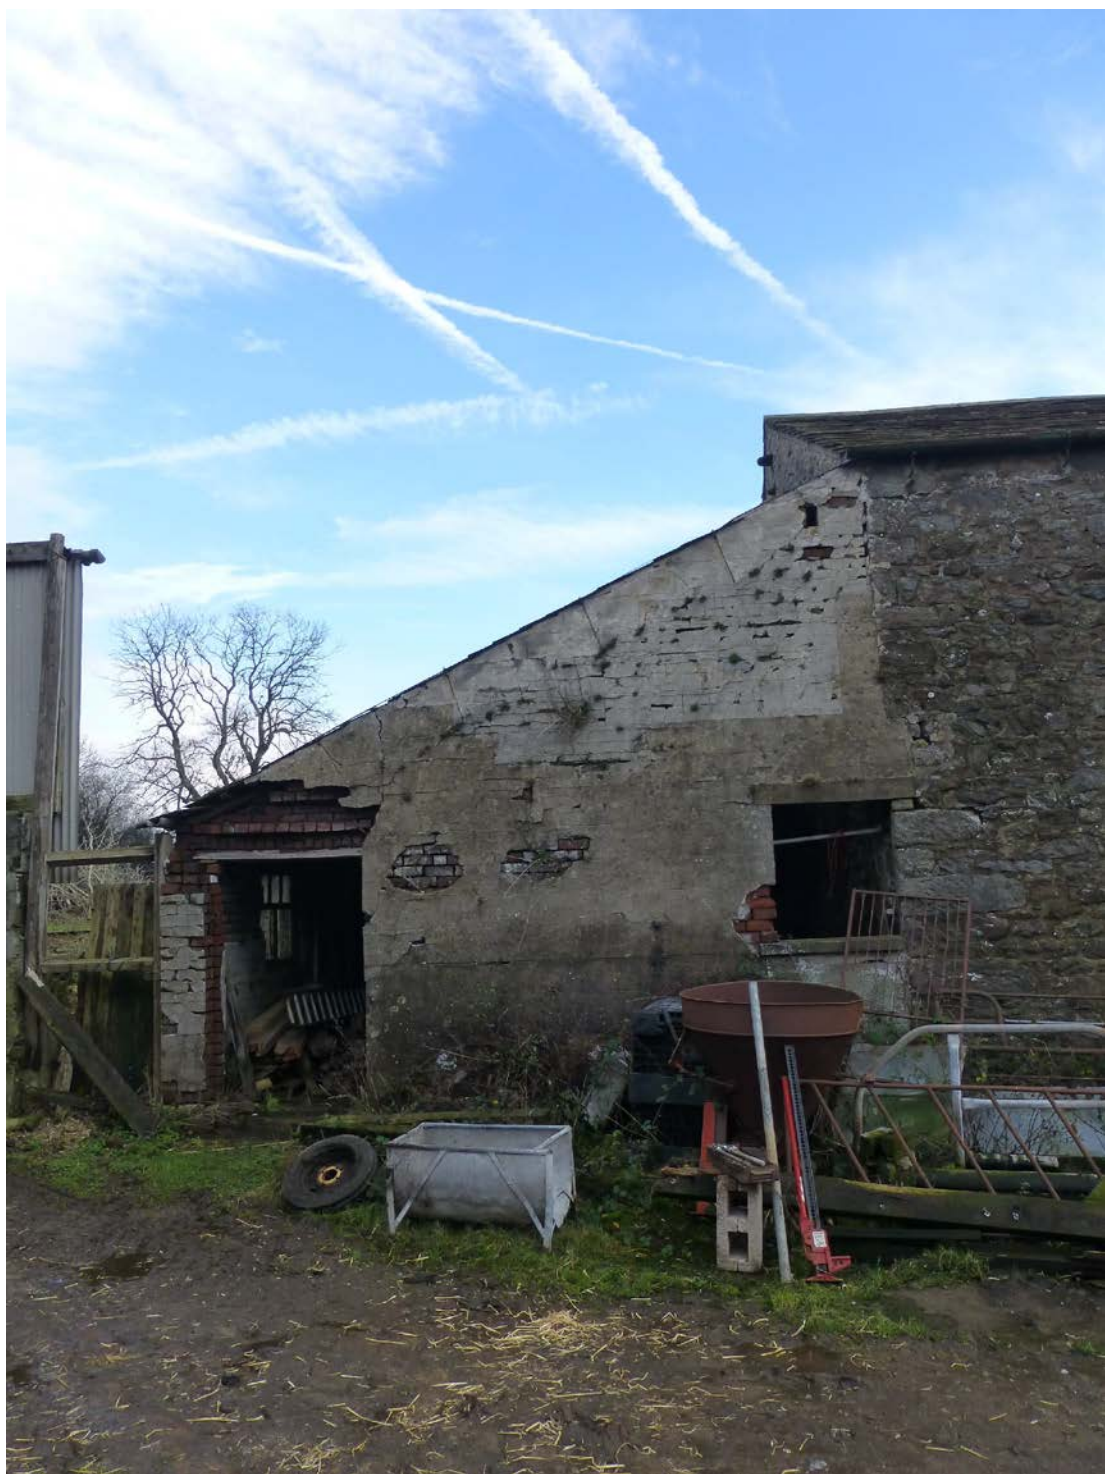
Photograph No. 10

The external wall construction that can be seen within photograph number 10 is in a poor state of condition and is only a red brick built lean too that was not built at the same time as the main barns.

The main barn wall (red brick section) as shown as position number 10 needs to be totally re-built off a new concrete strip footing. The wall construction will consist of an outer leaf of random stone with a 100mm thick concrete back blocking. This will be tied to an internal leaf of 140mm thick concrete block with ties as per the Architects details as supplied at the time of any Building Regulation application.

The above wall should only be removed once adequate support has been provided to the existing roof and floor construction. The contractor must also provide lateral support to the existing barn flank walls whilst the wall in question is being re-built.

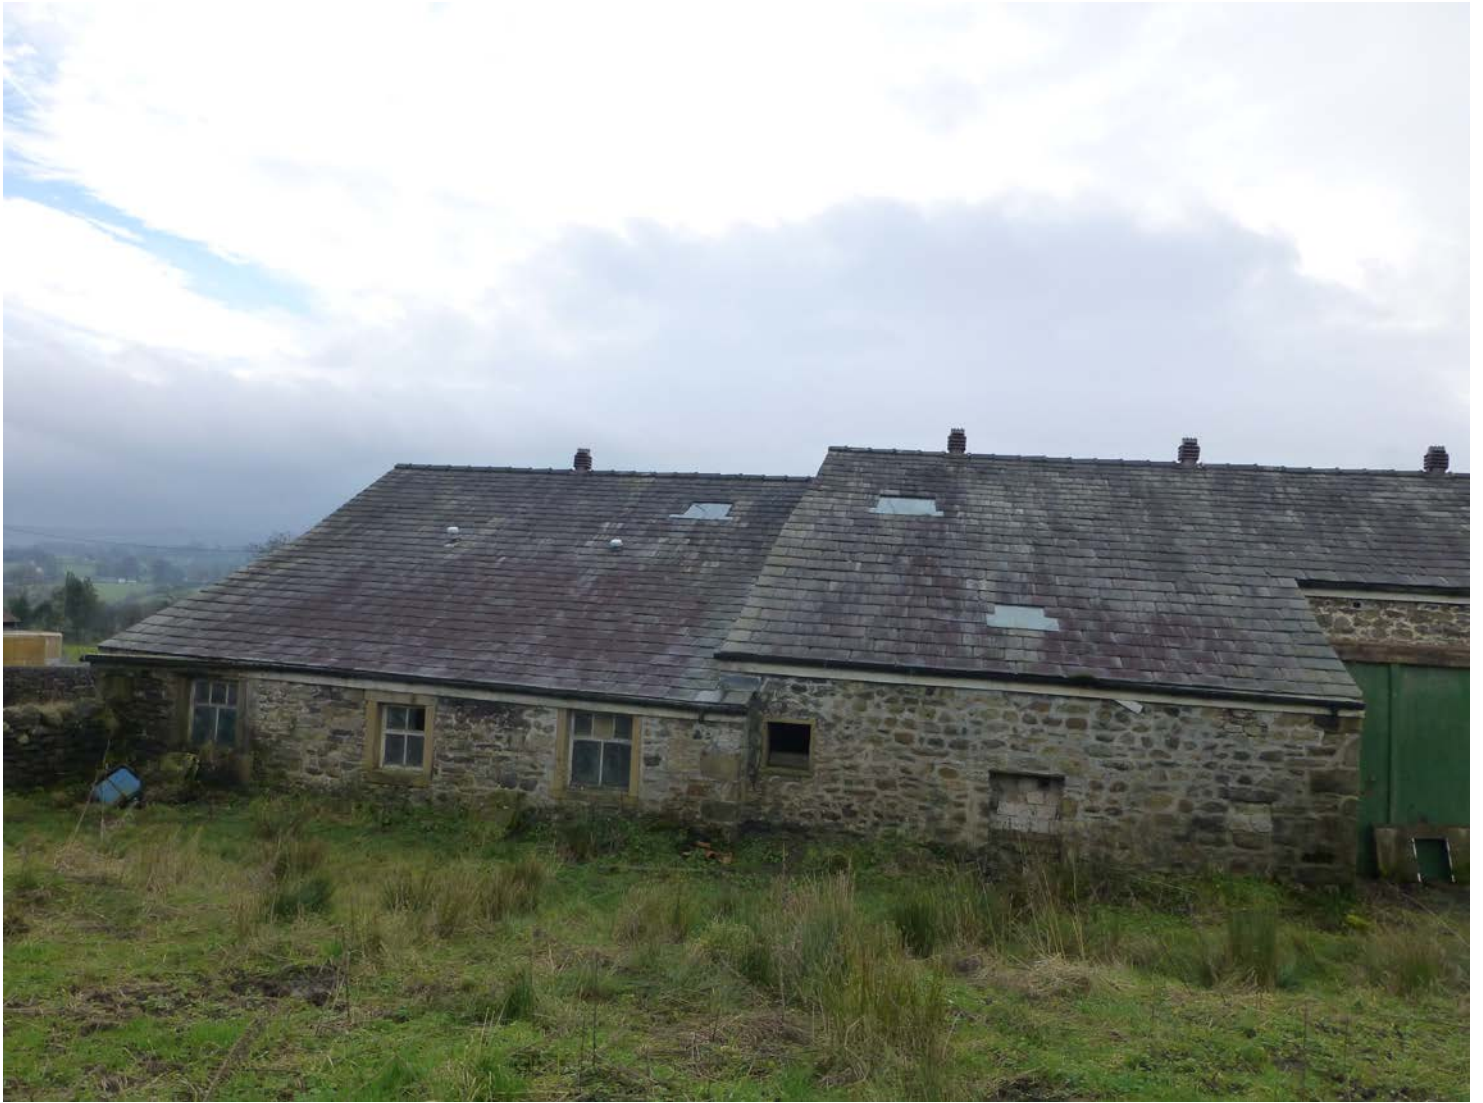
The external walls shown on the plans as positions 12 & 13 are reasonably plumb and in good condition showing no real signs of excessive movement or large cracking. All the pointing however is in poor condition.

All areas require the existing pointing to be removed and replaced. Any loose stonework must also be replaced as necessary once the pointing has been removed with stone work to match; this should be carried out both externally and internally
