# **STANDEN HALL, WORSTON ROAD, CLITHEROE, LANCASHIRE**

## **Historic Building Survey Report**

**Oxford Archaeology North**

August 2017

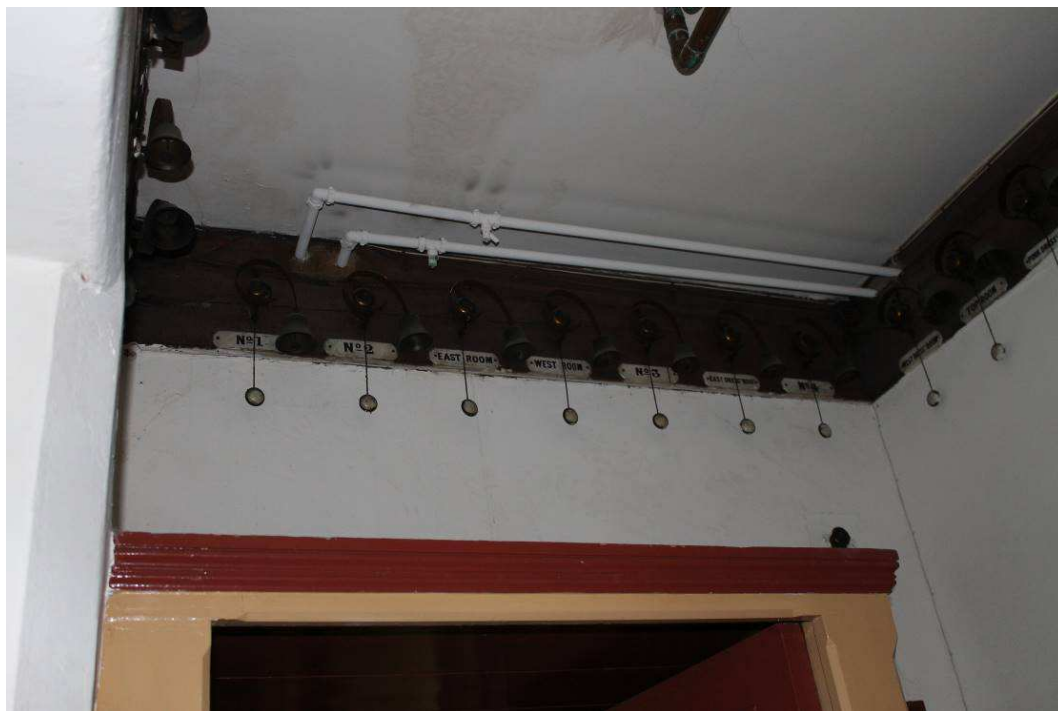
- 4.2.4 Lining the head of the southern, eastern and western walls, below a moulded picture rail were a series of white name plates, recording the names of 27 of the rooms in the house in black lettering (Plate 8). Each name was accompanied by a spring-mounted bell, with an attached pendulum to indicate which room that required service, except the front door where the original bell had been replaced with a modern electric bell.

*Plate 8: Servants bells at western end facing south*

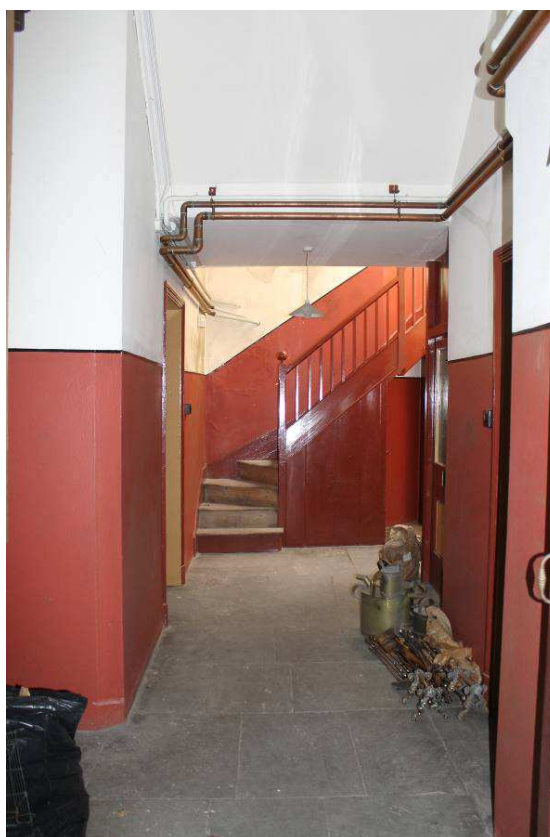
Plate 10: **Room G9b** facing north

- 4.2.6 **Room G9b (Fig 2):** this room was a north/south-aligned corridor that connected several service rooms within the north-western corner of the building (Plate 10). To the west, it was connected to the east/west-aligned corridor **G10**, and north of this to the scullery **G12** via door **GD29**. At the northern end it led onto corridor **G13**, while to the east it provided access to the cellar via doorway **GD30** and to room **G9c** through doorway **GD26**. At the southern end, a glass and timber door **GD25** led into the circulation space at the western end of **Room G9a**.
- 4.2.7 The corridor was plastered and decorated in the same white-over-red scheme as **Room G9a**, with red and mustard coloured doors, and the flagstone floor continued unbroken. A number of heating pipes were exposed, running across the ceiling.

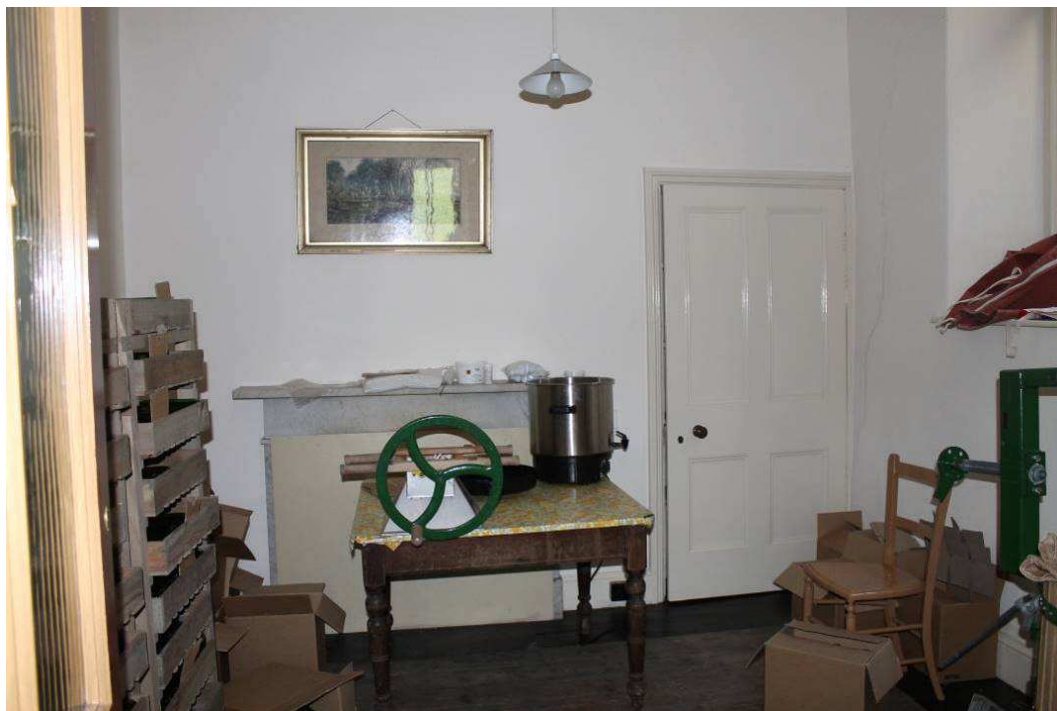
Plate 11: **Room G9c**, facing east

- 4.2.8 **Room G9c (Fig 2):** this was a small square room, located at the heart of the service wing and accessible from **Room G9b** via doorway **GD26**. The walls were plastered and painted white and there was a moulded skirting board (Plate 11). The ceiling was undecorated and the floor laid down to floorboards, with the margins of the floor painted black to suggest that a large rug or other floor covering had once been fitted. At the centre of the east wall lay a boarded over fireplace with marble surrounds and beside this, a cupboard had been built into the space to the south of the chimney breast, fitted with a four-panel door **GD27**.
- 4.2.9 Although the room had no external walls, natural light was borrowed from **Room G9a** via a two-light window **GW45** occupying the eastern half of the

southern wall. The remaining western half of this wall had been fitted with a built-in wall cupboard, fitted with a pair of two panel doors **GD28**.

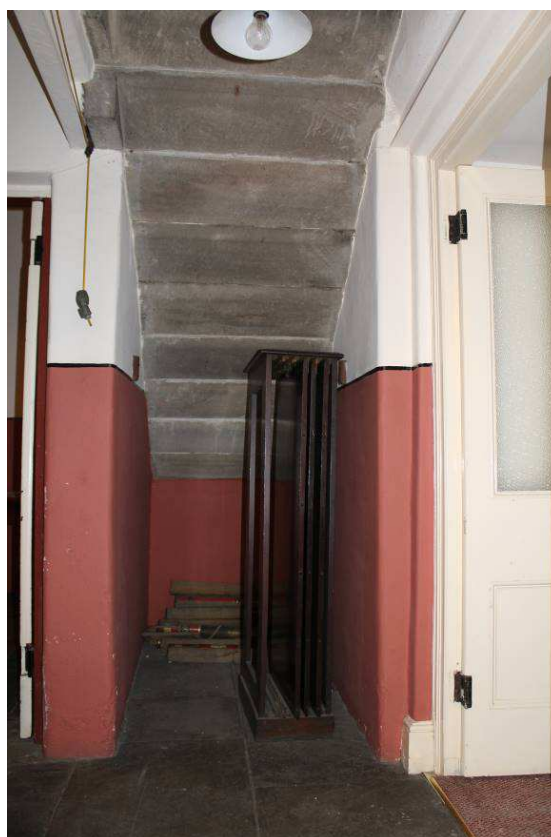
Plate 12: **Room G9d**, facing south

- 4.2.10 **Room G9d (Fig 2):** was a small corridor immediately to the south of the kitchen **Room G15** that also served as a landing at the foot of staircase **Room F14c** from which, it was divided at the western end by doorway **GD37** (Plate 12). At the eastern end, a small service cupboard **Room G9e** had been partitioned off and doorway **GD39** led through into the circulation area at the northern end of corridor **Room G9f**. To the west of this lay a narrow space sitting beneath staircase **Room F14g** and on the opposing wall doorway **GD36** that led into the Kitchen. The room repeated the red and white decorative paint scheme previously described, had a moulded white skirting board and a floor laid in flagstones.

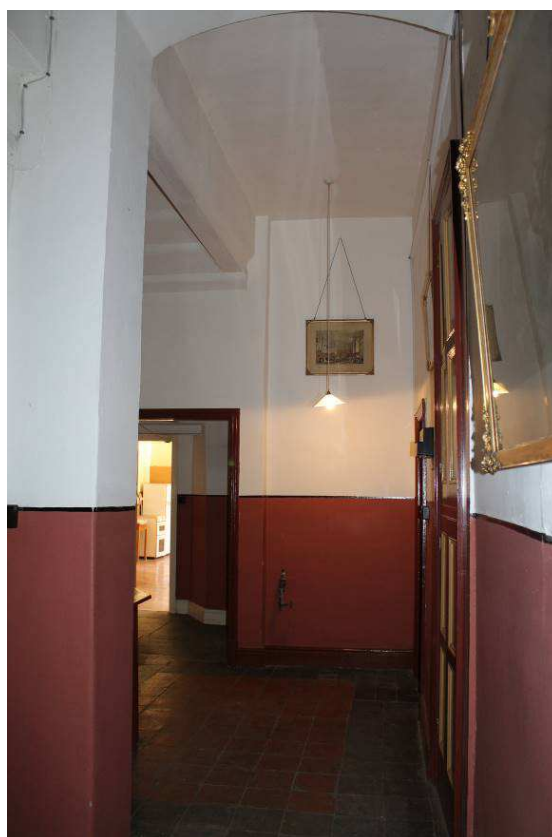
Plate 13: **Room G9f**, facing north

- 4.2.12 **Room G9f (Fig 2):** was a two-cell corridor aligned upon a north/south axis, with a circulation area at the northern end (Plate 13). To the south, a doorway **GD42** connected the space to corridor **G26** while to the west it led into corridor **Room G9g** through doorway **GD44**. A doorway at the northern end **GD39** linked the circulation space to **Room G9d** and another doorway to the east **GD40** led into corridor **G17**.

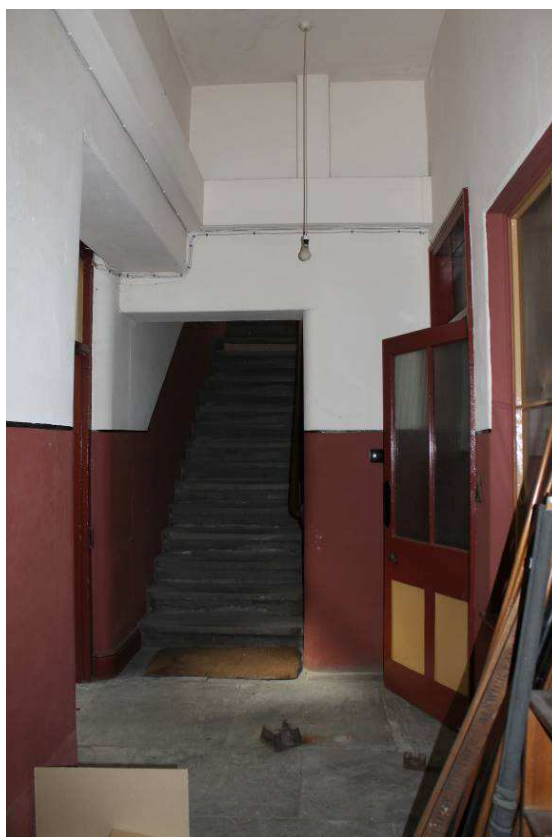
Plate 14: **Room G9g**, facing north

- 4.2.15 **Room G9g (Fig 2)**: was a north/south-aligned corridor located to the east of corridor **Room G9a**, from which, it was divided by a timber doorway, with a horizontal over-light above but no door. This room lay to the west of corridor **Room G9f** from which, it was divided by doorway **GD44**. To the south this room provided access to a store room **Room G27a** via doorway **GD45**, while to the north, it served as the landing for staircase **F14g** (Plate 14).

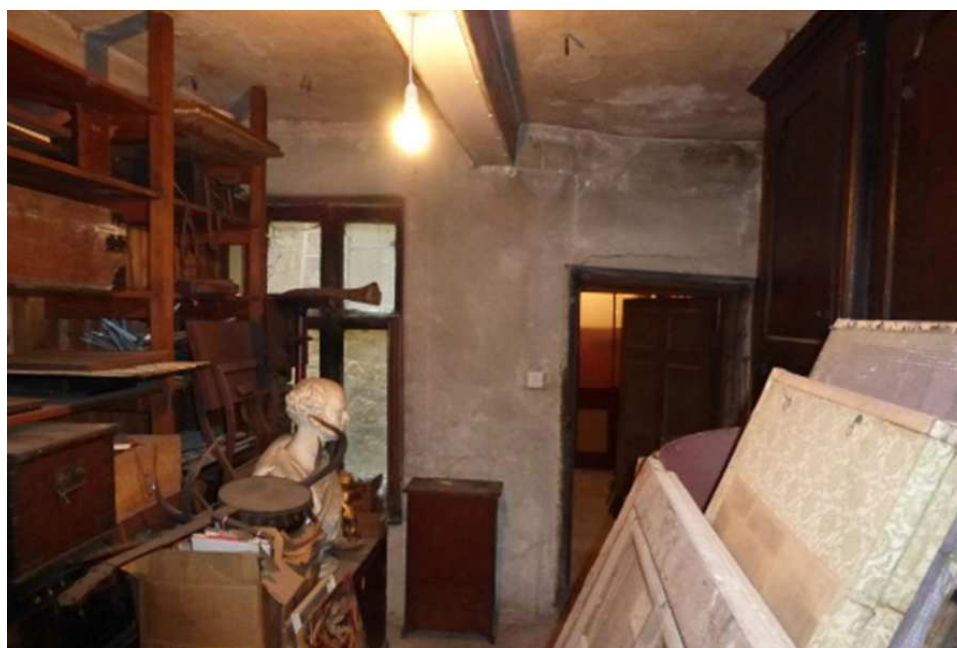
Plate 15: **Room G27a** facing north

4.2.18 **Rooms G27a and G27b (Fig 2):** these rooms had clearly once formed a single broadly square room to the north of the South Hall **Room G3**. The erection of a thin timber matchboard partition had divided this space into two unequal parts (Plate 15). The eastern part was accessible only from doorway **GD45** located in the north-east corner, while the western part was entered from doorway **GD16**, at the centre of the west wall.

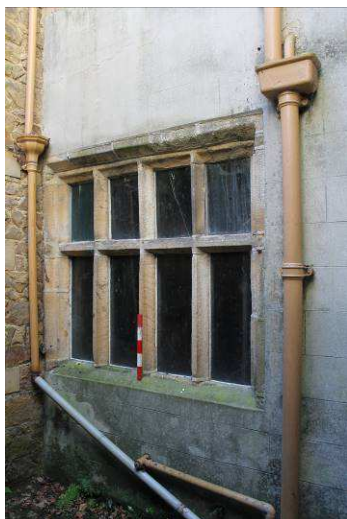
**GW44**

*Plate 73: Eight-light cross window with stone surrounds. Mullions cut with hollow chamfers, transoms with single plain chamfers both internally and externally. The cream coloured stone is heavily weathered to the north revealing a relatively coarse texture. Thick joints and worn arrises suggest an earlier period as does the semi-regular off perpendicular tooling where it survives. Early 17th century.*

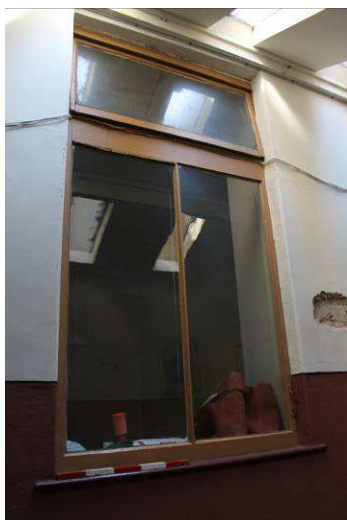
**GW45**

*Plate 74: Two-light fixed-frame window with timber surrounds and a slender vertical mullion. Lights set vertically and topped by a horizontal ventilator with a curving brass guide on the northern side. Windows jambs plastered and splayed to the north. Late 19th century*

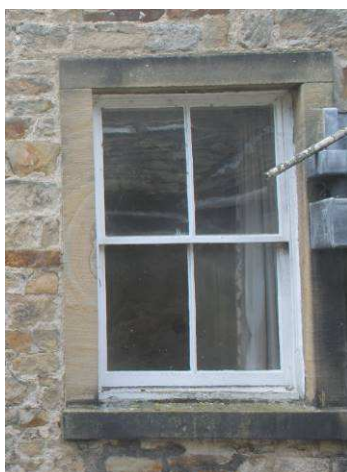
**FW37**

*Plate 103: Two-over-two light timber sash window. Plain square section external stone surrounds, with regular tooling pattern. The sash fastener on interior meeting rail has been replaced with a modern example. Late 19th century.*

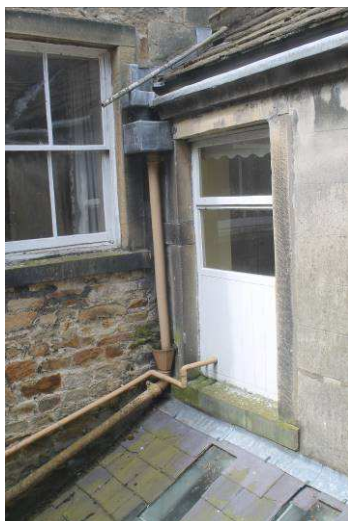
**FW38**

*Plate 104: The original window has been replaced by a modern fixed frame rectangular horizontal light with ventilator above. The lower half of the opening has been blocked but the exterior stone surrounds survive, being of plain square section. Diagonal tooling pattern visible externally. Twentieth century window with early 19th century opening.*

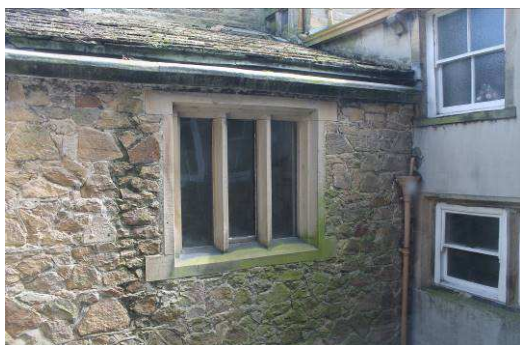
**FW39**

*Plate 105: Three-light window with stone surrounds to interior and exterior. Mullions have hollow chamfers on both faces and regular perpendicular tooling pattern. Central light hinged as a casement, with window stay on sill. Late 19th century.*

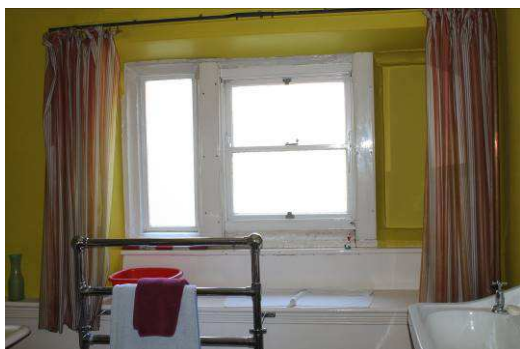
**FW40**

*Plate 106: Four-light window with stone surrounds modified to two lights with the removal of the central mullion and blocking of the eastern light. Eastern mullion replaced. Original surviving mullion hollow chamfered on both faces. Early 17th century.*
