## Structural Appraisal carried out on 12<sup>th</sup> March 2014

# Cowley Brook Farm Higher Road Longridge

For the Proposed Barn Conversion to 2 Dwellings

**Project Ref: BUTC/02**

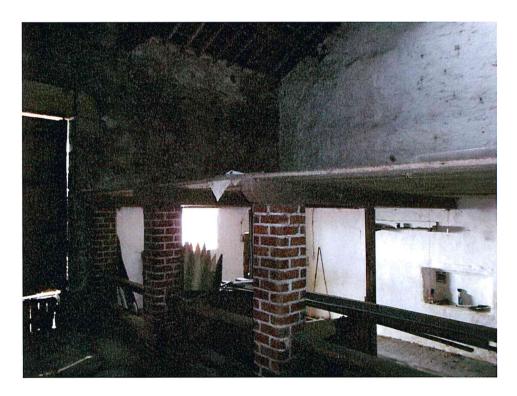
In the Mezzanine Areas the construction consists of flooring board, fixed to timber joists, spanning on to timber beams. The construction in general is of an adequate standard for its intended use but some of the flooring board is of poor quality. When the conversion works are carried out most of the floors will have to be upgraded to meet requirements in terms of loadings.

The existing Mezzanine Floors would have to be replaced/upgraded using appropriately sized timbers in accordance with TRADA.
