Structural Appraisal

Gazebo at Bank Hall Sawley

Martin and Claire Molyneux

April 2016

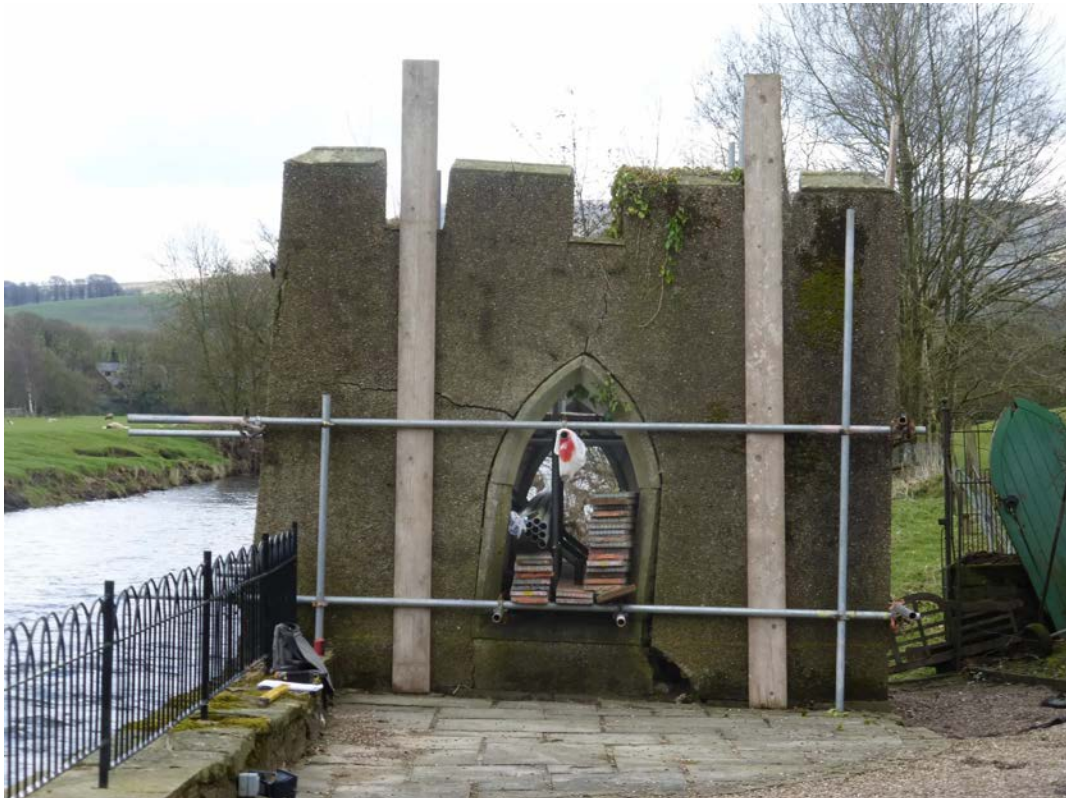
North Elevation

On the North elevation a significant crack, of 70mm wide, has formed next to the right window jamb, which extends around the window opening and follows up the wall to the base of the battlements.

This crack has caused the window stonework to drop out of plumb and the wall panel has moved laterally to the West, by 320mm.

On the remaining elevations 2 pairs of 2No. cintec anchors are to be installed at high and low level, above and below the window openings in a staggered alignment.

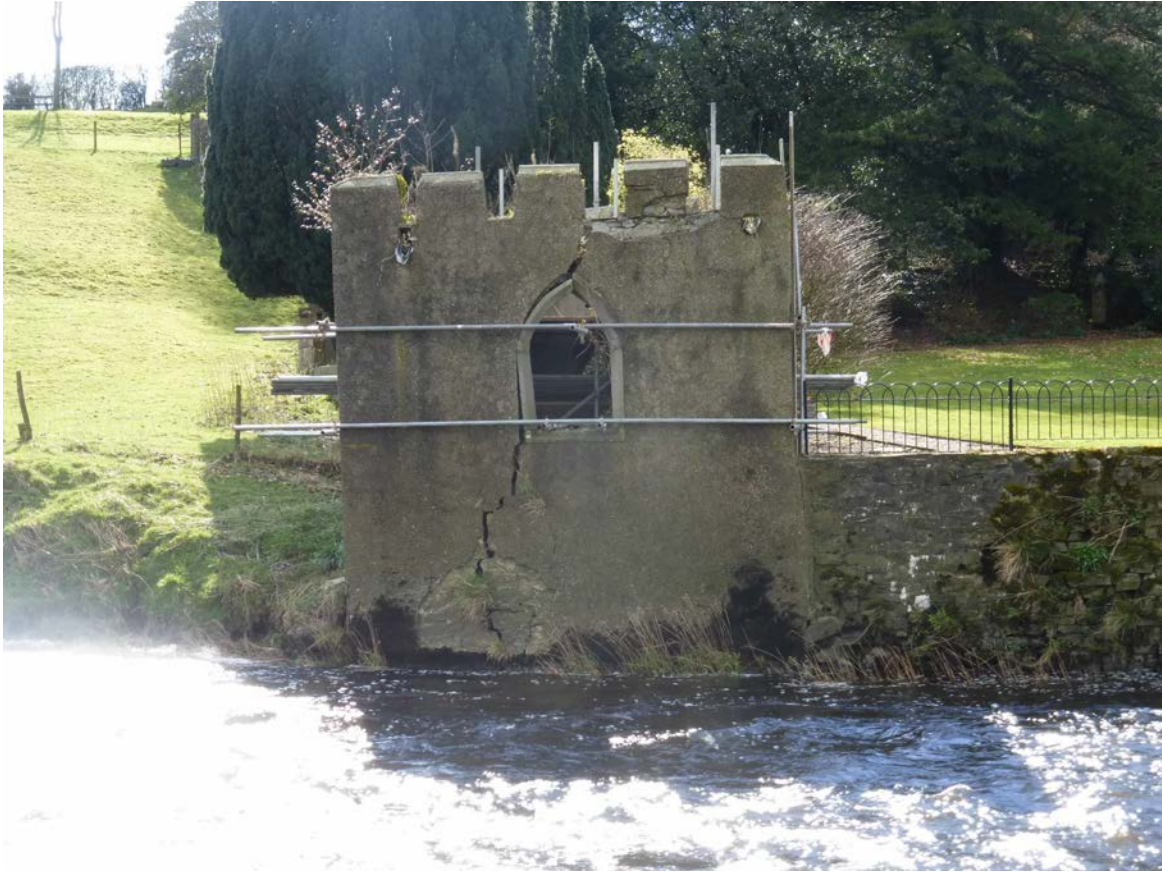
East Elevation on River Side

On the East Elevation a large crack has formed diagonally from North to South, running from the top of the battlements to the bottom of the river retaining wall.

This crack has caused the window stonework to drop out of plumb and the wall panel has skewed to the South by 320mm and to the West by 300mm.

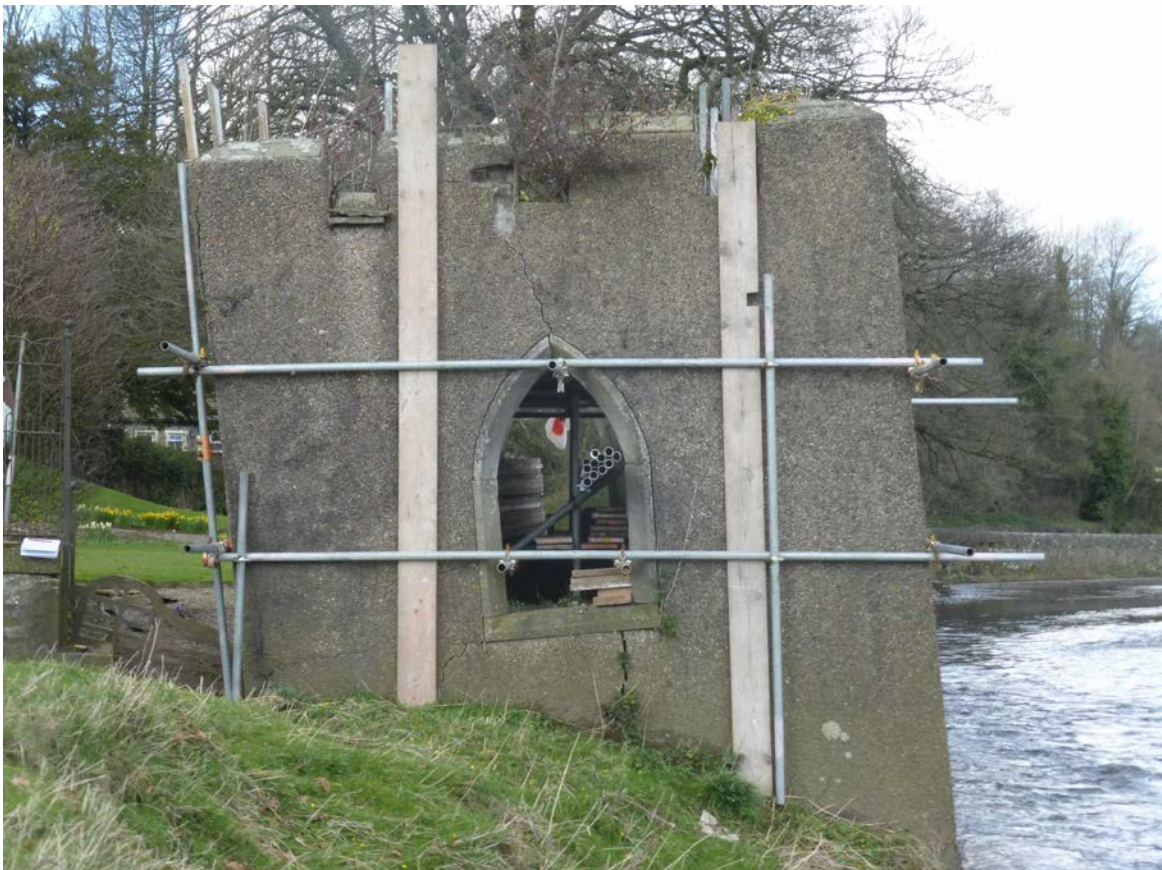
On the South Elevation cracking has appeared in the wall above the apex of the window and below the window sill.

The cracks have caused the wall to displace and offset the window stonework towards the West elevation.

The wall is unstable along this elevation; the wall is out of plumb outwards by 300mm and laterally by 300mm.

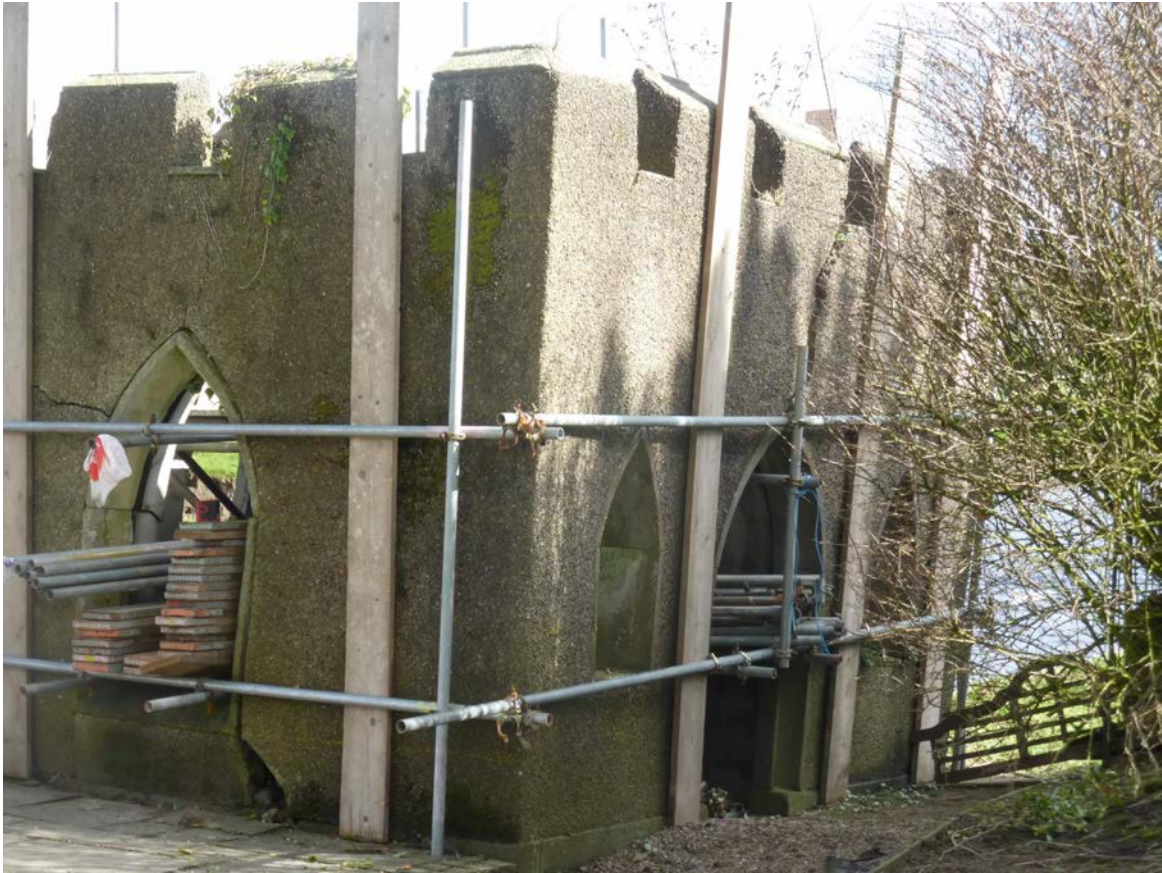
On the West Elevation there is a wide crack above the door opening, which follows up the wall to the base of the battlements.

The 2 windows and door frame are all out of plumb and have dropped towards the South West corner of the structure.

The wall is unstable along this elevation; the wall is out of plumb, outwards by 290mm and laterally by 320mm.

Due to the scale of cracking and the displacement within the walls it is clear that there is a settlement issue with the foundations, particular in the South West corner.

On the West Elevation, 2No. cintec anchors are to be installed at high level above the door opening in a staggered alignment.

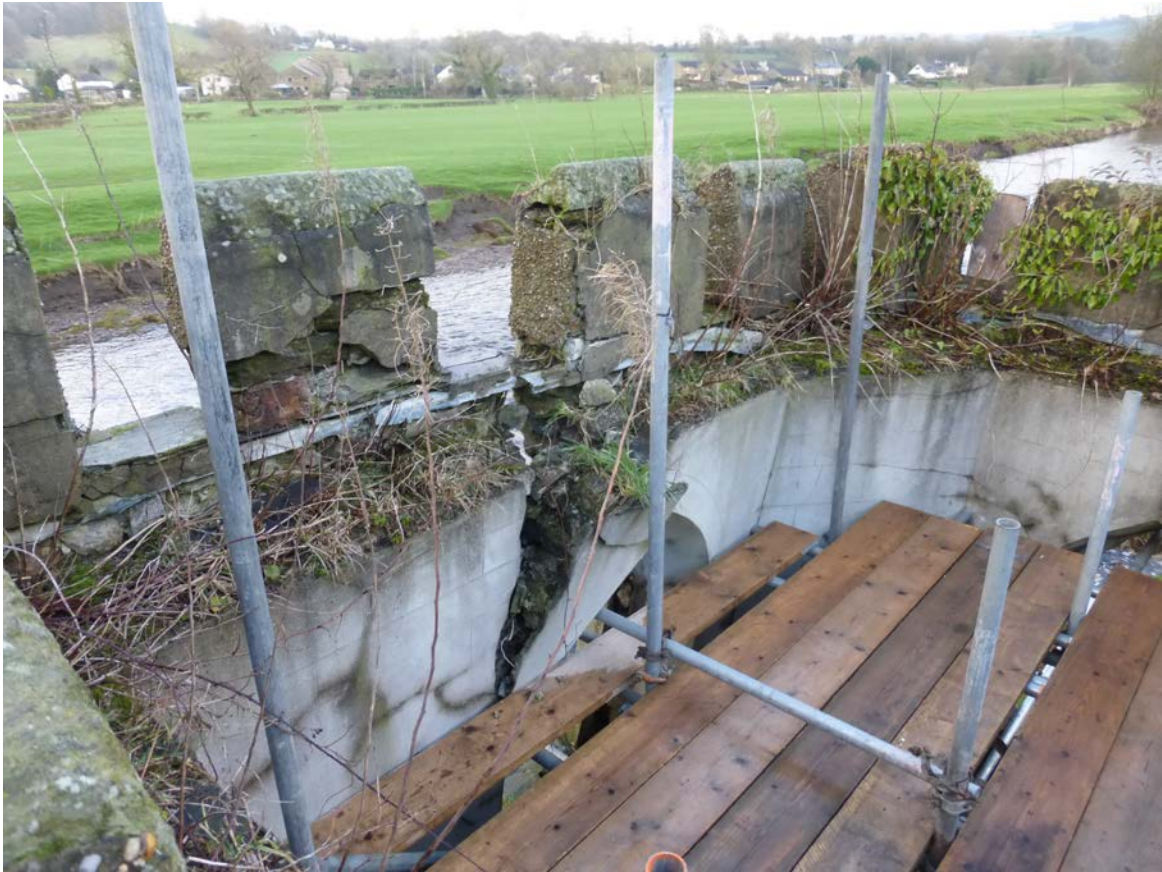
Battlements along East Elevation

- Voids and cracks should be infilled with stone and re-routed, both externally and internally, including around the dressed stone door and windows openings.
- Battlements to the East and South elevation to be re-built because they have been badly damaged by vegetation.
- Render to be repaired in lime where required, and the whole building could then be limewashed to cover up the repairs.

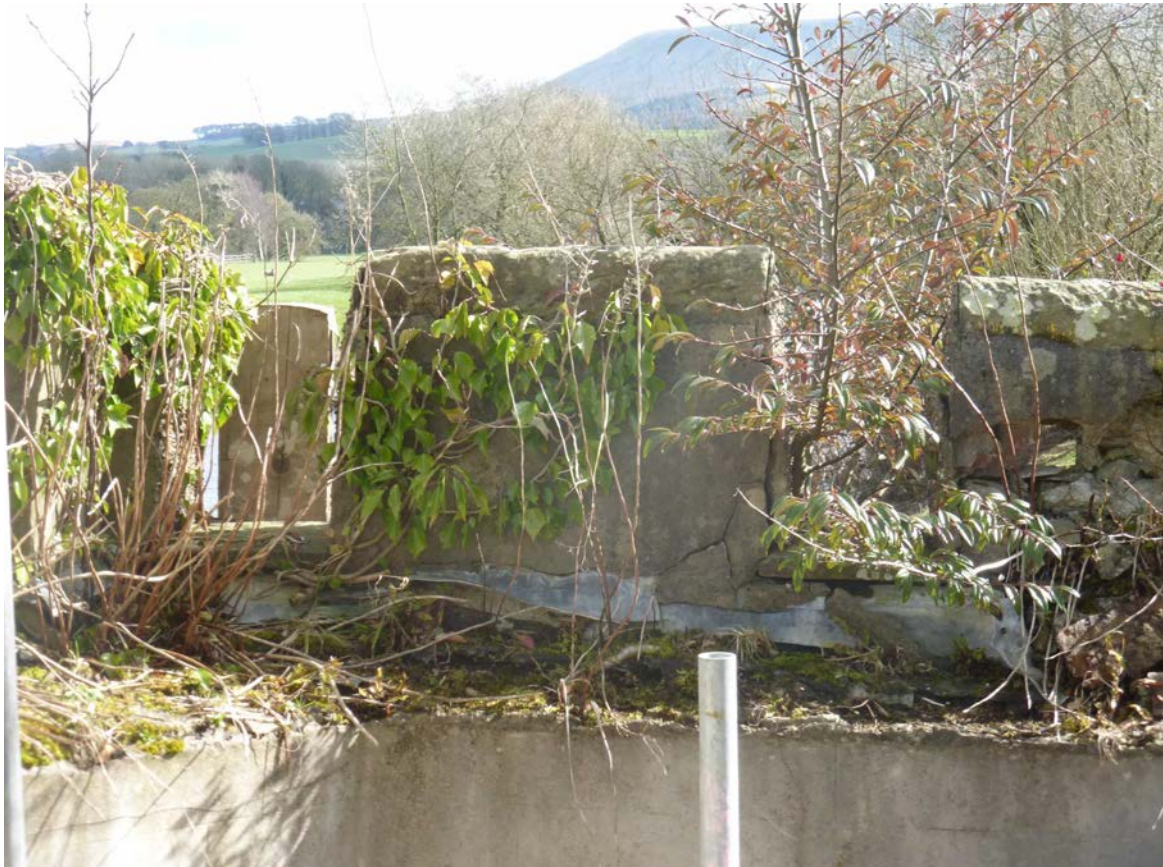
Vegetation on Battlements along South Elevation

All vegetation should be removed from the masonry walls.

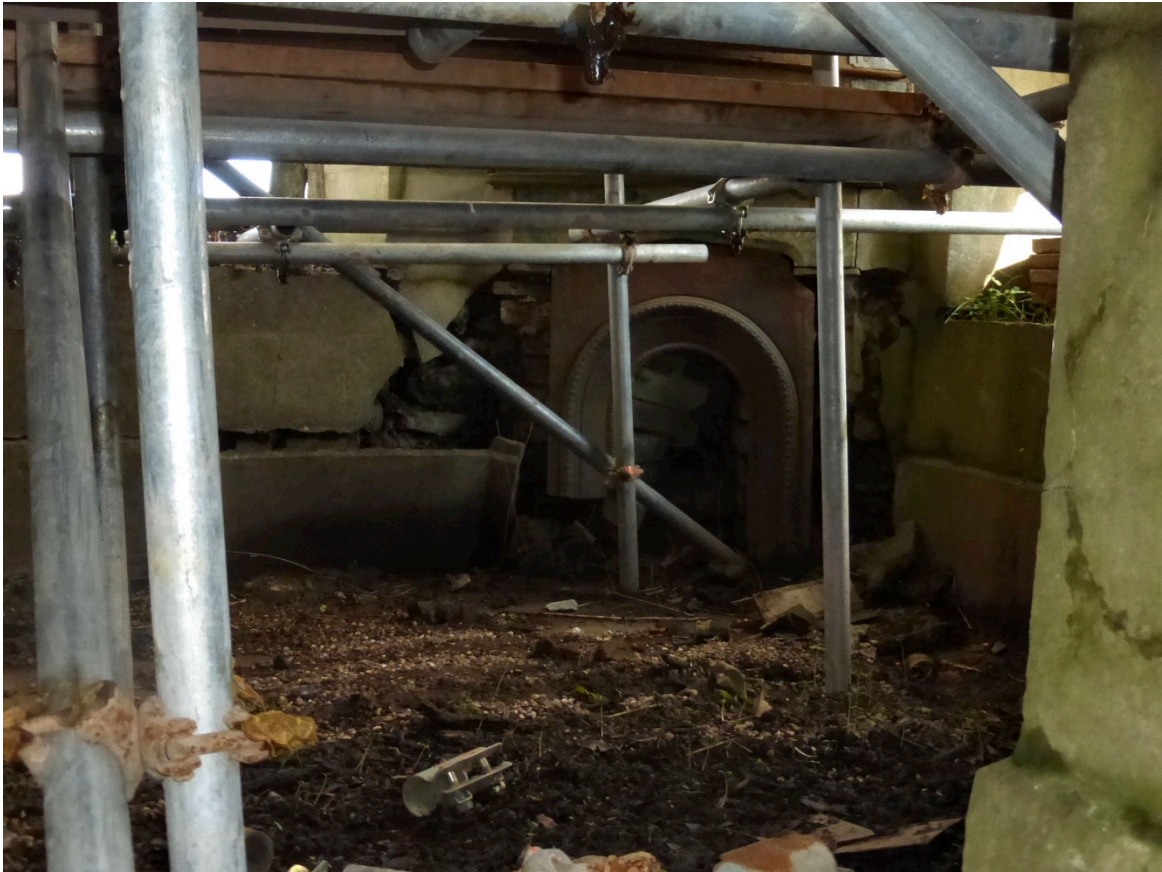
Internal Cracking on Plasterwork and Loose Stone along East Elevation
