Central Garage
Warwick Street
Longridge
PR3 3EB

APPENDIX 1

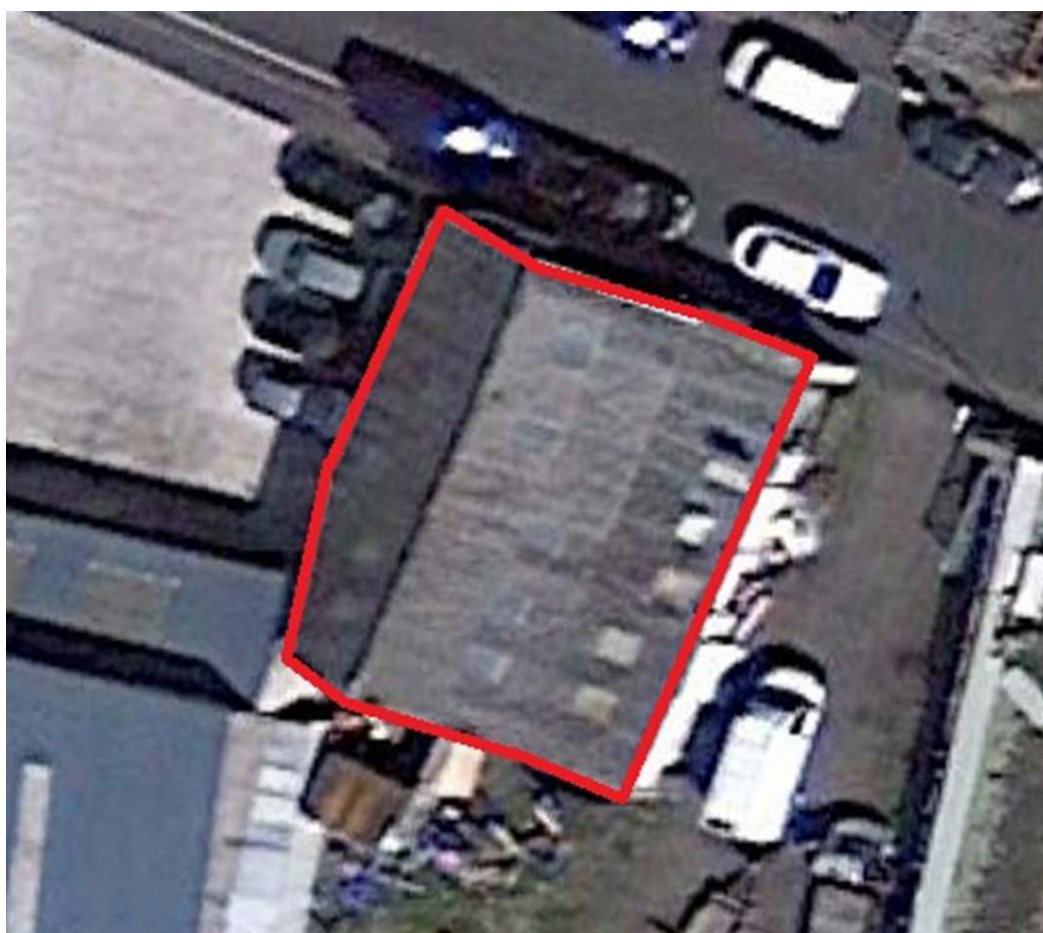
The building is a traditional brick built building with timber purlins and trusses. The roof area is currently covered with asbestos cement sheets. Water ingress is occurring in a number of different locations across the roof area. The timber purlins appear to be in a reasonable condition, and are suitable to remain in situ. There is significant moss/vegetation growth across the roof slopes and evidence of corrosion to fixings.

There is evidence of previous repairs to the left-hand slope with liquid applied coating treatments. A flash-band type repair has been provided to the rear section of the ridge which is a temporary repair only and not suitable for permanent use. There are splits/cracks evident to some areas of the roof sheeting. The roof sheeting appears to have reached the end of its economic lifespan and now needs replacing, rather than continuing repairs.

Aerial Image - Roof area to be replaced highlighted.

Removal of Existing Roof Covering Remove the existing roof covering by carefully taking down the asbestos cement sheeting and plasterboard lining. The waste material to be removed in full sections (as far as possible) and lowered to ground by mechanical means, place into specialist certified waste skips for removal to a licensed waste disposal station.

New Roof Covering Install KS1000RW composite panels. Formed from two skins of profiled steel which are locked around a core of rigid PIR Insulation, the new panels would be installed in accordance with the manufacturers' recommendations. The new profiled roofing sheets will be mechanically fixed to the purlins using suitable mechanical fixings as recommended by the manufacturer with neoprene washers and sealing caps in a colour to match the roofing sheets.

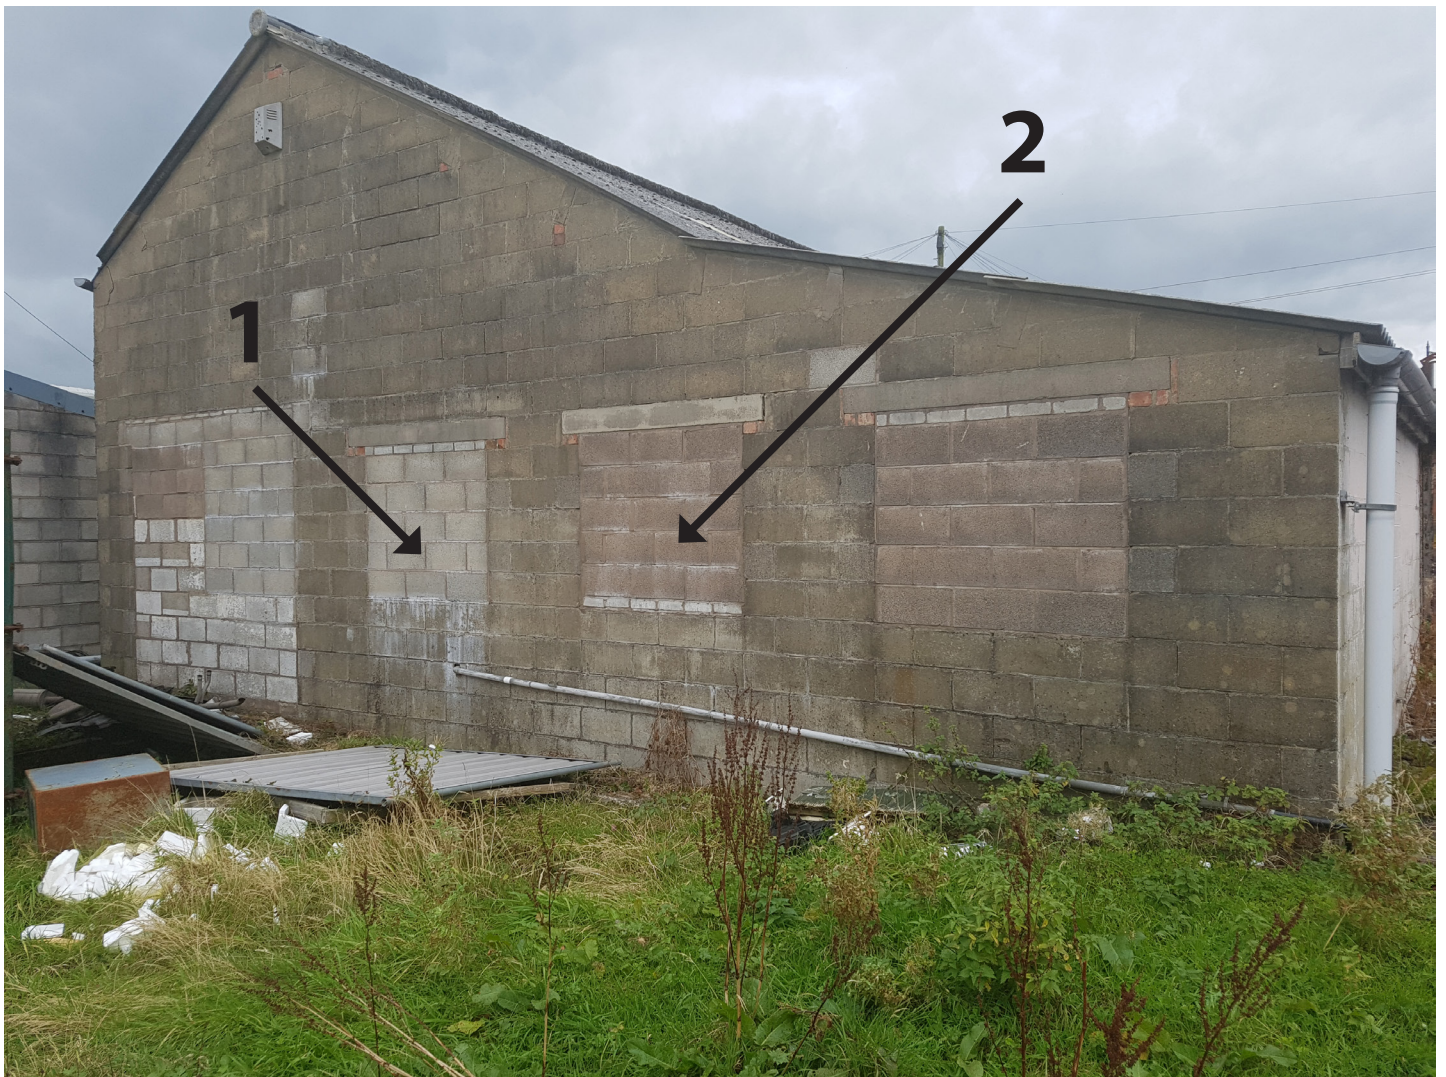
APPENDIX 2 - Rear Of Building

The rear of the building has previously had various doors and windows which are now blocked off. We hope to reopen the door (arrow 1) and the window (arrow 2). The proposed window and door will be constructed of alluminium with alluminium frames.

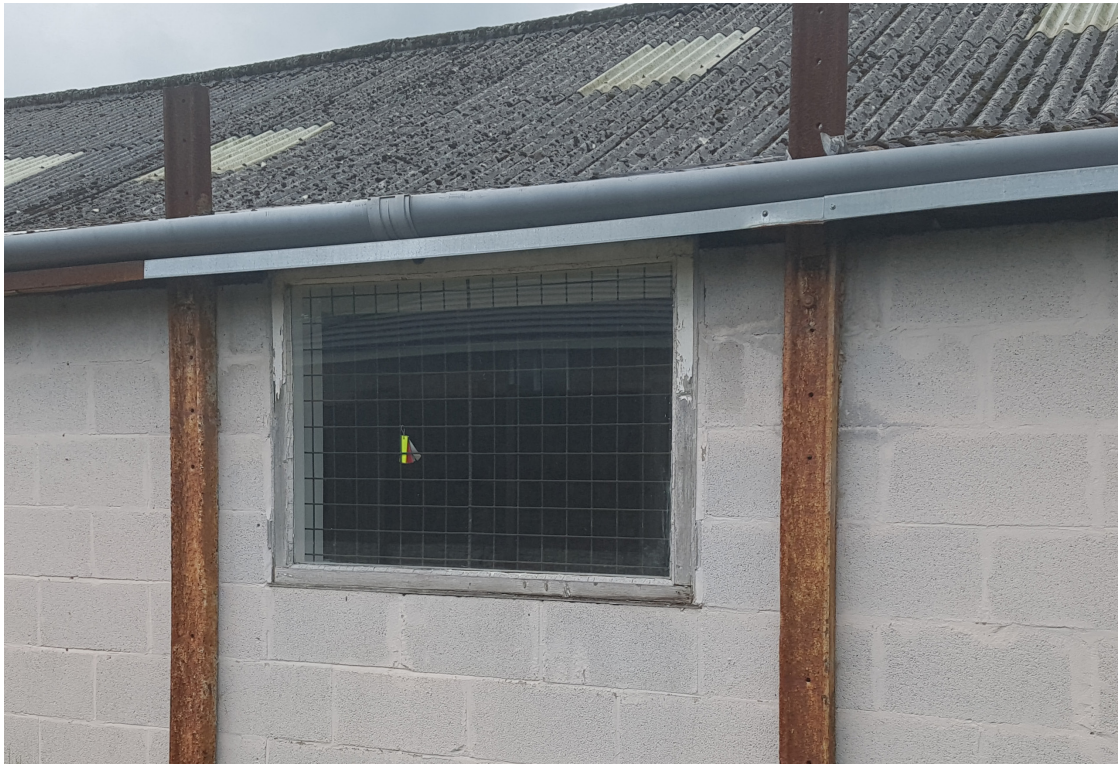
1

The side window (1) and the front window and door (2) are currently single glazed with a wooden frame, all of which are rotten. They will be replaced with alluminium framed windows and an alluminium door. This will also increase the security level of the building.
