# HISTORIC BUILDING RECORD

2NO. BARNS AT LITTLE DUDLANDS FARM, RIMINGTON LANE, RIMINGTON, LANCASHIRE, BB7 4EA

REF: 4739 VERSION 1.01 DATE: DECEMBER 2016

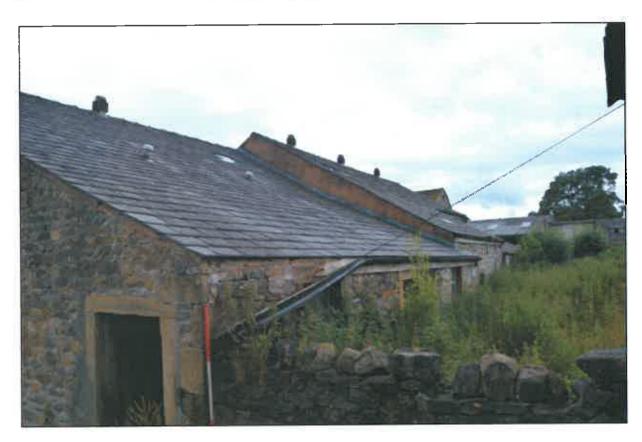
Photo 01: View of the north elevation to barn no.2.

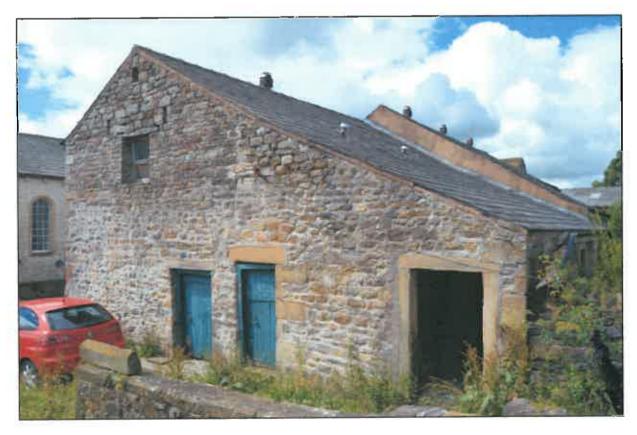
Photo 02: View of east elevation of barn no.2.

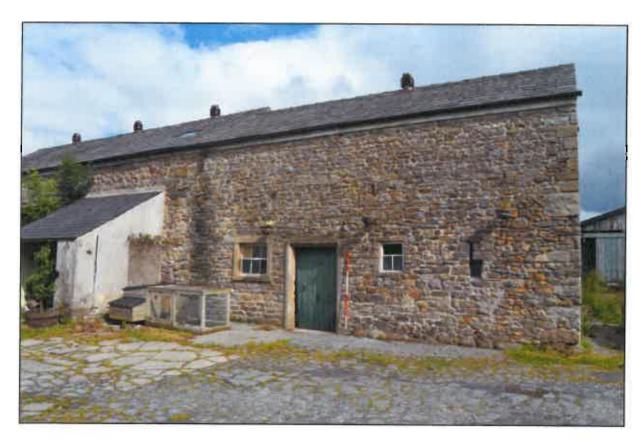
Photo 03: View of eastern side of the south elevation of barn no.2.

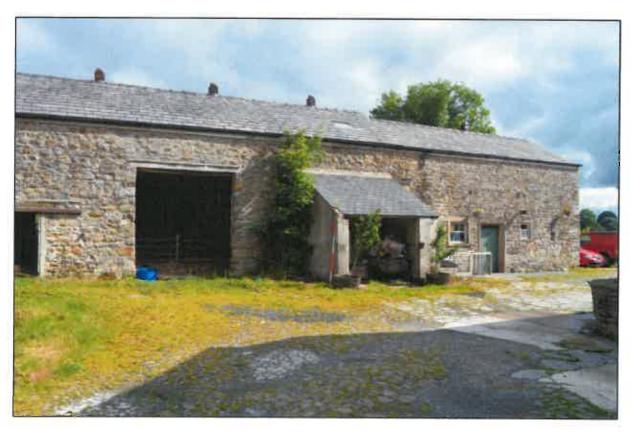
Photo 04: View of the south elevation of barn no.2. from the south west.

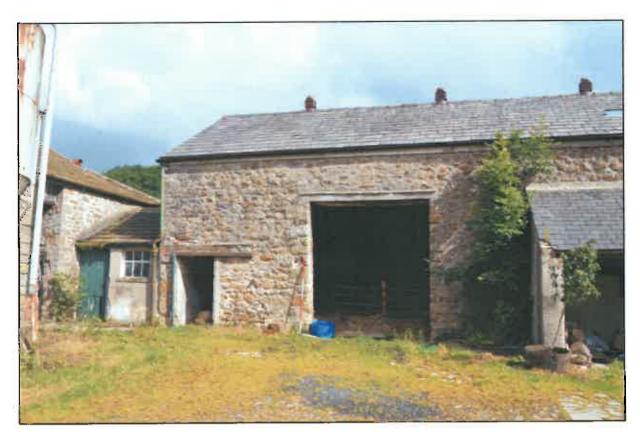
Photo 05: View of the western side of the south elevation of barn no.2.

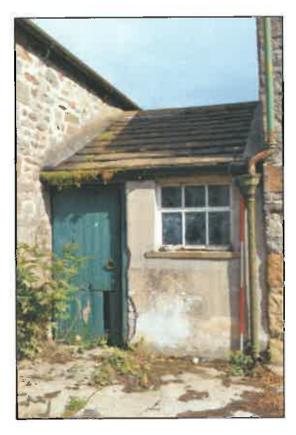
Photo 06: View of the south elevation of the infill building located to the west of barn no.2.

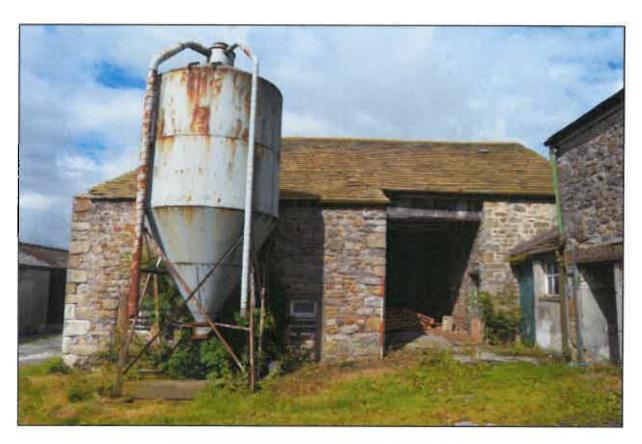
Photo 07: View of the east elevation of barn no.1.

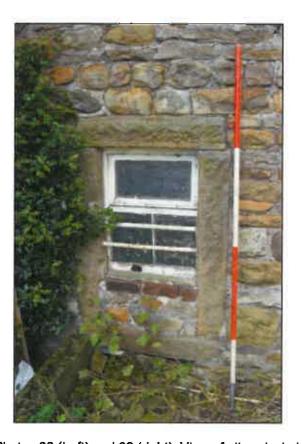
Photos 08 (Left) and 09 (right): View of altered windows located to the east elevation of barn no.1.

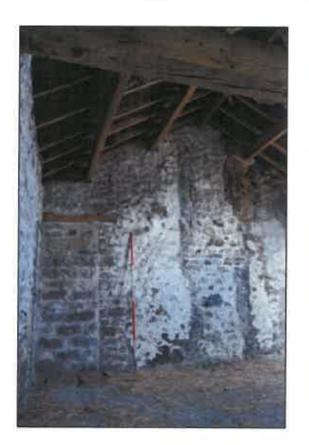
Photos 21 (left) and 22 (right): View west within the first floor area above the stables to barn no.2.

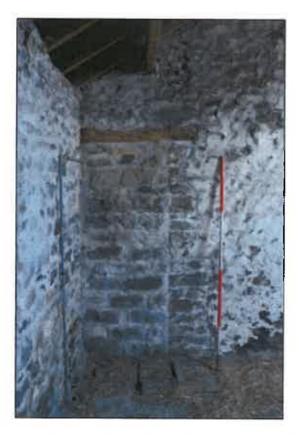
Photo 23: View of blocked up door opening to the first floor area above the stables to barn no.2.

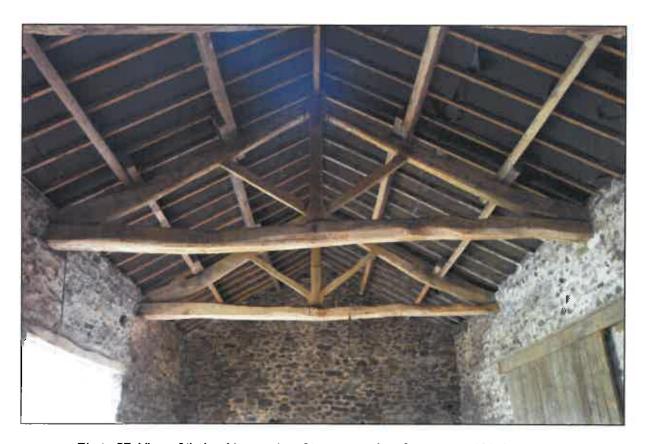
- 7.11 The roof structure to the threshing area of barn 2 consists of 3no. timber kingpost trusses. The timbers are hand worked and are likely to be original. Notched into the trusses are a number of timber purlins with timber rafters positioned on top. The purlins and rafters are machine cut and are likely to be replacement timbers. A roofing underlay is present over the rafters suggesting that re-roofing has occurred in the more recent past.

Photo 27: View of timber king post roof trusses and roof structure within barn no.2.

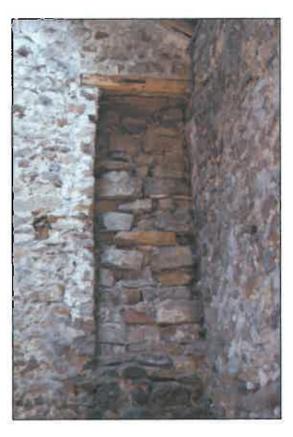
Photo 28 (left): View of blocked up door opening to the east wall at first floor level within barn 02.

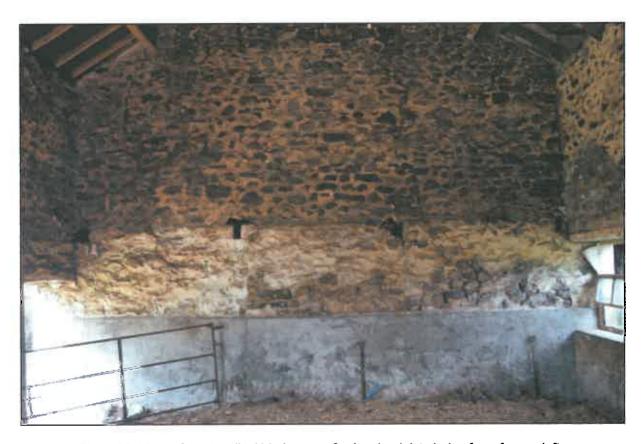
Photo 29: View of west wall within barn no.2. showing joists holes from former loft.

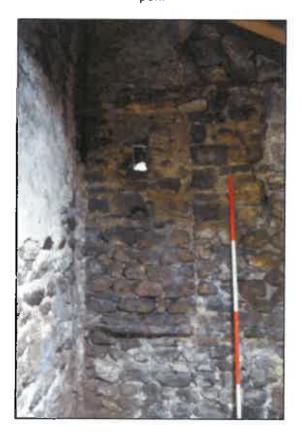
Photo 36: View of blocked up opening to the west wall of the livestock pen.

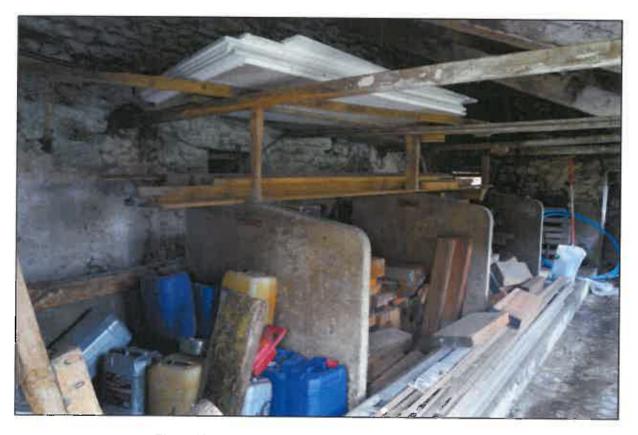
Photo 40: View of concrete boskins within shippon 01.

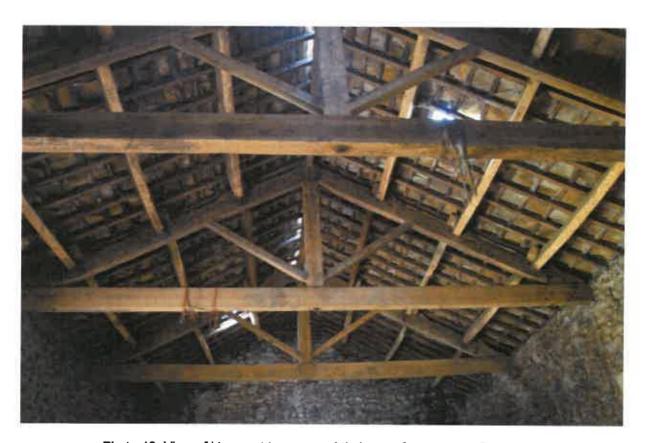
- 7.3 The roof structure to barn 1 consists of 3no. timber king post trusses with a central king post and a single raking strut to each side. The king post is fixed to the tie beam with an iron bolt and supports the ridge beam with timber jowels. The trusses support the remaining roof structure in the form of timber purlins, rafters and battens. The constituents of the roof structure are machine sawn in nature suggesting that they are replacement elements originating from the late 19<sup>th</sup> to early 20<sup>th</sup> centuries. The height of the roof structure also indicates the main barn area was used for hand flailing as sufficient space was required over head in order to accommodate the use of a flail.

Photo 49: View of king post trusses and timber roof structure to Barn no.1.

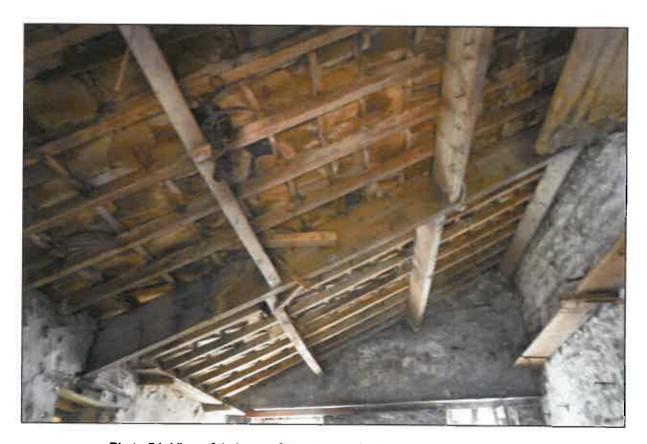
- 7.7 To the first floor of barn 1 is a harness room with a timber roof structure. The structure is comprised of a single timber lean to beam in which a series of timber purlins are fixed and are built into the wall at opposite ends. Timber rafters are fixed above the rafters with timber battens above. All timbers are machine sawn suggesting more modern origins.

Photo 54: View of timber roof structure to the harness room / workshop.
