# FRANCIS BRADSHAW PARTNERSHIP

Consulting Civil and Structural Engineers

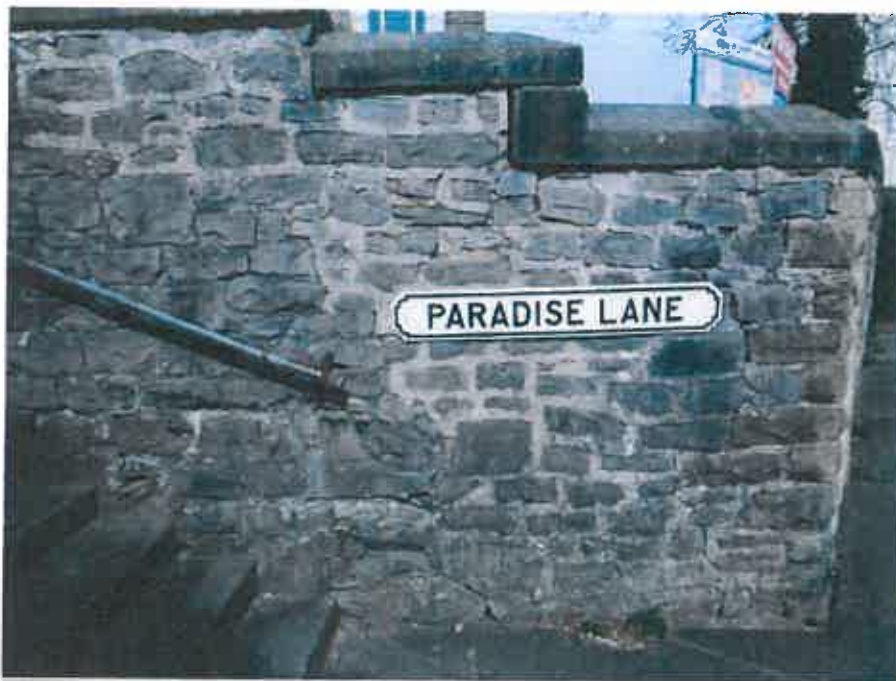
**PHOTOGRAPH No. 8:**  
STEPPED VERTICAL/DIAGONAL HAIRLINE CRACKING TO FACE OF WALL  
AT CORNER OF PARADISE LANE/YORK STREET WITH OPEN MORTAR JOINT.  
NOTE ALSO LEANING OUTWARDS AT HEAD OF WALL FACE TO YORK STREET.

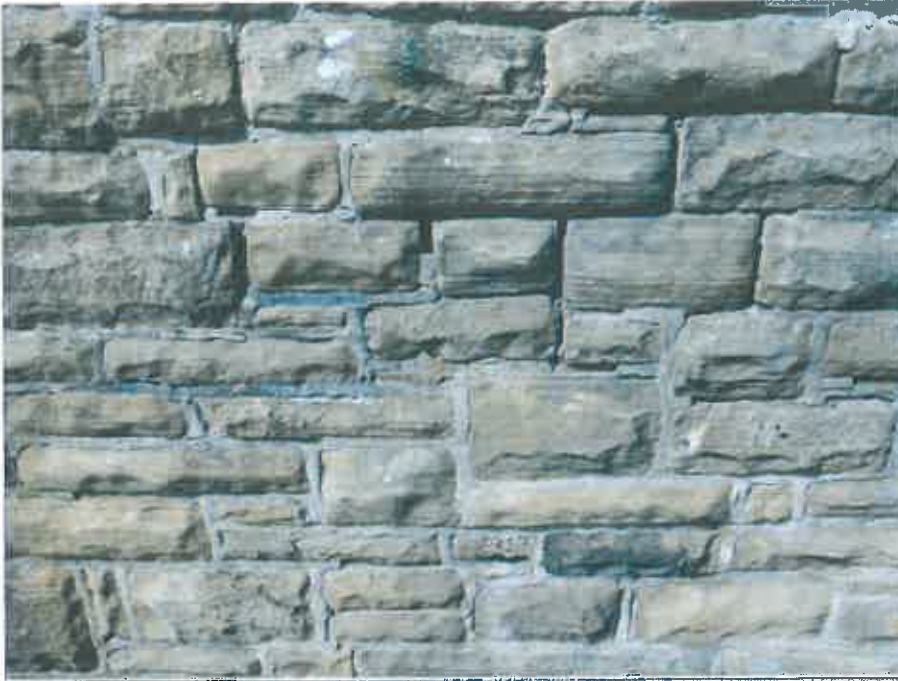
**PHOTOGRAPH No. 9:**  
AREA OF OPEN/RECESSED JOINTS TO STONEMWORK ON EXTERNAL WALL  
FACE ELEVATION TO YORK STREET.

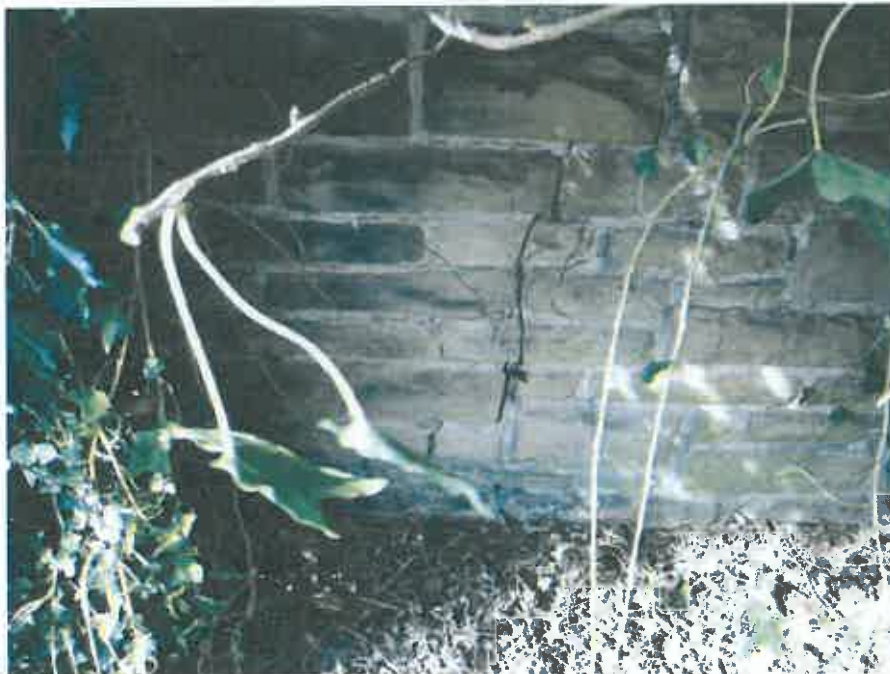
**PHOTOGRAPH No. 10:**  
3MM-5MM WIDE STEPPED VERTICAL CRACK EXTENDING OVER FULL HEIGHT  
OF FRONT WALL FACE IMMEDIATELY IN FRONT OF EXISTING TREE. CRACK  
EXTENDS ACROSS STONE BLOCKS AND WALL IS DISPLACED ACROSS CRACK LINE.

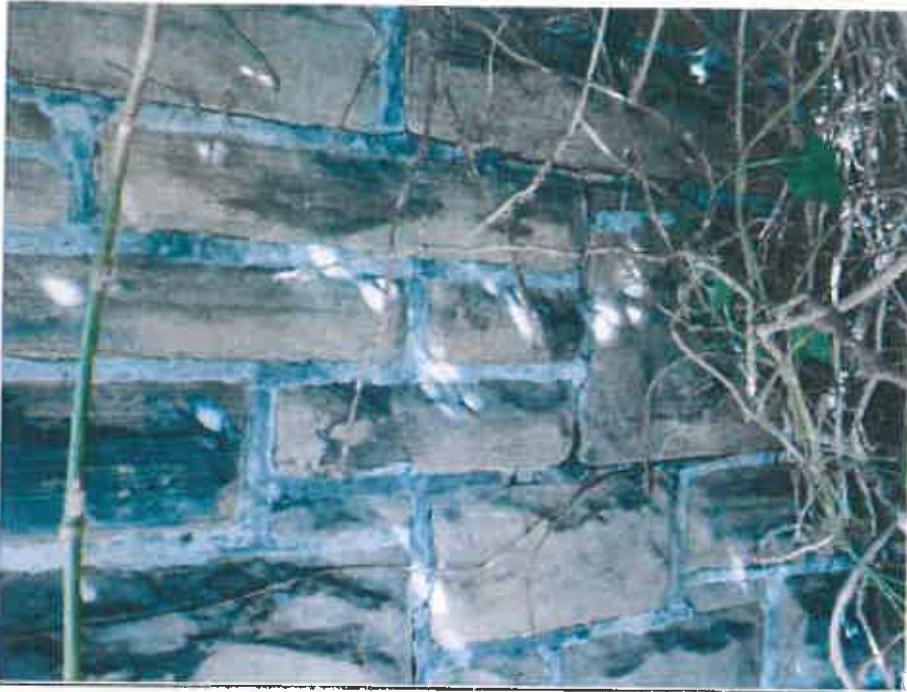
**PHOTOGRAPH No. 11:**  
**VARYING HAIRLINE TO 3MM HORIZONTAL CRACK TO BELOW HEAD OF WALL AT MID SECTION OF WALL ADJACENT EXISTING TREE.**

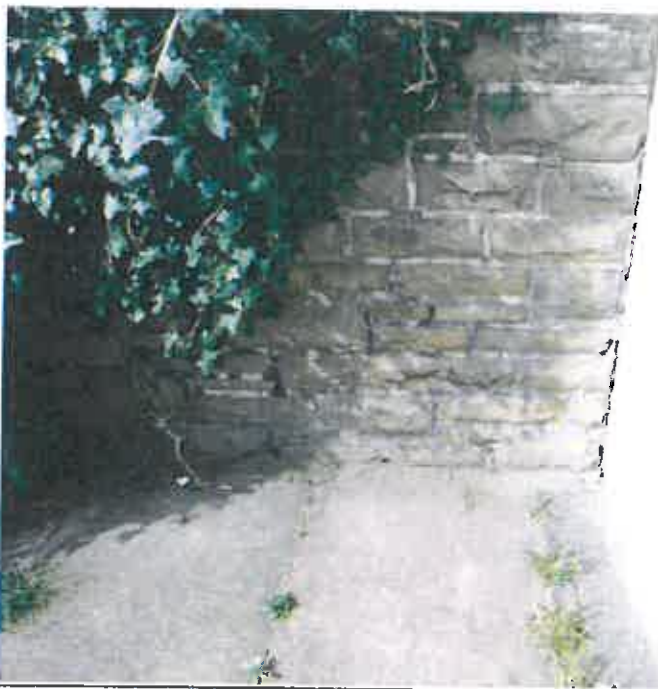
**PHOTOGRAPH No. 12:**  
**SPALLING OF POINTING TO MORTAR JOINTS OF WALL FACE AT LOW LEVEL ADJACENT GABLE TO NO. 11 YORK STREET.**
