# QUANTIFIED TREE RISK INSPECTION OF TREES AT ST MARYS HALL, STONYHURST COLLEGE, HURST GREEN, CLITHEROE

Client: Mr M Leyland, Grounds manager, Stonyhurst College.

Date of Tree Inspection: 5.10.16

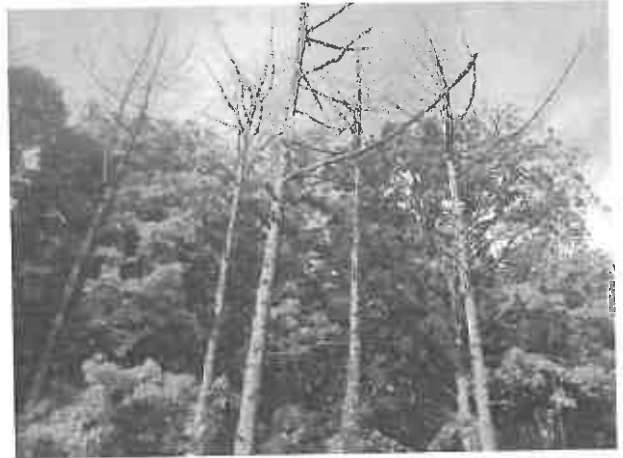
- Along the southern boundary of Woodland area D there is a scatter of dead larch and some sycamores which are ranging in height from 15-20m.
- The trees have been standing dead for some time and may have succumbed to waterlogging or root damage when a subsoil and rubble spread was carried out on the edge of the wood perhaps with the intention of raising the overall land levels.
- These trees now all marked with a yellow spot should be felled to ground level and removed.
- A large number of late mature larch are within area D and their removal and replacement is overdue.

In addition to the trees refered to below 11 standing dead trees, mainly larch have been yellow spot marked and should be removed. See Photo previous.

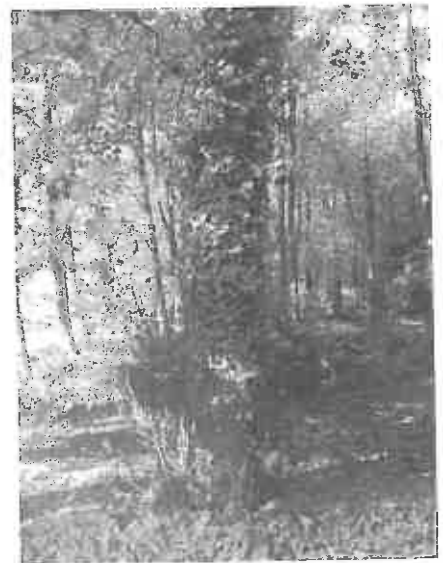
- Many of the mature oak and several sycamores have been heavily infested with ivy.
- Ivy is not poisonous to trees but their effect is to give the trees a greater wind drag in winter when canopies are usually clear of leaves, restrict an inspectors view of the stems and branches necessary to make an judgement regarding safety and condition and can also (especially on sycamore) cover branch stomata and hence restrict tree growth and vigour.
- The ivy should be severed at Ground level and 1000mm above ground. The stems will die back within a year and eventually fall out of the tree in 3 to 4 years.
- Trees requiring this attention are listed on the schedule of each Area A-G
- This work could be carried out by properly equipt ground staff

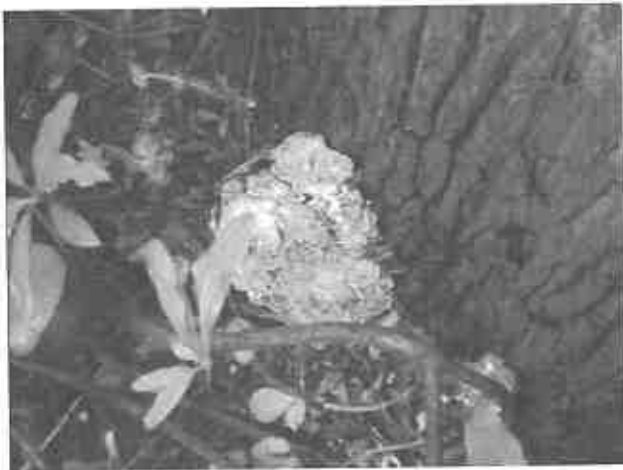
Oak 284

Number	Species	Remove Deadwood And sever ivy	Fell to ground level	Other
243	Oak	X		
244	Beech	X		
245	Beech	X		
246	Oak	X		
249	Oak	X		
251	Oak	X		<i>Aerial inspection</i>
256	Oak	X		
264	Oak	X		
269	Oak	X		
284	Oak	X		<i>Grifola Frondosa Fb at base. Aerial Inspection and report. Monitor 2017.</i>
285	Oak	X

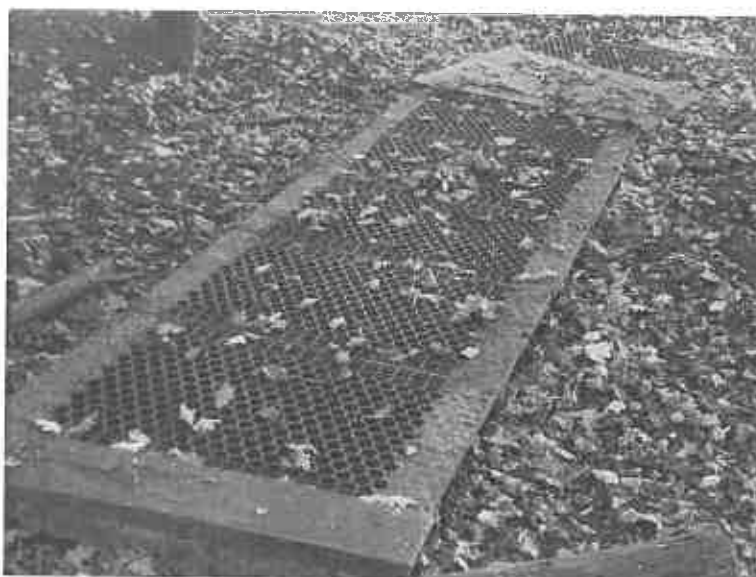
The woodland is also pitted with past drainage and service excavations as shown below:

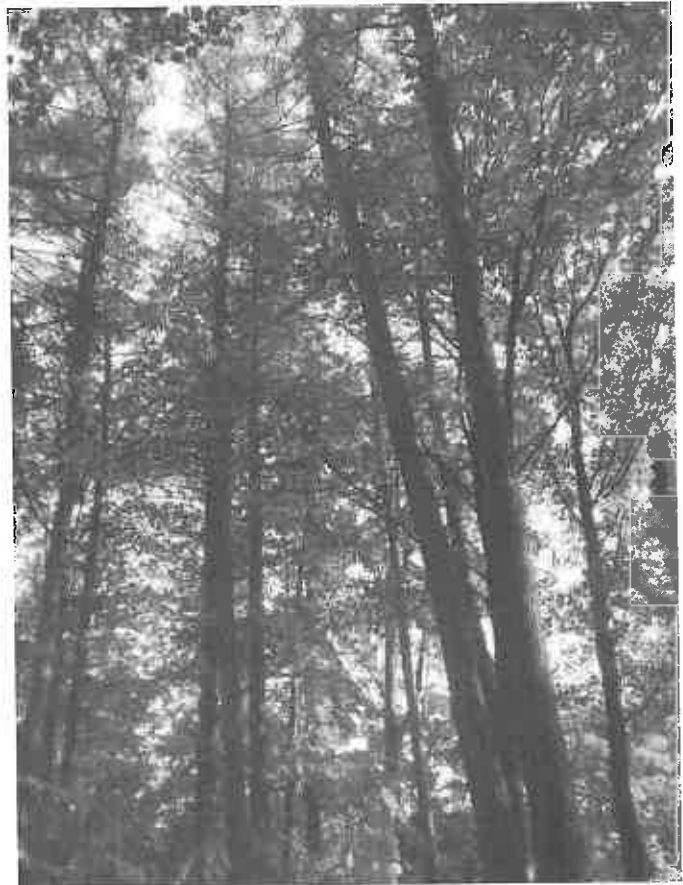
Many of the live larch remaining are late mature with the start of basal decay and a pronounced lean to the west of 7-15 degrees.

It is our view that harvesting this group of trees may cover the cost of felling and reduce the likelihood of coilateral tree damage in the event of windthrow. A replant of oak could then be carried out. In total there are 28 larch in this category and are numbered on the schedule but not spot marked on site.

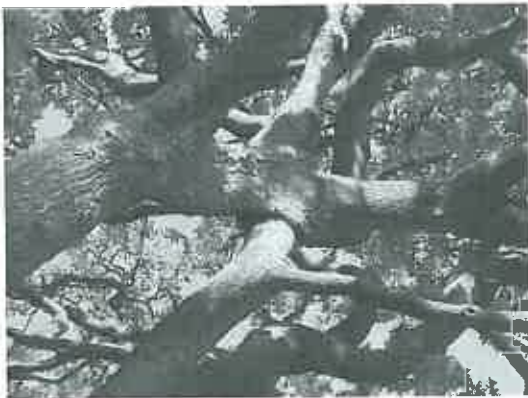
Number	Species	Remove Deadwood	sever ivy	Fell to ground level	Other
380	Oak	X			<i>Prune back low limb towards adjacent Cypress See Photo below</i>
381	Oak	X			<i>Inspect canopy to check on integrity of conjoined branches. See Photo</i>

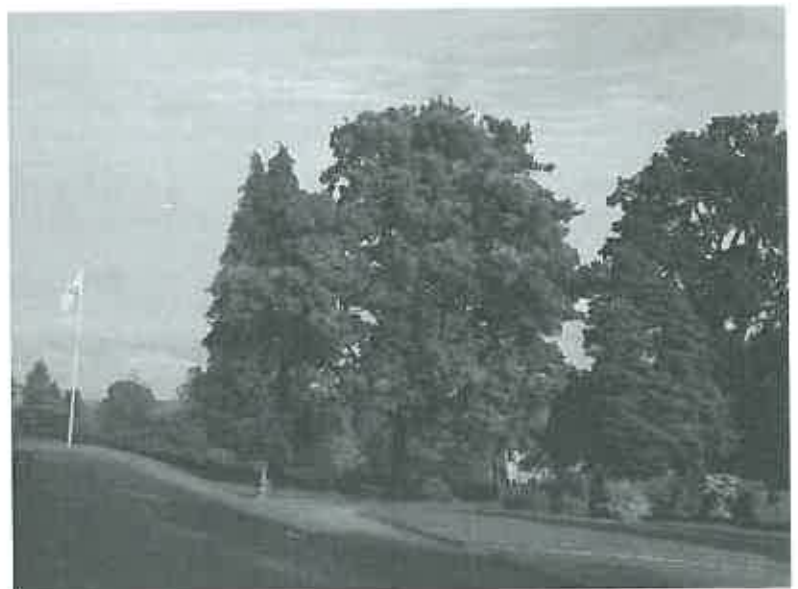
381 oak encroaching on cypress to left

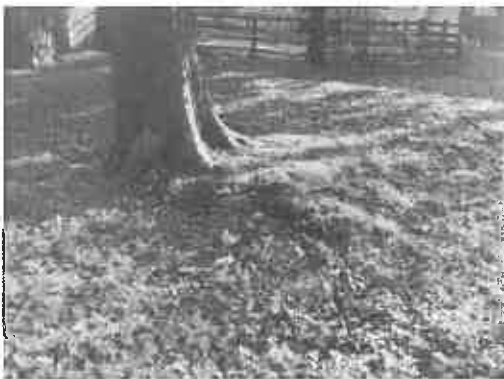
Number	Species	Remove Deadwood	sever ivy	Fell to ground level	Other
365	Lime				Becoming stag headed. Monitor
366	Cherry				Close to bin store Foundations and sewage treatment plant. Fell and stump poison
367	Oak				Recent root plate lift to west. See Photo. Reduce canopy by 4m at appropriate unions on Western side. Monitor
368	Oak				Past pavement and recent trenching damage. See Photo. Remove deadwood and reduce canopy by 2m in process.
369	Cherry			X	Root plate close to path and wall. Tree Suppressed by oak.
370	Oak				Reduce canopy spread by 2m at appropriate unions
Yellow spotted close to road hedge	3 Small yellow spotted suppressed oaks			X	
Within road hedge line.	4 Limes Red spot marked		X

Root plate lift on 367 Oak
