BUILDING (STRUCTURAL) CONDITION SURVEY
IN CONNECTION WITH
BARN AT HIGHER BOYCE FARM,
RIBCHESTER

MR M. SELLS AND MISS M. HOWORTH,
HIGHER BOYCE FARM,
STONEYGATE LANE, RIBCHESTER, PR3 3YN

JOB REF: 4874, DATED: 23/09/2015, VERSION: 1.00.

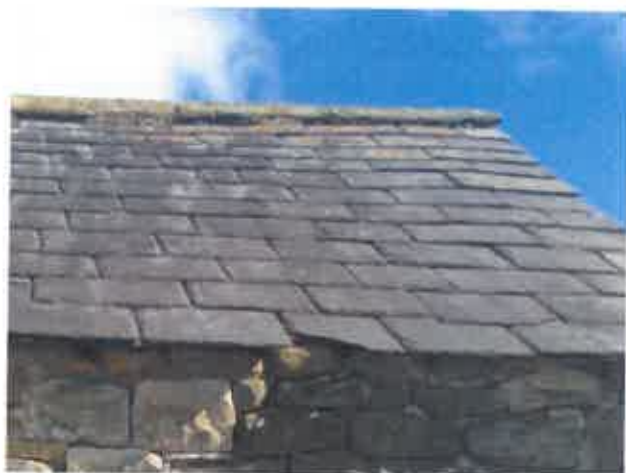
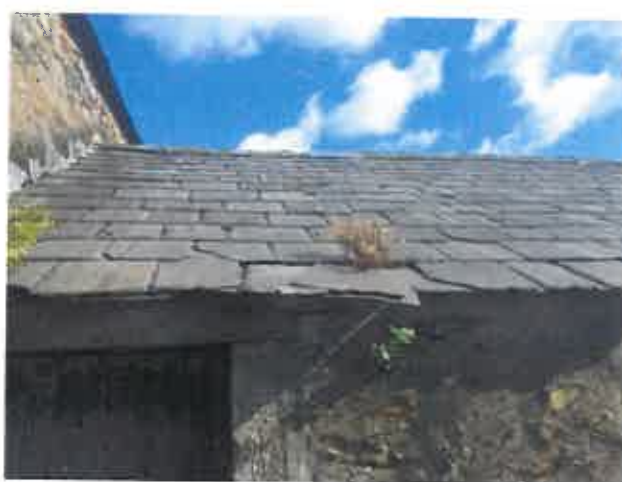
The natural slate covering to the roof is in an average condition and is showing signs of weathering with a number of chipped and cracked slates throughout. There are also a number of loose / dislodged and missing slates as well as an ad-hoc repair to the roof covering to the west elevation of the south section of the barn. All of which is to be expected given the age of the barn. All ridge tiles appeared to be present at the time of construction however they appeared to be in poor condition throughout along with the mortar pointing which was degraded and missing in places. Moss and vegetation growth was also present at roof level. These issues have the potential to allow for unwanted water ingress into the barn.

PL2 (Left) and PL3 (Right) showing cracked, chipped and dislodged slates along with vegetation growth.

- All timber wall plates should be replaced throughout.
- All degraded ridge tiles should be removed and replaced with new ridge tiles throughout.
- Damaged areas of the roof covering should be repaired and all damage slates should be replaced whilst ensuring that the roof is water tight.

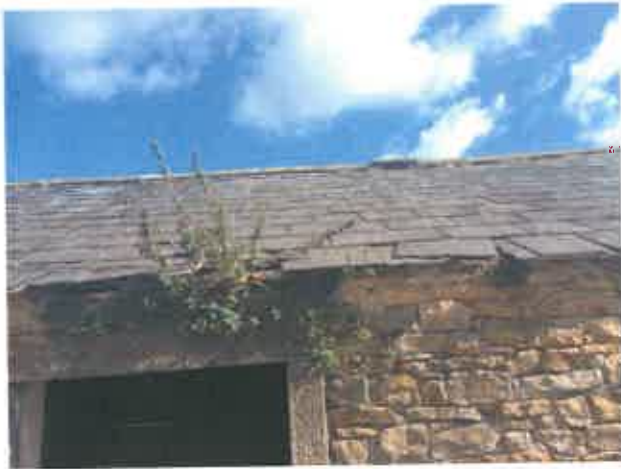
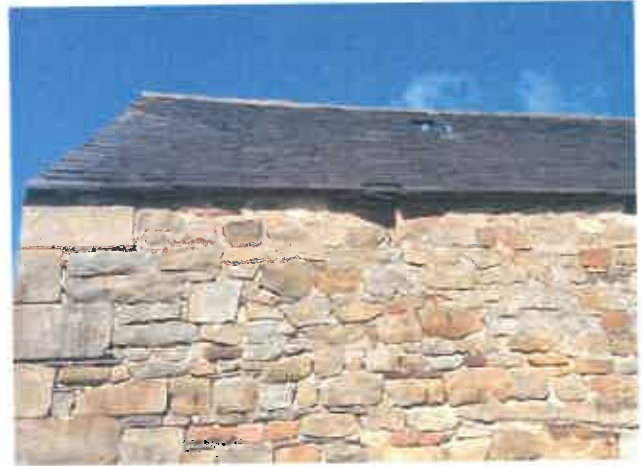
PL4 (Left) and PL5 (Right) showing cracked, chipped and dislodged slates along with vegetation growth.

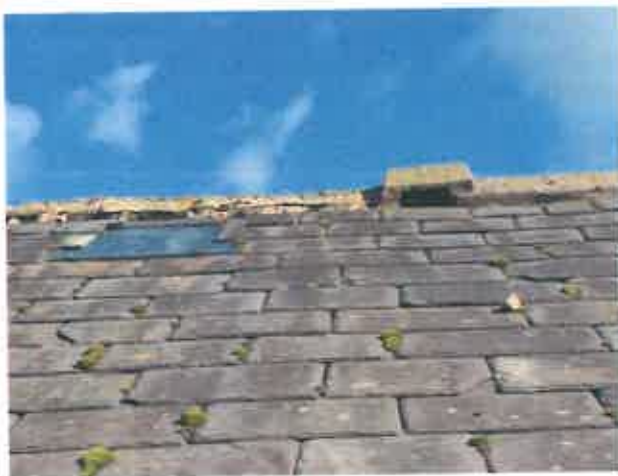
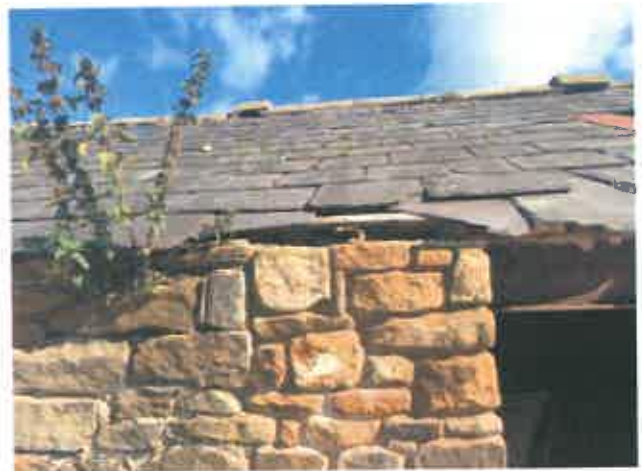
PL4 (Left) and PL5 (Right) showing degradation to ridge tiles and pointing as well as cracked, chipped and dislodged slates with vegetation growth.

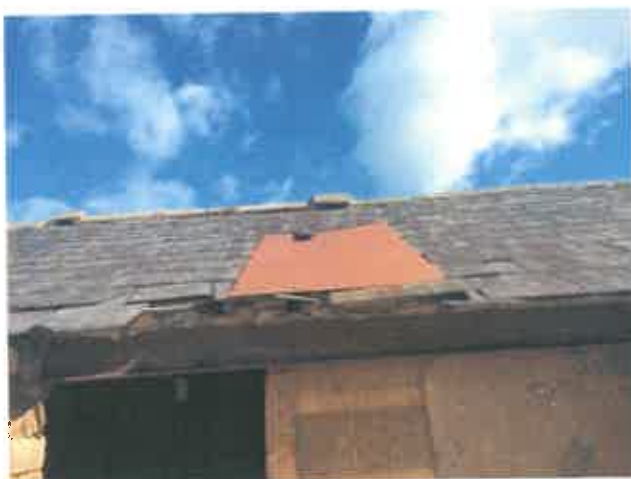
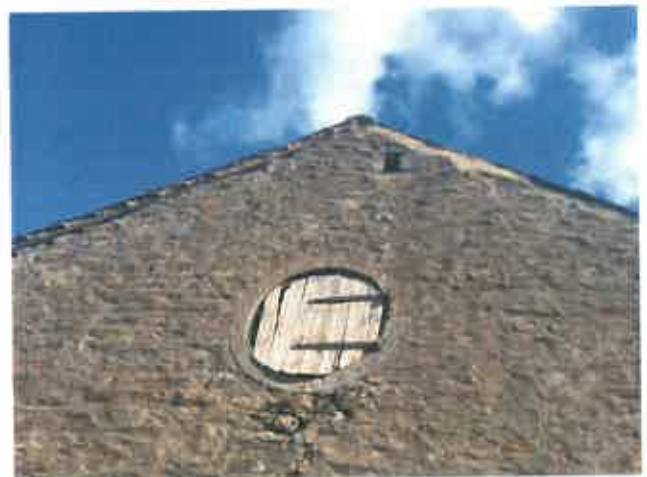
The verges to the main roofs were in poor condition due to mortar degradation and areas of missing mortar pointing. Areas of exposed timber wall plates were also exposed due to the degradation and lack of mortar pointing.

PL6 (Left) and PL7 (Right) showing cracked, chipped and dislodged slates with ad-hoc roofing repair. Degradation and missing mortar pointing noted to roof verges.

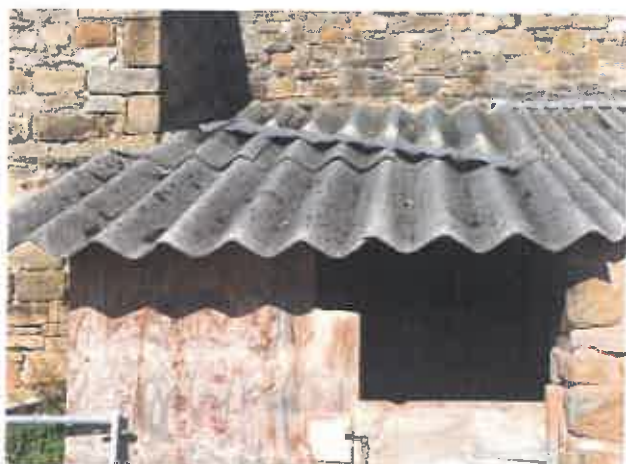
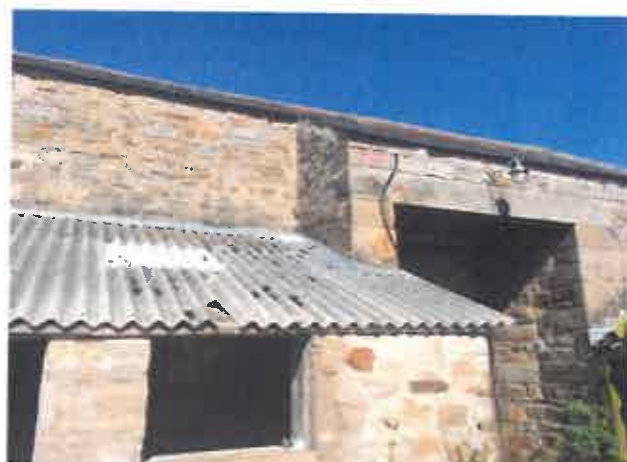
The asbestos roof covering to the south elevation of the north section of the barn was in poor condition with cracked and damaged asbestos sheets as well as vegetation growth and weathering visible to the surface of the covering. All asbestos sheets were present at the time of inspection with no dislodgements or breaches present at the time of inspection. In accordance with this application, this area of the barn is to be demolished. This said, suspected Asbestos Containing Material (ACMs) were highlighted during the inspection and subsequently a full demolition and alteration asbestos survey will need commissioning and undertaking by the client prior to any works commencing. In addition, any ACM will require removing in full by a specialist asbestos removal contractor and Clean Air Certificate authorised prior to conversion works commencing.

The lead work that is present at the junction between the north and south buildings of the barn is in average to poor condition with no obvious breaches, dislodgements or missing sections of flashing however the flashing had become discoloured. The lead work to the asbestos roof was in average condition at the time of inspection; however a large section of the lead flashing had become completely dislodged from the roof and wall junction.

PL8 (Left) and PL9 (Right) showing the condition of the asbestos roof covering and the section of dislodged lead flashing (this particular area is to be demolished).

- All asbestos containing materials should be fully removed from site and disposed of by a licenced specialist contractor. (See also Section 1.1 - ACMs note).

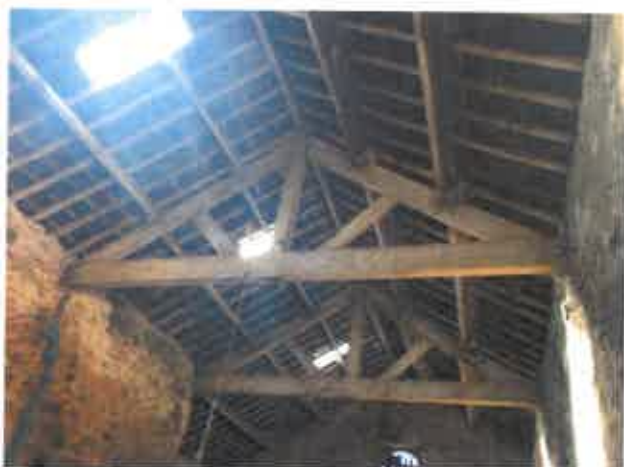
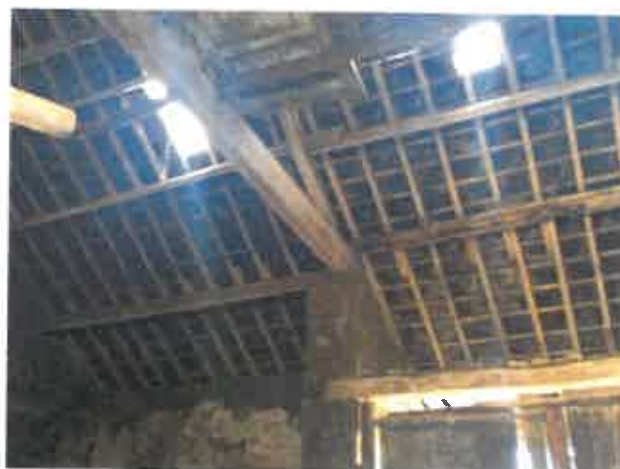
The trusses throughout are beginning to dilapidate and on visual inspection of the trusses; they appear to be suffering from decay. This could have occurred over time as a result of the breaches within the roof covering which could have allowed for water ingress to occur. Evidence of possible insect attack is also present. However, these issues would need to be fully confirmed with a closer visual inspection of the trusses.

PL10 (Left) and PL11 (Right) showing internal roof structure to north section of the barn.

- Remedial works should be carried out to the timber roof structure where required. This may consist of the treating of all timber components that are to be retained i.e. trusses, to protect against rot and insect attack.

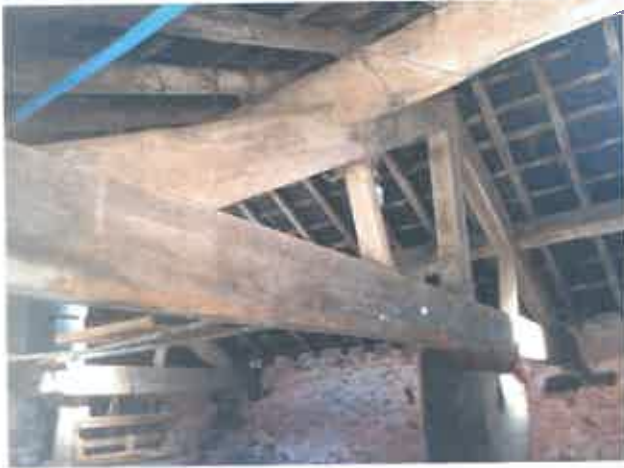
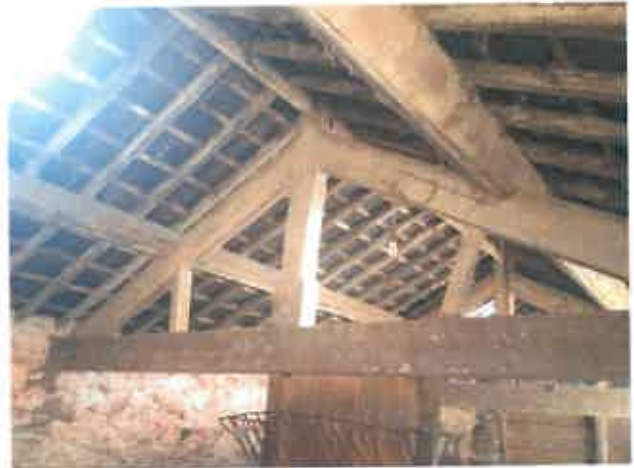
PL12 (Left) and PL13 (Right) showing internal roof structure to south section of the barn.

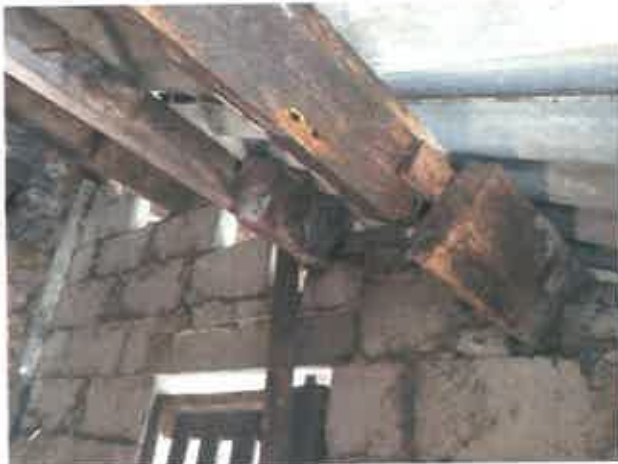
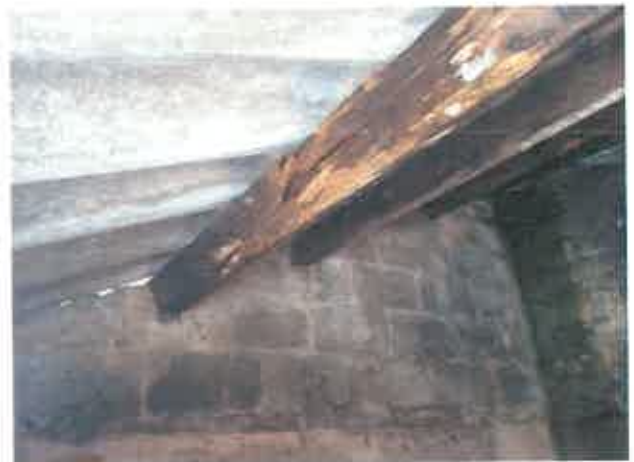
The purlins which supported the asbestos roof covering to the south elevation, where in poor condition, with clear evidence of decay and rot visible at the time of inspection.

PL14 (Left) and PL15 (Right) showing internal roof structure to lean to roof on the south elevation of the north section of the barn building.

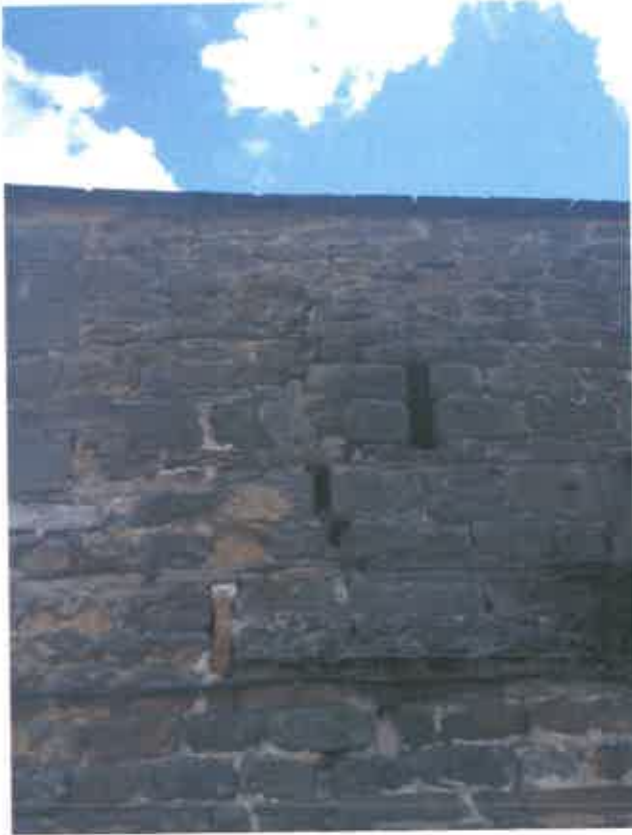
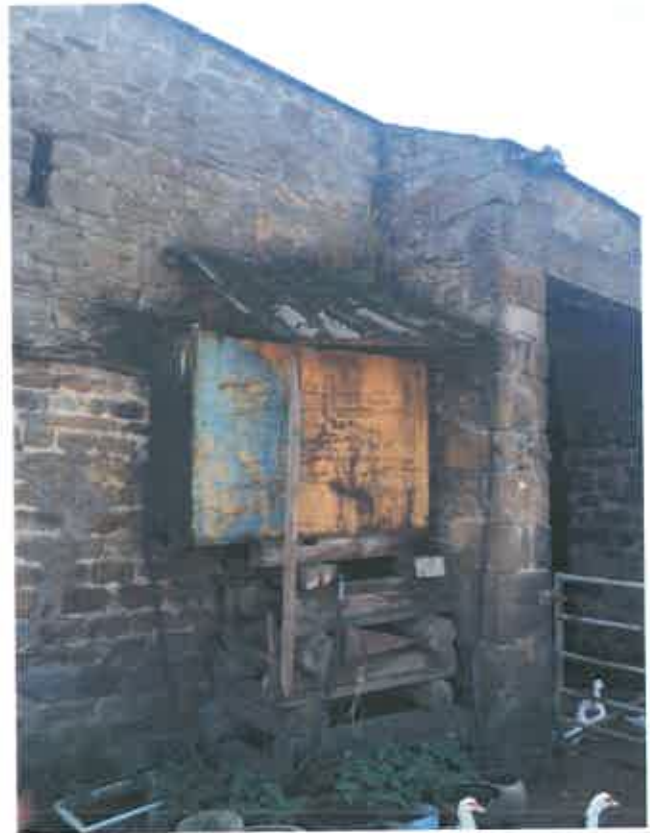
The condition of the external walls to the barn is that of average condition throughout with no obvious structural cracking and breaches. However this is with the exception of the presence of ventilation holes and vertical wall cracking to the north and east elevations with associated patch mortar repairs. Potential minor, isolated areas of remedial crack stitching / lateral restraints required at these points. Mortar degradation and missing mortar pointing was prevalent throughout particularly to the base of the walls where the mortar is more susceptible to decay through the splashback of rainwater. Hairline cracking of the mortar joints was also evident throughout. Mortar cracking was also noted to the right hand side face of the stone lintel over the barn entrance to the north elevation.

PL17 (Left) showing area of cracking to eastern side of north elevation. PL18 (Right) showing dilapidated ad-hoc structure, used to store water tank, which is to be demolished.

- Remedial works should be carried out to the external walls where required. This will involve the raking out of the degraded mortar and repointing the affected areas with a suitable lime mortar. Stone replacements may also be required in order to replace any degraded / damaged / missing stones. Crack stitching to take place in order to repair wall cracking to the north and east elevation walls.

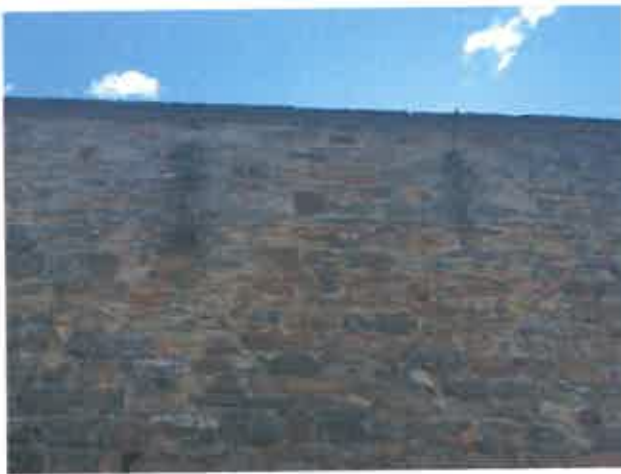
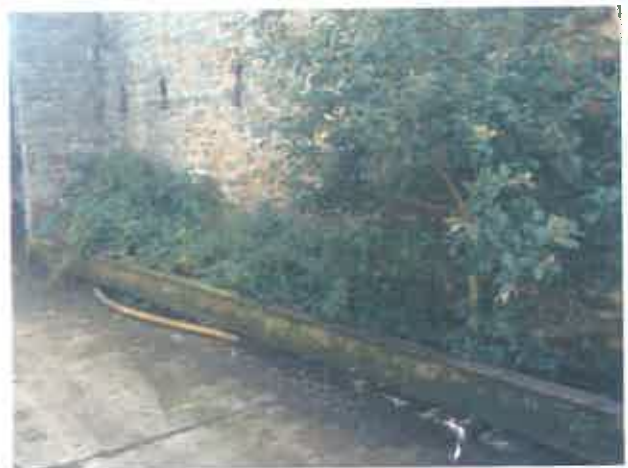
Vegetation / weed growth was noted to the bases of all elevations and should be removed prior to commencement of any proposed works. An area of ad-hoc construction for the storage of a water tank was noted to the left hand side of the barn entrance to the north elevation and was in poor condition and dilapidated and is also to be removed in line with the proposals. Minor rust staining was also noted to the top of the north elevation and is caused by the corrosion of the metal fixtures that are fixed at eaves level.

PL19 (Left) showing rust staining to below metal fixtures. PL20 (Right) showing significant vegetation growth to the base of the elevation.

- All vegetation growth is to be removed from the base of all walls and also from the affected areas of the roof structure / covering.

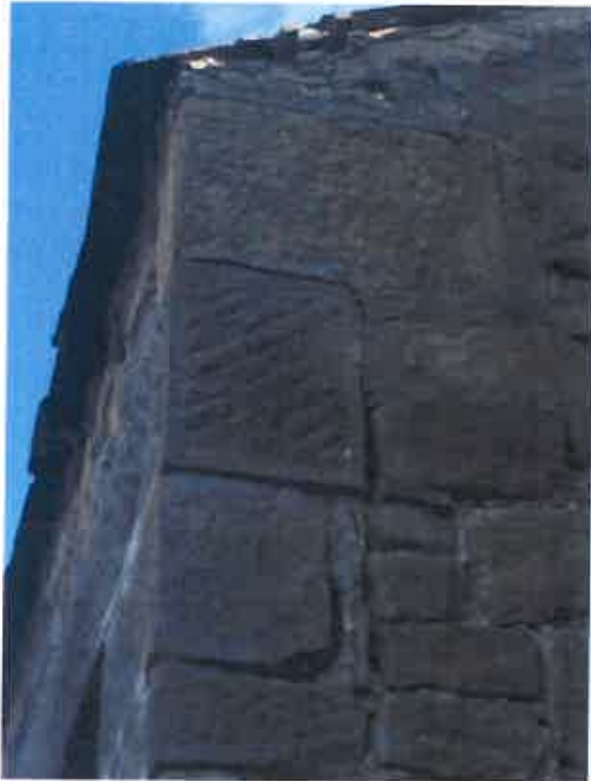
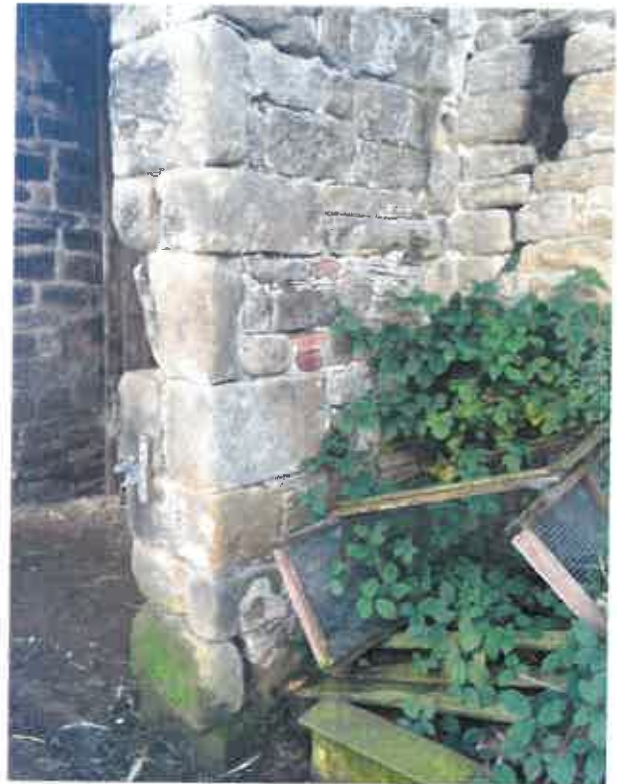
PL21 (Left) showing mortar crack to right hand side of stone lintel to barn entrance. PL22 (Right) showing condition of stonework and degradation to base of wall.

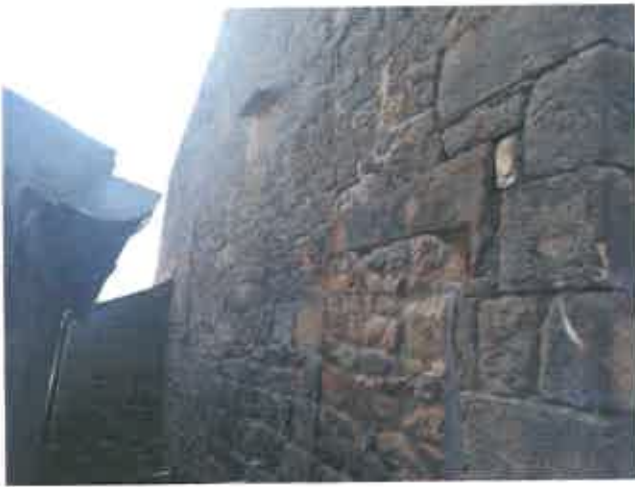
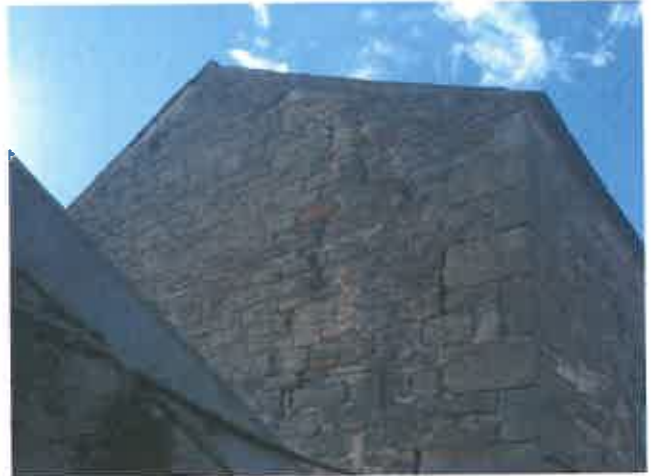
PL25 (Left) showing condition of the east elevation gable wall with degraded mortar and patch repairs. PL26 (Right) showing cracking to east elevation gable wall.

Another issue was the presence of cracks within the walls of the building both internally and externally. The possible cause of this could be down to a number of contributing factors. It is likely that the building has shallow foundations which are inadequate for the loading requirements that have been placed on them. In turn this has resulted in movement of the building. Further investigations would be required to fully determine the cause of movement and whether or not further movement is likely and the extent of any remedial action required.

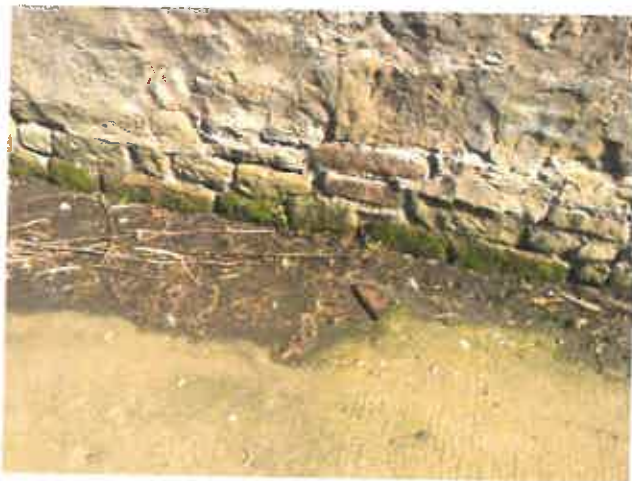
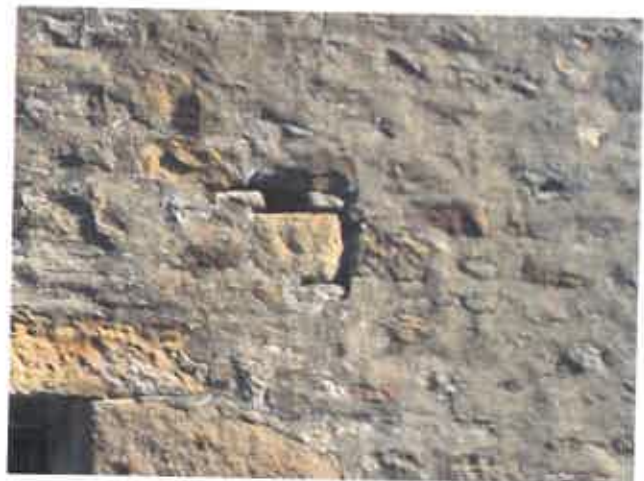
PL33 (Left) showing mortar degradation to base of wall. PL34 (Right) showing hole damage and hairline cracking to west elevation.

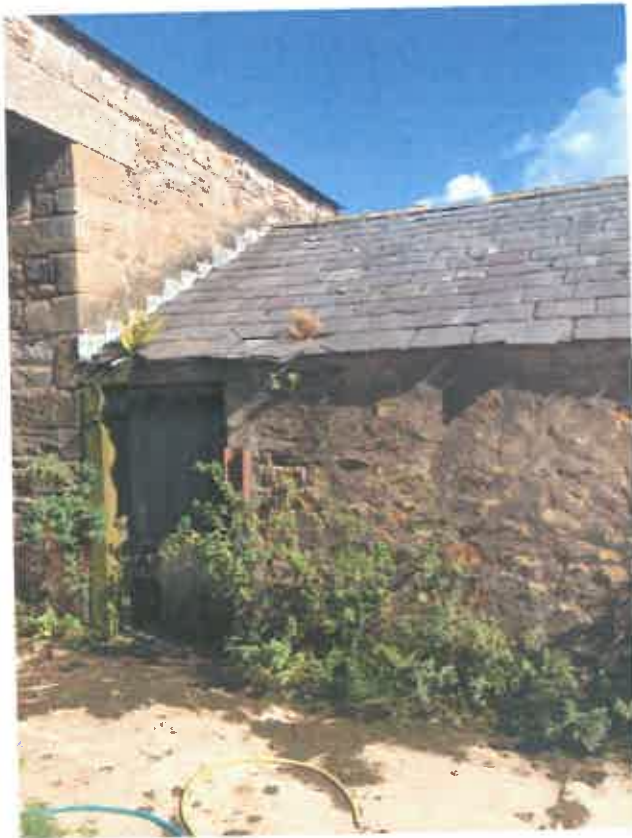
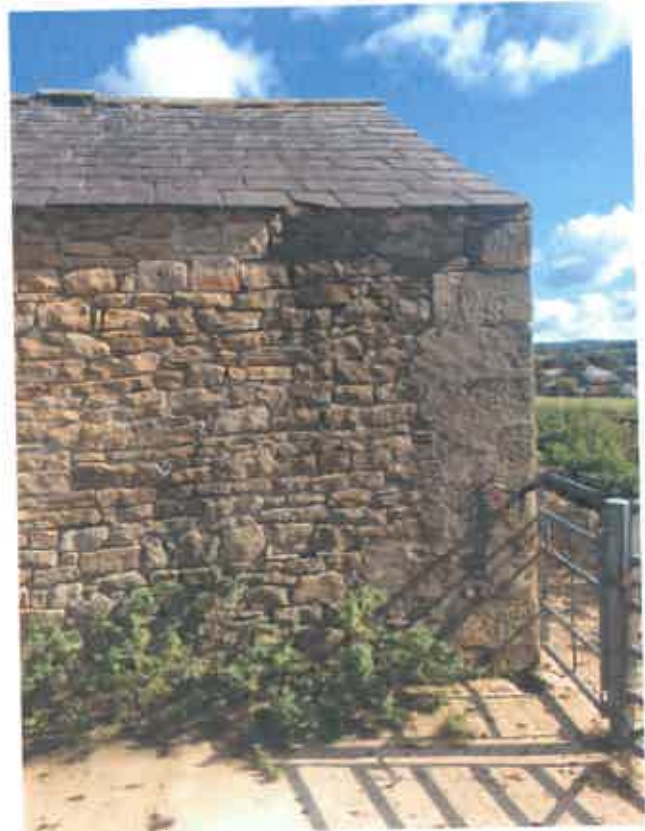
PL35 (Left) shows mortar repairs to stone joints and significant plant / weed growth to base of wall. PL36 (Right) showing mortar patch repairs, mortar degradation and plant / weed growth.

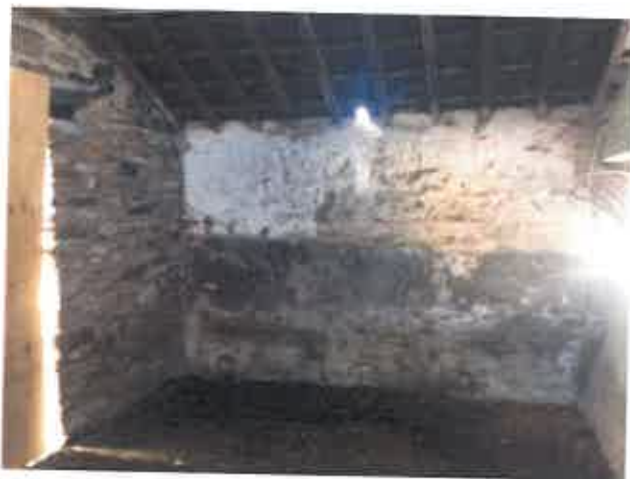
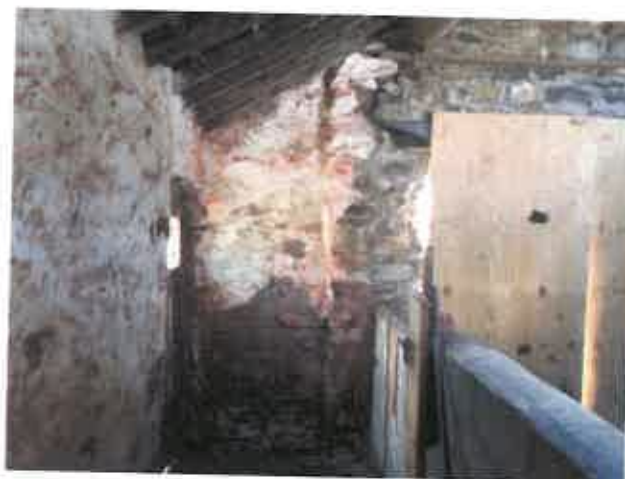
Internally throughout, the internal walls where in average to poor condition. The internal white washes and renders were degraded with areas of stonework being exposed beneath the white wash. The white wash was also stained, soiled and discoloured throughout. Hairline cracking was also present to the areas of cement render. The blockwork walls where in average condition with some soiling and patch mortar repairs present however, the dwarf walls are to be removed as part

PL38 (Left) and PL39 (Right) shows difference in internal wall finishes and also condition.

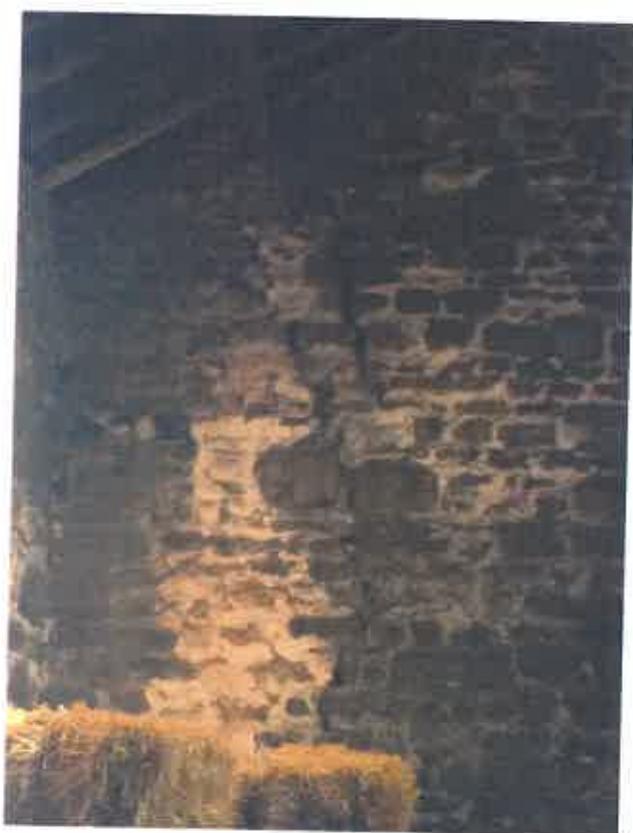
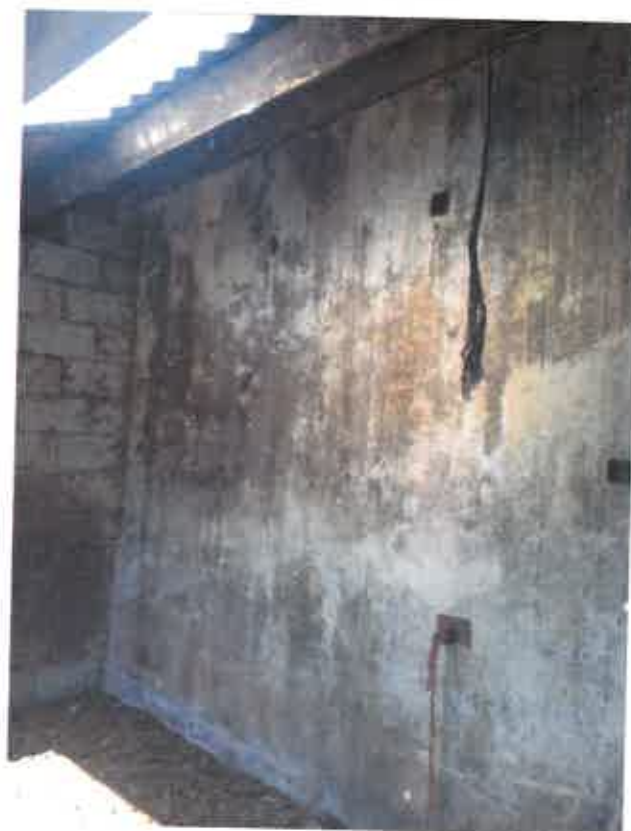
An area of wall cracking was present to the internal face of the east external gable wall. This crack was reflective of what also occurred on the external face of the wall in the same location.

PL40 (Left) shows wall cracking to the internal face of the east gable wall within the north section of the barn and is in the same location as the external wall cracking. Minor isolated crack stitching / lateral restraint ties potentially required at this point. PL41 (Right) shows soiling and staining to internal walls.

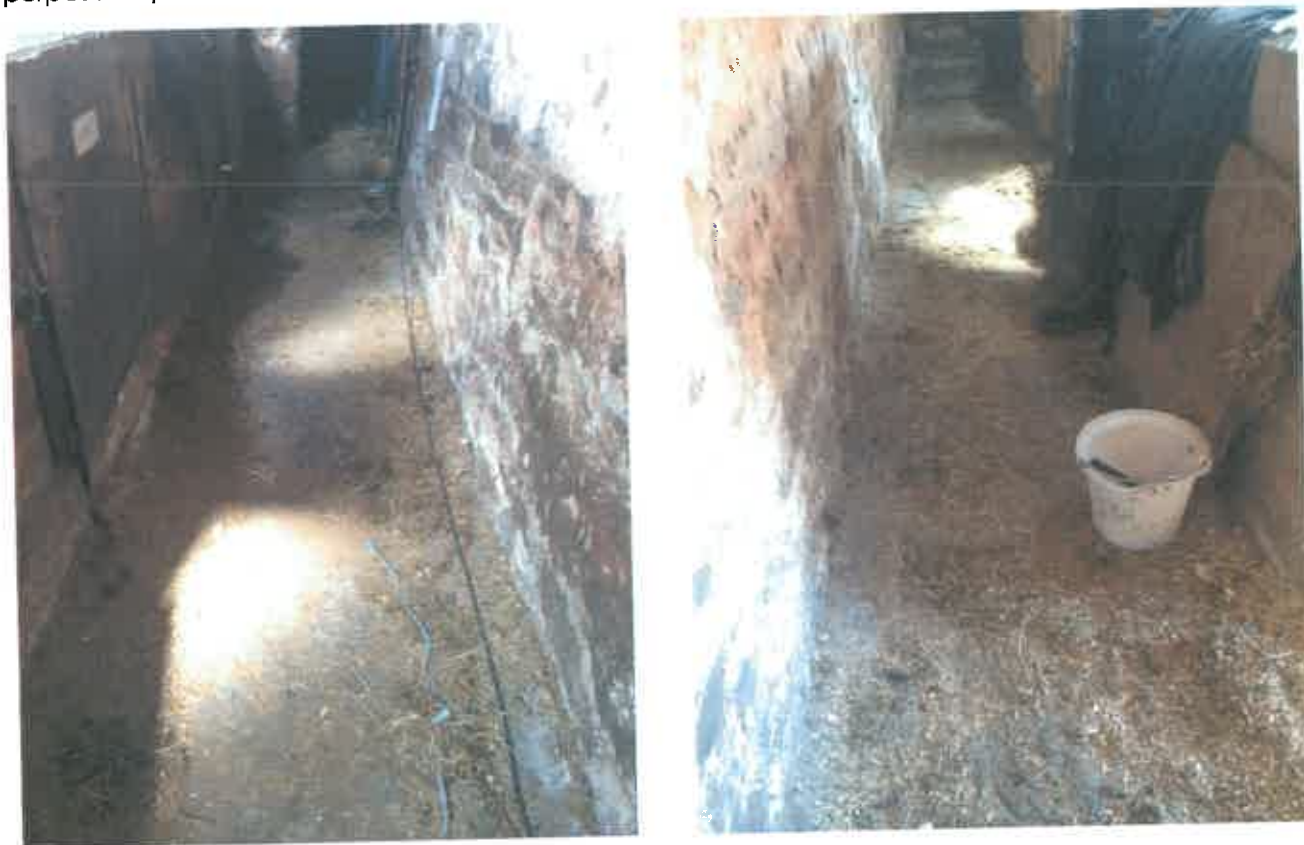
The concrete ground floor appeared to be in moderate condition with no obvious signs of substantial cracking and appeared to be relatively level. However the finished surface was rough and contained various areas of staining and surface blemishes, however it is fit for its intended purpose at present.

PL42 (Left) and PL43 (Right) showing the internal concrete floor of the south section of the barn building.

- Existing concrete ground floor should be grubbed up and replaced with a new insulated concrete ground floor structure incorporating DPMs with DPCs lapped up to new internal block lining walls.

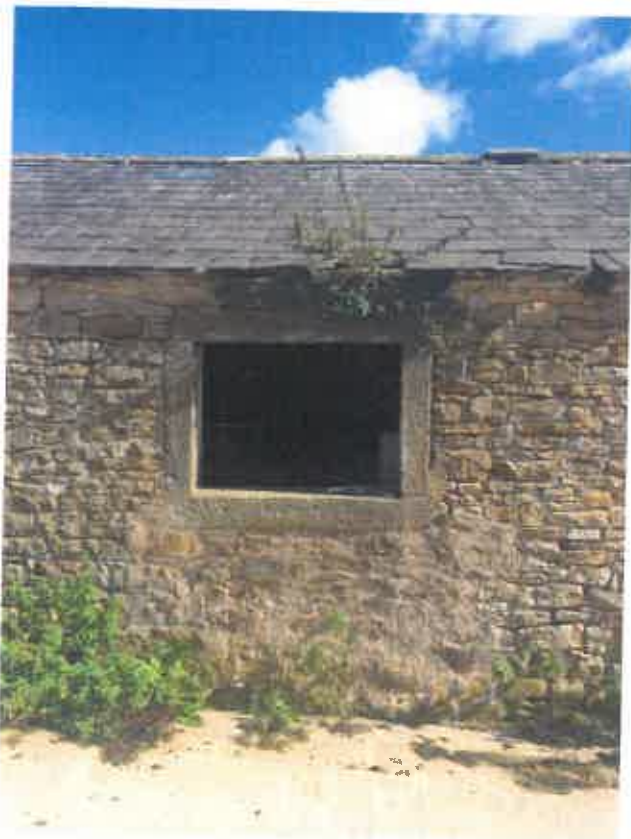
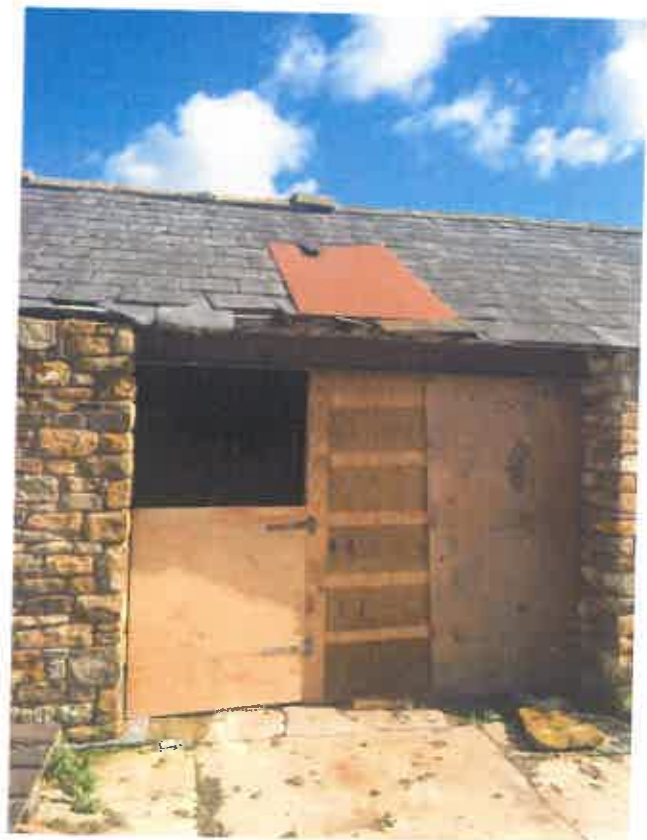
PL44 (Left) showing empty structural opening. PL45 (Right) showing ad – hoc gate / door arrangement.

- Existing timber windows and doors should be removed and replaced with new double glazed uPVC or timber units to ensure water tightness from wind driven rain at these points.

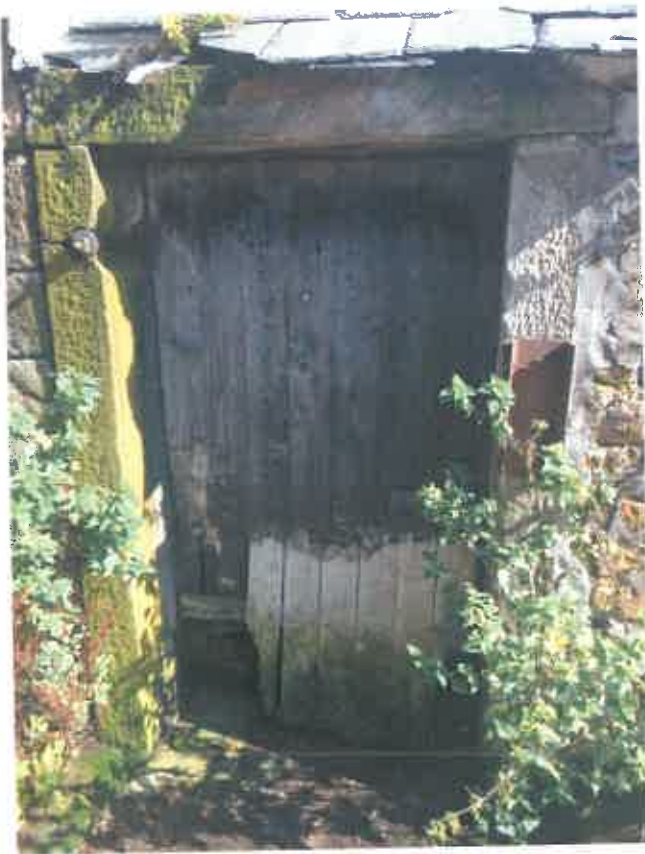
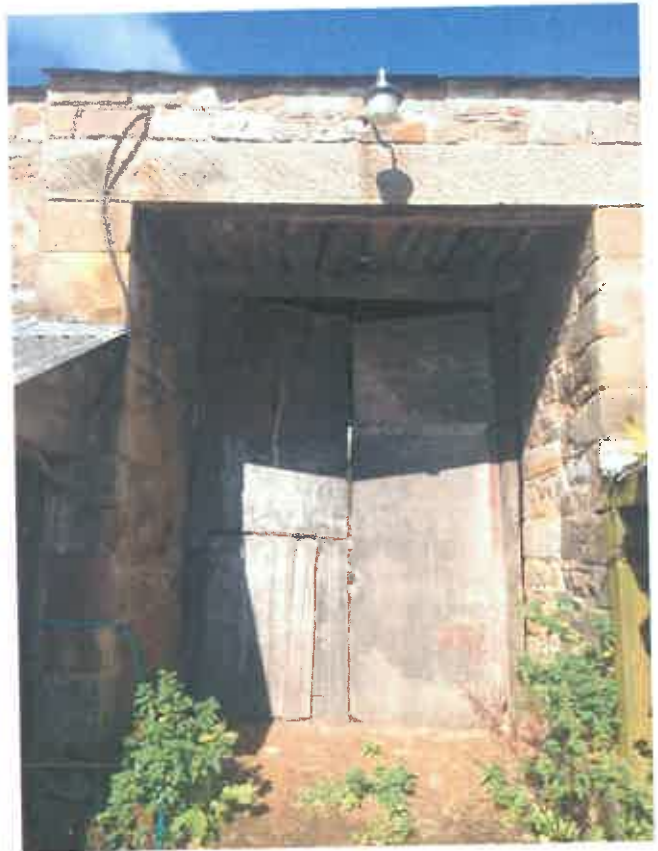
All windows and doors, including frames, were in poor condition and dilapidated with graining of the surface and virtually no paint finish visible at the time of inspection. A number of the doors had been repaired in an ad-hoc nature, through which they had also become unsightly. Many of the timber components were also showing signs of timber decay.

PL46 (Left) and PL47 (Right) showing dilapidated and damaged external doors.

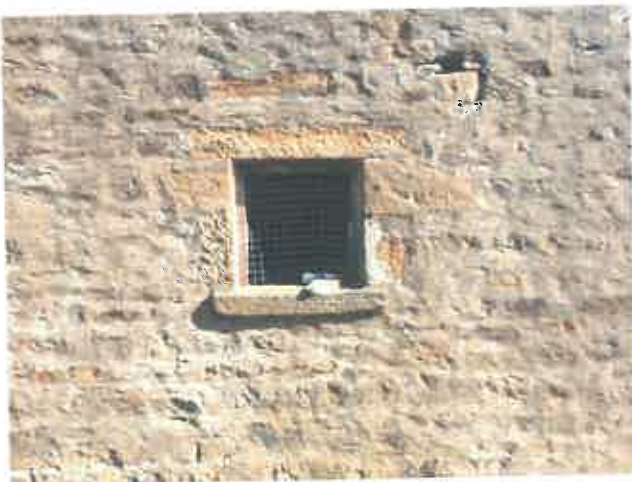
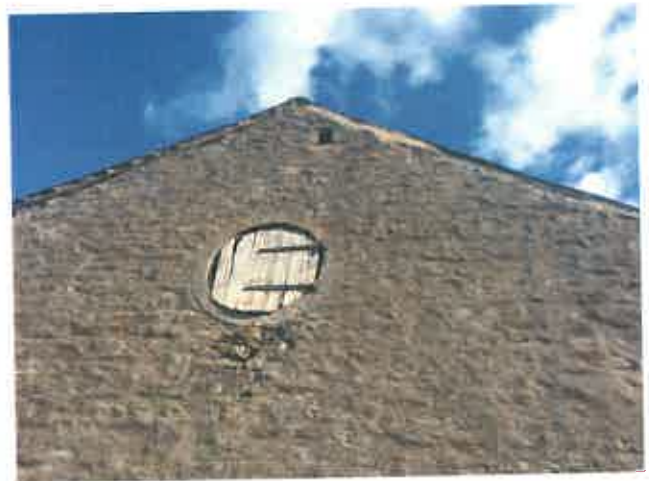
PL48 (left) showing dilapidated window frame with wire mesh infill. PL49 (Right) showing poor condition of pitching hole door and rusting hinges.

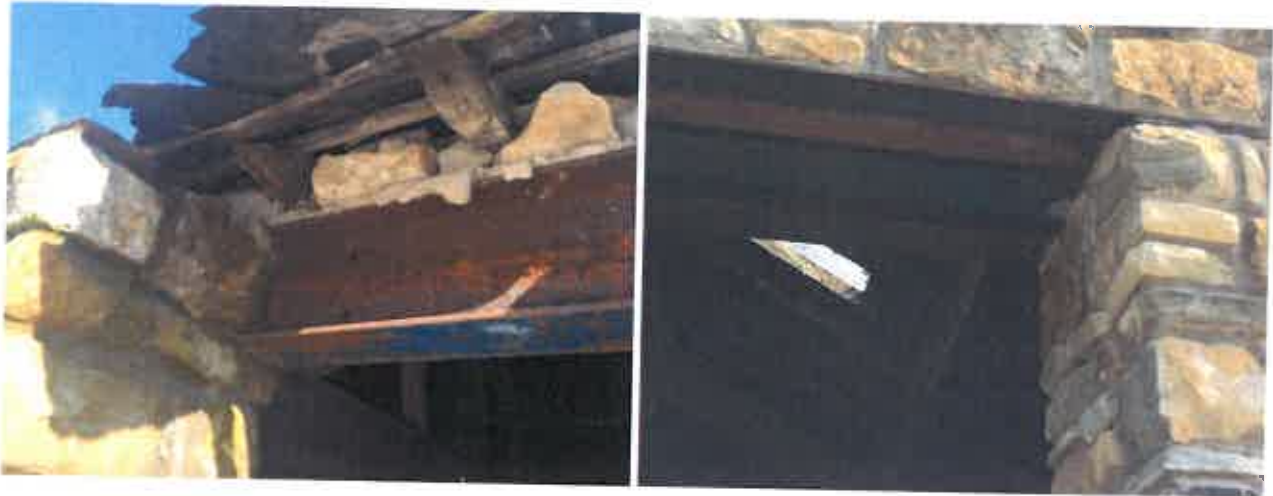
PL50 (left) and PL51 (Right) showing rust and corrosion to steel lintels above openings.
