PROVISIONAL OUTLINE SCHEDULE OF WORKS AND METHOD STATEMENT:

Job title
Proposed Structural Works To
Hark To Bounty
Townend
Slaiburn
Nr Clitheroe
Lancashire
BB7 3EP

Drawing title
Proposed Plans and Elevations

5124 -03 A

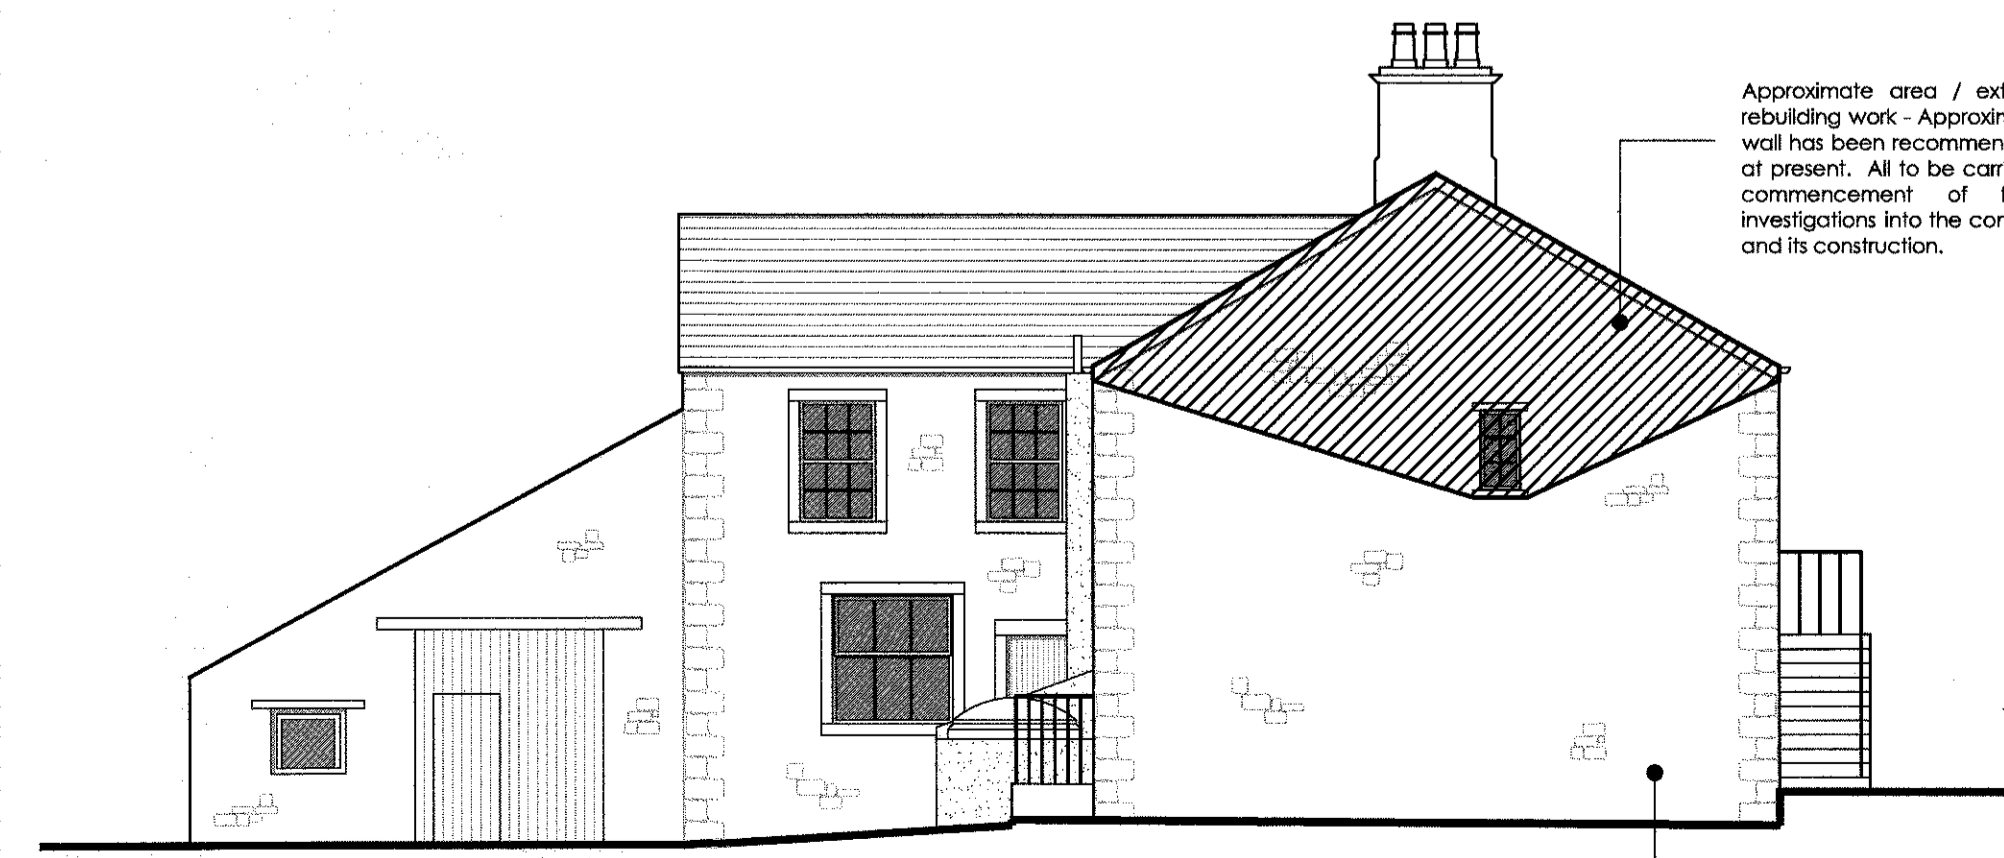
Existing West Facing Elevation
Scale 1:100

PURPOSE OF THE WORKS:
The works are being carried out in order to repair and correct an area of wall bowing which has occurred to the west facing elevation of the building as a result of structural movement in order to restore structural cohesion and unity. The undisturbed areas of the wall are to be repointed to prevent further water ingress which is currently an ongoing problem at this particular location of the building. Only unsound areas of mortar are to be repointed.

Approximate area / extent of localised rebuilding work - Approximately 30% of the wall has been recommended to be rebuilt at present. All to be carried out upon the commencement of further intrusive investigations into the condition of the wall and its construction.

Repointing works to take place throughout the remainder of the elevation. Only unsound areas of mortar are to be repointed.

The affected gable end wall of the building is to be rebuilt following the commencement of further intrusive investigations regarding the condition of the wall and its construction. The approximate extent of the rebuilding work is highlighted on drawing 5124-03 to the proposed west facing elevation. At present, approximately 30% of the gable end wall will be require rebuilding and this is to be confirmed by the Structural Engineer, however this is expected to be the worst case. As per Structural Engineers report ref: W/15/110/P2/P/GW/LAW dated 13th November 2015, it is suggested that the use of steel plates in order to tie the out leaf of stonework to the inner leaf would be uncertain as the plates would be retaining an element of potentially weak walling against a void and would not be considered as a suitable means of remediation. Therefore the rebuilding of the affected area is required.

REBUILDING:
The dismantled section of walling is to be rebuilt using the retained stonework in the order that the stonework was dismantled. All stones are to be laid onto a clean surface and rebuilding is to take place on vertical areas of existing walling. Steel ties to be inserted during rebuilding in order to tie the rebuilt wall back to the inner stonework and is to be carried out in accordance with structural engineers recommendations.

All rebuilding is to be carried out using a traditional 3:1 mix (sharp stone, coursed sand/diffing aggregates: 3.5 Natural Hydraulic lime). Mix will be applied throughout complete with stipple/brushed finish. Joint/mortar thickness to be well-proportioned.

Existing mortar to be carefully raked out to a minimum depth of 25mm or twice the width of the joint (whichever is greater). Raking out of existing mortar joints is to be strictly done by hand using the correct hand tools i.e. a mason's chisel. Under no circumstances should mechanical methods of removal be used in order to prevent damage to the stonework.

The repointing of the affected stone joints is to be carried out using the following mortar specification. All repointing is to be carried out using a traditional 3:1 mix (sharp stone, coursed sand/diffing aggregates: 3.5 Natural Hydraulic lime). Mix will be applied throughout complete with stipple/brushed finish. Joint/mortar thickness to be well-proportioned.
