STRUCTURAL APPRAISAL

GABLE WALL

HARK THE BOUNTY INN

Slaidburn

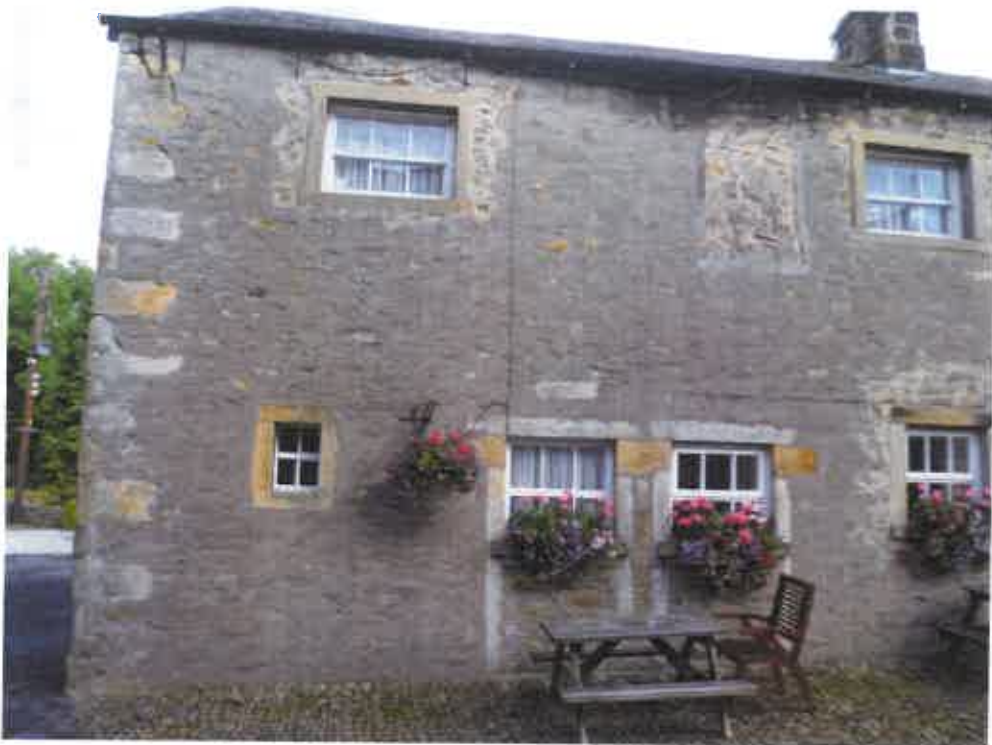
Front Elevation

The wall is generally virtually plumb.

The roof displays a noticeable sag adjacent to the left hand side.

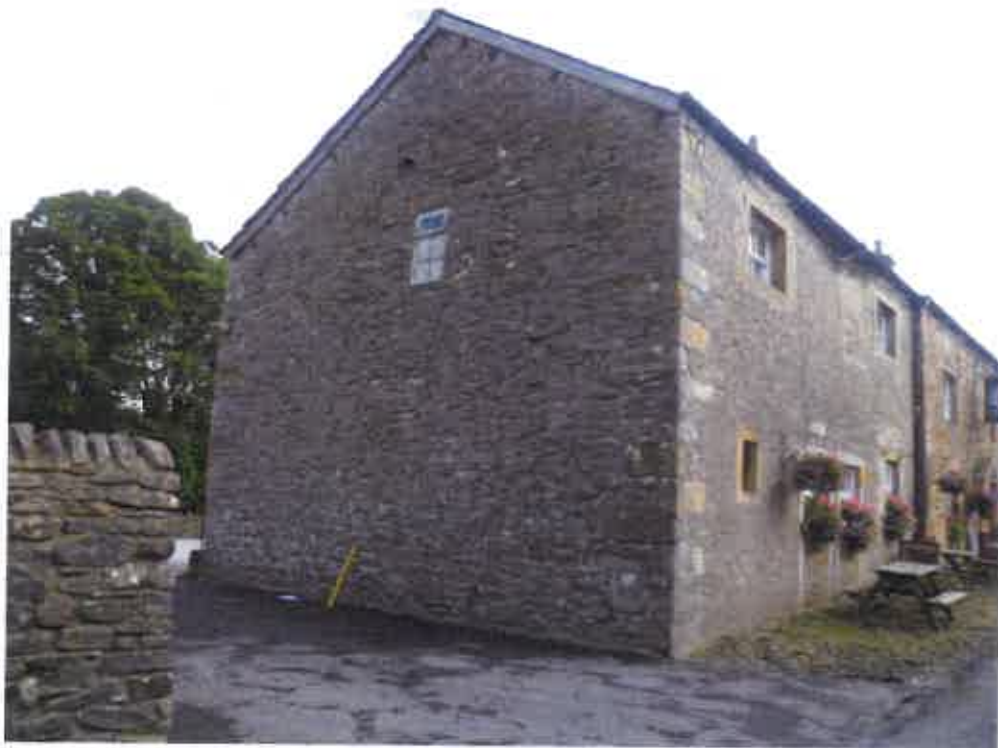
Left Hand Gable

Adjacent to the front the wall leans out at 0-5 in 1000; in the middle the walls out at 15 in 1000.

At first floor level there is a significant bulge.

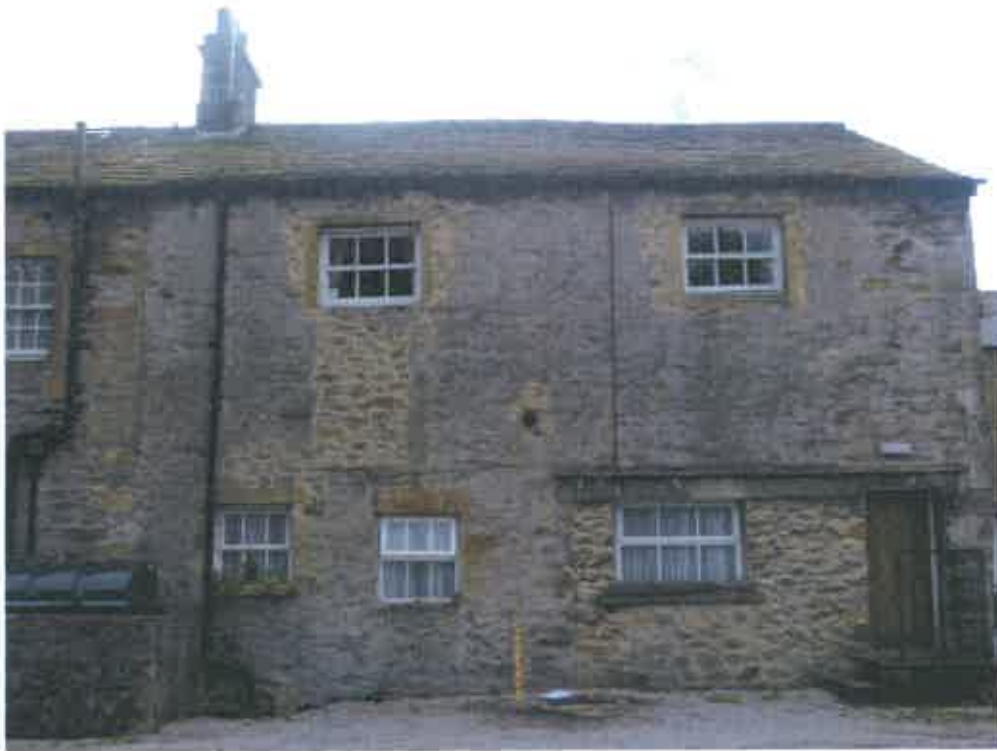
Rear Elevation

Adjacent to the left hand gable the wall leans out at 15 in 1000;

There is a slight bulge at first floor level; above the left hand ground floor window head.

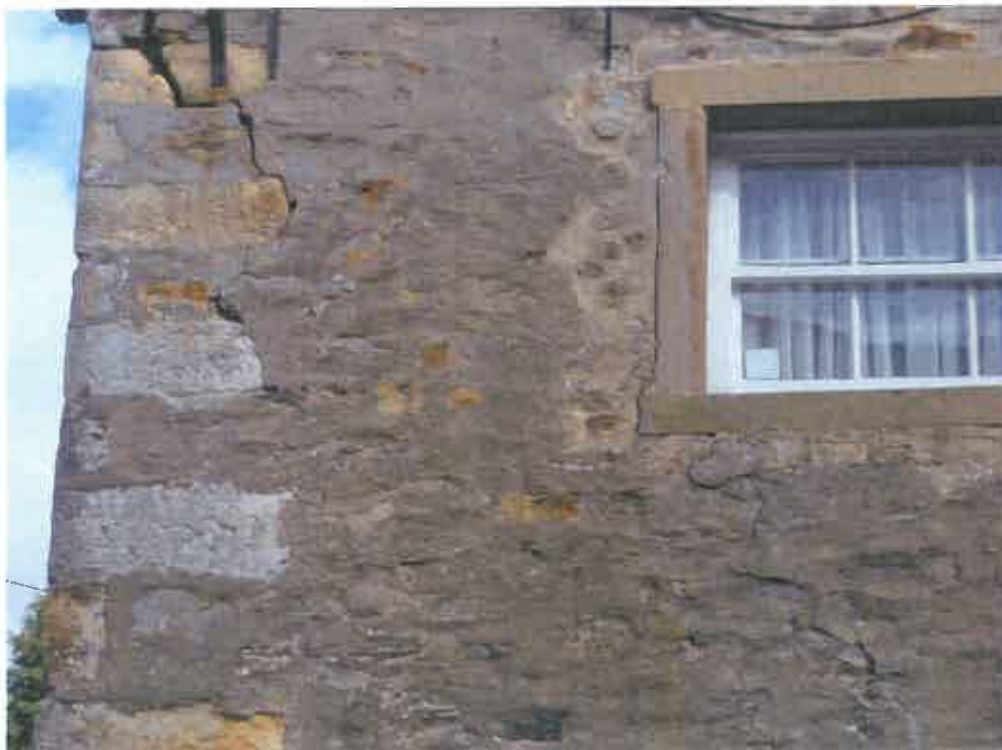
There is diagonal cracking at high level at the junction of the roof and left hand gable wall which spread down to the right.

Beneath the left hand side of the left hand first floor window cill there is cracking which spreads down to the right.

There is vertical cracking to the left hand side of this window.

Front Elevation – cracking

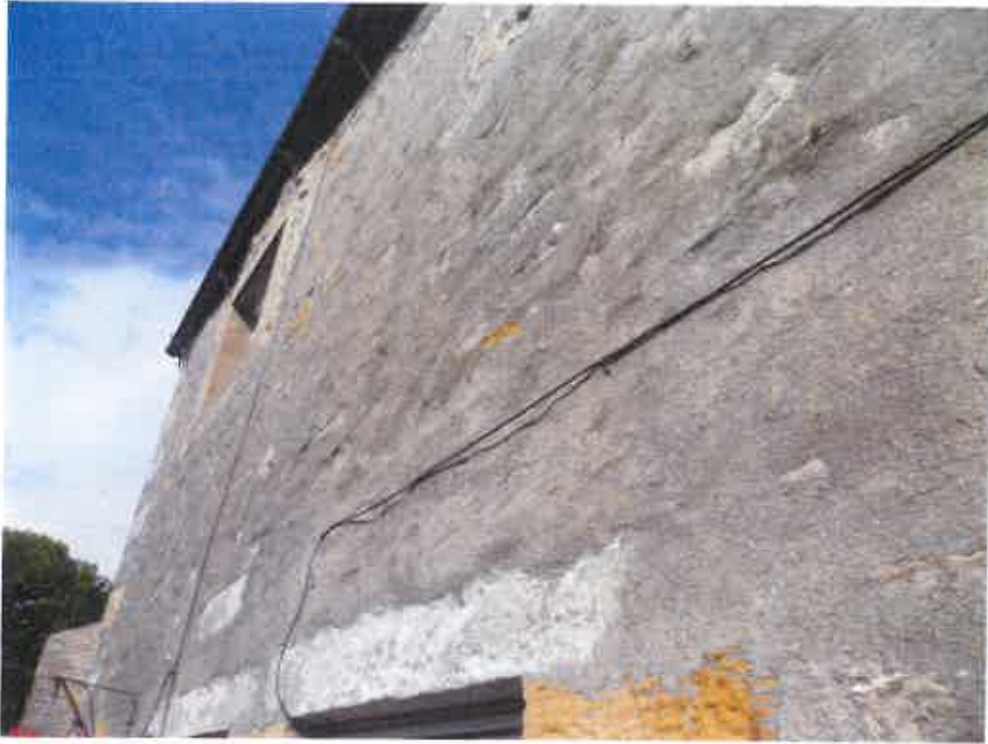
Left Hand Elevation– bulge

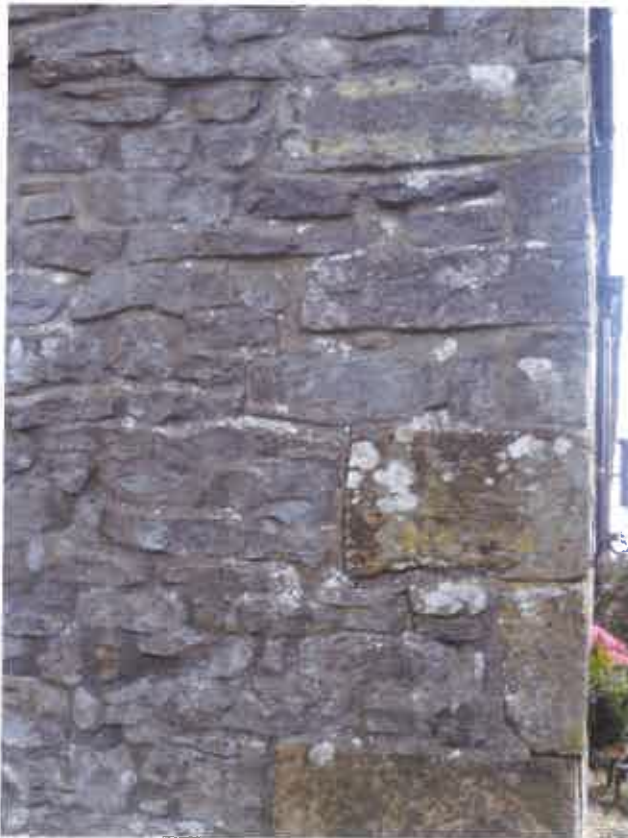
There is near vertical cracking at low level adjacent to the front.

Left Hand Elevation – cracking

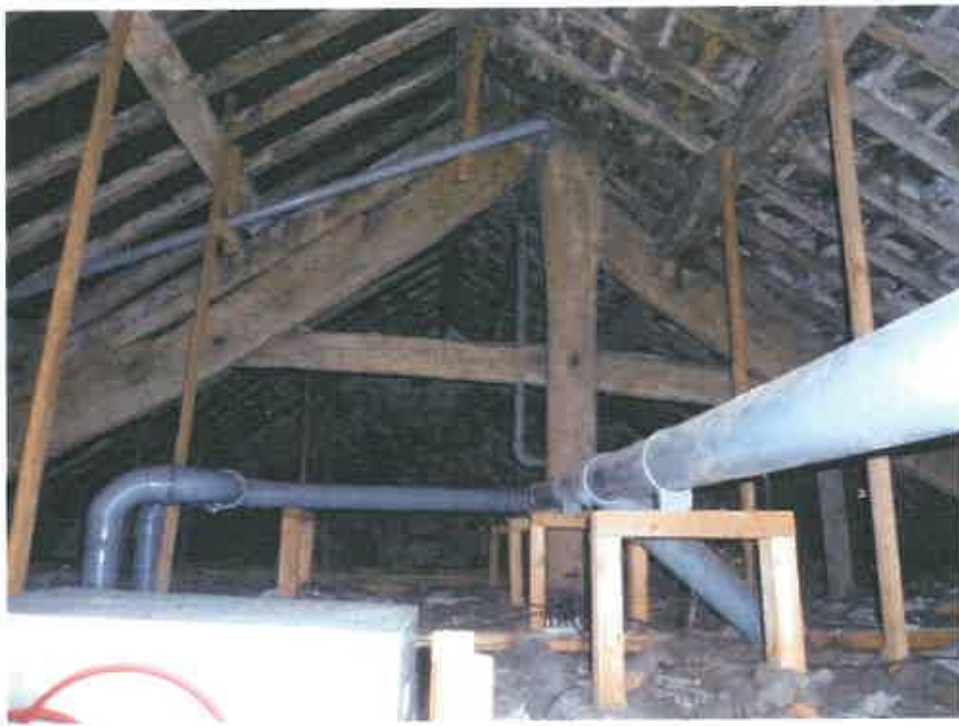
Roof Structure

The original wall displays a noticeable bulge.

The roof at the front has been re-felted. The slates at the rear have moved and there are open areas apparent.
