**STRUCTURAL APPRAISAL**

**FURTHER INVESTIGATIONS  
GABLE WALL**

**HARK THE BOUNTY INN  
Town End  
Slaidburn**

**W/15/110**

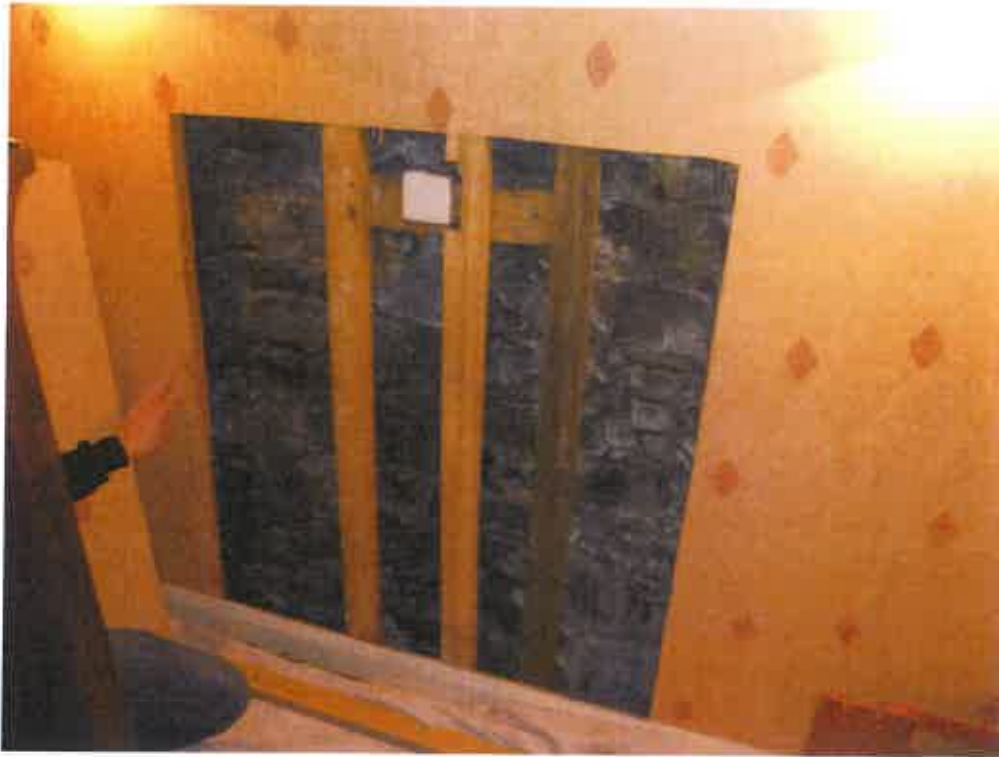
- 2.05 Plywood boarding has been fixed to timber vertical members adjacent to the stonework.
- 2.06 An area of the first floor was also removed to permit a view of the wall at this level.
- 2.07 The stonework appears in reasonable condition in this vicinity and is nominally vertical.
- 2.08 The floor is boarded in chipboard and the timber floor joists (75x225 @ 380mm centres) appear of recent origin.

Front Bedroom-opening showing inner stonework

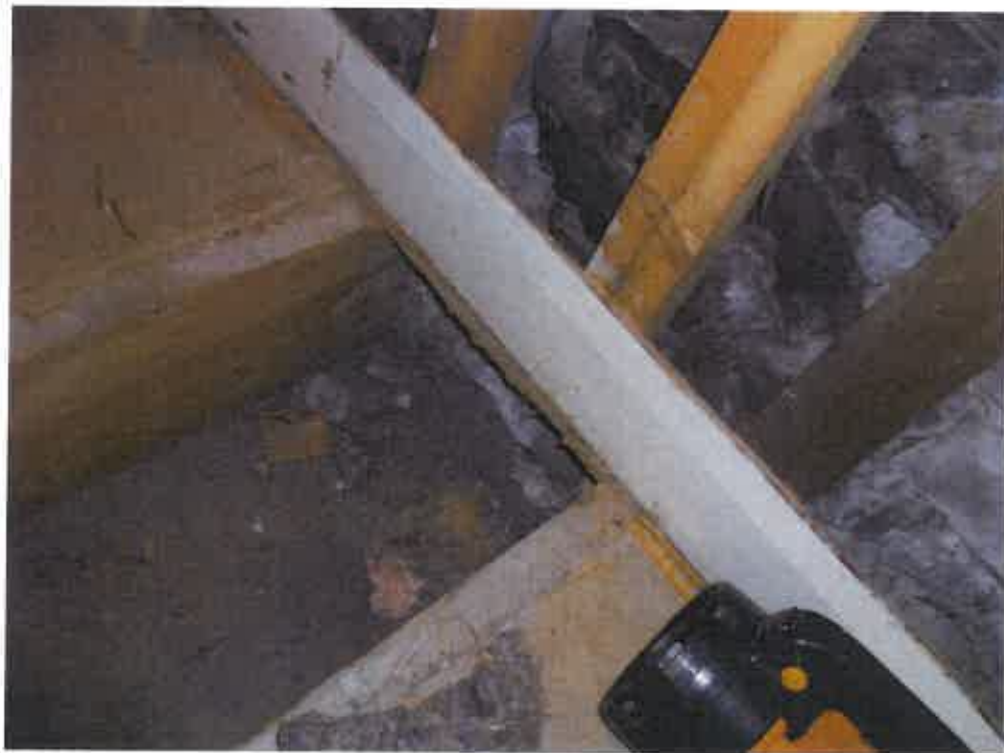
Front Bedroom – floor opening

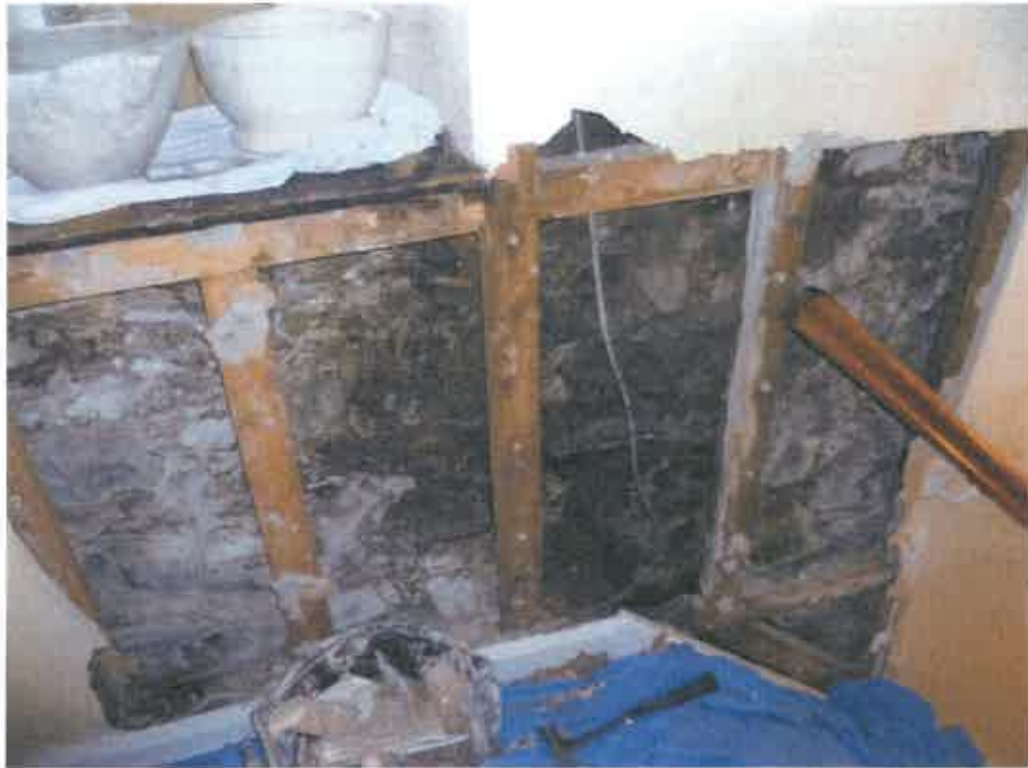
- 2.09 An area of the plaster boarding was removed from beneath the gable window.
- 2.10 The wall lining is plaster boarding fixed adjacent to the inner stonework of the gable wall, with timber vertical members.
- 2.11 The plaster boarding was found to be saturated and the timber verticals also saturated.

Landing - opening

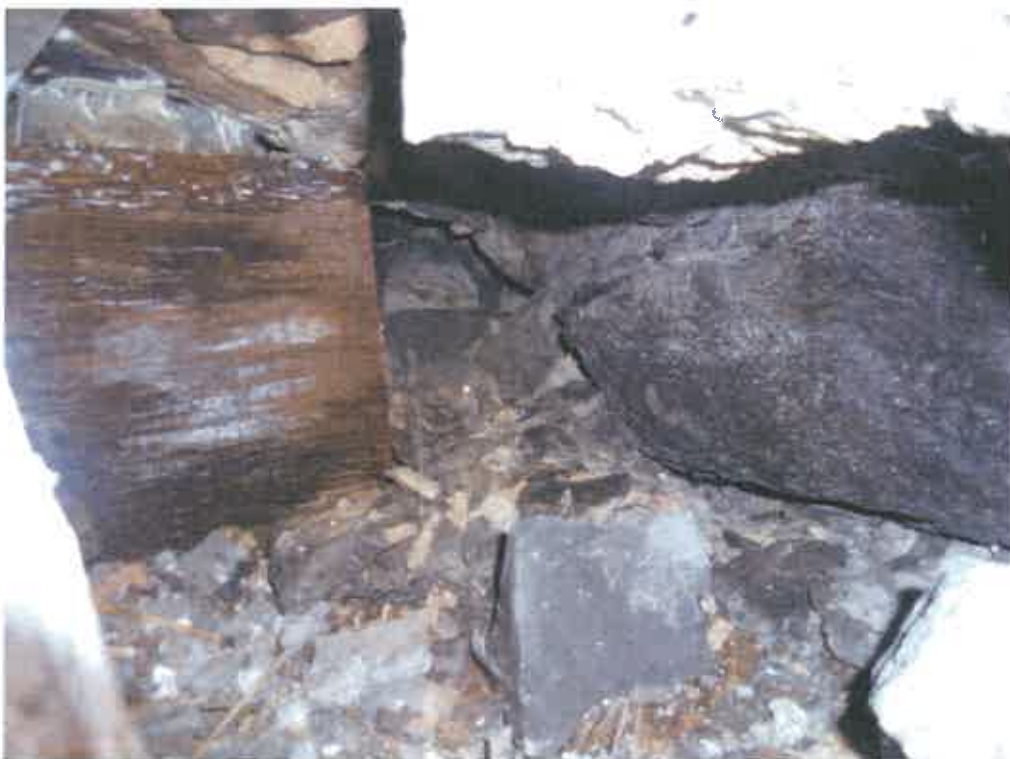
- 2.12 The opening was extended to permit an inspection of a landing floor joist.
- 2.13 The timber joist exposed is resting on the stonework. The seating of the joist is satisfactory.
- 2.14 There is a significant void around the joist. The immediate opening is approximately 300mm from the face of the inner wall; this void extends approximately another 150mm.

- 3.01 Within the bedroom the inner stonework face was found to be in reasonable condition and nominally vertical.
- 3.02 There is a significant void in exposed inner stonework on the landing around the joist.

Landing - joist and void in wall

- 3.06 We recommend that scaffolding is installed against the gable wall externally, with internal propping and scaffolding internally.
- 3.07 The areas of wall displaying significant bulging should be carefully taken down from the outside.

- 3.08 Given the findings of this limited inspection if the outer stone work has moved away it may be possible to re-build this and tie it back to the internal stonework without disturbing the inner wall.

- 3.09 This can only be determined at that time.
- 3.10 The wall should be re-built carefully ensuring a satisfactory bond/tie with the remaining stonework and floor/roof.

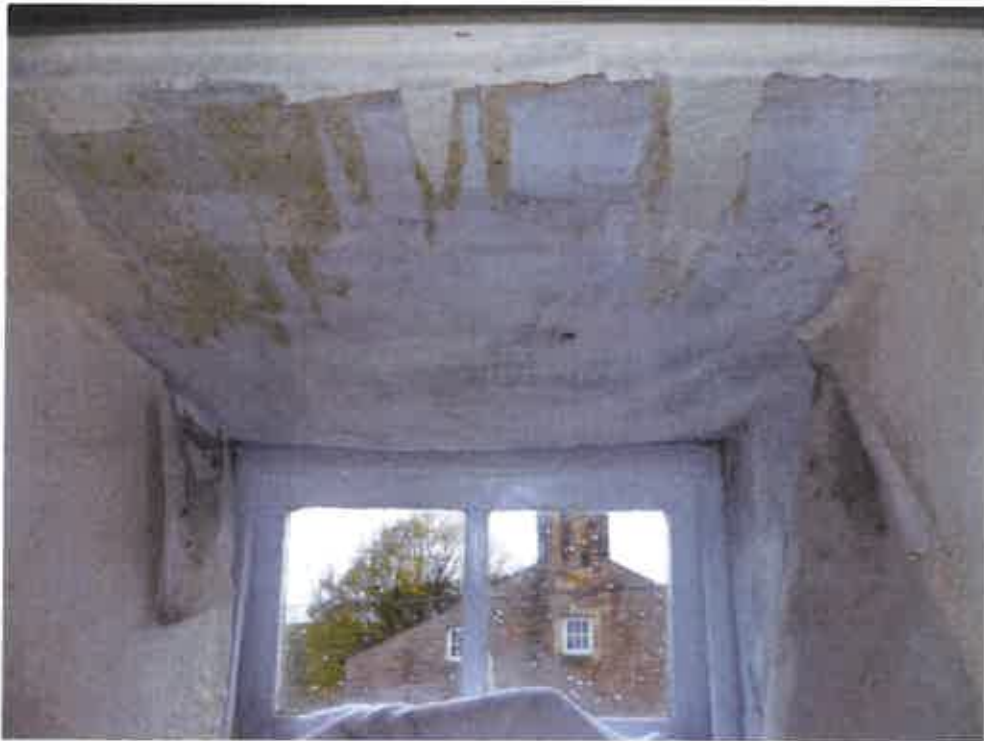
- 2.01 The notation used in this report assumes facing the property from the front (Town End).
- 2.02 An area of the inner boarding to both the left hand wall of the left hand first floor bedroom and the landing were removed.
- 2.03 This exposed the inner stonework face of the left hand gable in both areas, with the following findings:-
- 2.04 Above the landing window the boarding is saturated, and we were informed that water comes through this at times of heavy rainfall.

Gable window – water penetration
