## **Martin Prescott Environmental Services**

### **Initial Bat Survey of Primrose Dairy, Clitheroe**

**Surveyor- Martin Prescott, Lic. no. 2015/15466-CLS**

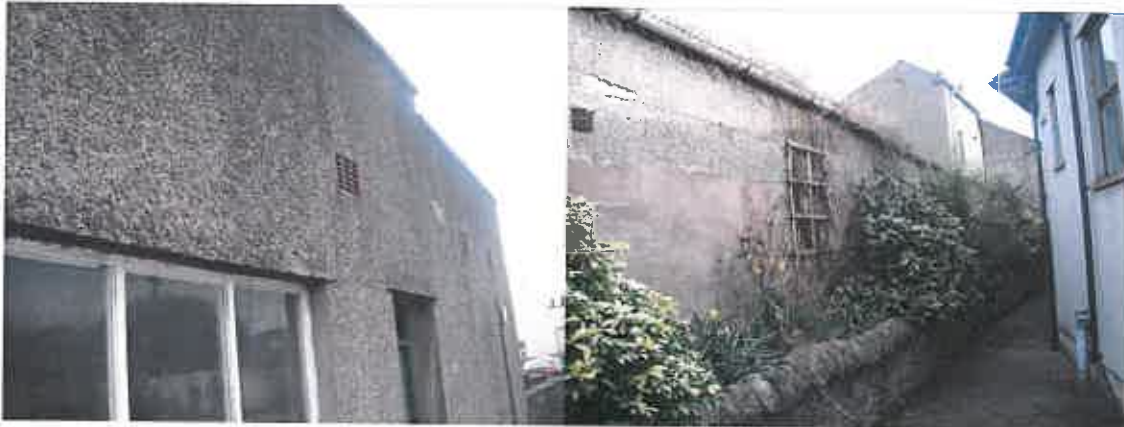
At the front there were vents and a gap in a steel lintel with low potential for bat access, but unlikely to be used due to the high level of lighting.

There were small areas of scrub to the rear of the building with low nesting bird potential.

P1 Front aspect, gaps in vent, but brightly lit P2 Rear aspect, possible nesting birds in scrub

- 5.1** It is recommended that the building can be demolished with minimal risk to roosting bats.
- 5.2** It should be remembered that bats are occasionally found in the most unexpected places. If any bats are found during the work, the consultant (0161 796 6211, 07946 488467) or the local bat group should be notified and work stopped immediately.
- 5.3** Although nesting birds are considered unlikely, if any active nests are found, they must be left undisturbed until the young have fledged. If in any doubt refer to the consultant.

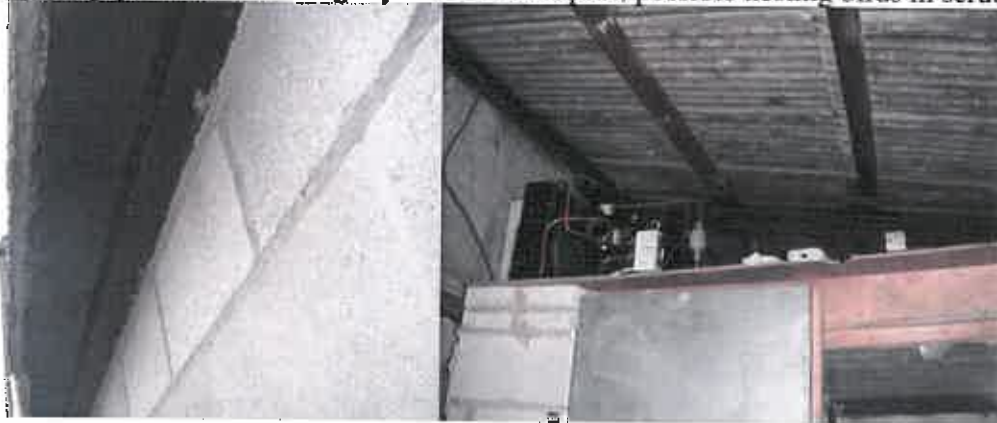
The building was of rendered brick with a sloping unlined corrugated sheeting.

P3 Gap under lintel, but not suitable for bats P4 Inside showing unlined corrugated roof
