RE: COUNTESS HEY BARN, LOUD BRIDGE ROAD, CHIPPING

Further to your instructions, we attended the above property on Monday 18 April, to assess the structural condition and form with regard to a proposed planning application.

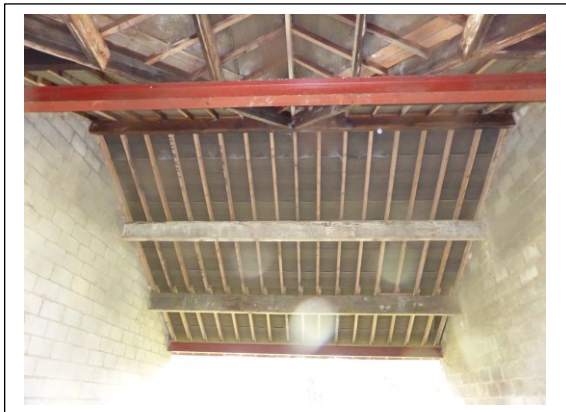
Fig 3. Central Core Roof Structure

- 1.5 The walls are all in line and level.
- 1.6 The roof structure appears in good condition with all areas appearing dry, the central core does include some reclaimed timber members and it would be prudent as part of any development to check the sizes although from our visual survey they appear to be adequate.
