**STRUCTURAL CONDITION SURVEY
FOR THE**

**PROPOSED CONVERSION OF BARN
TO FORM 3 NO DWELLINGS
AT GREENGATES FARM
GISBURN
CLITHEROE**

FOR MR & MRS A ROBINSON

Date: 9th March 2017
Our job ref : 4402
Author: LYNNE RUSHWORTH

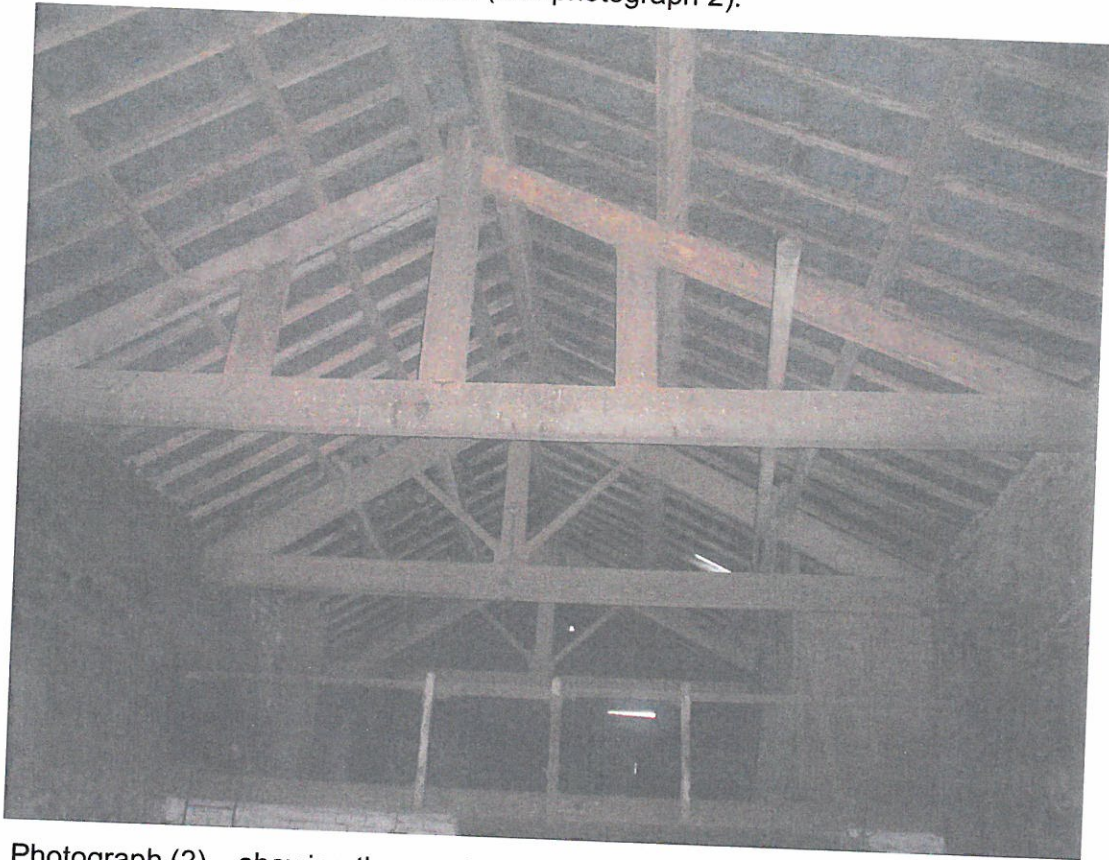
The roof to the barn has been kept in a reasonable state of repair, as a result the roof timbers are also in good condition (see photograph 2).

Photograph (2) – showing the good condition of the trusses purlins and rafters in the main barn.

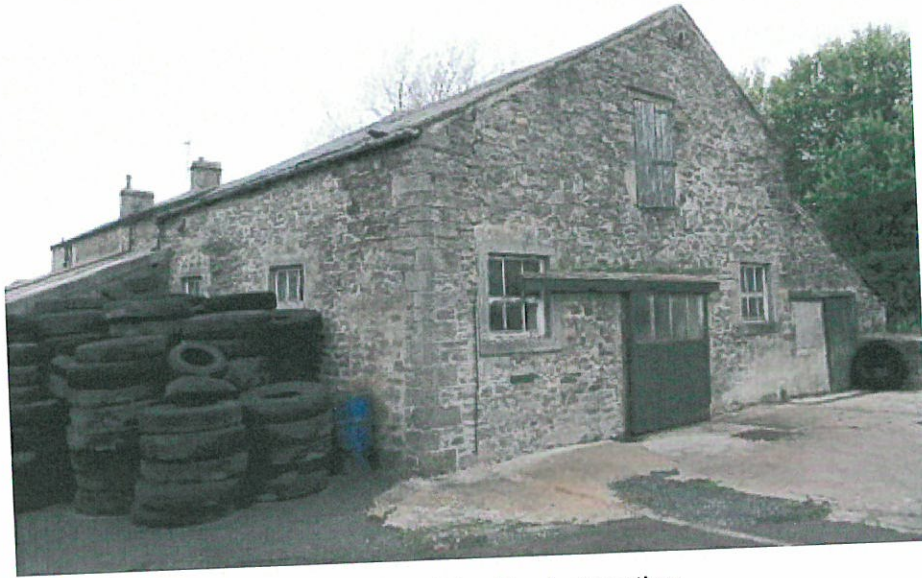
Photograph (3) – East elevation

The 2no window openings to the east elevation have been formed with dressed stone surrounds. The forking hole has a stone head and the sliding door openings which are more recent additions have concrete lintels over. All the stone surrounds are in good condition and will be retained. The concrete lintels will be replaced with stone to match existing. There is also a triangular vent opening at the apex of the gable formed in stone.

There are a few sections of the wall which require re-pointing, but the walls are generally in extremely good condition.

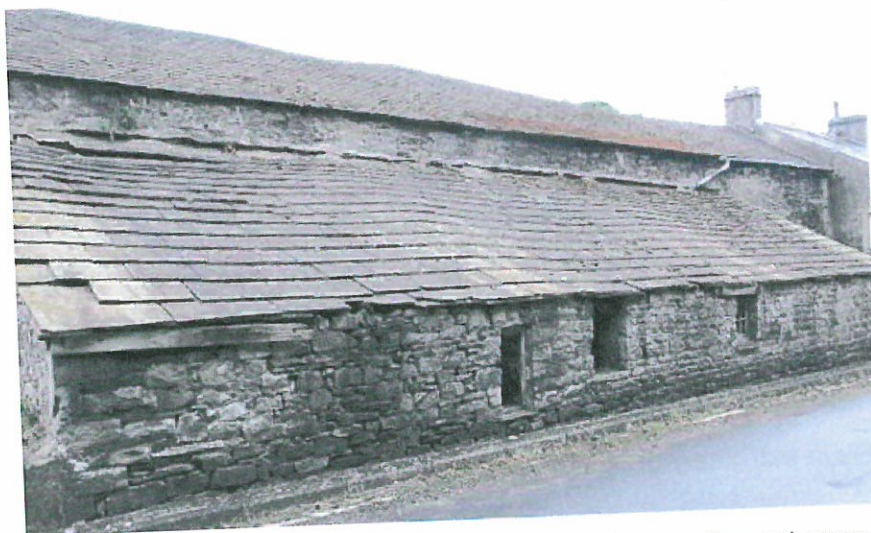
The wall to the north elevation has a lean -to covering approx 4/5 th's of the North elevation. The Lean-to has 3no window openings in the wall adjacent to the road. They have slim stone heads and sills with no frames to 2 of them. The North east corner of the lean -to wall has deteriorated the stonework needs to be rebuilt . The return wall has a window opening with a slim stone head, it has been a door opening which has been built up with no sill. There is a further small window opening with a stone head. both the wall and the pointing are in good condition. There are a few sections of the wall which require re-pointing and north west corner rebuilding, but the walls are generally in extremely good condition.

Photograph (4) – North elevation Stones missing north east corner

This structural condition survey of the barn shows that the building is in good condition, the north east corner on the lean-to (area approx 1.5 m) requires some rebuilding repair but the barn can be converted without major intervention these repairs are minor in comparison to what would normally be expected when converting buildings of this age.

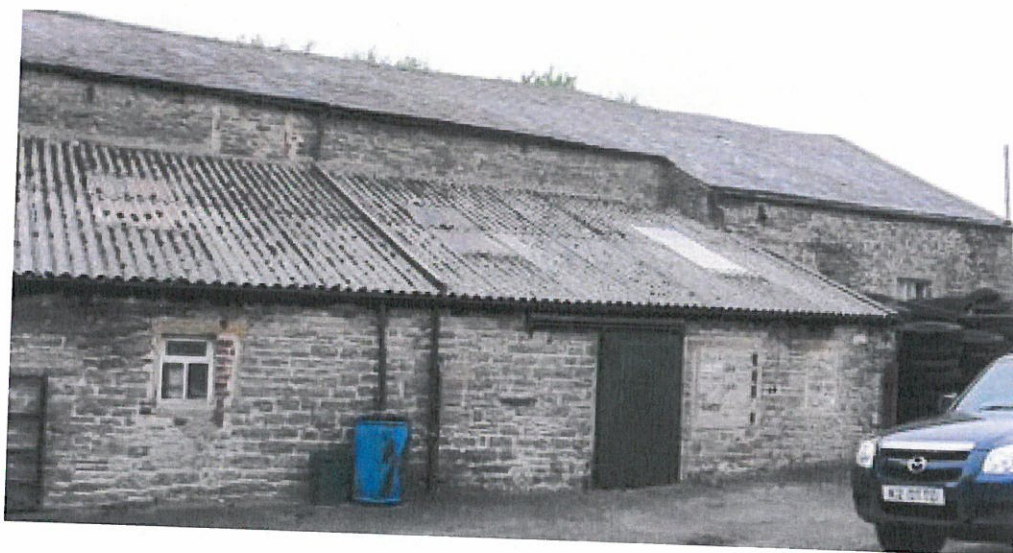
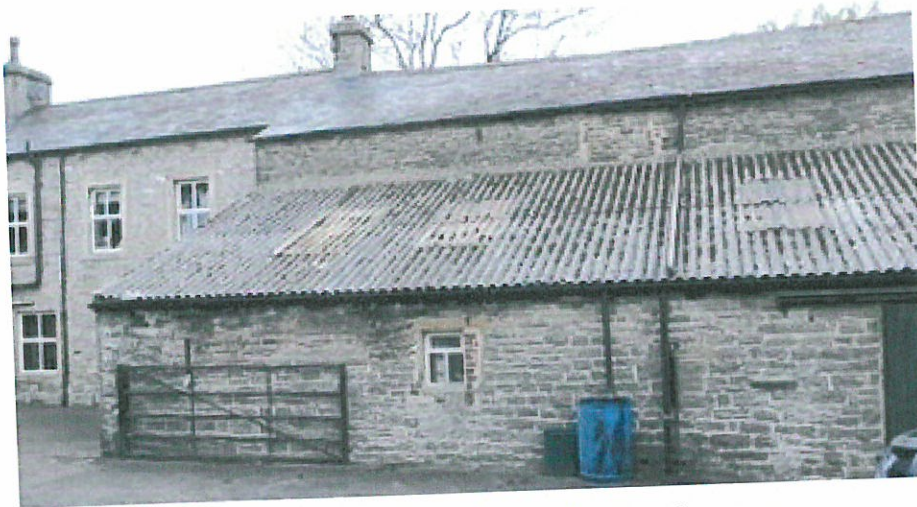
Photograph (6 & 7) – South elevation

The door and window openings to the south elevation and returns have dressed stone surrounds, the lean-to having 2no openings which have been built up the 1no remaining window opening has a brickwork jamb and a sand stone head and sill. The pointing on this elevation is in very good condition as is the stone work.

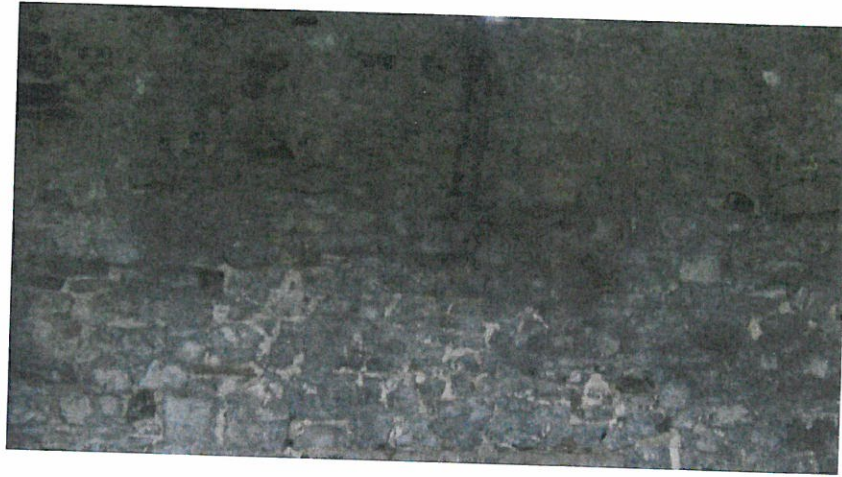
Photography (10) – Internal wall

The internal walls of the barn are in good condition, this can be seen in the photograph below.
