Barn No. 2 at Wheatley Farm, Four Acre Lane, Thornley with Wheatley , PR3 2TD

Structural Condition Survey for Conversion to Dwelling

PSC-001

November 2016

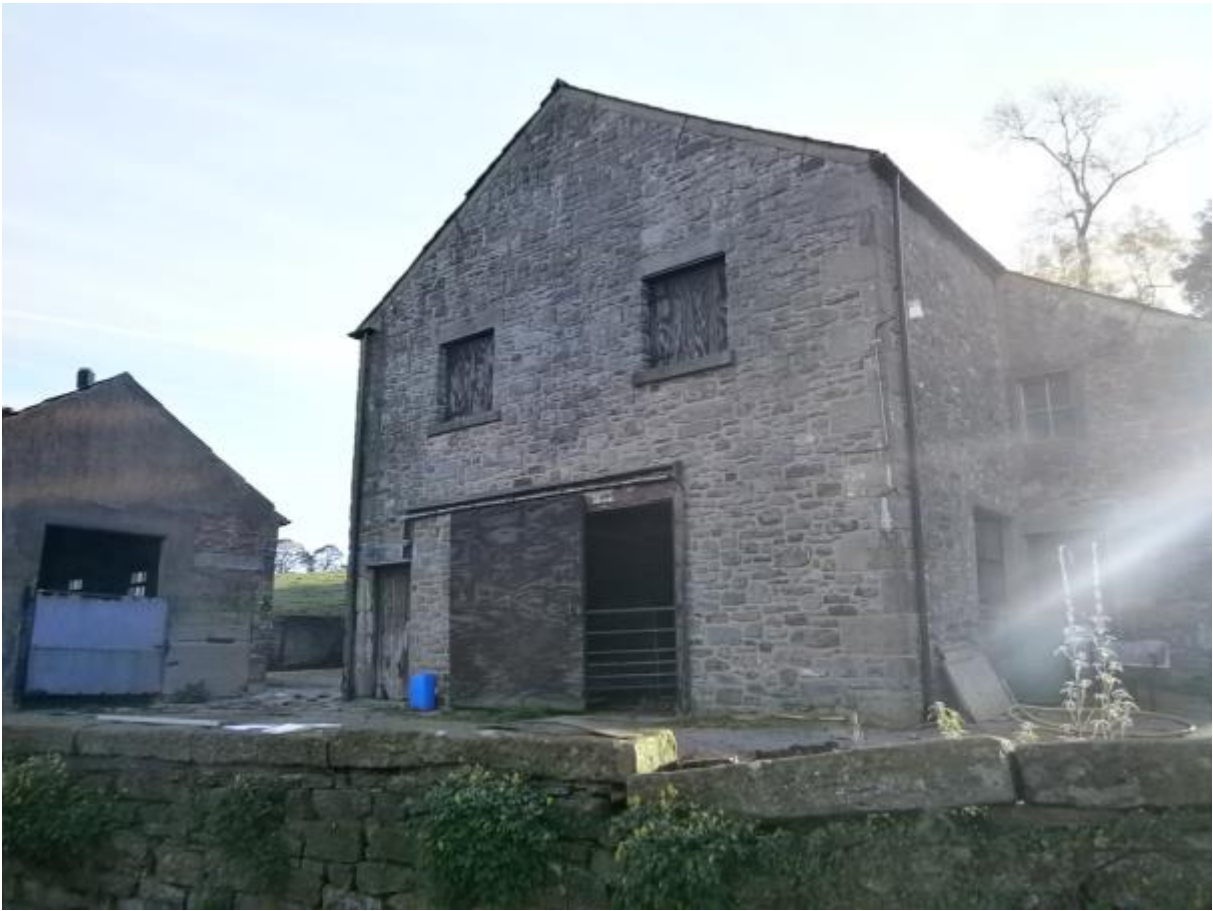
There is a concrete yard to the front of this elevation and an existing surface water system with a downspout on this elevation (photo 1).

Photo 1 - North West Elevation

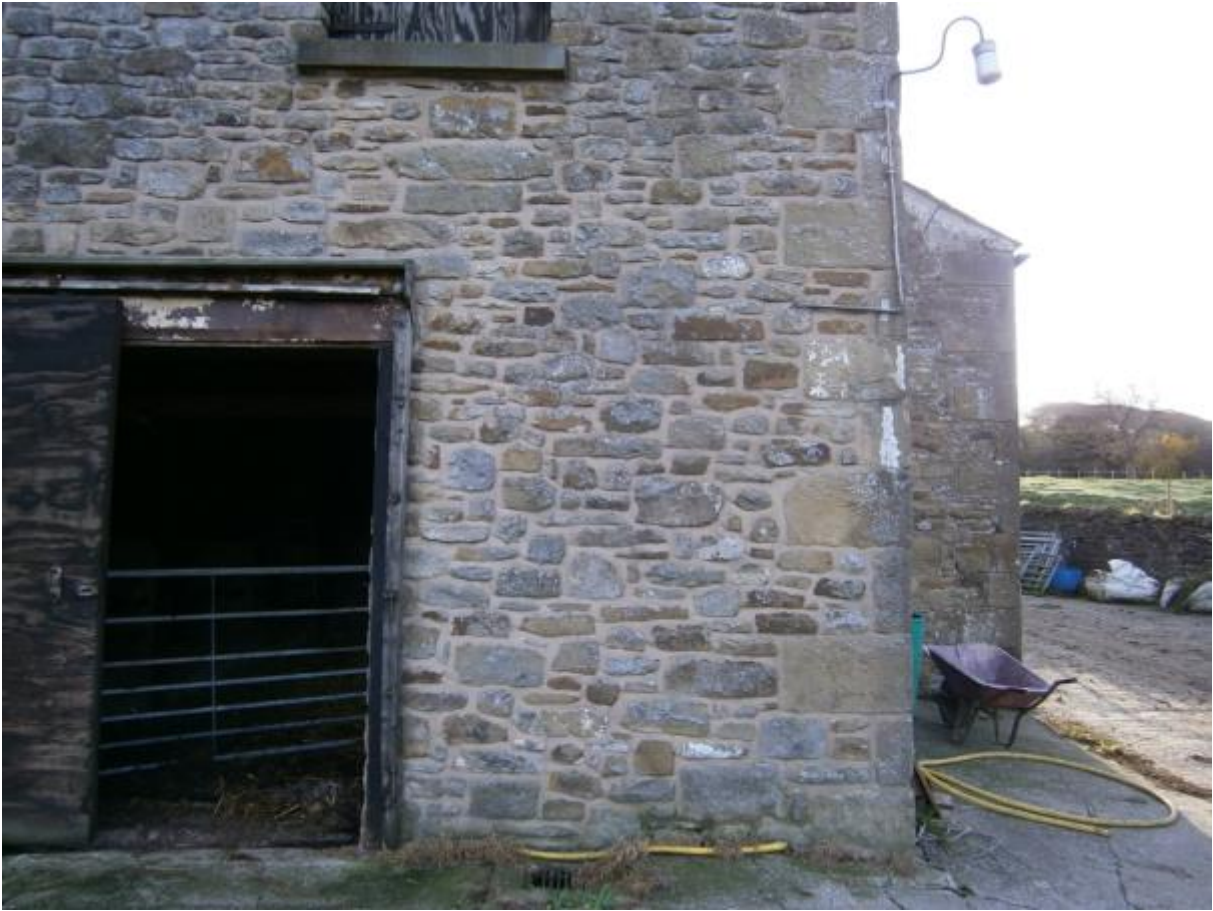
Photo 2 – North West Elevation

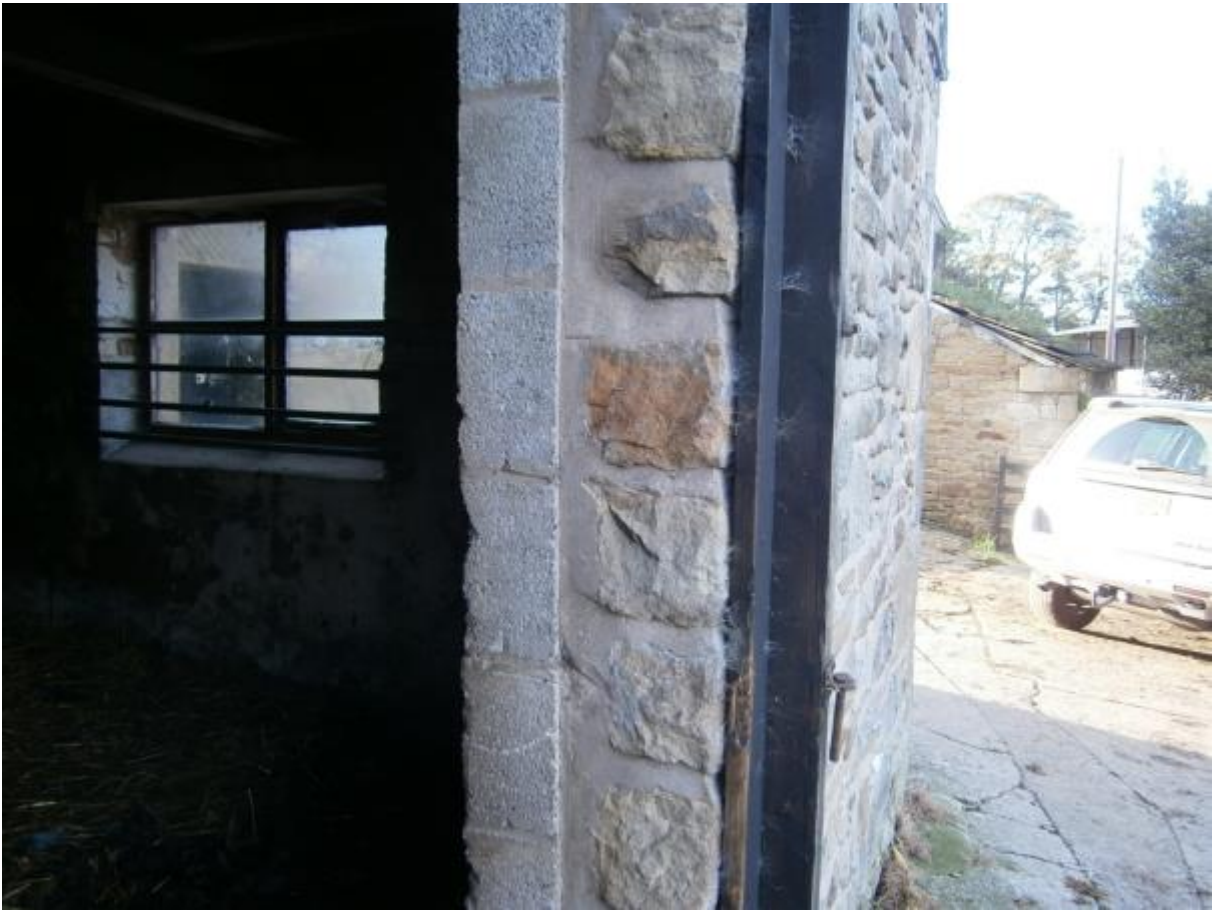
The owner advised that this gable wall has been re-built in the past, following previous movement. The wall is now constructed of 200mm random stone outer face, backed by a 140mm concrete block (photo 3). The wall is plumb, in good condition, free from any sign of movement and well pointed. There are 4 existing openings and it is proposed to keep these and introduce a further opening at second floor level. The large opening at ground floor level has a steel beam and the other openings have stone or concrete lintels.

Photo 3- North West Elevation – Re-built wall detail

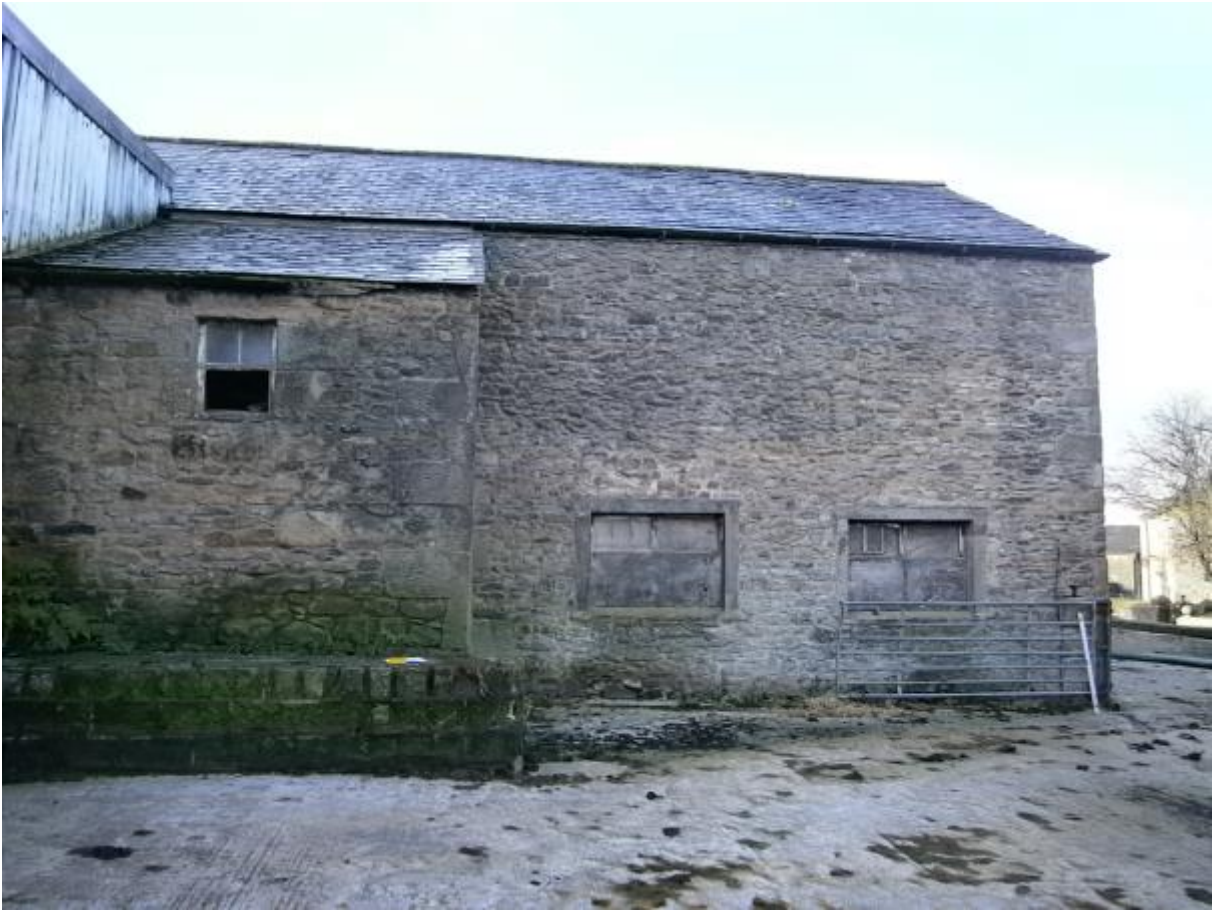
Photo 4 – North East Elevation

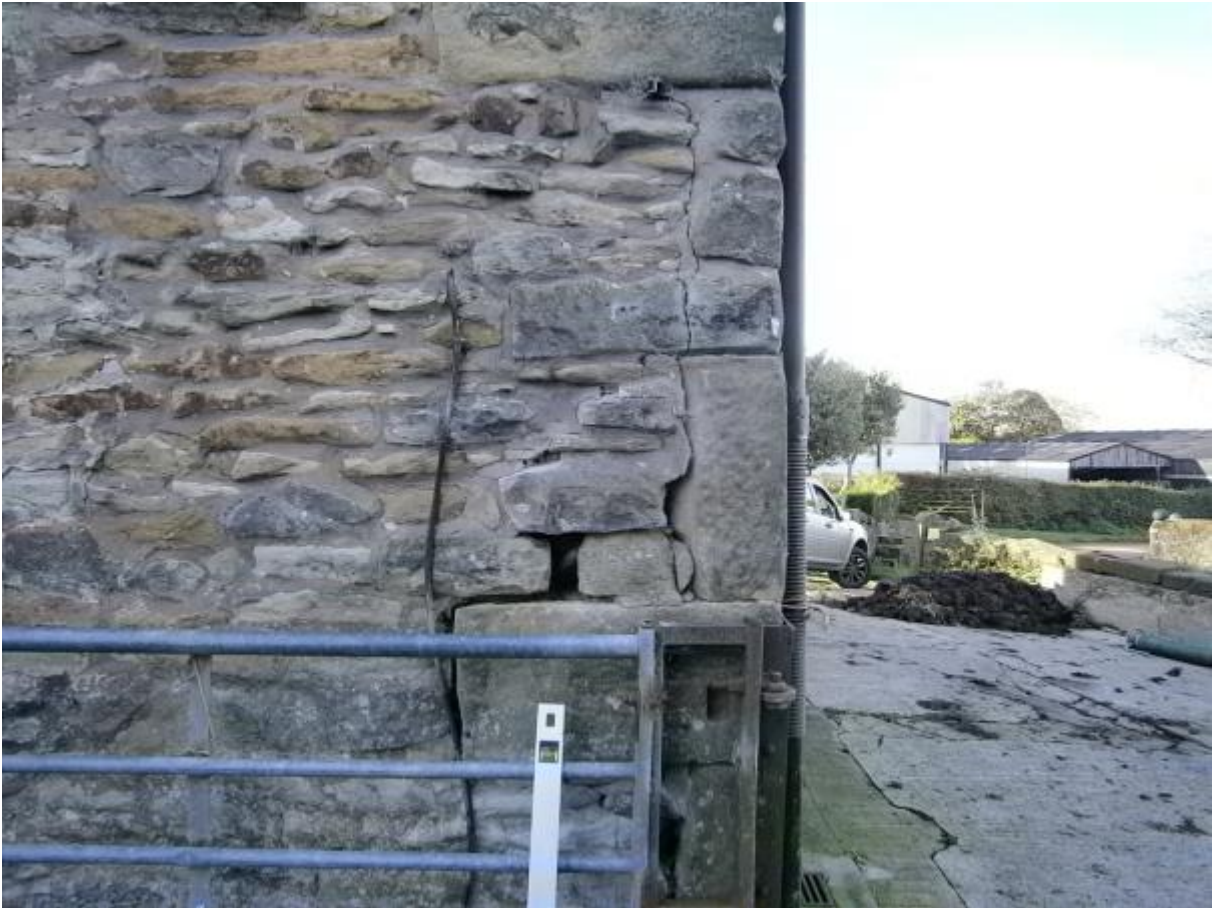
This elevation is a 450 mm random stone wall. The wall is plumb, well pointed and free from signs of movement. There has been some damage at the corner with the north west gable (photo 5). This will need repair or re-building over a maximum of 1m². The outrigger shown in photos 6 to 8 is in good condition but it should be noted that the lower section of the wall is protected at the base by a block/concrete retaining wall. This may have been placed to retain the founding stones when the adjacent yard was excavated and concreted to the current level. The upper section of this elevation is hidden by an existing steel lean-to building (to be removed) but is shown on photo 23. This section is again in reasonable condition with no sign of movement.

Photo 5 – North East Elevation – Damage at corner with gable

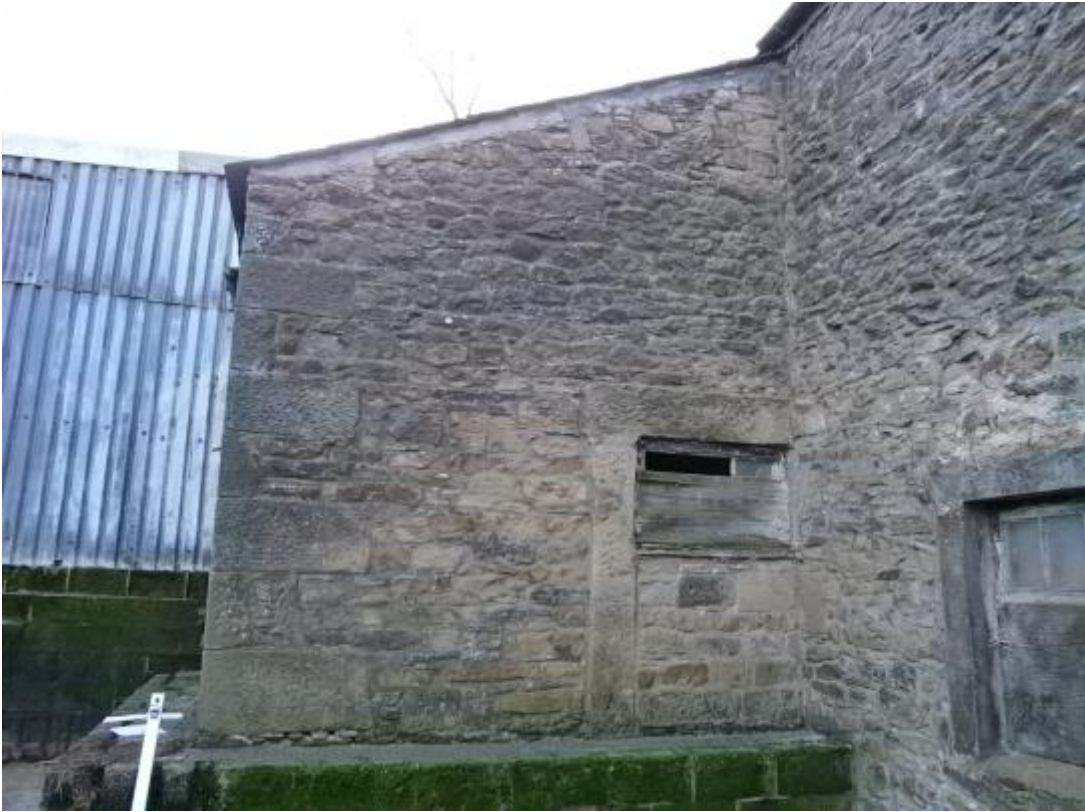
Photo 6 – Outrigger to North East Elevation

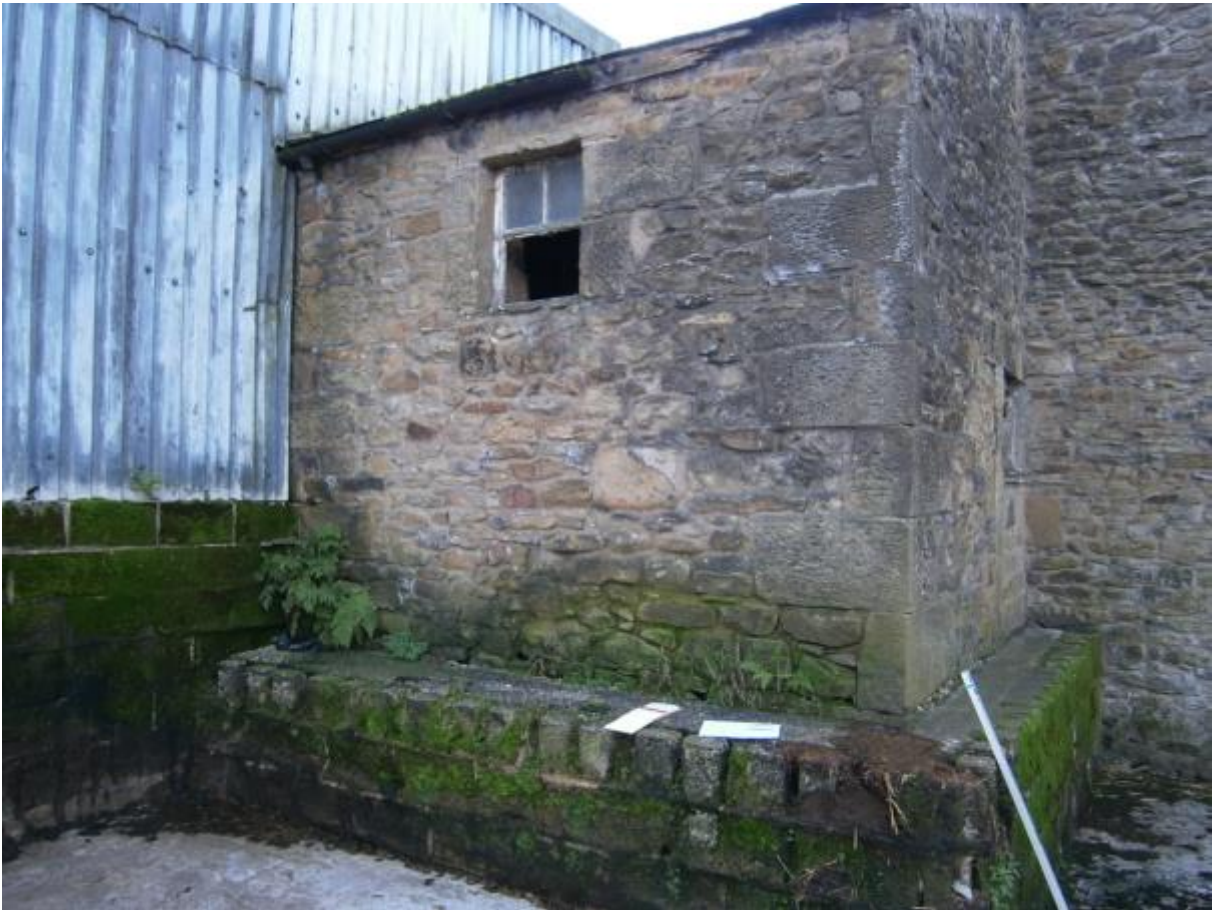
Photo 7 – Outrigger to North East Elevation

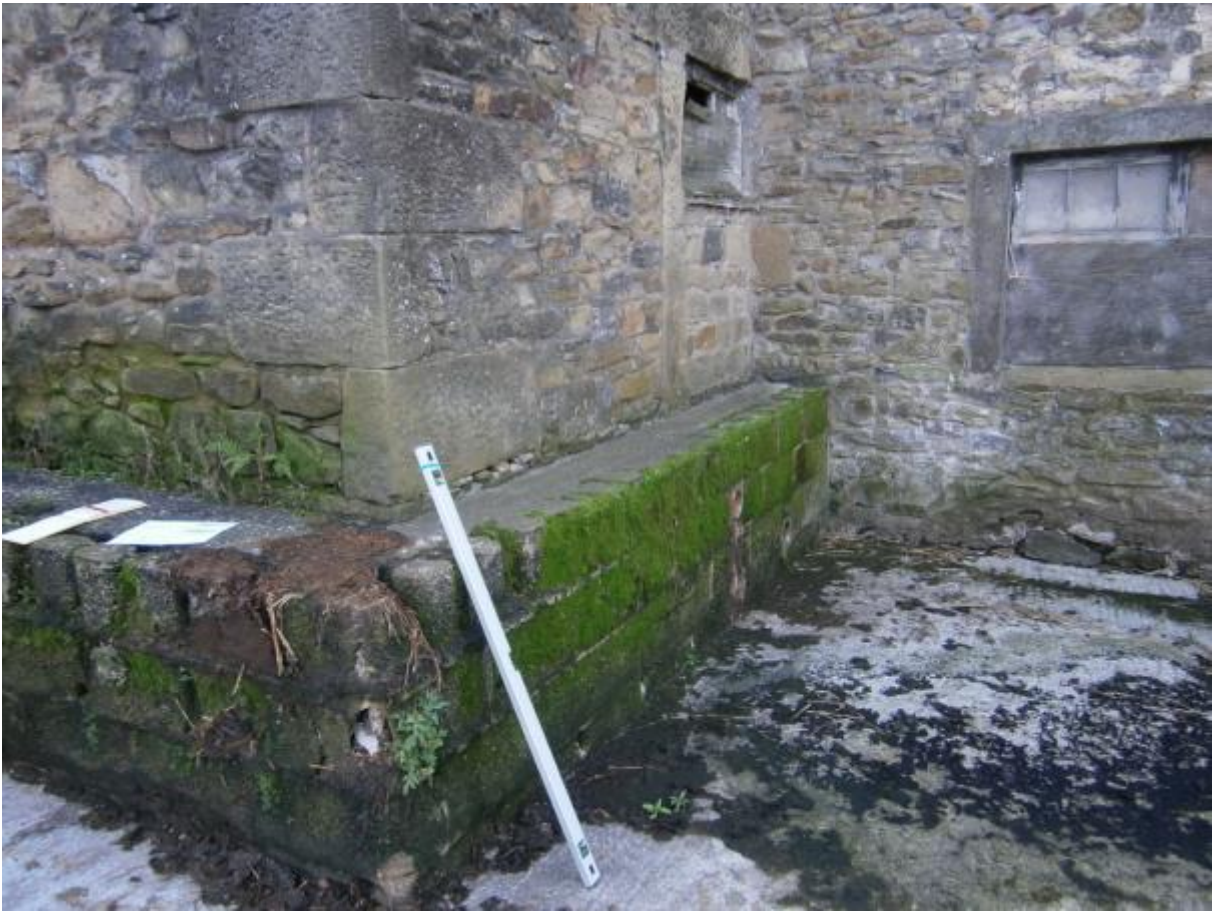
Photo 8 – Outrigger to North East Elevation – block/concrete cladding

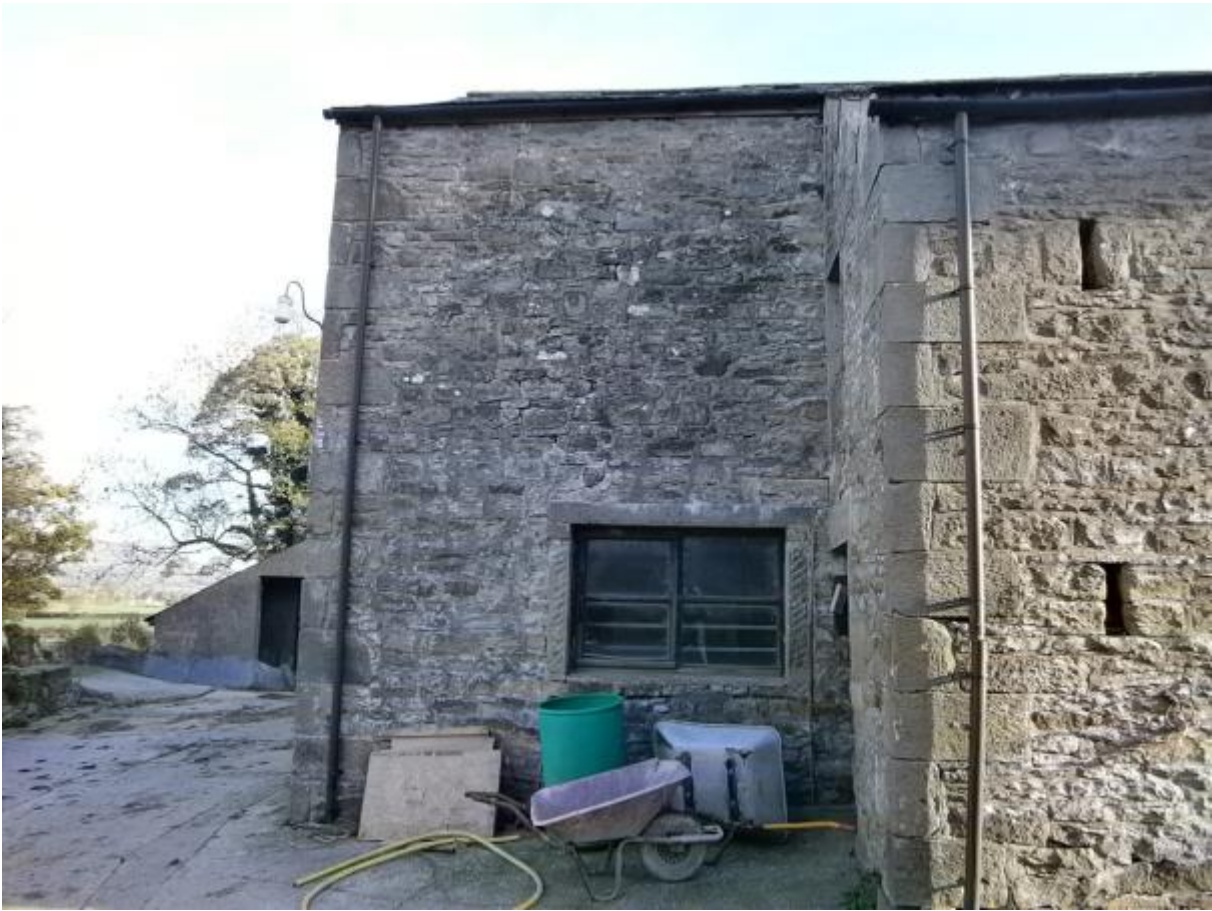
Photo 9 – South West Elevation – lower section

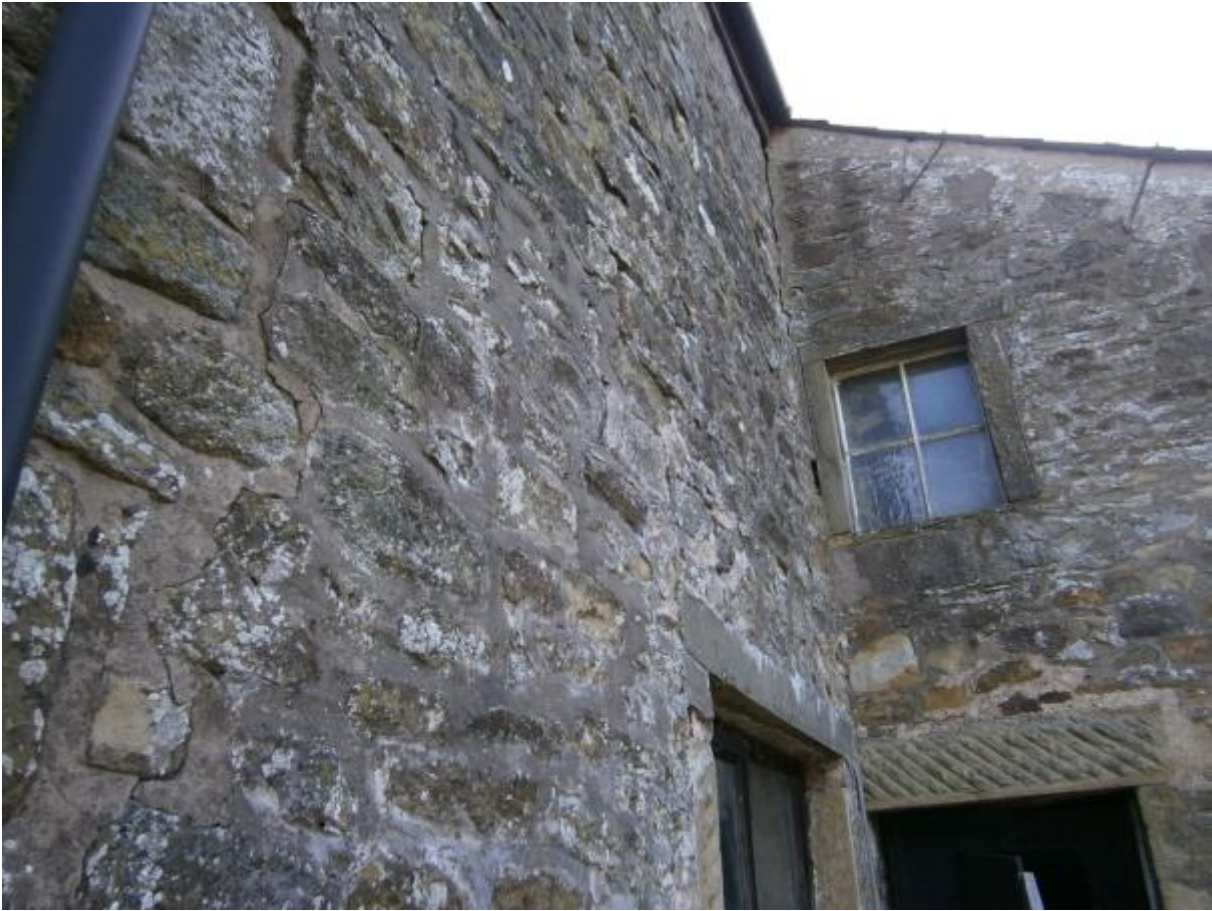
The lower section of the elevation (photo 9) is generally in good condition but has an area above the window opening where the outer skin of stone has suffered from movement leaving a slight bulge (photo 10). The re-constructed gable has also settled slightly as indicated by the pointing adjacent to the downspout (photo 11). This wall will benefit from the strength provided by a new internal leaf of block but up to 2m² of the outer face may need to be re-built to remove the bulge noted. Re-pointing this elevation will remove the cosmetic crack from slight settlement of the re-built gable.

Photo 10 – South West Elevation – lower section – bow over window

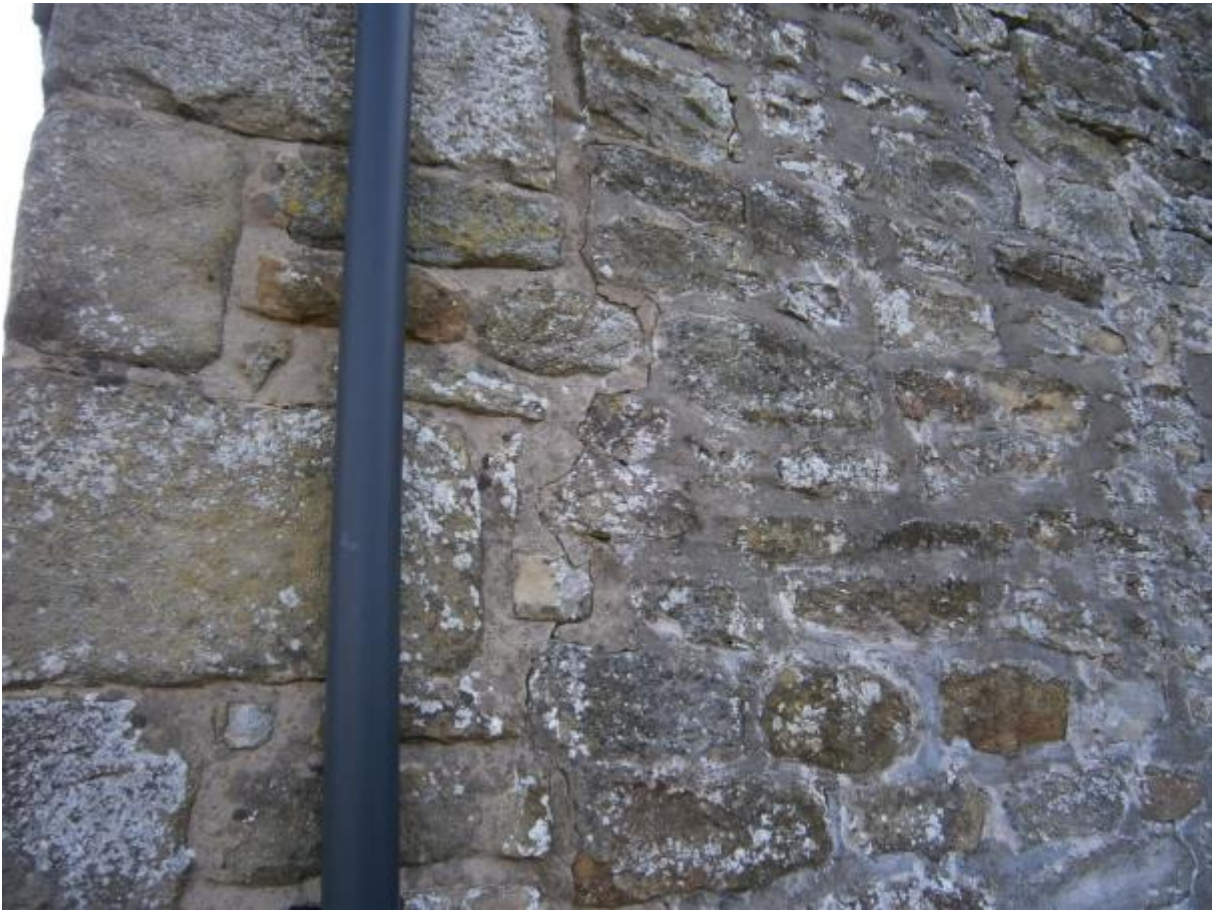
Photo 11 – South West Elevation – joint to re-built gable

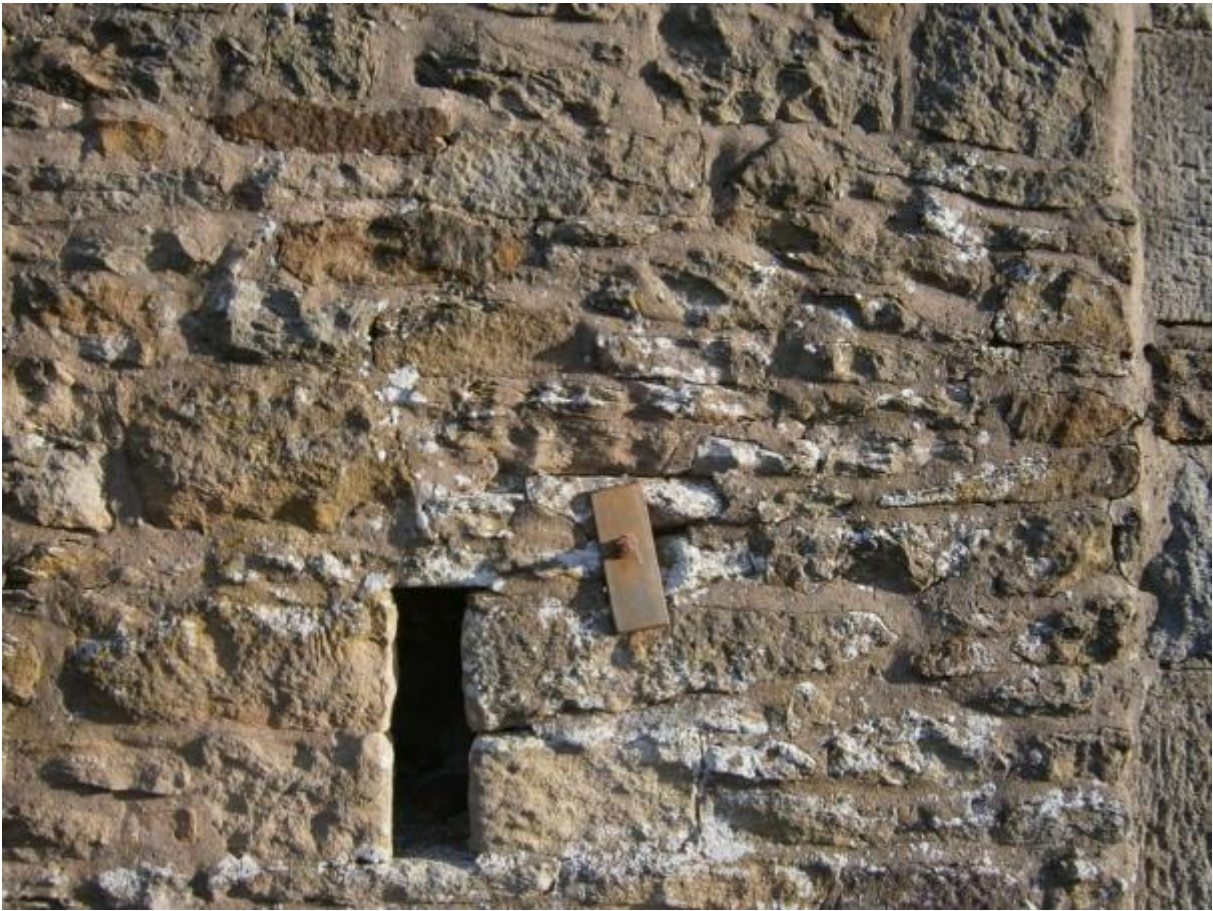
The mid-section of the elevation is occupied by the outrigger housing the barn entrance and a store area. All the walls to this section are 450mm random stone and are in good condition, free from movement and reasonably well pointed. Photo 15 shows a through tie although the wall is in good condition and this may have been put in place for a different purpose. The internal wall inside the store where a new opening will be introduced is in good condition.

Photo 15 - South West Elevation – mid section – through tie

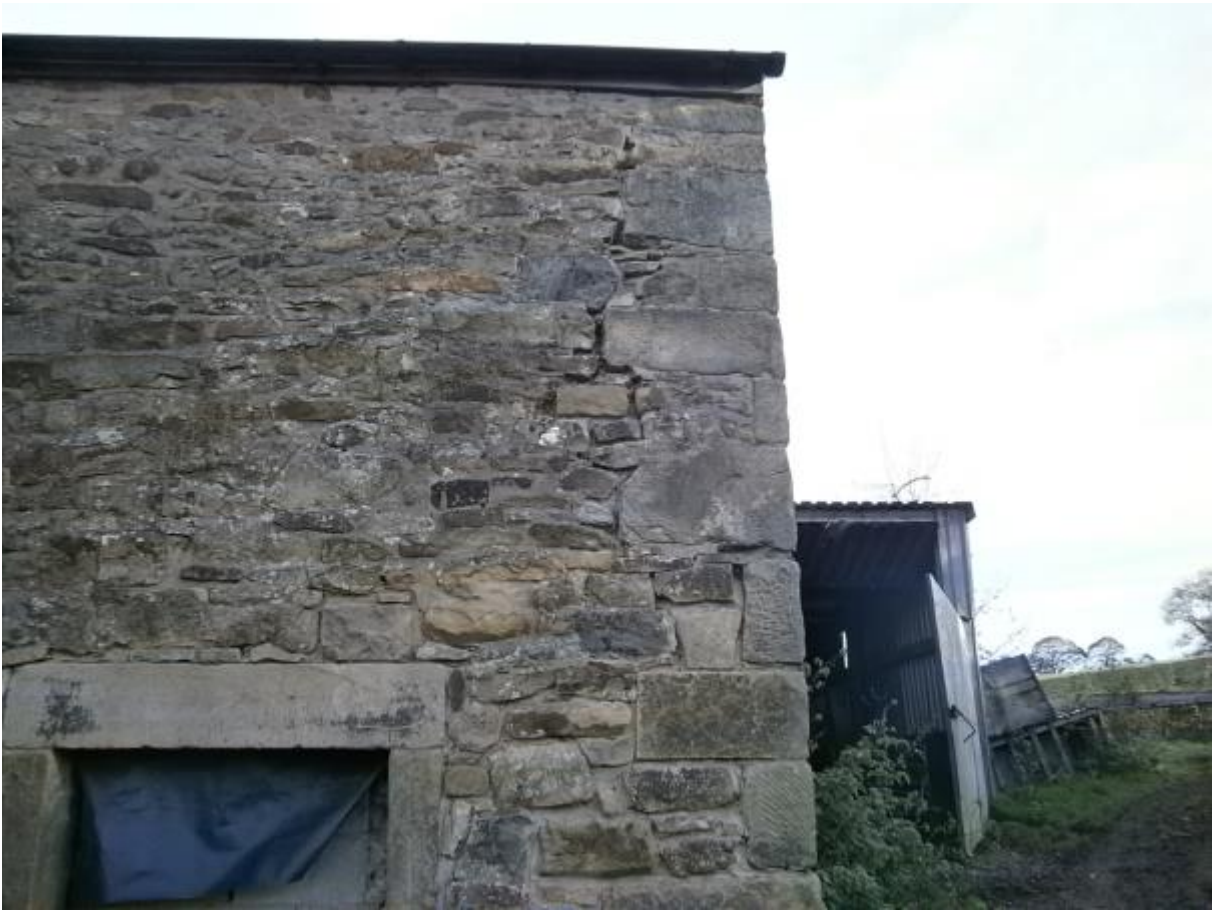
Photo 17 - South West Elevation – upper section

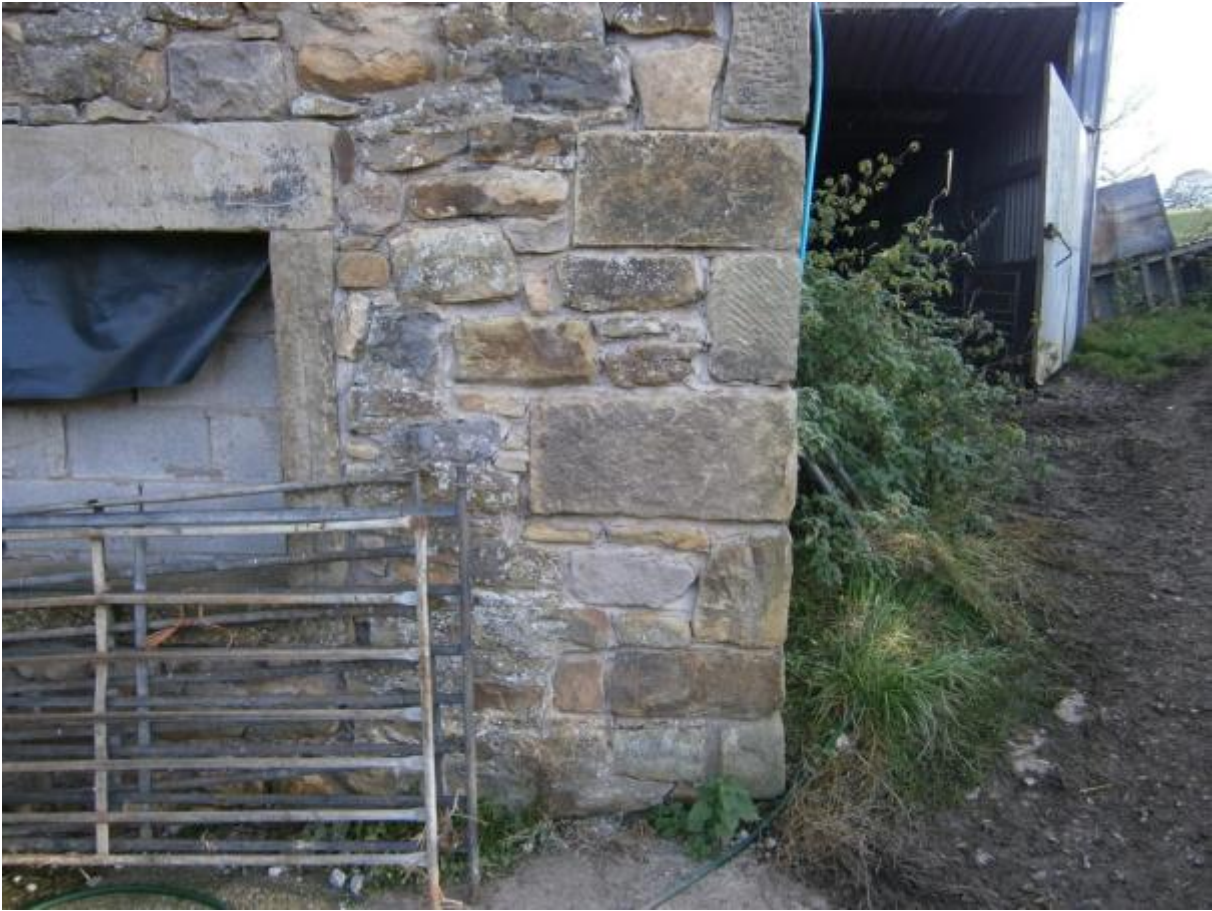
The upper section of this elevation (photos 16 to 18) is generally in good condition but there is evidence of damage/movement to the corner with the gable (photos 17 & 18). This may have been caused by vehicle impact and the lower section has been repaired but is not quite plumb. Some re-building of this corner may be necessary, up to 2m².

Photo 18 - South West Elevation – upper section – re-built corner

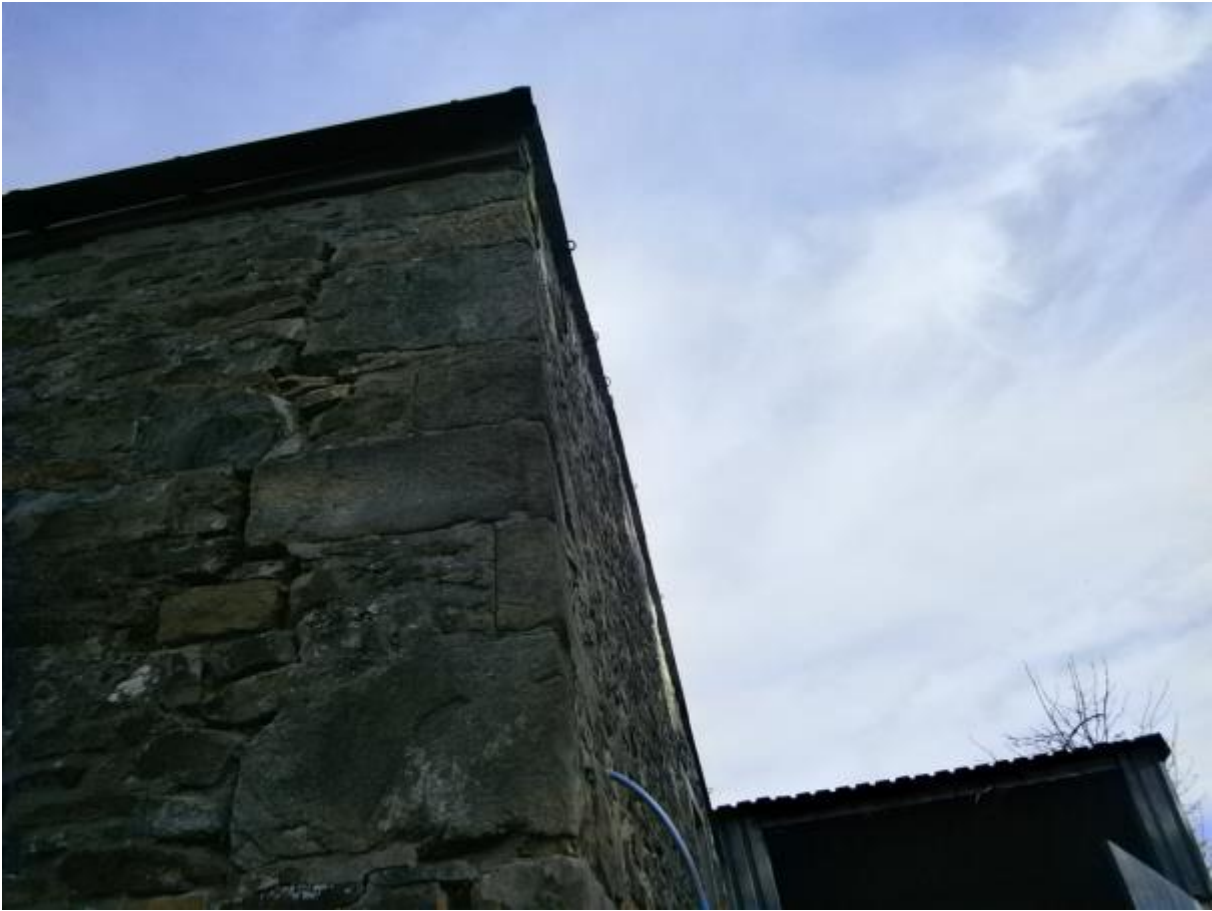
The gable is in reasonable condition and is plumb. However, externally the wall appears to bow inwards at the centre. There are no visible signs of ongoing movement or cracking and internal inspection revealed a reasonably plumb, straight wall. There would therefore be little to be gained from any re-building.

Photo 22 - South East Elevation- indicating bow inwards

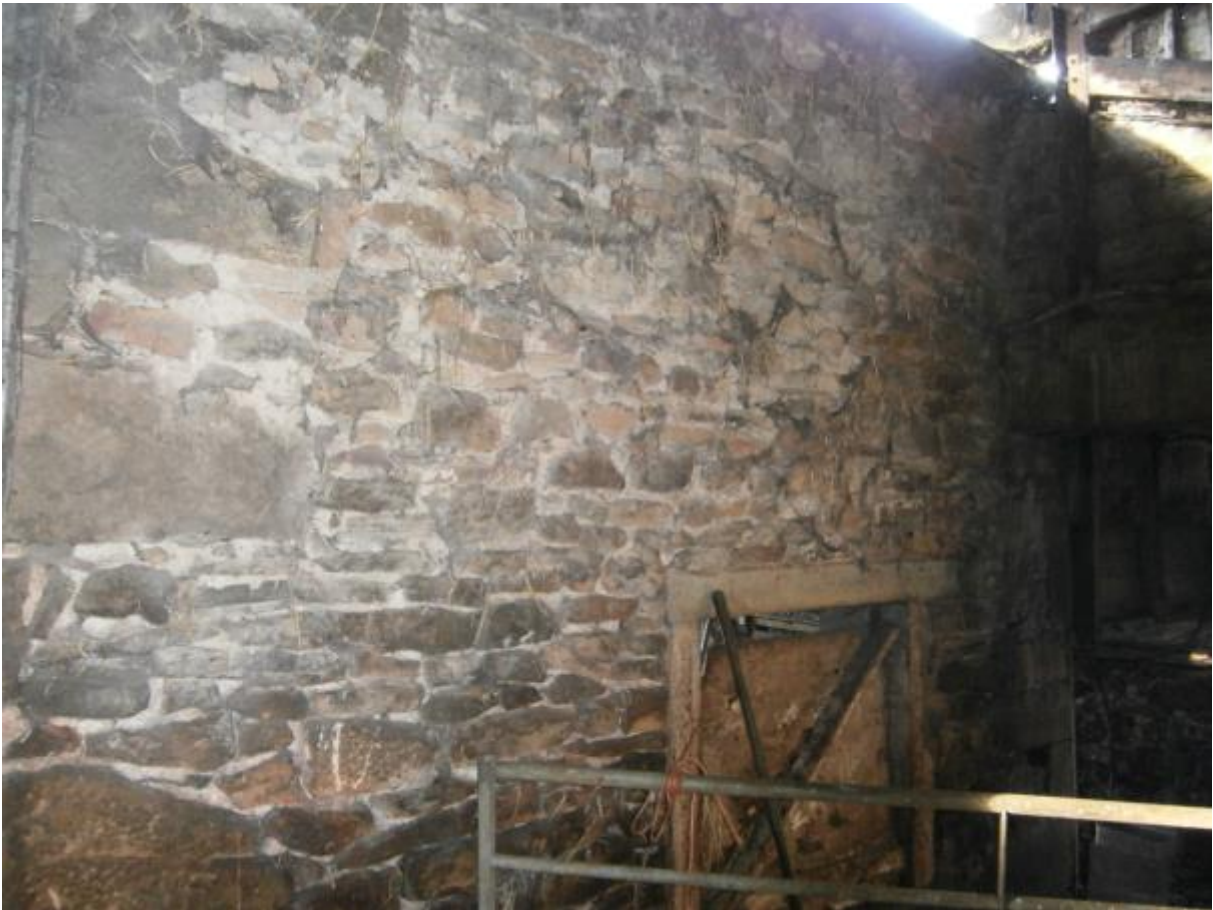
Photo 23 – North East Elevation – upper section (inside lean-to)

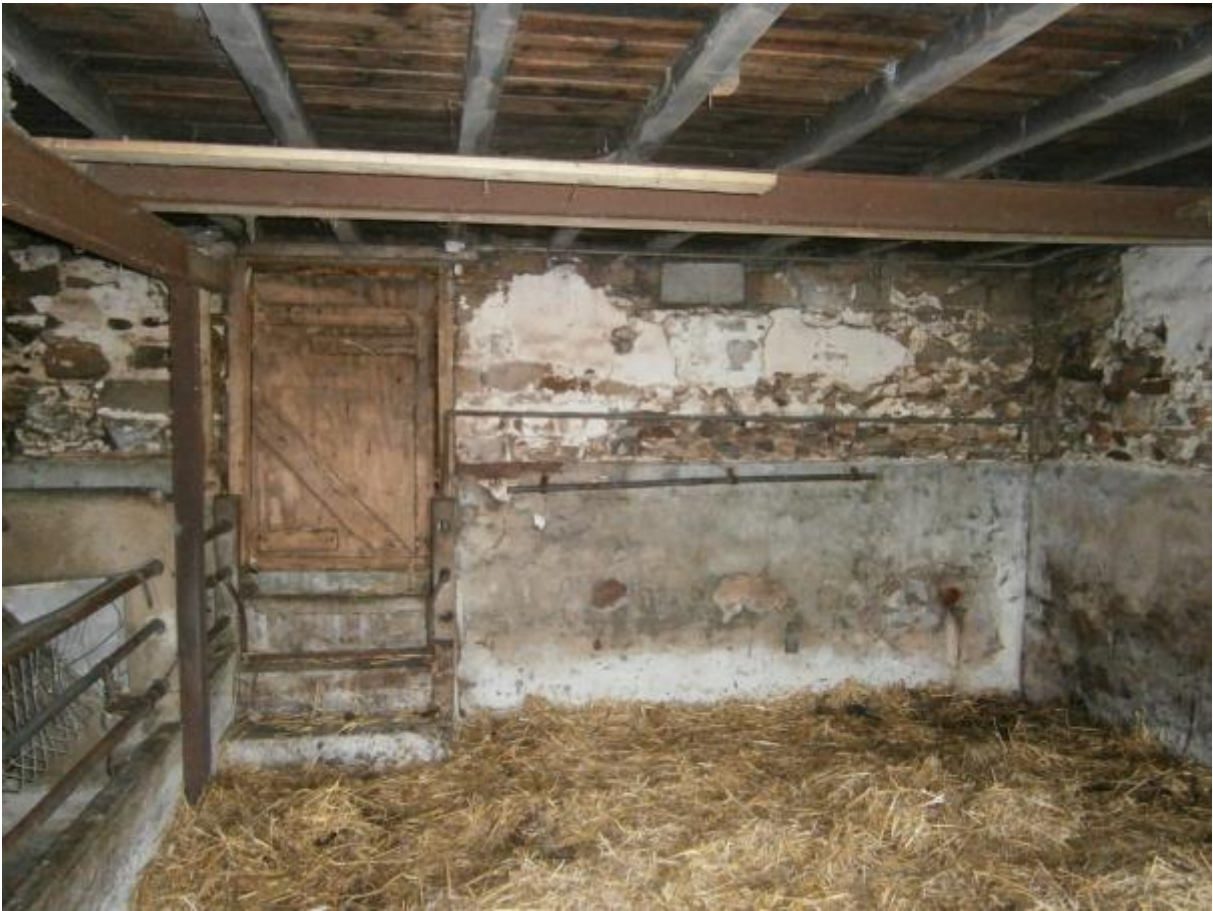
There is a level difference between this lower section and the main barn which is indicated by the steps on Photo 26. This level difference is to be retained and the reconstruction and raising of the existing wall will need to consider this in terms of a retaining structure.

Photo 26 – Internal wall – lower to upper divide

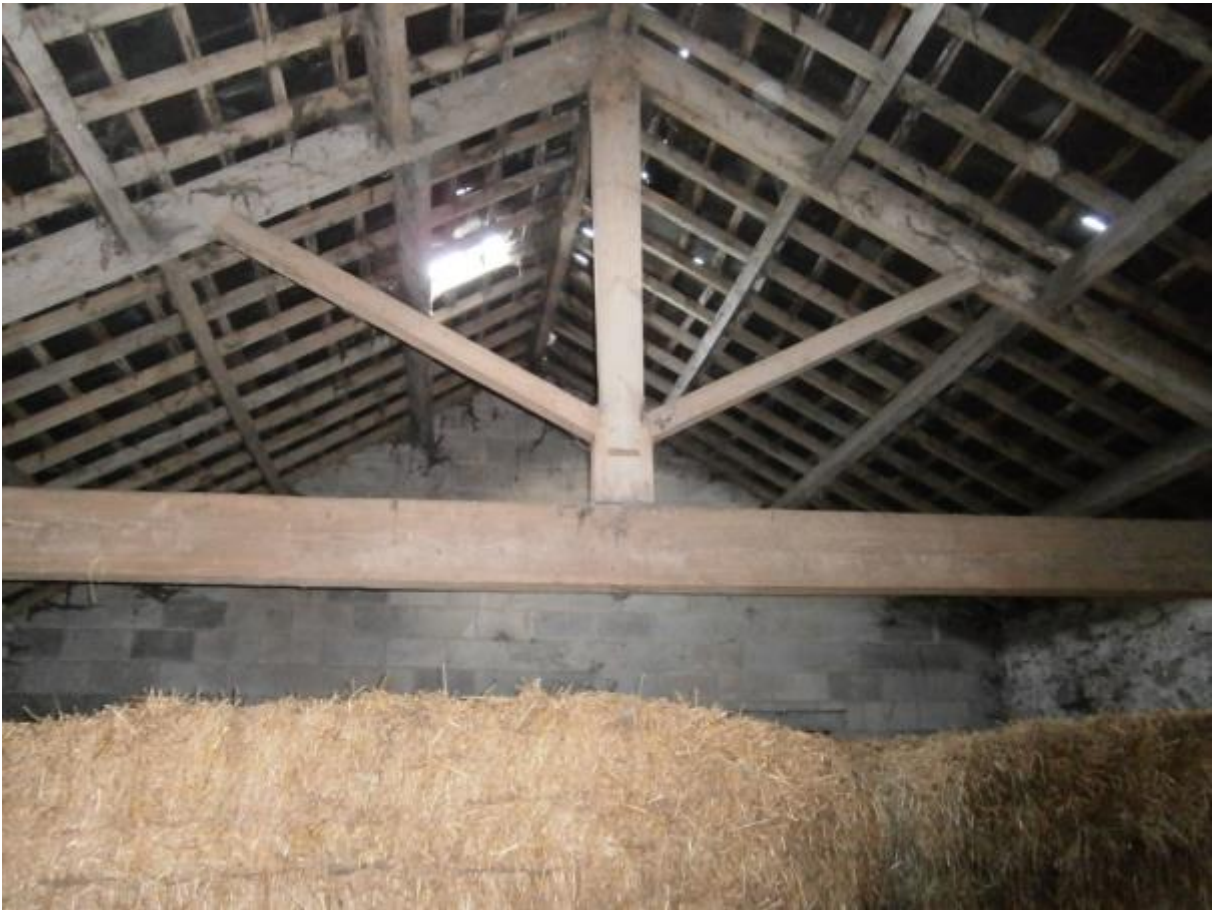
The timbers to the roof can be seen on photos 27 & 30 and show little or no sign of rot or infestation. The roof is to be reconstructed but some of the timbers may be re-used either structurally or cosmetically subject to design checks and appropriate treatment.

Photo 27 – Roof structure and North West Gable

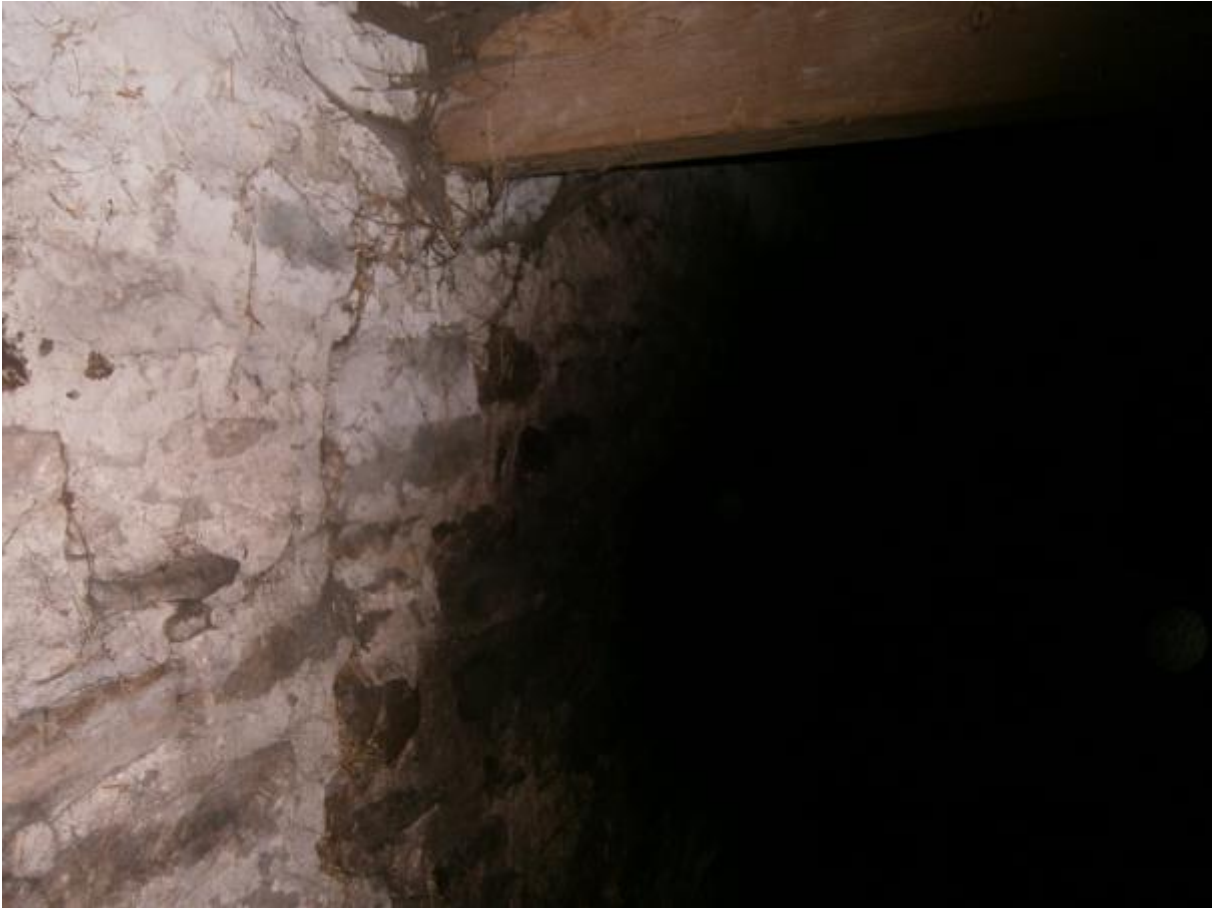
Photo 29 – Truss sat on walls – no cracking or movement

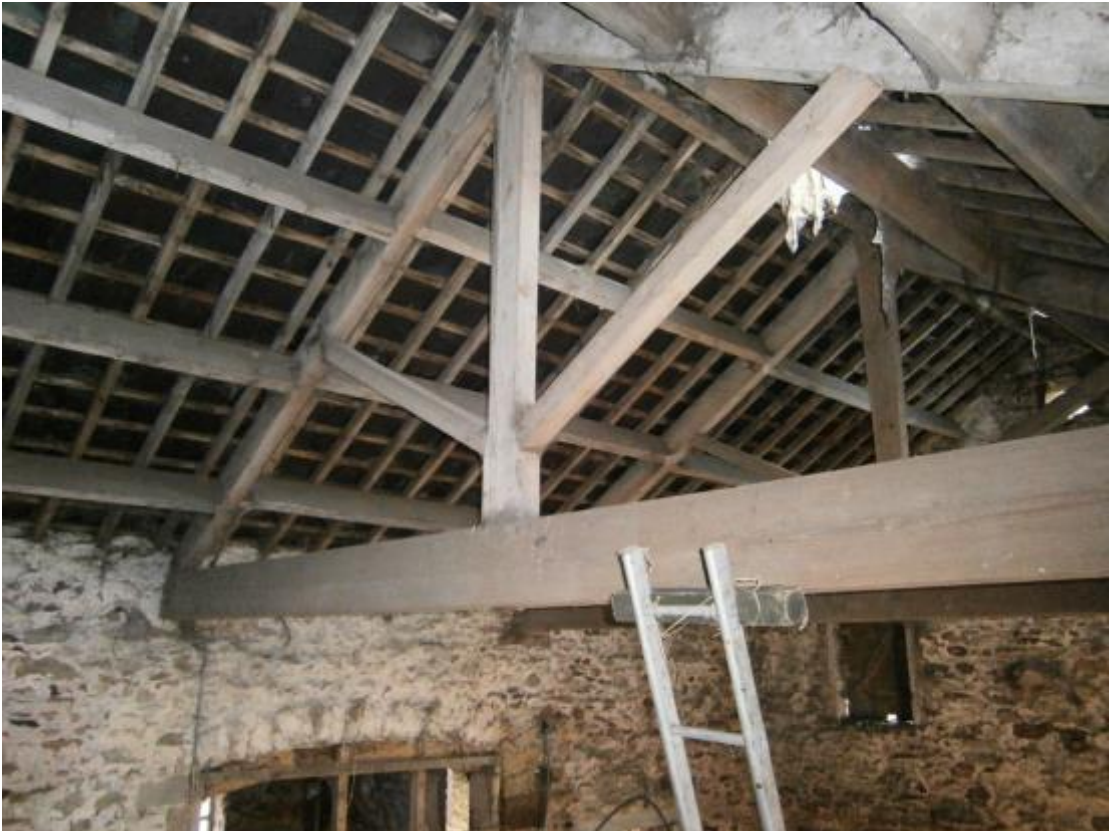
Photo 30 – Truss and purlins – North East and south east walls
