Barn No. 2 at Wheatley Farm, Four Acre Lane, Thornley with Wheatley , PR3 2TD

Structural Condition Survey for Conversion to Dwelling

PSC-001

November 2016

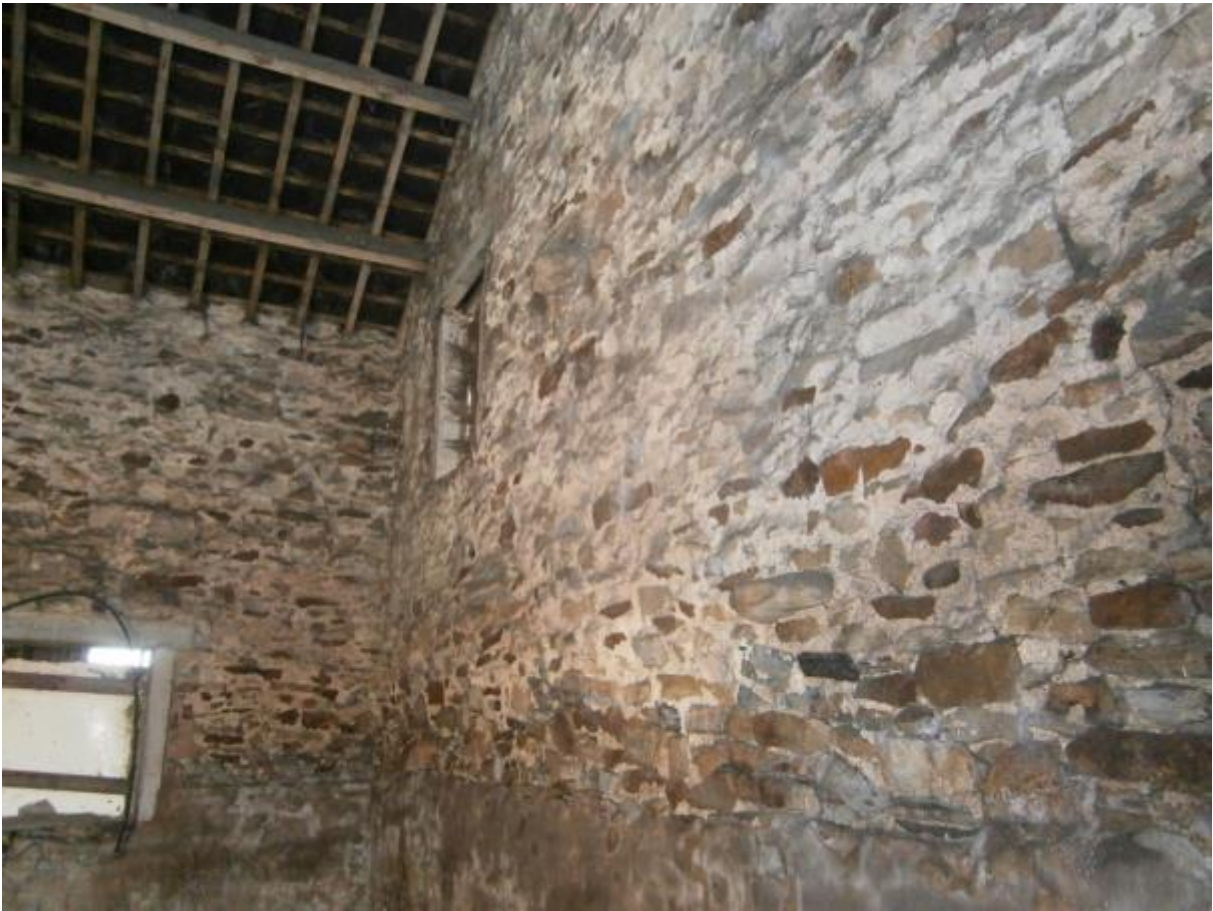
The upper end of the barn is an open area with a mezzanine above the lower ground floor described above. The mezzanine is currently used to store hay. The walls to this area are all in good condition with lime mortar pointing in reasonable condition. There is no sign of movement and unusually no signs of stress cracking below the seats of the trusses (photos 29 & 30). Internal inspection of the south east gable (photos 31 & 32) shows the wall to be in good condition with no sign of the bow evident externally.

Photo 32 – Internal of South East gable
