**STAGE 1**  
**ARBORICULTURAL REPORT WITH**  
**TREE CONSTRAINTS PLAN**  
**&**  
**ARBORICULTURAL IMPACT ASSESSMENT**  
**TO AID IN THE**  
**SITE DESIGN / LAYOUT**

**SITE ADDRESS:**     The Punchbowl Inn,  
Longridge Road,  
Hurst Green,  
Clitheroe,  
BB7 9QW

STAGE 1: ARBORICULTURAL REPORT WITH TREE CONSTRAINTS PLAN TO AID IN THE SITE DESIGN / LAYOUT

DATE: 15/05/2012

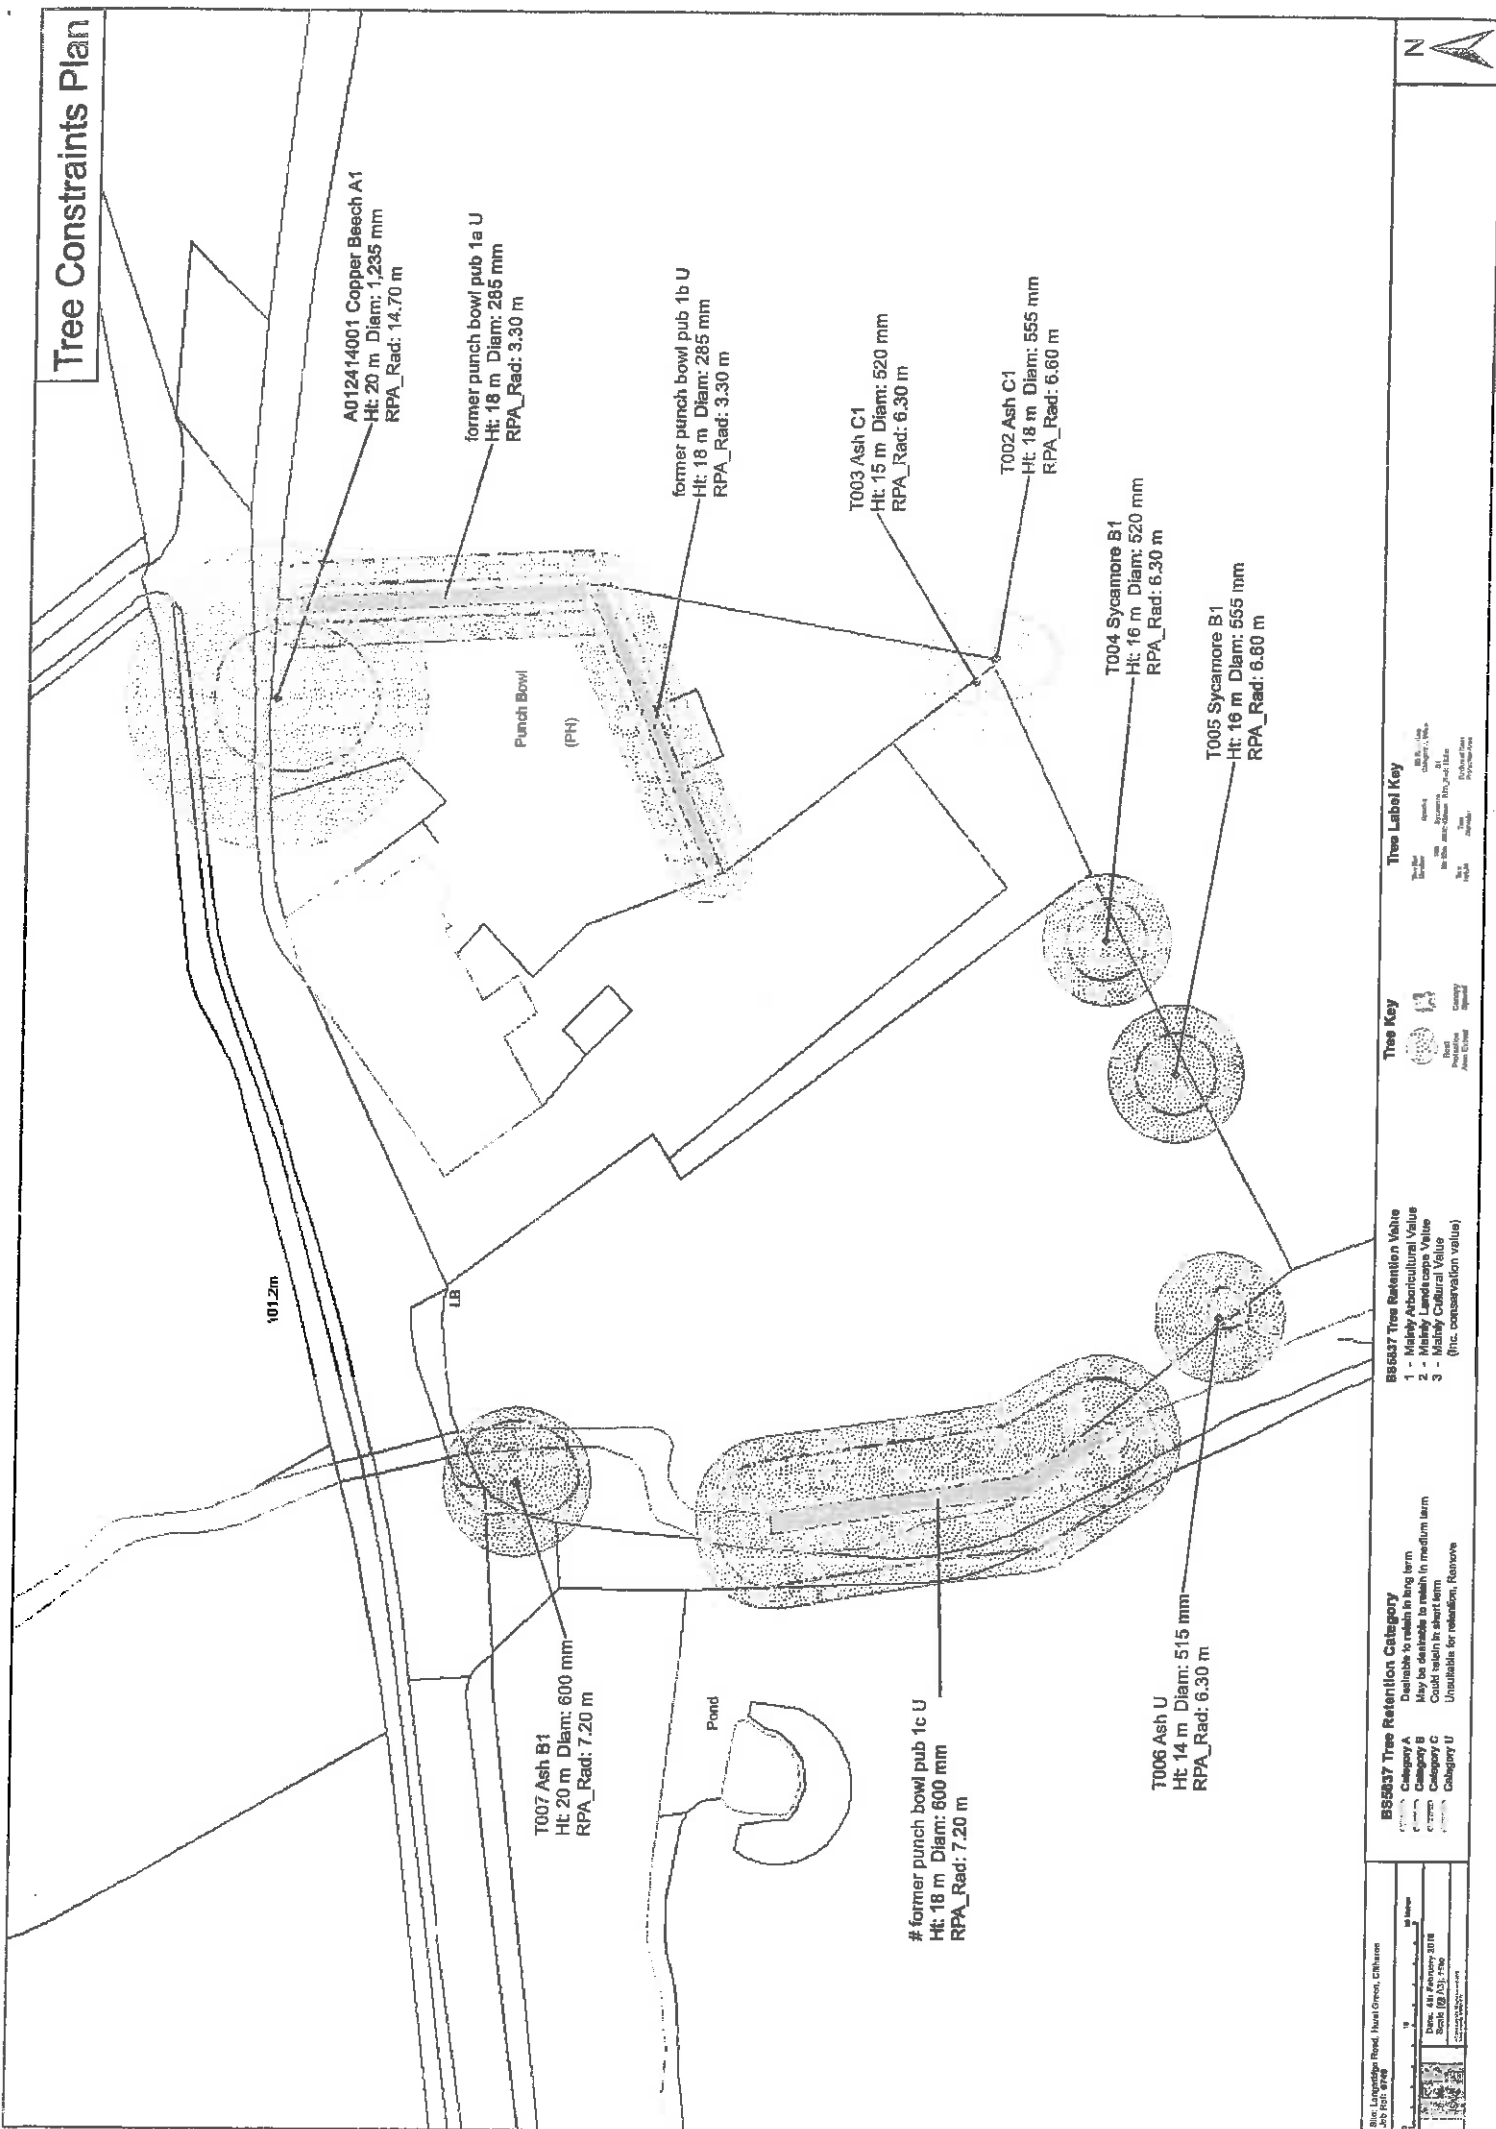
## Tree Constraints Plan

- The turnaround road to the north east of the site and cabin 15 is located within the root protection area of T001 Copper Beech. as there has already been damage to the trees rooting system further site activity in this area should be avoided. If cabin 15 was removed and the turnaround moved further south this would reduce any perceived conflict. If retained appropriate ground protection measures would need to be implemented to allow the road to be laid, e.g., anti-compaction cellular confinement system
- Cabins 7 – 8 – 9 are also located within the root protection areas of trees T004 and T005, again engineering solutions will be needed to allow the cabins to be located there, this should involve constriction above ground level without soil stripping or trenching.
