**BARN ONE, ELMRIDGE FARM, ELMRIDGE LANE, NR.  
CHIPPING, LANCASHIRE, PR3 2NY**

**Building Record of Barn One**

**Job No: 16/197**

January 2017

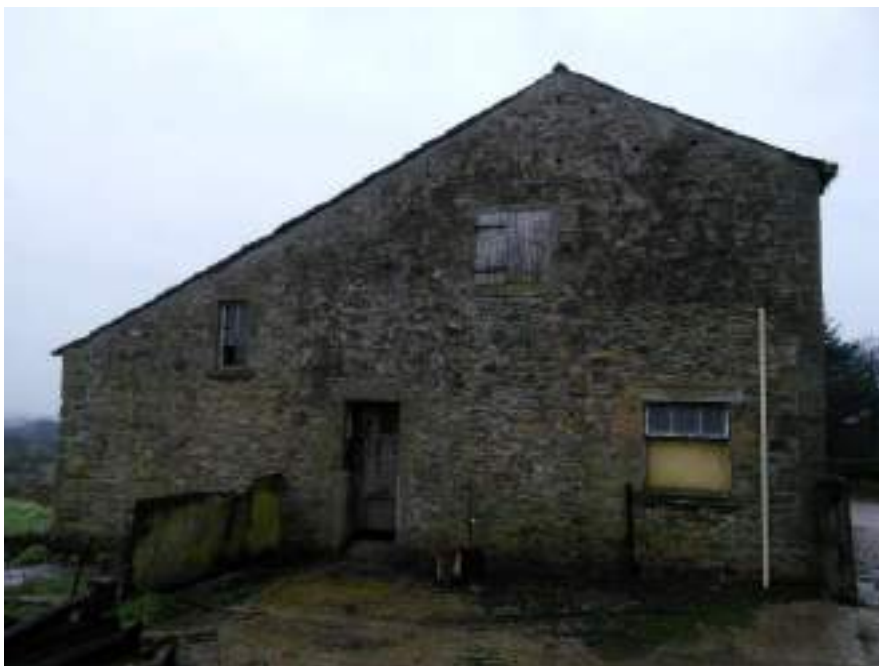
Figure 9 The north-east elevation of Barn One showing the access door.

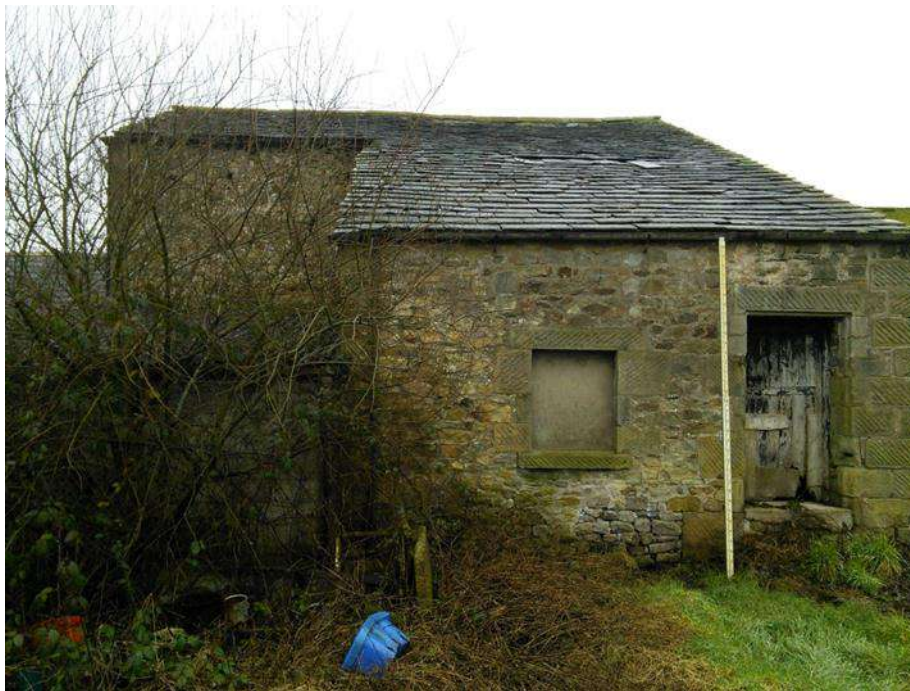
Figure 10 The south-east elevation of Barn One showing the rear outshut structure and disused slurry pit outside rear doorway.

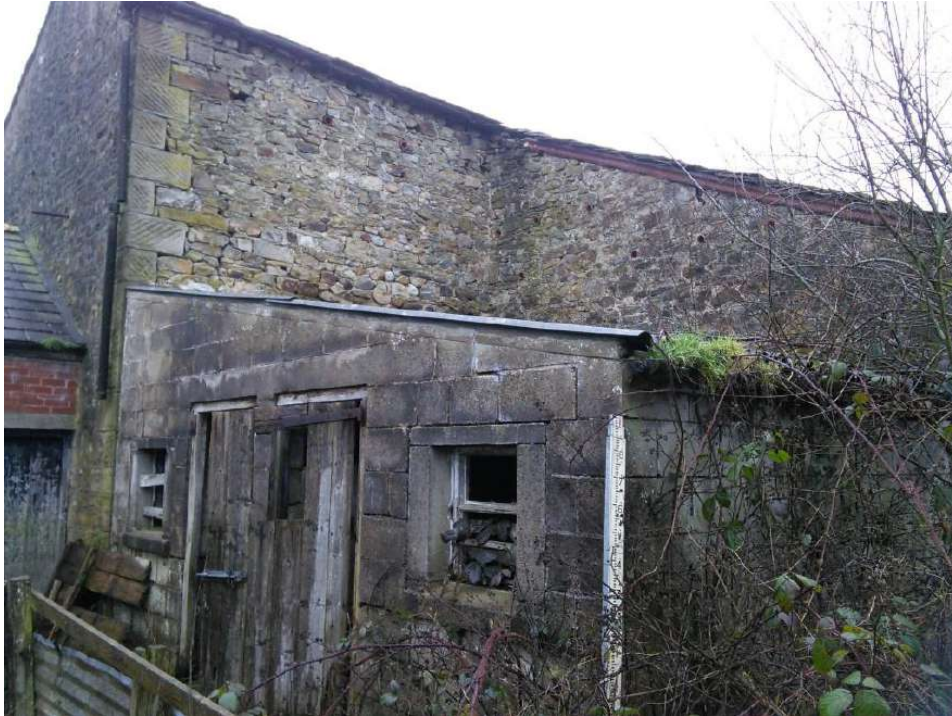
Figure 11 The south-east elevation of Barn One showing the modern lean to structure

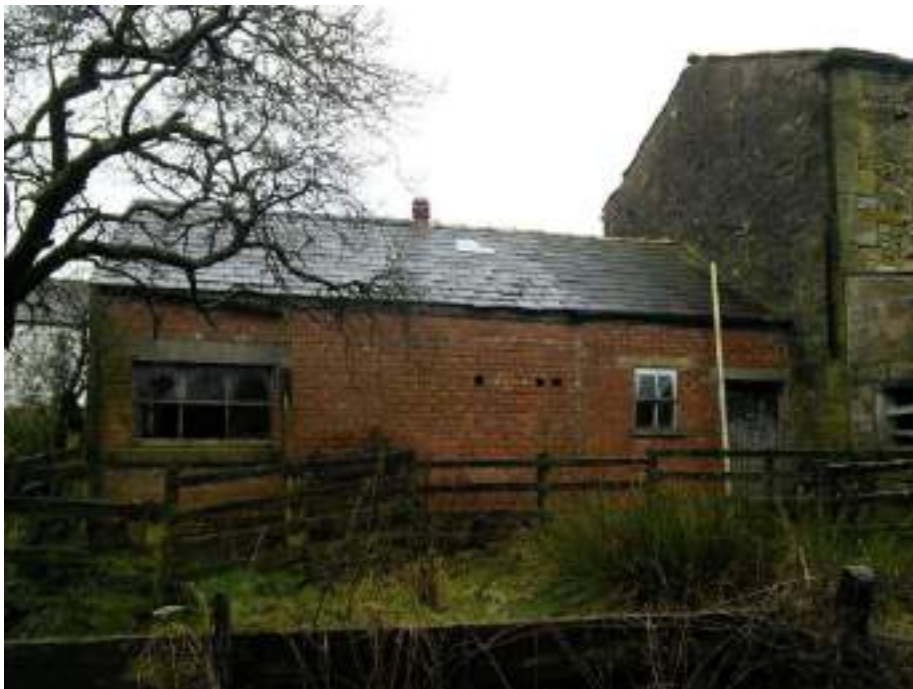
Figure 12 The south-east elevation of Barn One showing the single structure dairy building

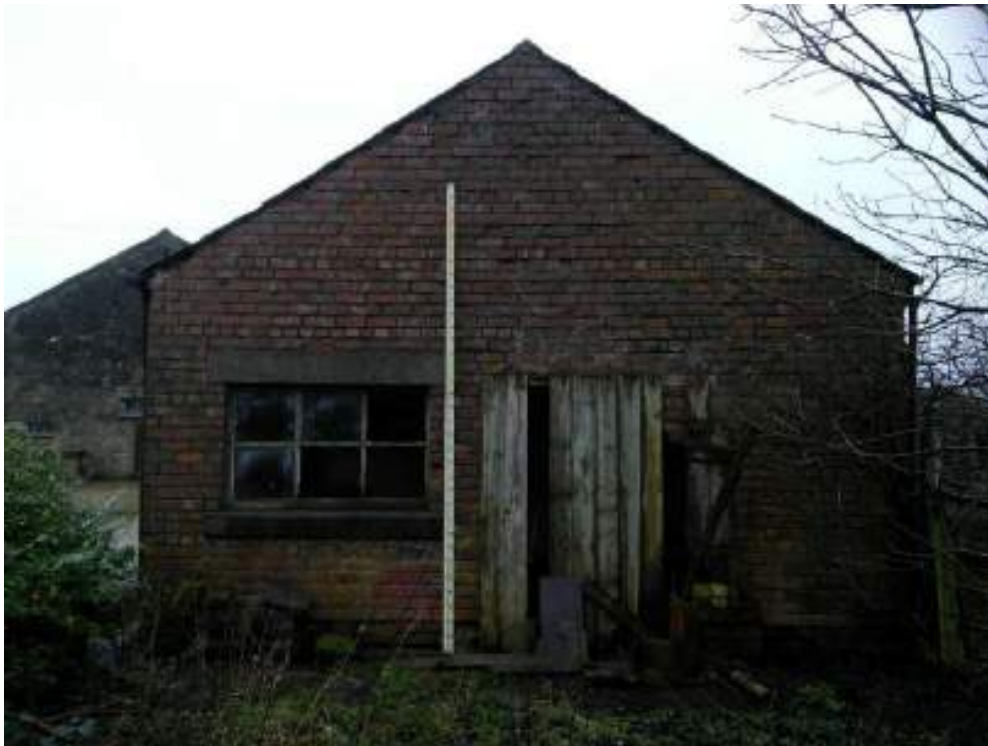
There has been some damage to the doorway and this is partially boarded up with timber. The window opening has precast stone heads and cills and is enclosed with a timber window frame. The brickwork to this elevation is in poor condition, requiring repointing.

Figure 13 The south west elevation of Barn One showing end gable of the brick dairy.

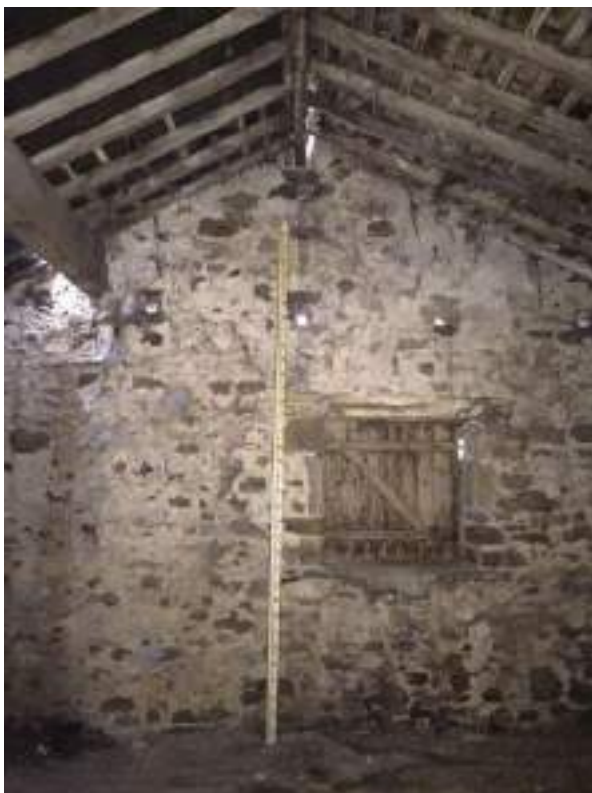
Figure 17 Internal view of the first-floor hayloft

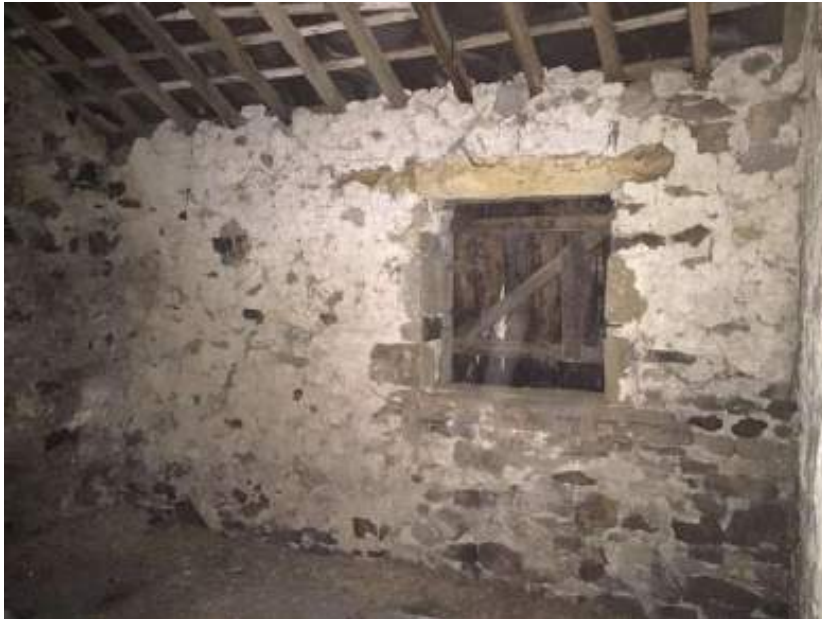
Figure 18 Internal view of the first-floor hayloft and access opening

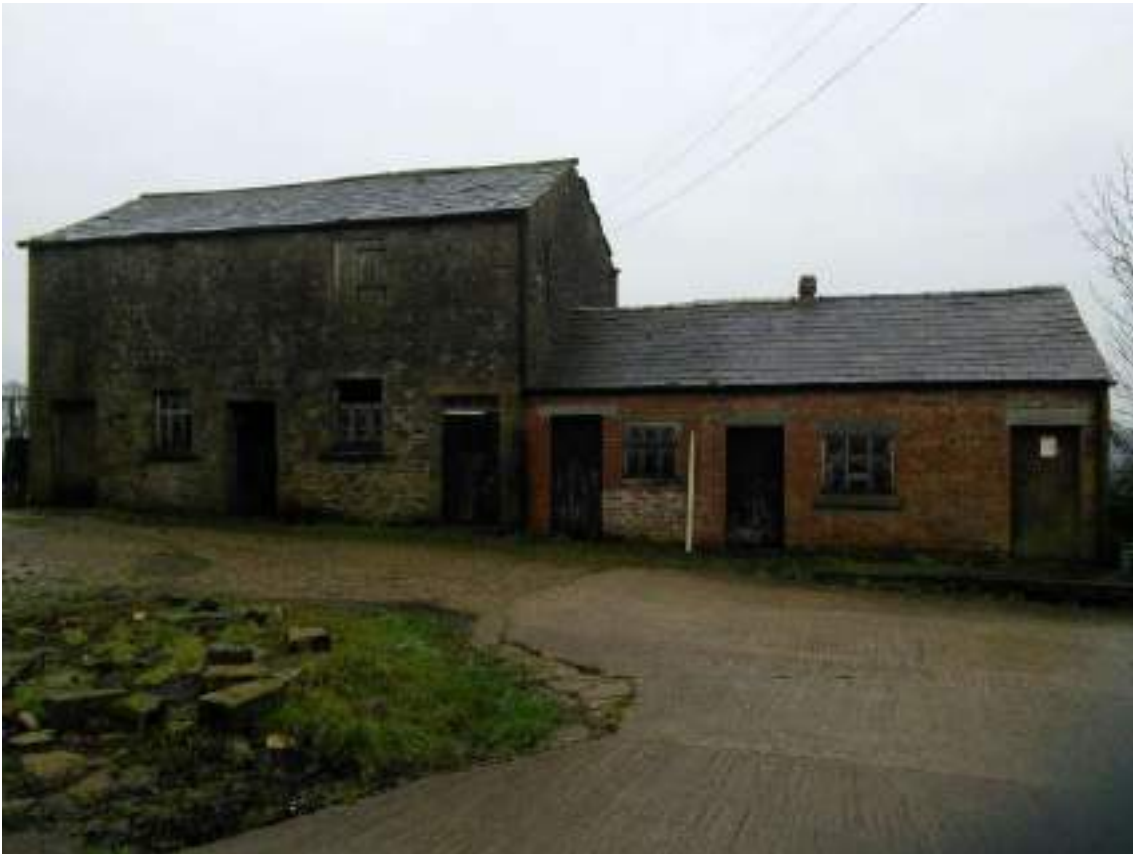
1 Front (north east) elevation showing the single storey dairy and original two storey barn

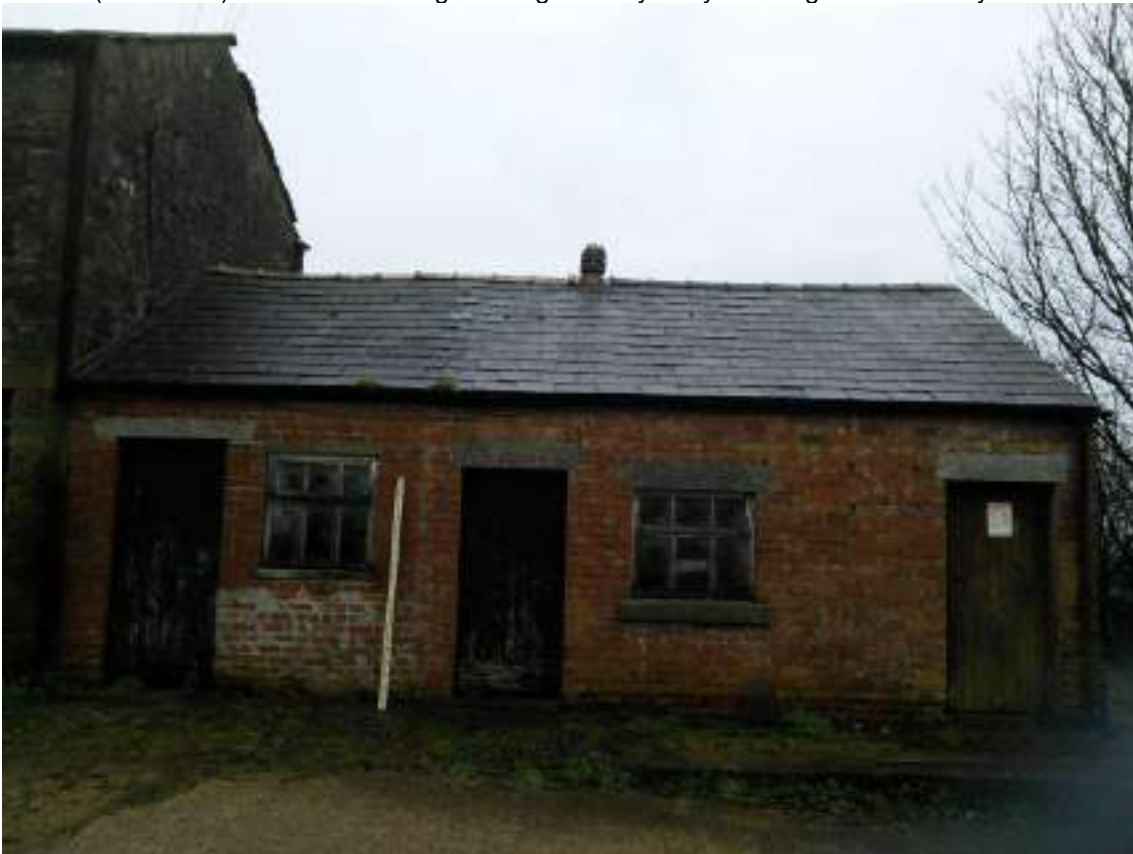
2 Front elevation of the single storey brick dairy structure with slate roof

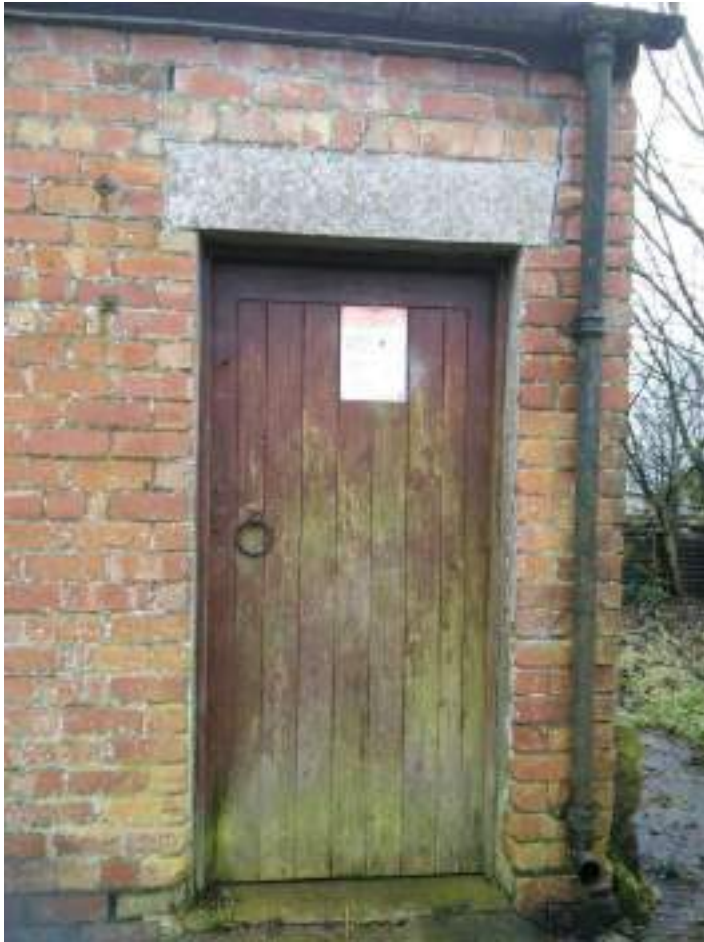
5 Modern timber door to dairy and cast iron rainwater goods.

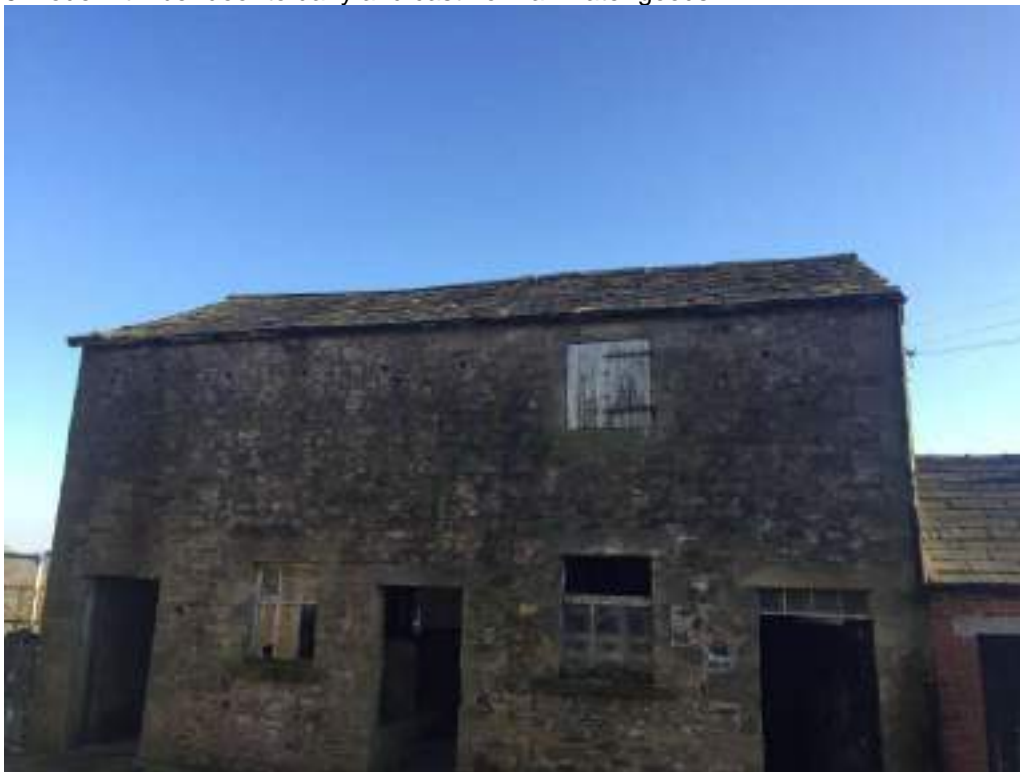
6 Front elevation of the two-storey barn showing ground and first floor openings, note stone flags to main barn roof.

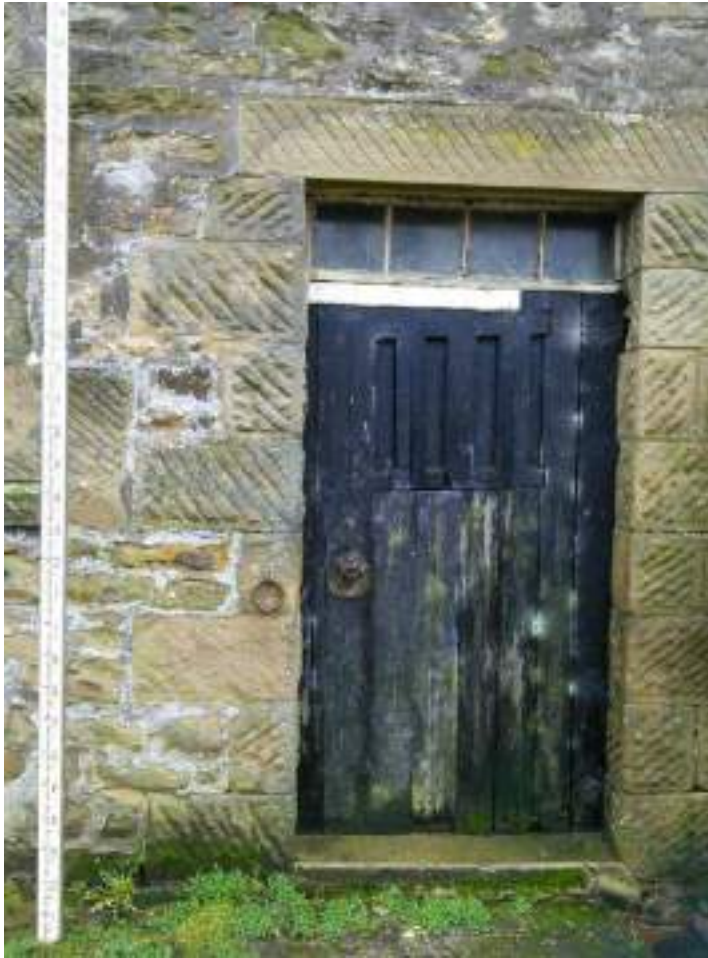
9 Door detail with fanlight over

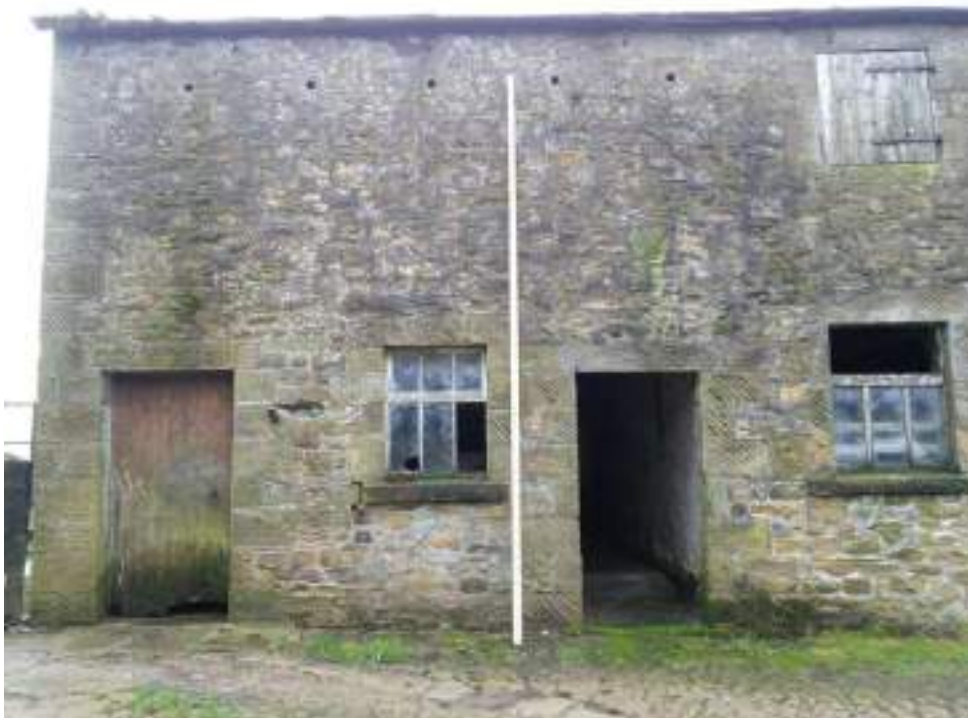
10 Part view of front elevation showing openings and ventilation holes at first floor.

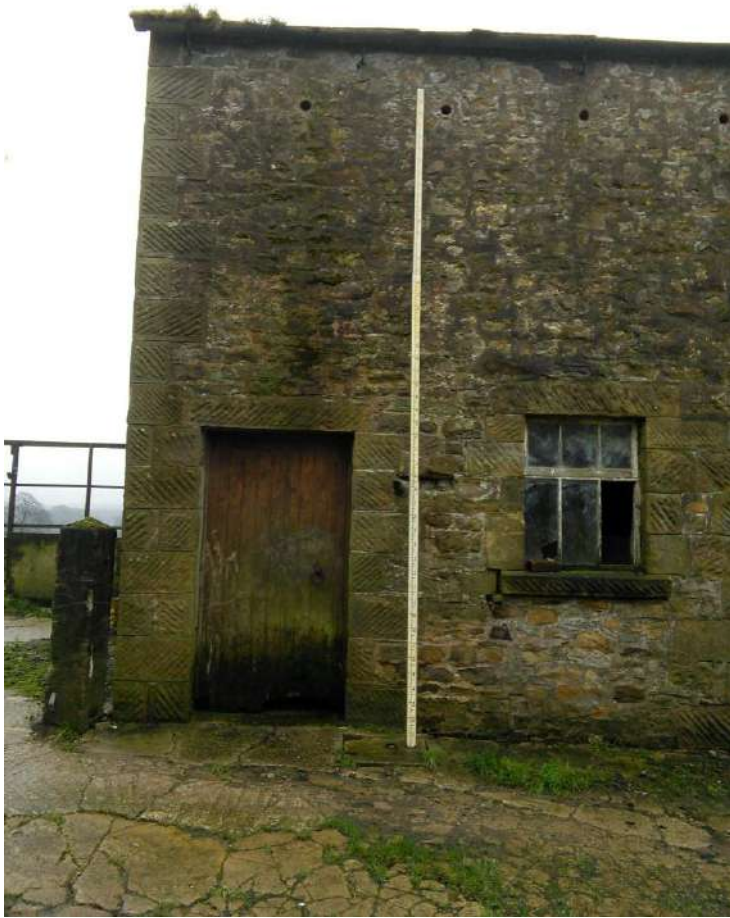
11 North west entrance door leading to shippon, note ventilation holes at first floor level for cross ventilation of hayloft at first floor

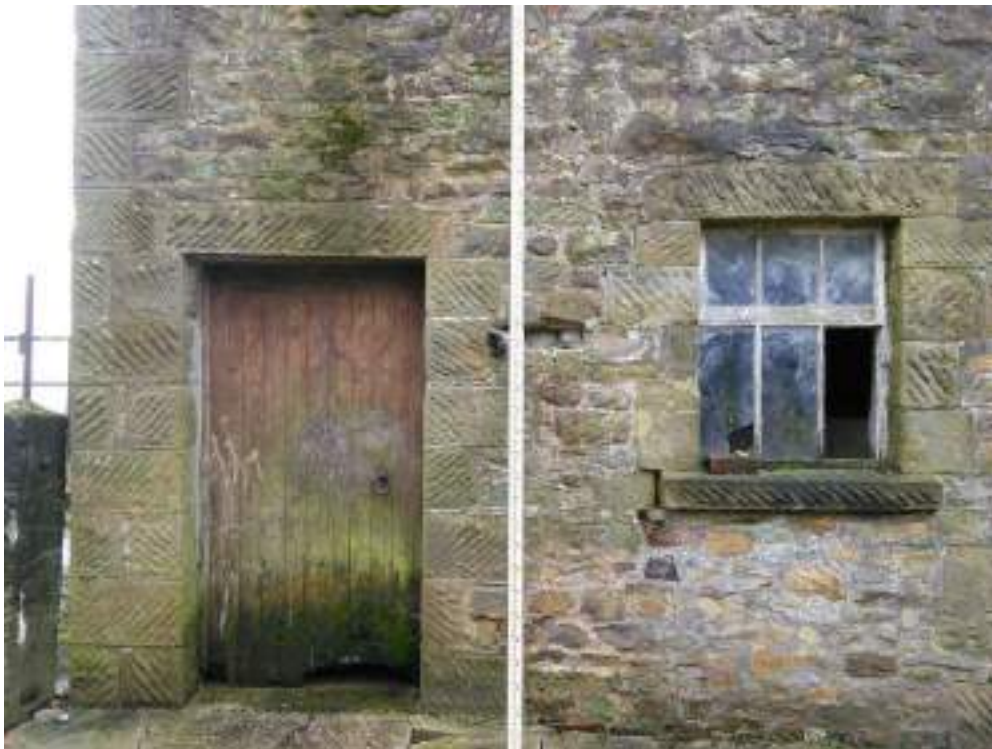
12 Door and window detail, note quoins to corner of the barn

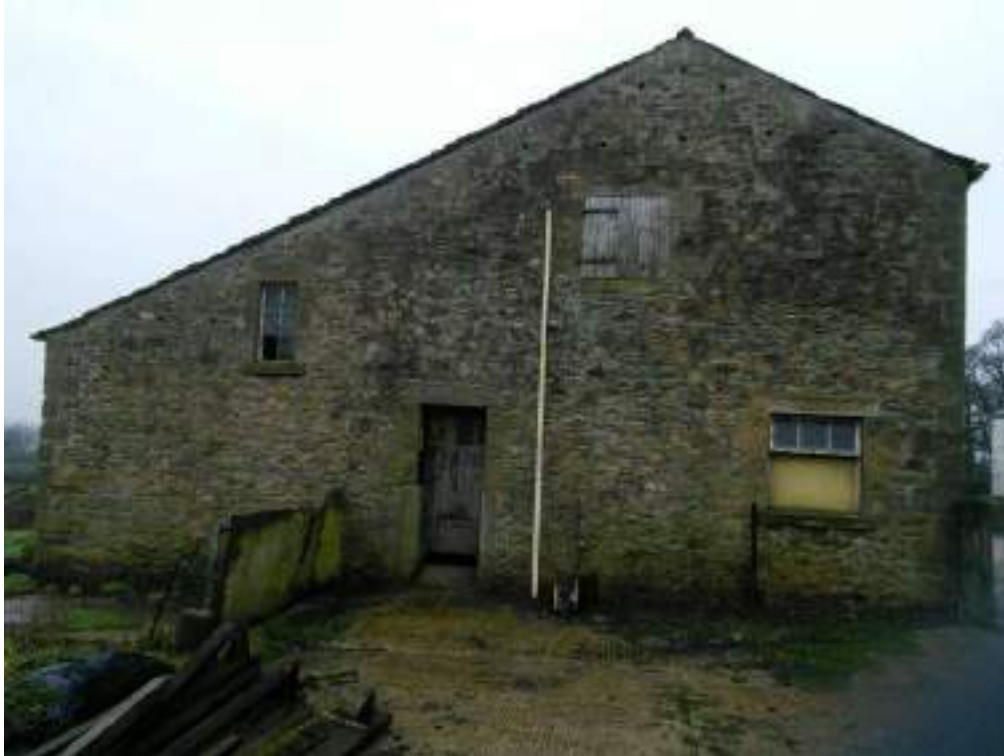
13 Left Side (north east) elevation of the two-storey barn with extended shutout and side access door for cattle

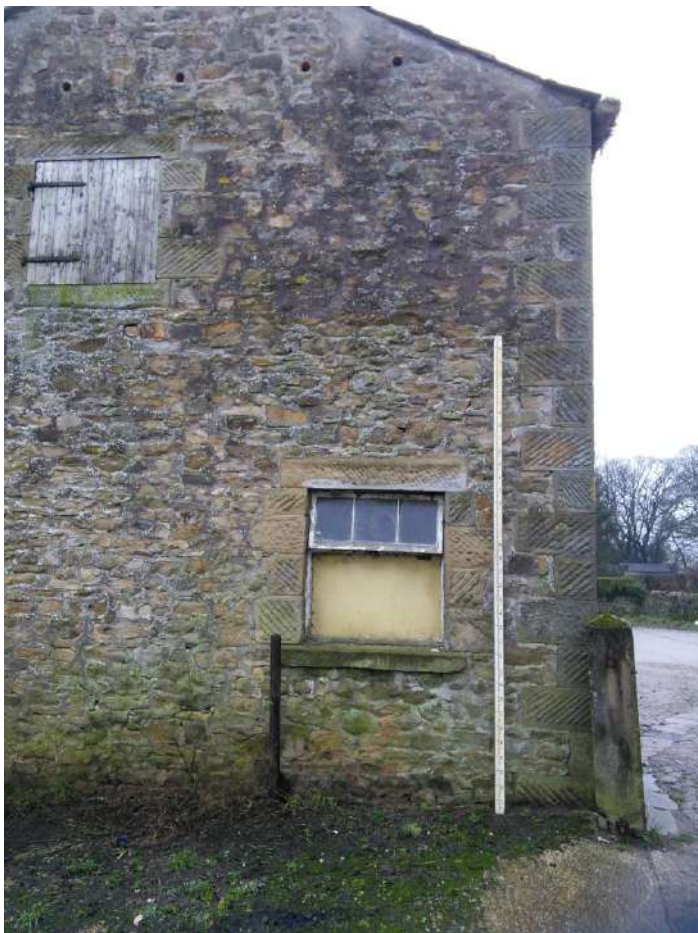
14 Detail of corner stone quins and openings. Note first floor door directly hinged to stone quins.

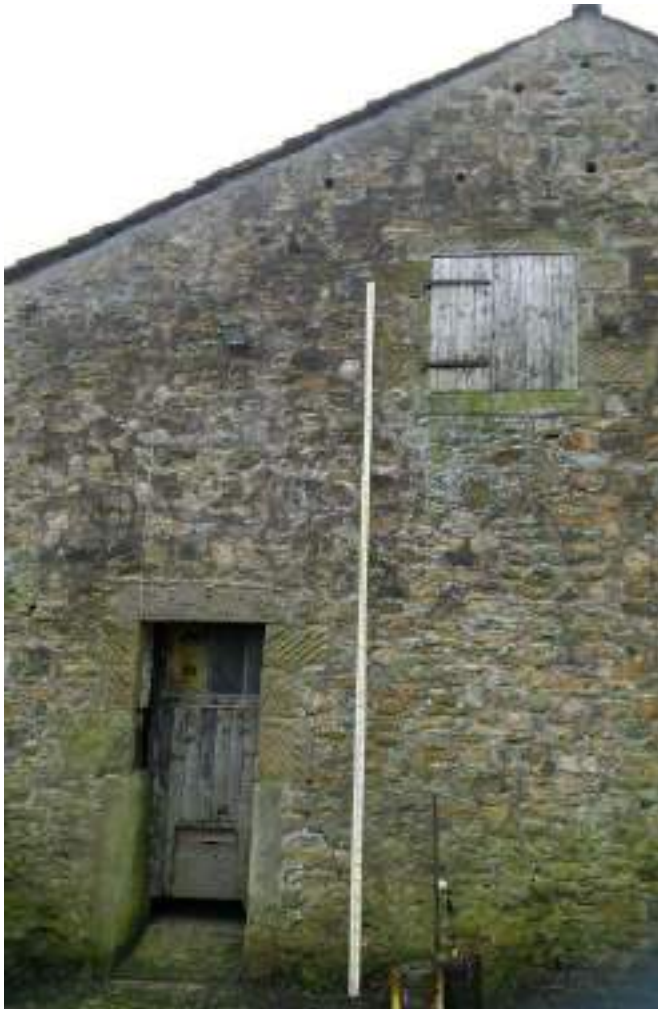
15 Detail of openings. Note ramp to access door and ventilation holes in gable.

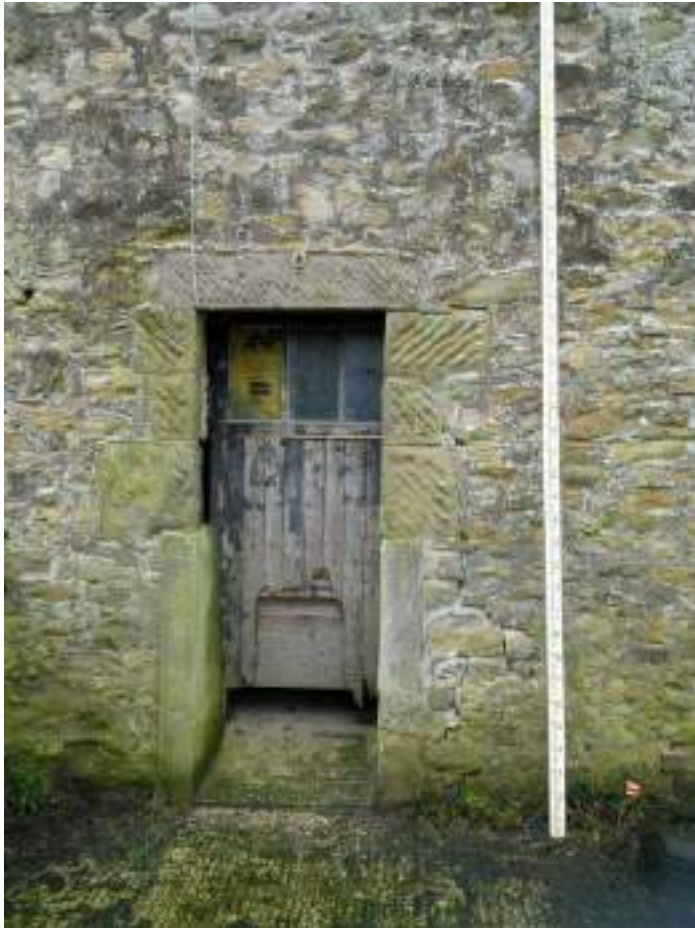
17 Detail of side access door, note ramp for cattle access.

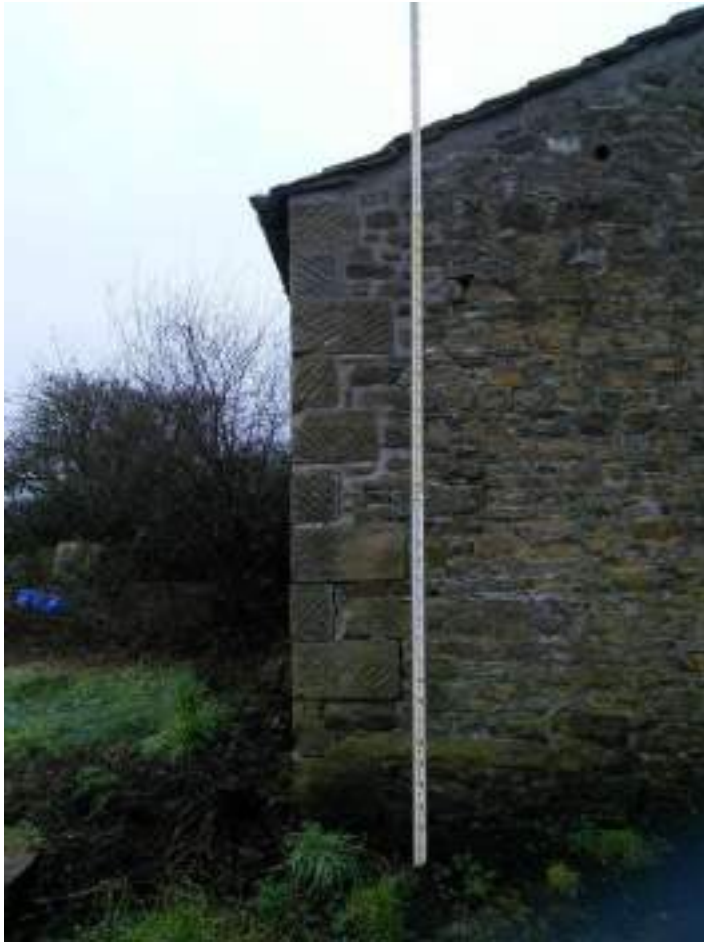
19 Corner quoin detail to outshut, note slurry pit to rear of building.

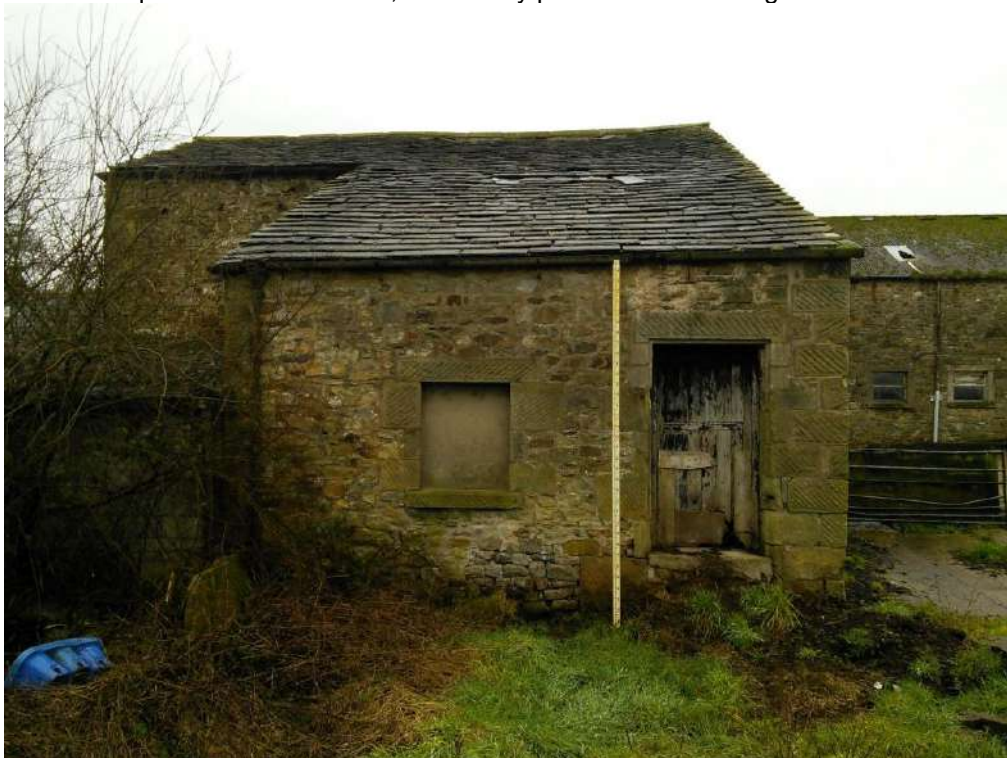
20 Rear (south east) elevation showing drop from rear door to slurry pit level.

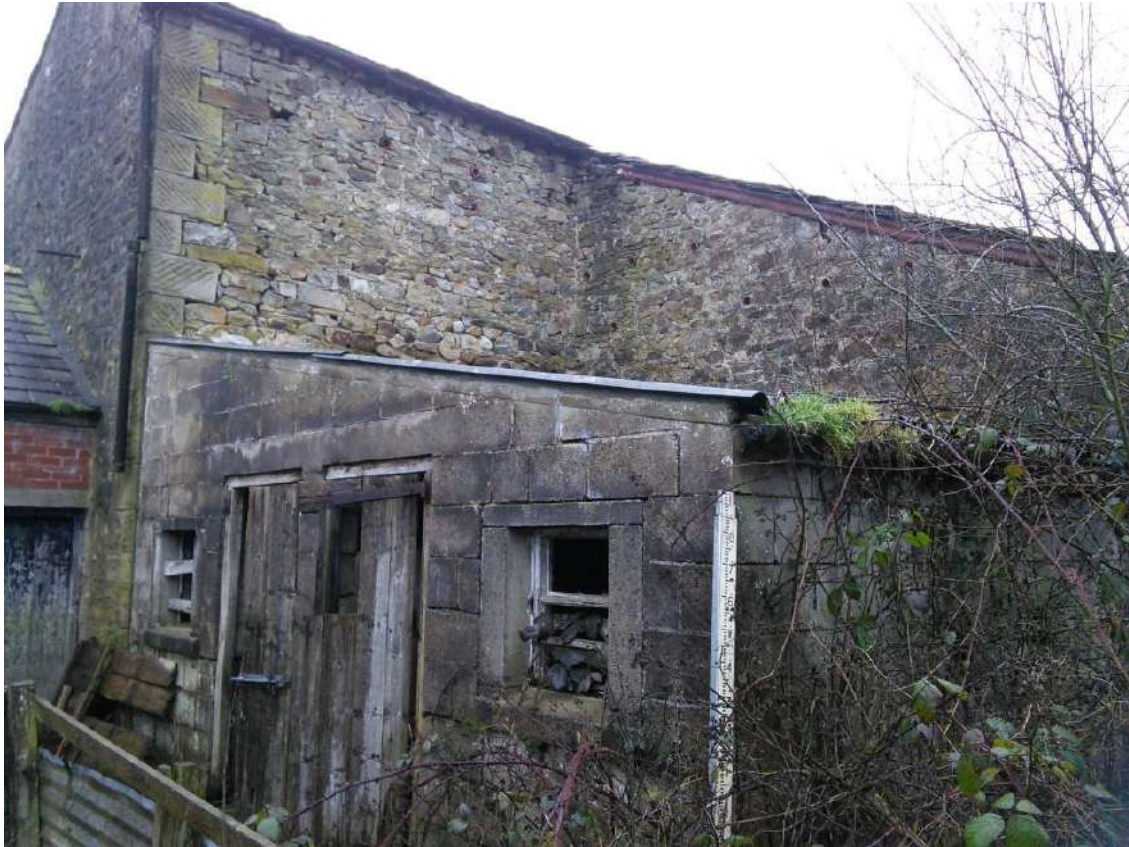
23 Rear (south west) corner showing lean to building (no access possible)

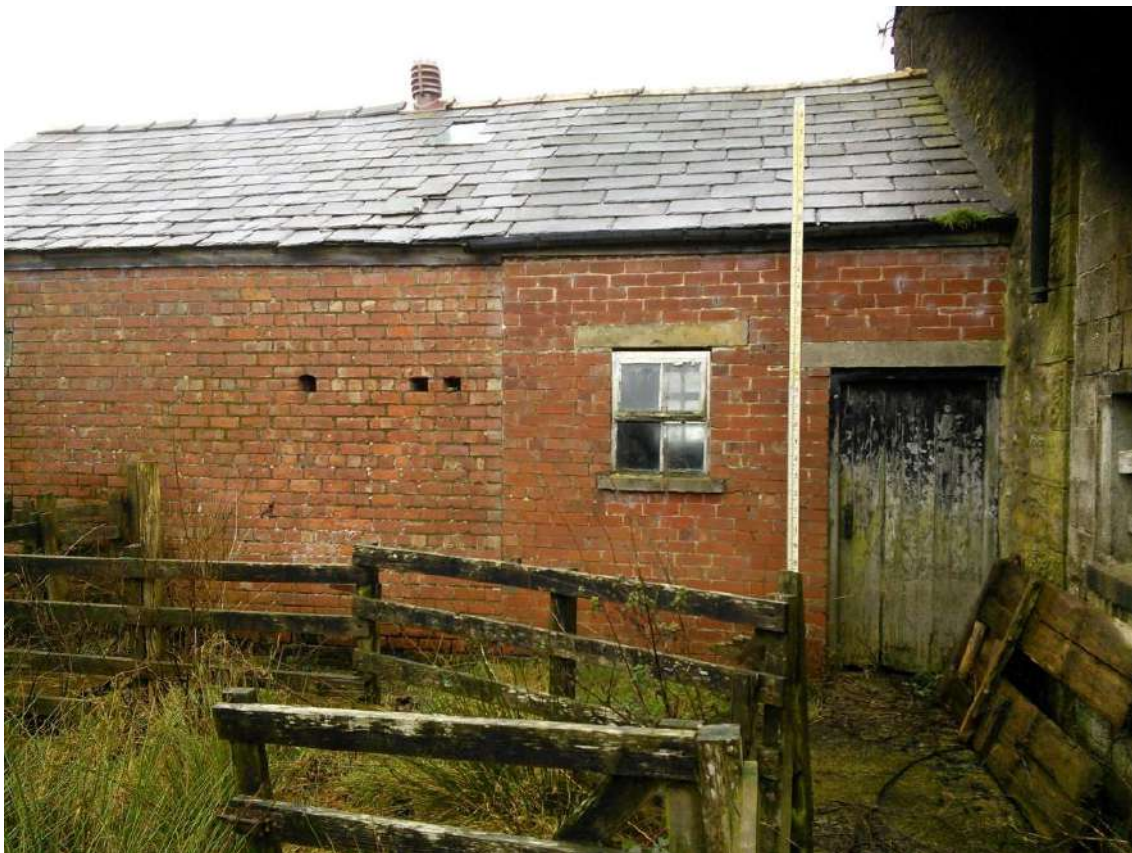
24 Rear elevation to single storey dairy building showing infill area in differing brick.

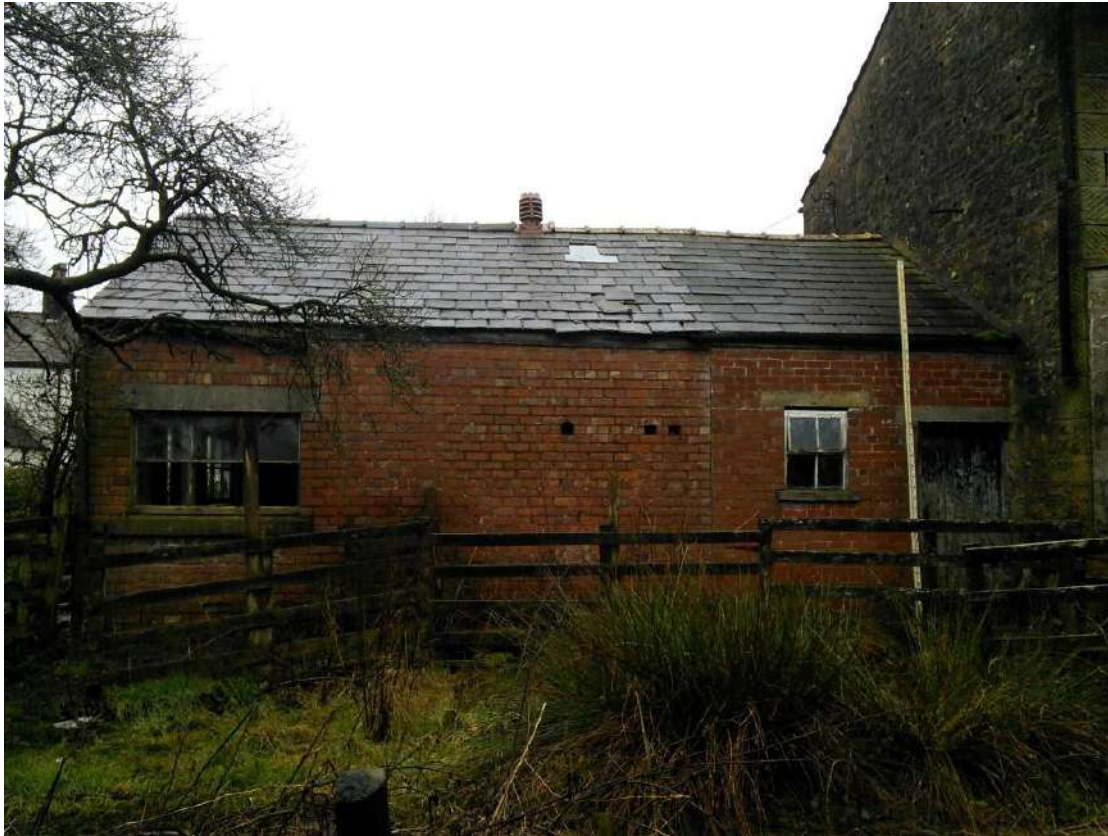
25 Rear view of dairy building showing ridge vent to roof

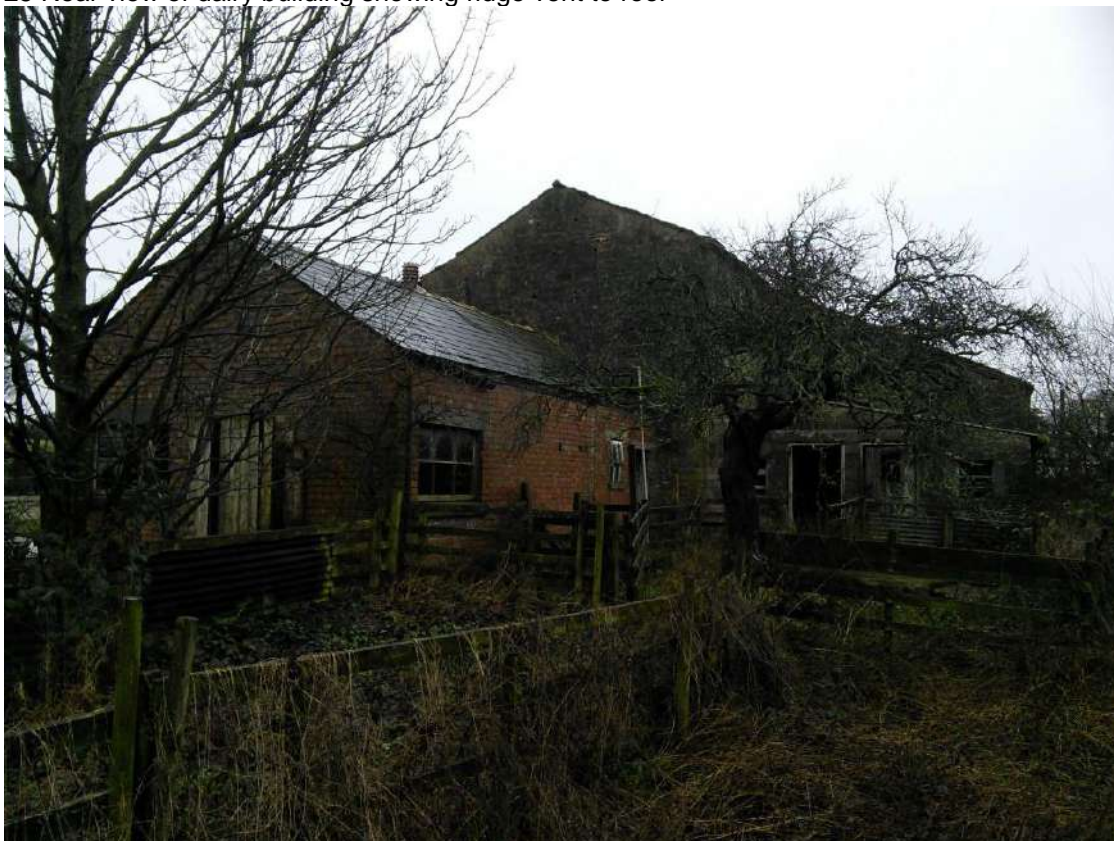
26 Rear (south west) elevation showing single storey dairy in context with main barn.

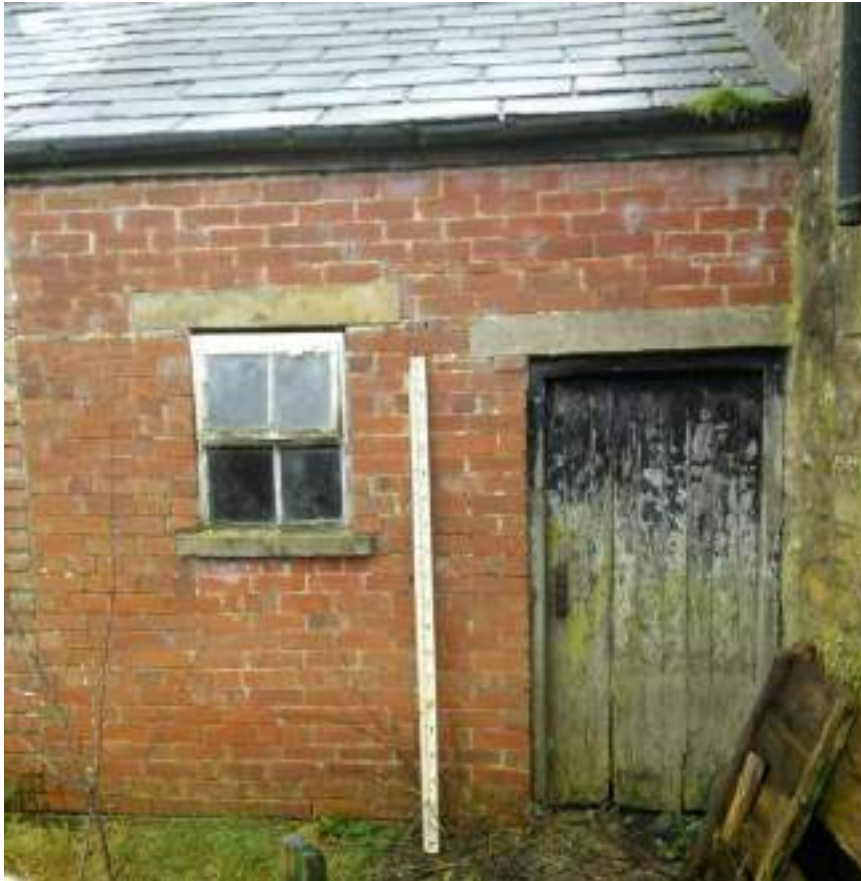
27 Door and window detail

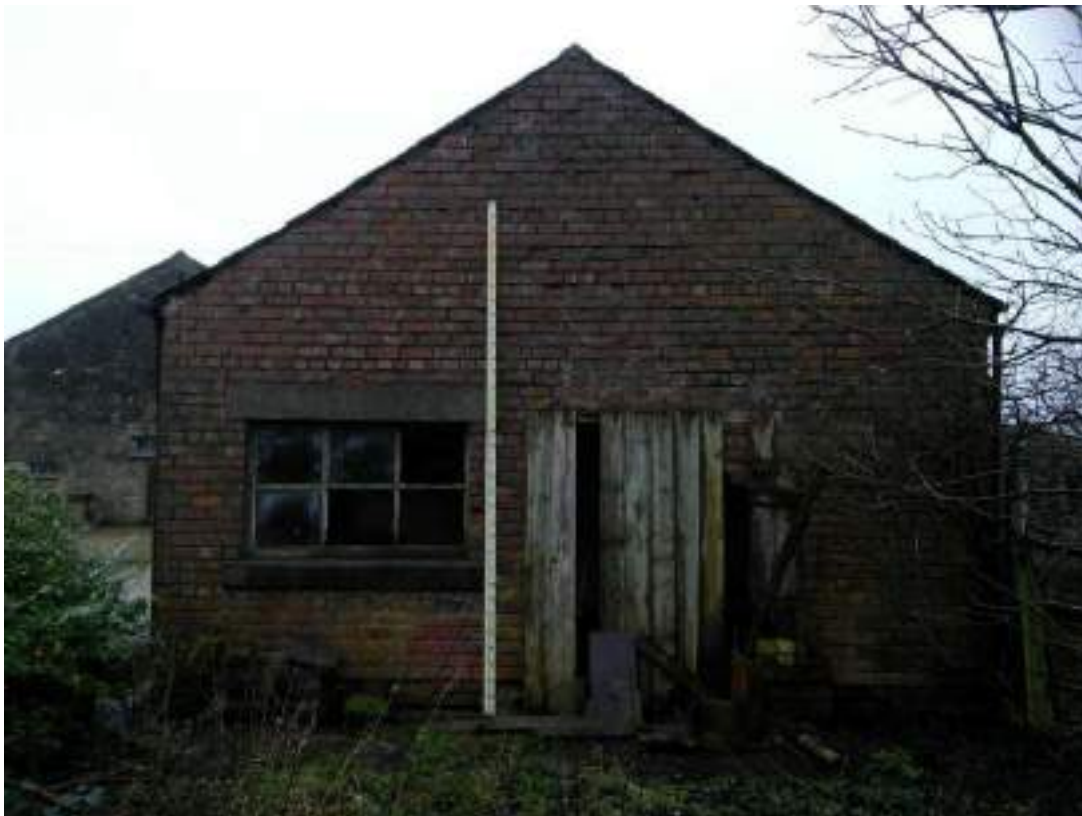
28 South west elevation showing gable to single storey dairy.

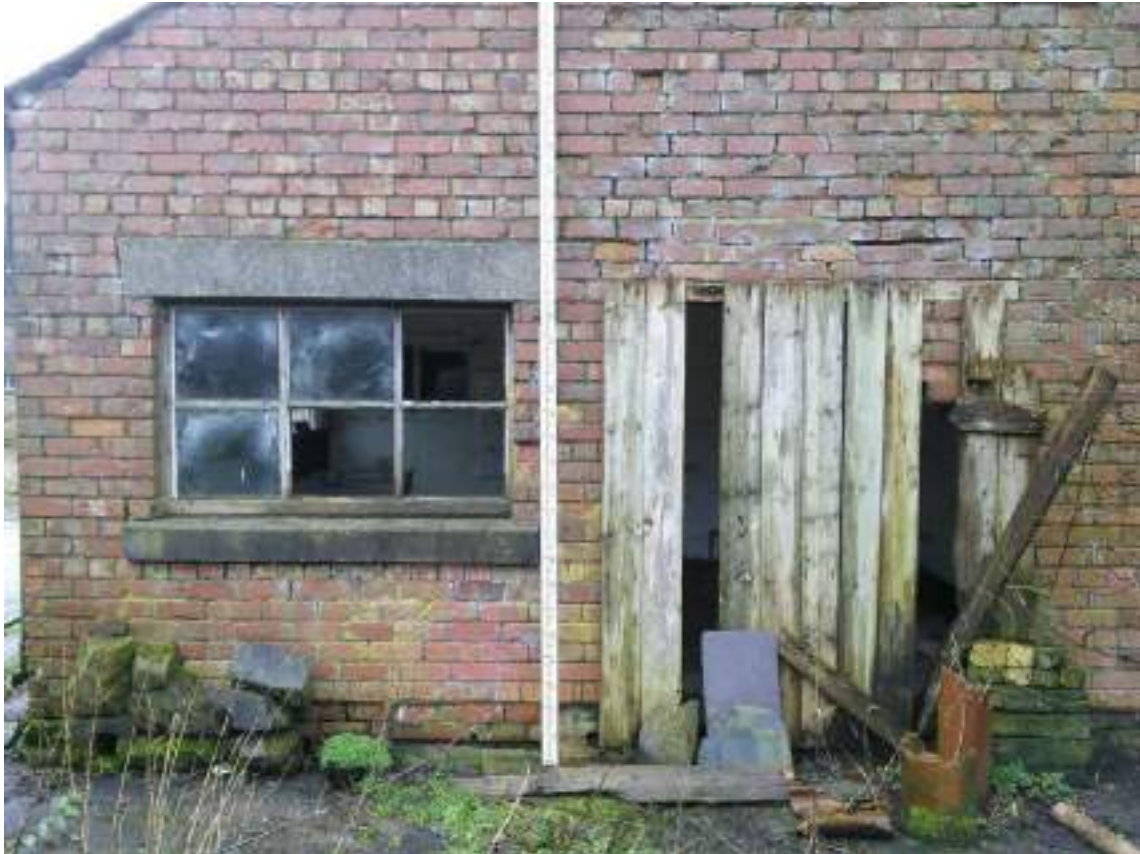
29 Window and door detail, note spalled brickwork and damage to door opening.

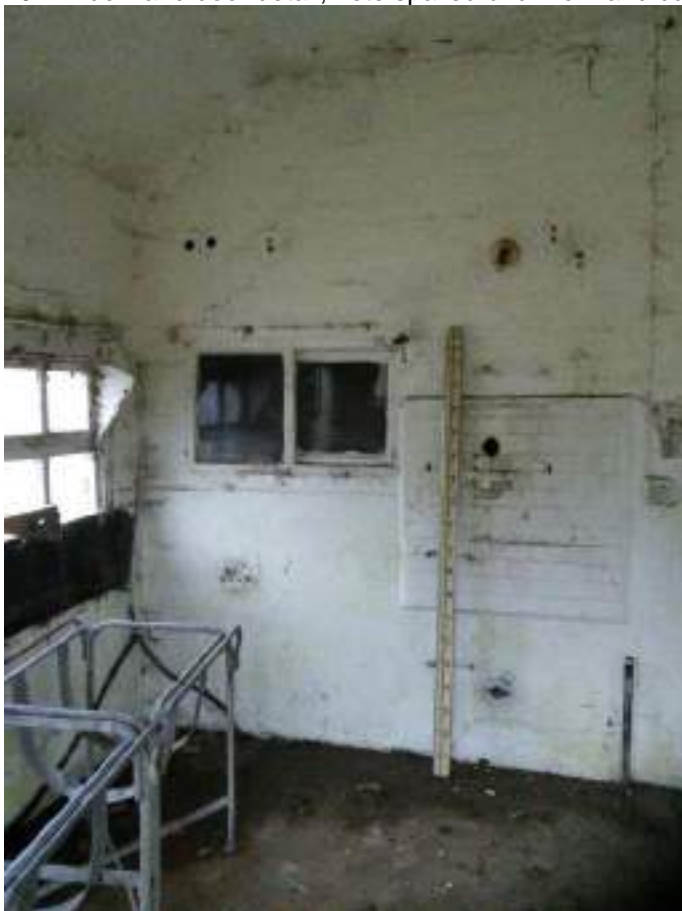
30 Internal view of dairy showing internal windows and finishes to walls and ceiling; LH wall.

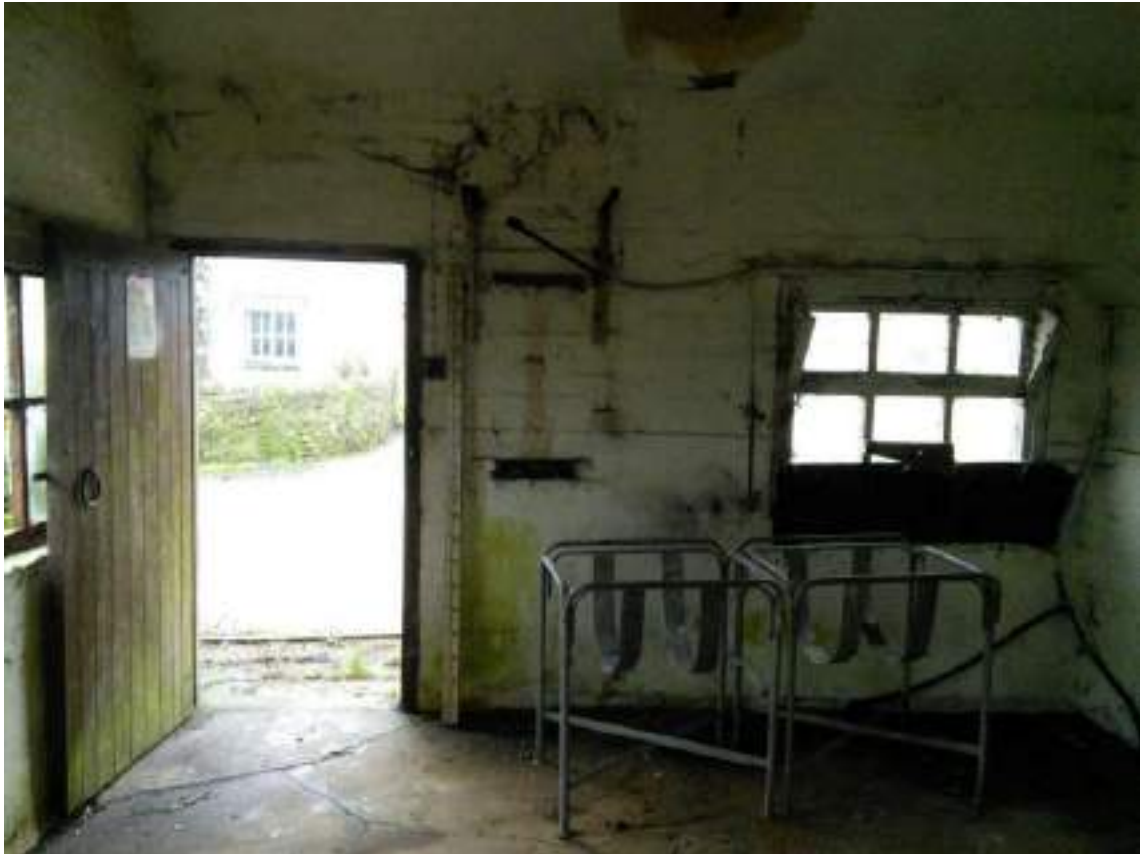
31 Internal view showing access door and window; Front wall.
