**BARN ONE, ELMRIDGE FARM, ELMRIDGE LANE, NR.  
CHIPPING, LANCASHIRE, PR3 2NY**

**Building Record of Barn One**

**Job No: 16/197**

January 2017

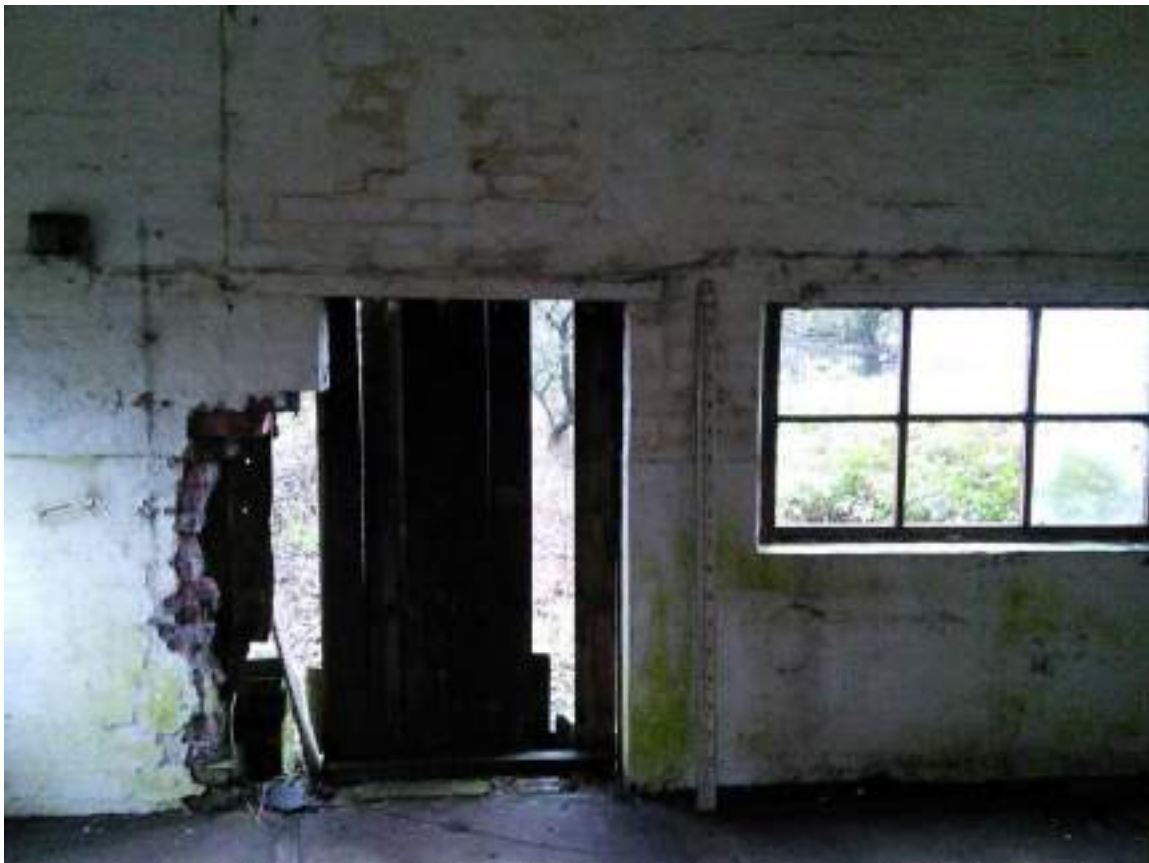
32 View showing damage to existing opening and cracking above doorway; RH wall.

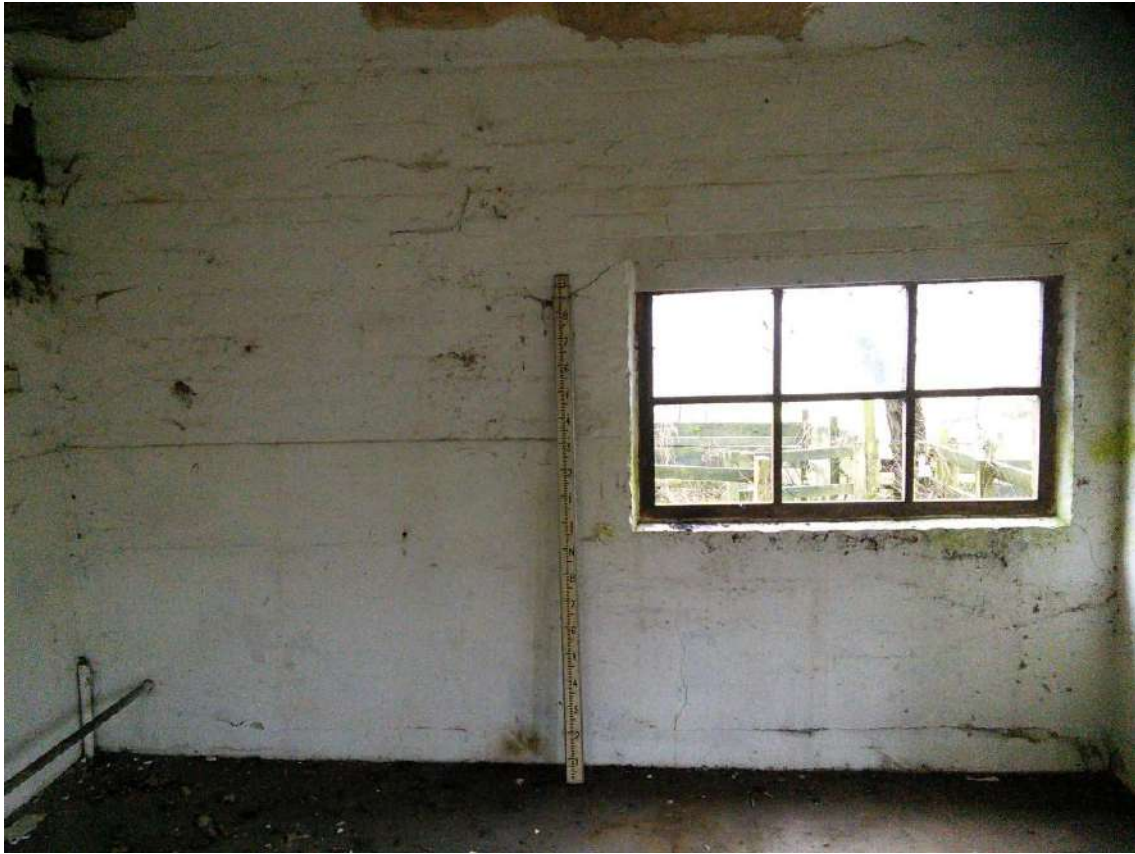
33 Rear wall and window to dairy

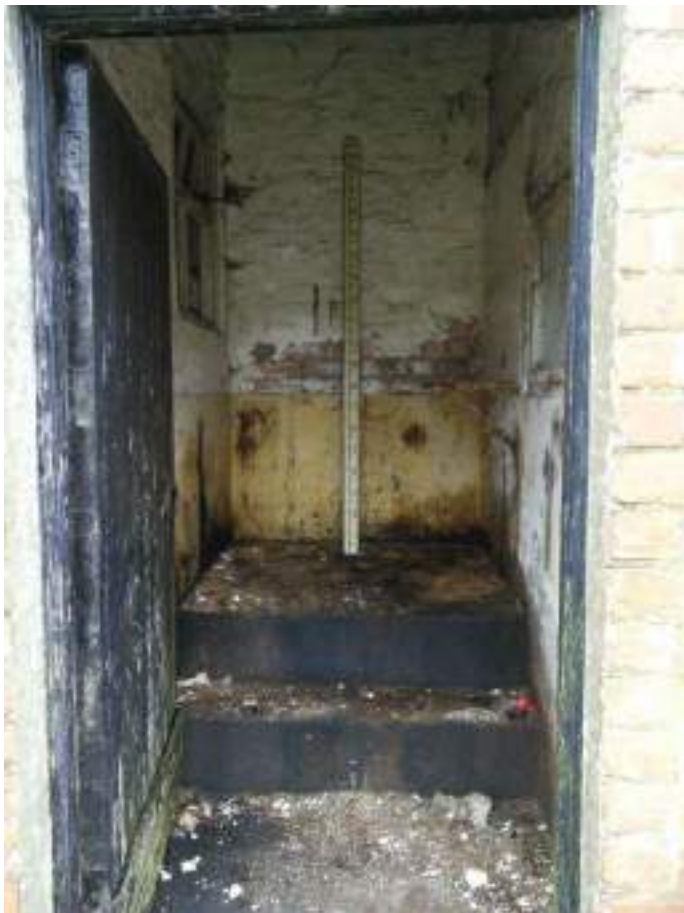
34 Oil store with raised floor.

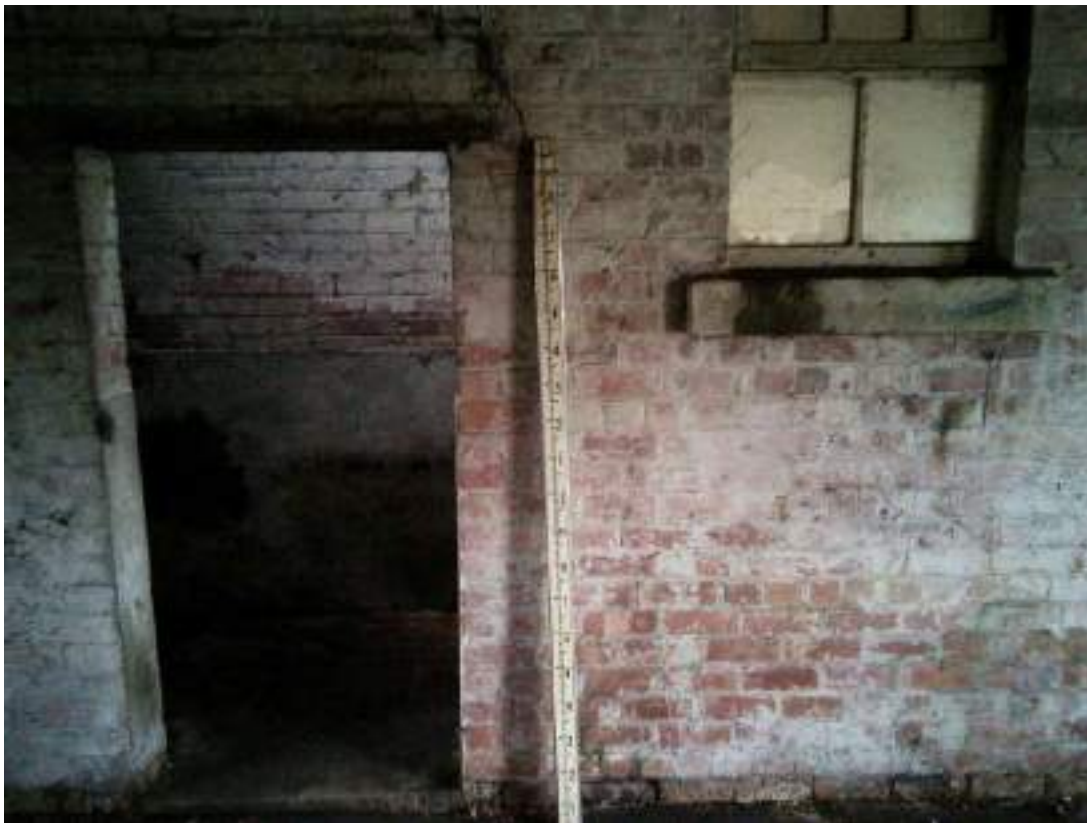
36 Internal view of store room showing internal window. This was possibly the external wall prior to the gap between the two structures being enclosed; RH wall.

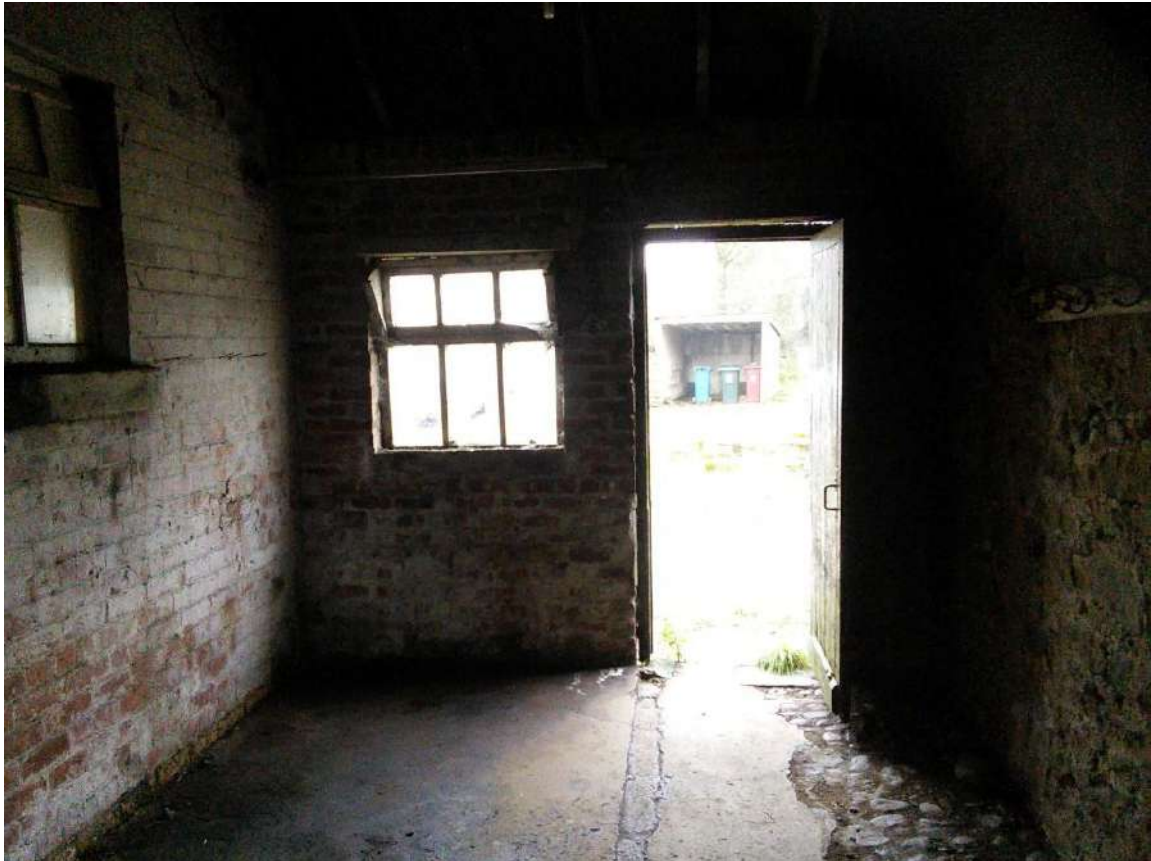
37 View of front wall to store, note change to floor finishes

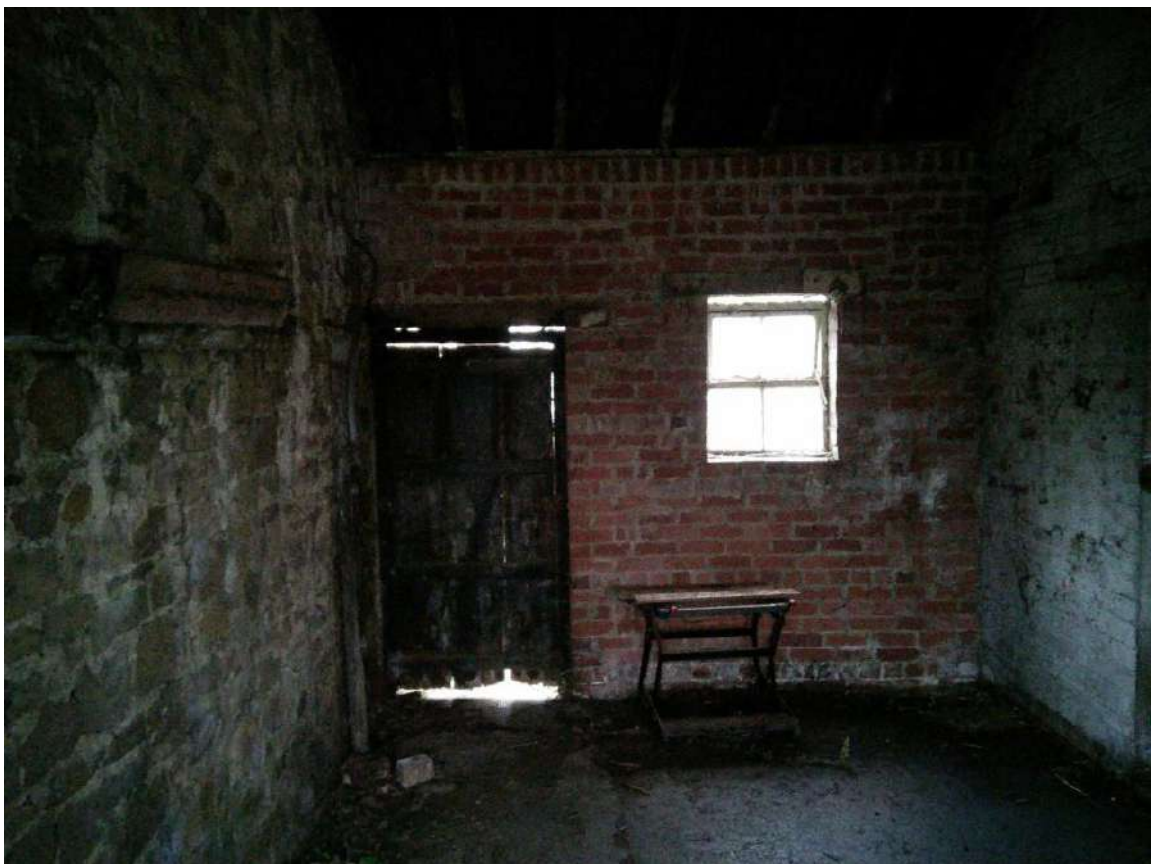
38 Rear wall to store showing timber door and window detail.

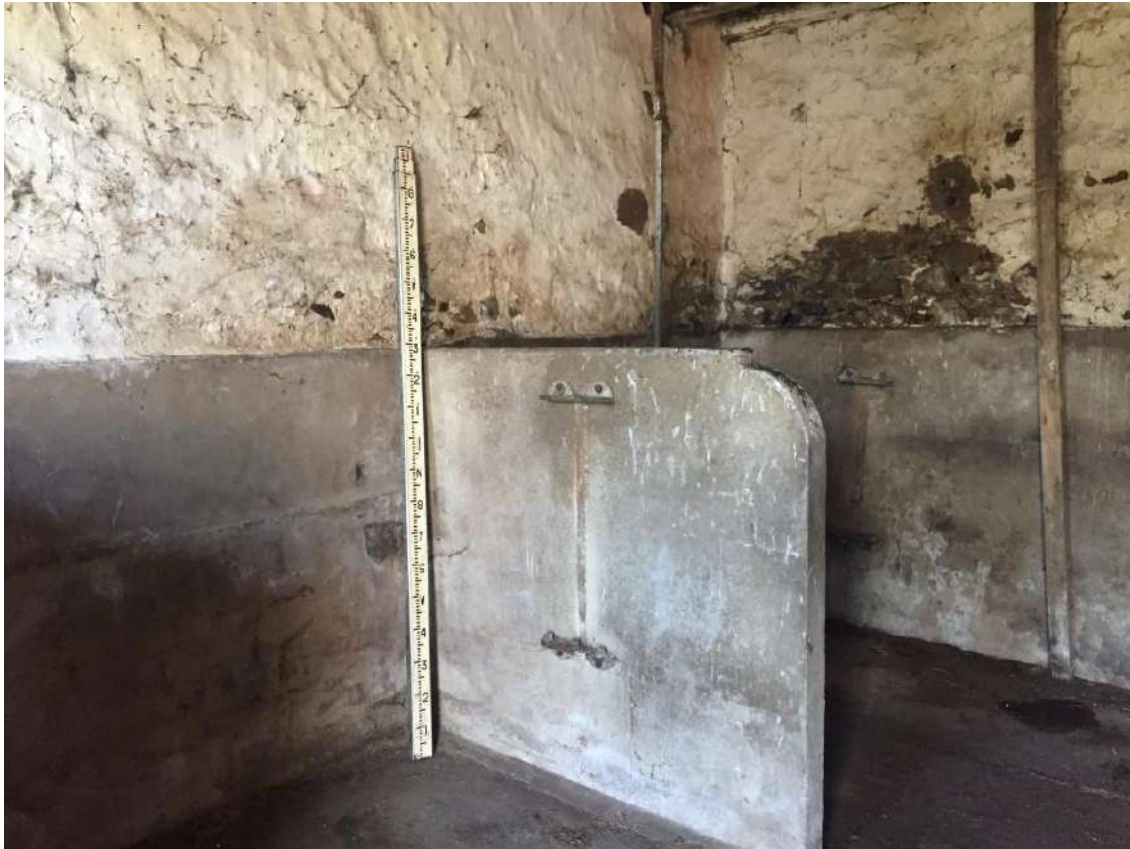
39 View into small shippon showing concrete cattle stalls, part rendered walls, concrete floor, and floor joists to upper floor hayloft. Note supporting timber beam splitting joist span.

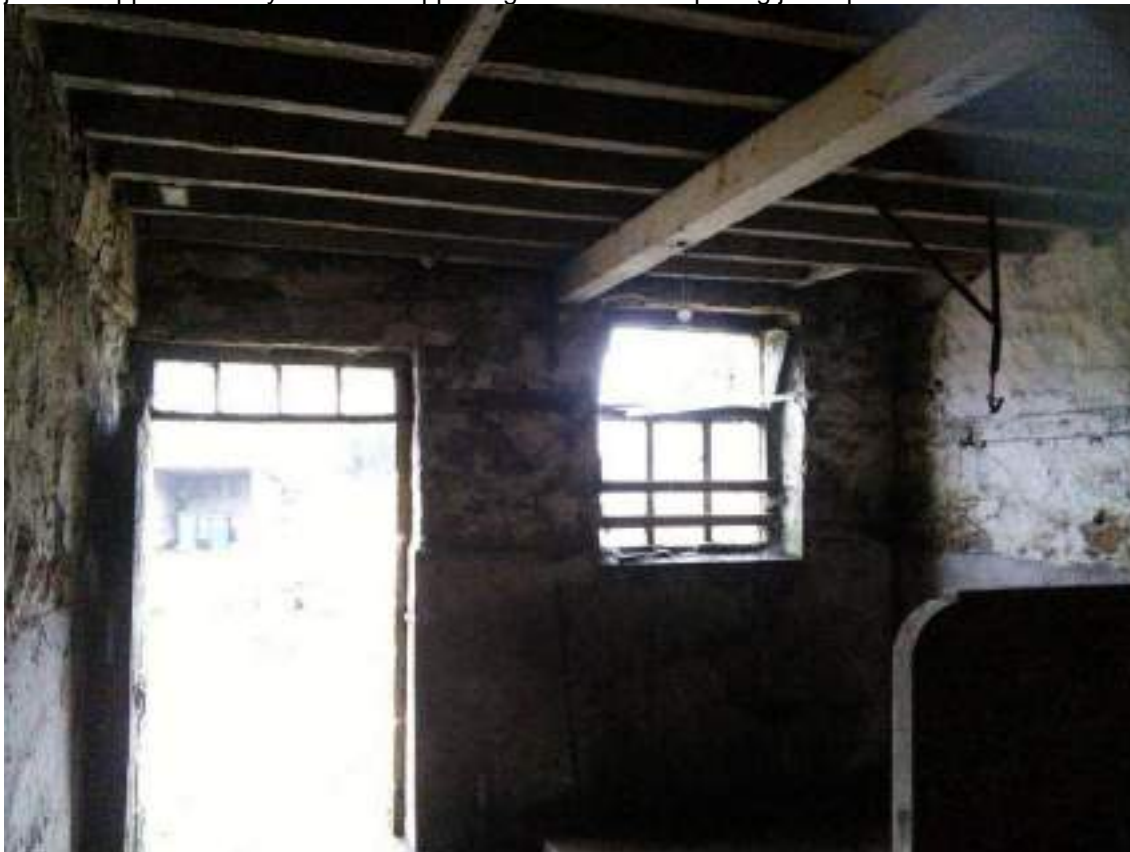
40 View of front wall showing fanlight over door, floor joists and supporting timber beam.

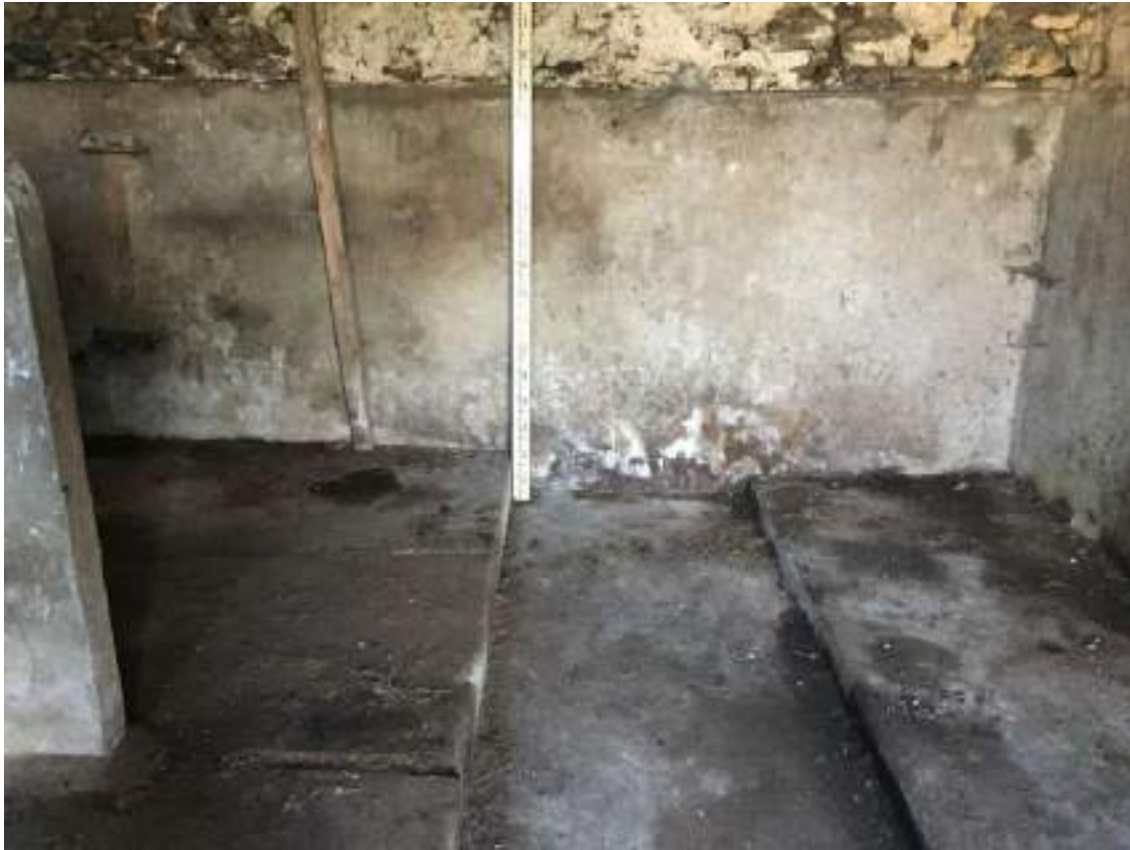
41 View of part rendered wall and concrete floor with channels, note metal rings to stall for tethering.

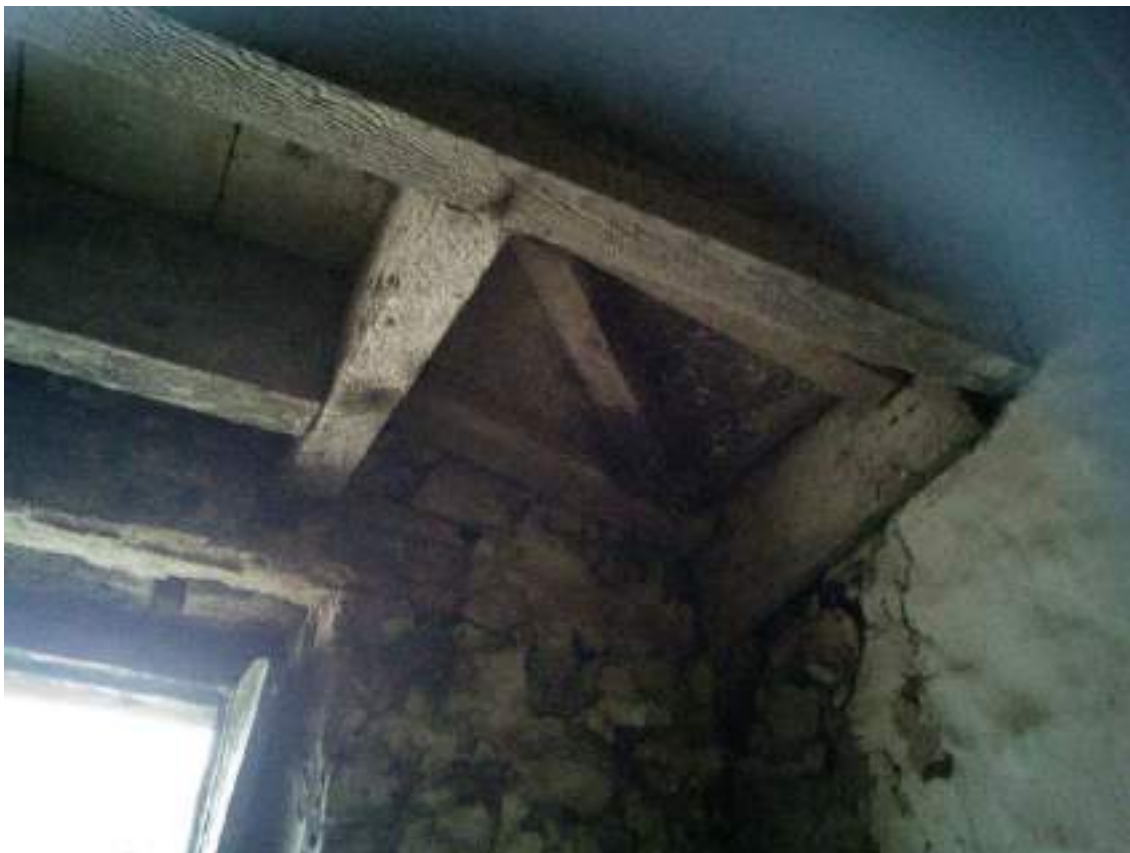
42 Trap door to north west corner of small shippon providing access to first floor.

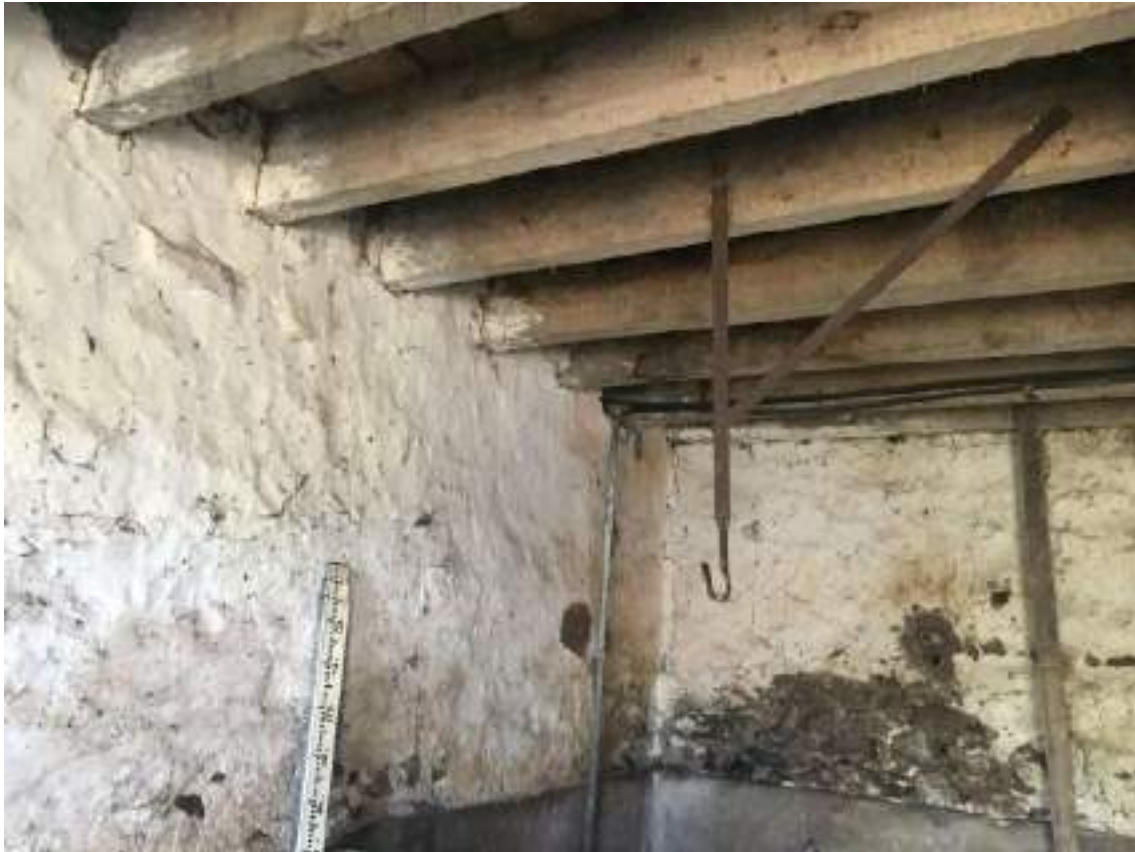
43 Steel hooks fixed to ceiling joists over cattle stalls.

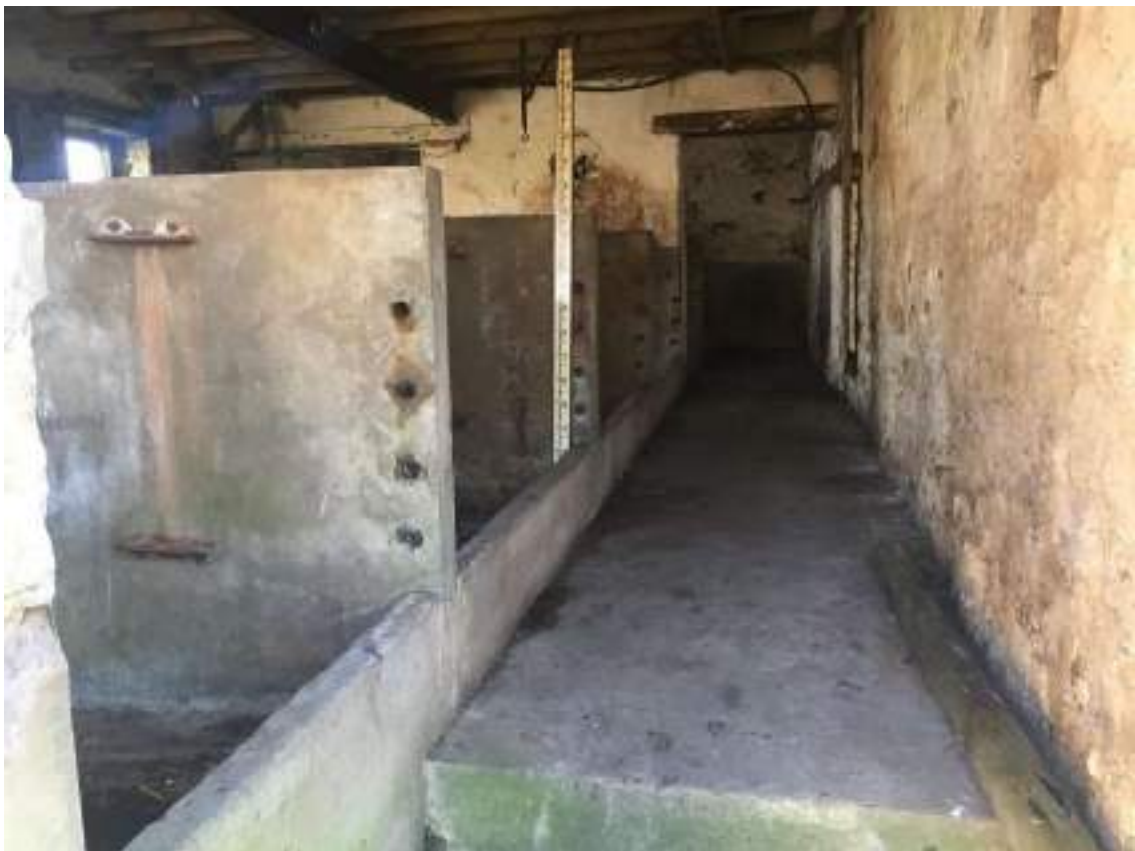
44 View into large shippon showing concrete cattle stalls and raised concrete floor, note low level concrete upstand and holes in stalls where steel tubing has been removed.

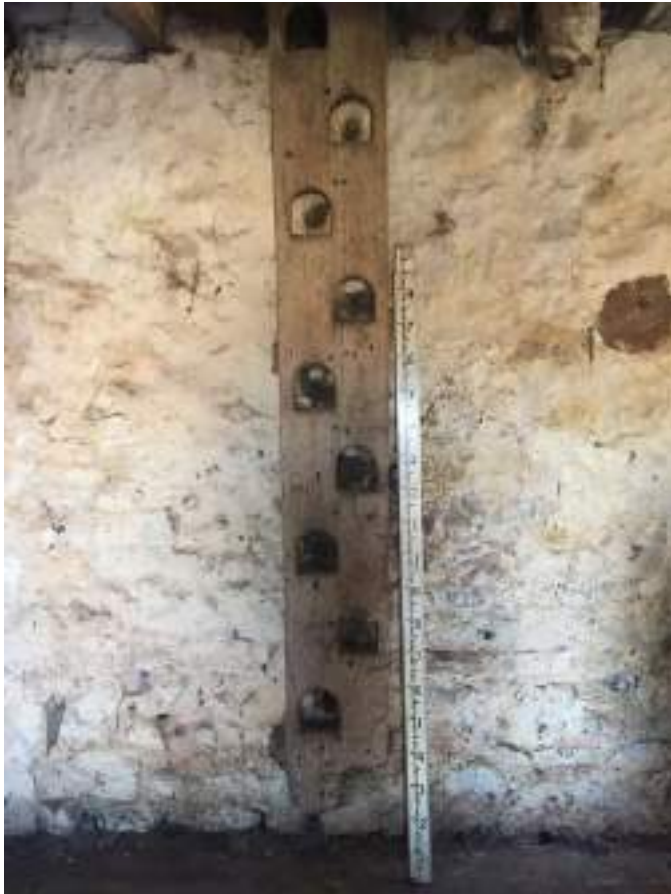
45 Ladder access to first floor hayloft.

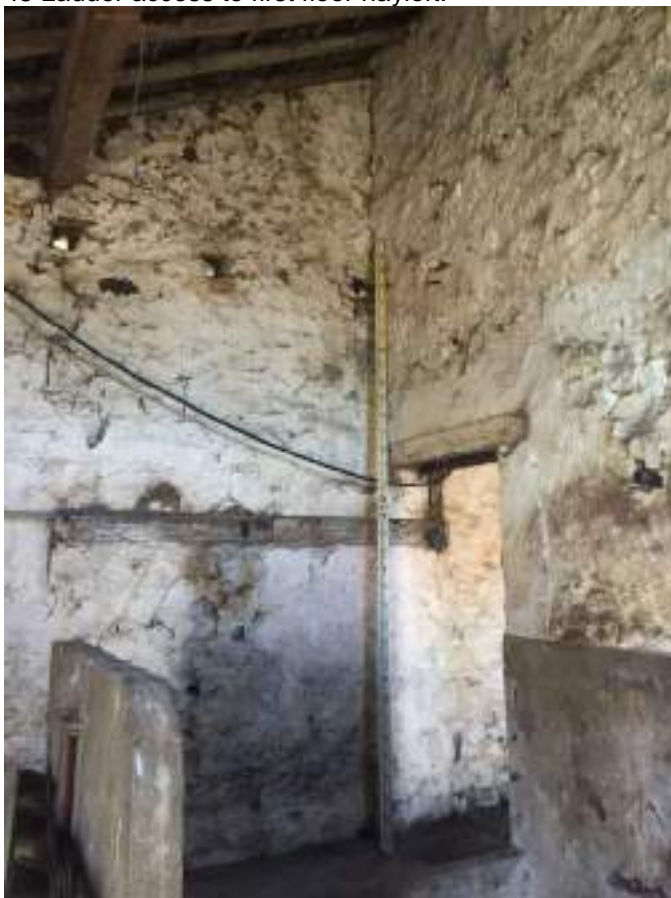
46 View of concrete cattle stalls and separating wall to rear shutout.

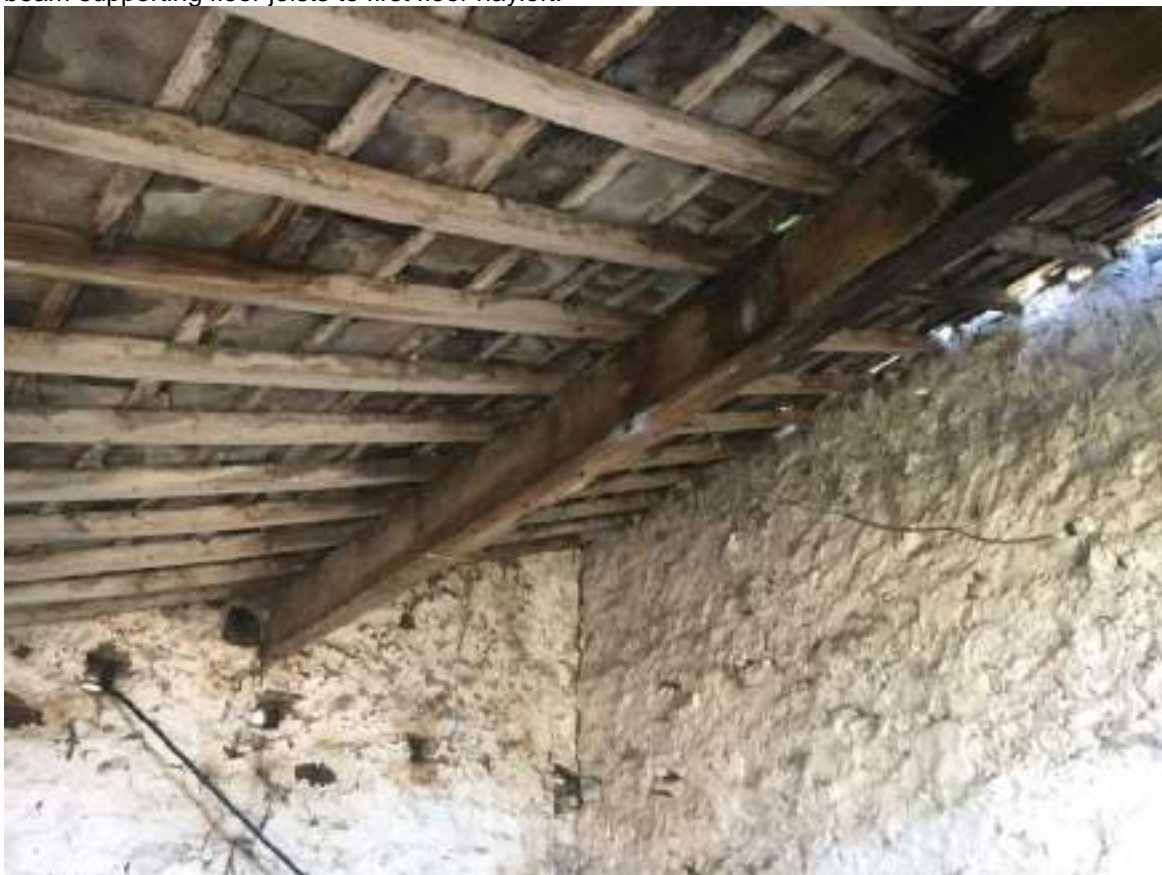
48 View of timber roof to rear shutout showing purlin spanning between gables supporting rafters.

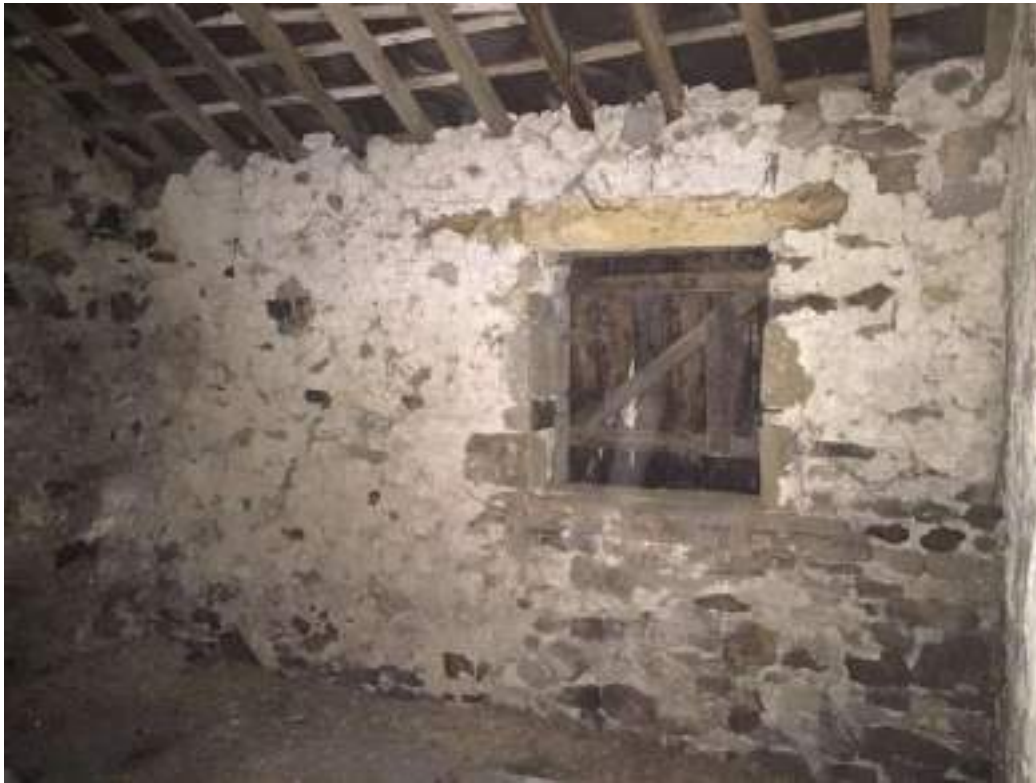
51 Access door to front elevation

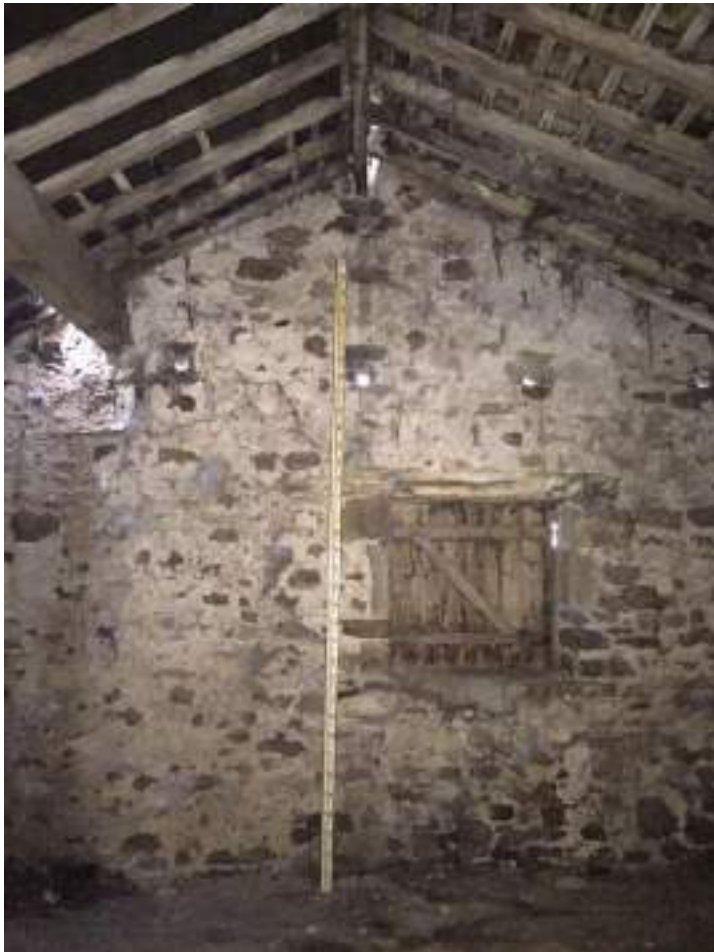
52 Access door to side elevation and detail of roof construction.

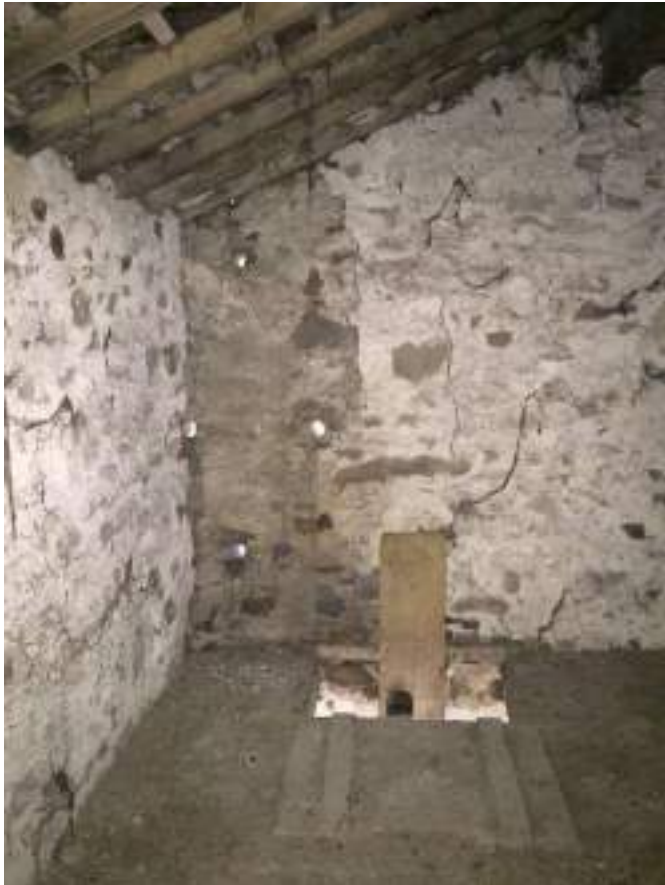
53 Access hatch and ladder. Note ventilation holes to wall

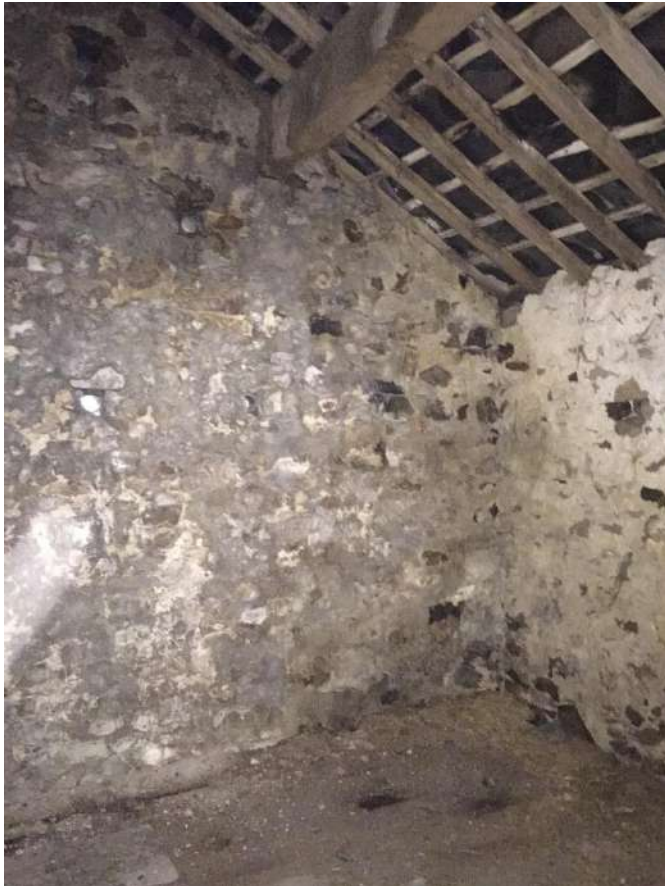
54 North west corner showing wall and roof construction.

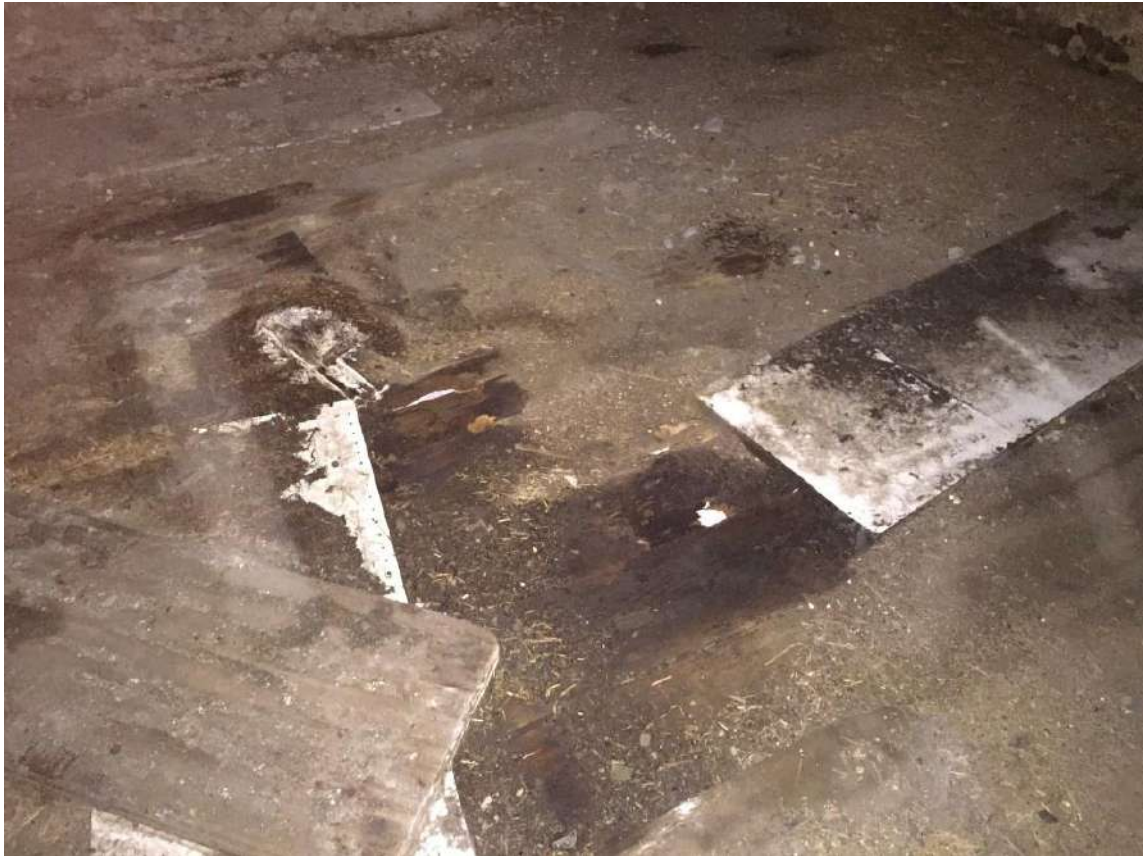
55 Water damage to floor causing rot within floor timbers.

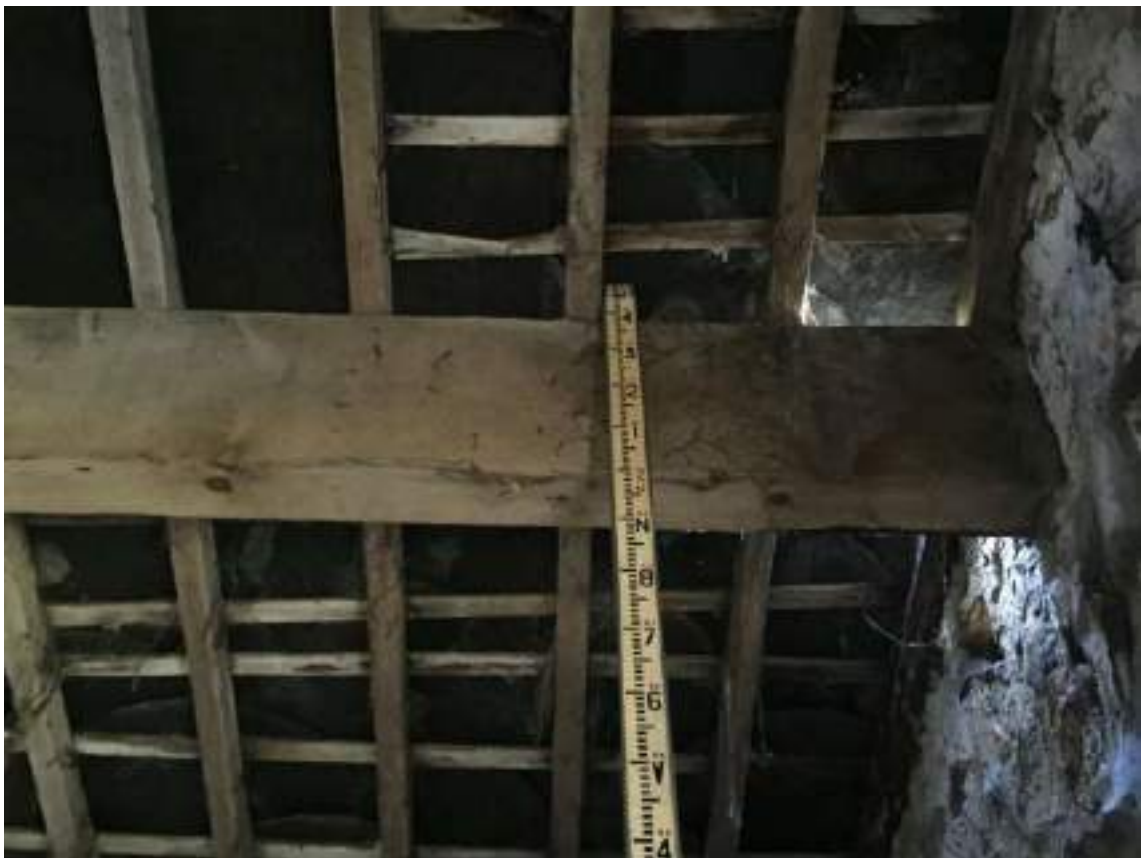
56 Detail of purlin and rafters to roof at first floor level.

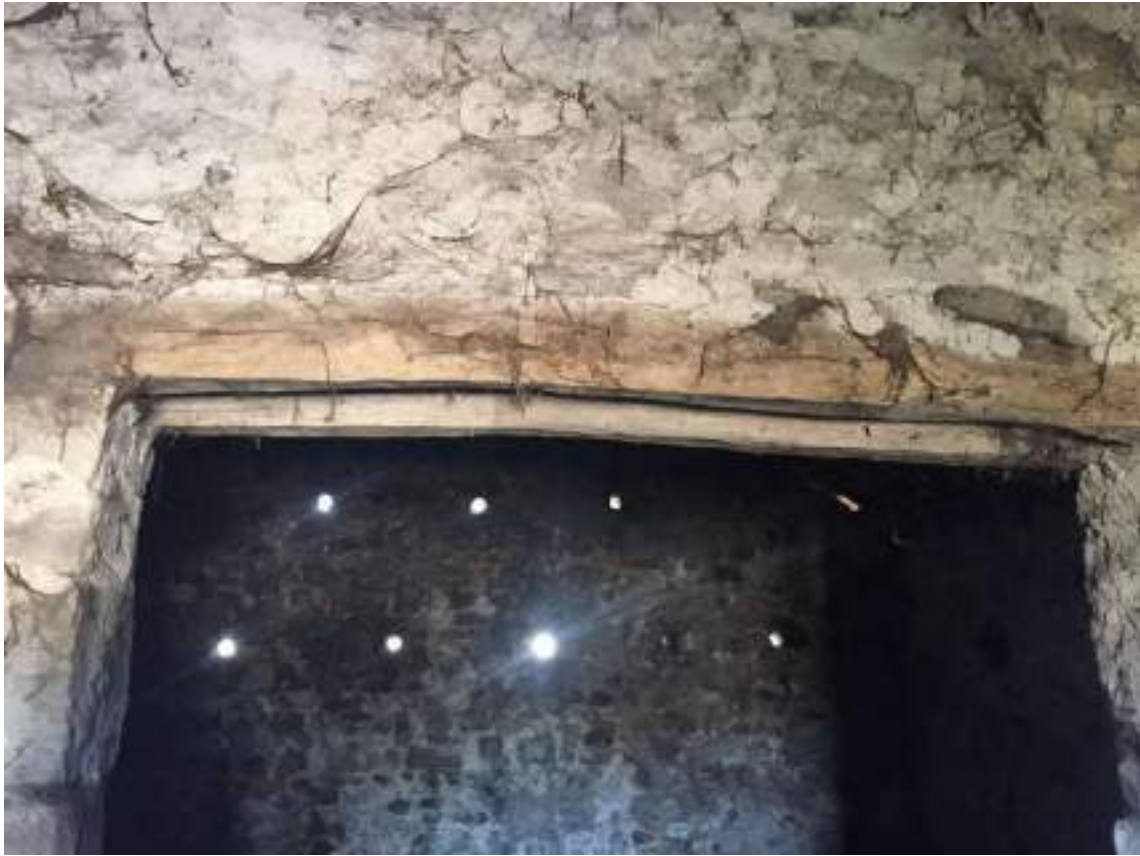
57 View of timber beam to opening between the two first floor hayloft rooms.

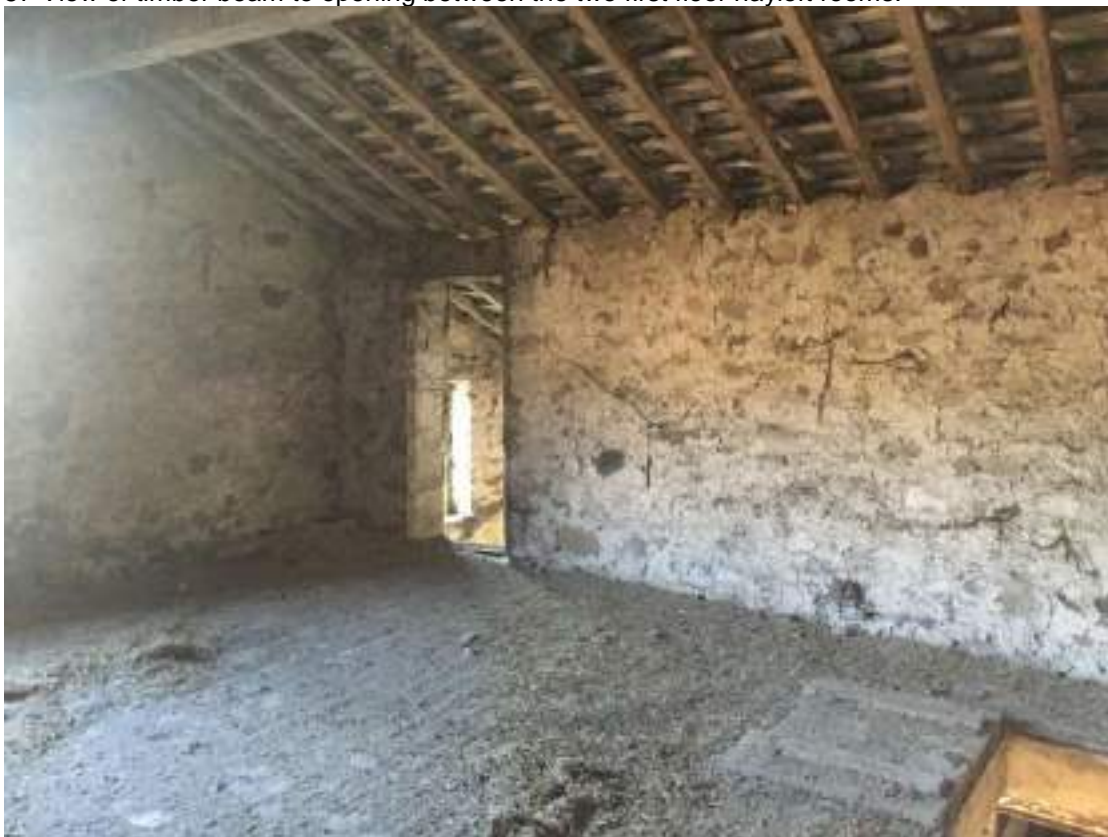
58 View towards southeast elevation showing opening to rear outshut and access hatch.
