spa
SUNDERLAND PEACOCK ARCHITECTS
SURVEYORS

HERITAGE STATEMENT

REF: 4902 DATE: March 2017 VER: 1.01

Waddow Hall – Repairs to Door Surround

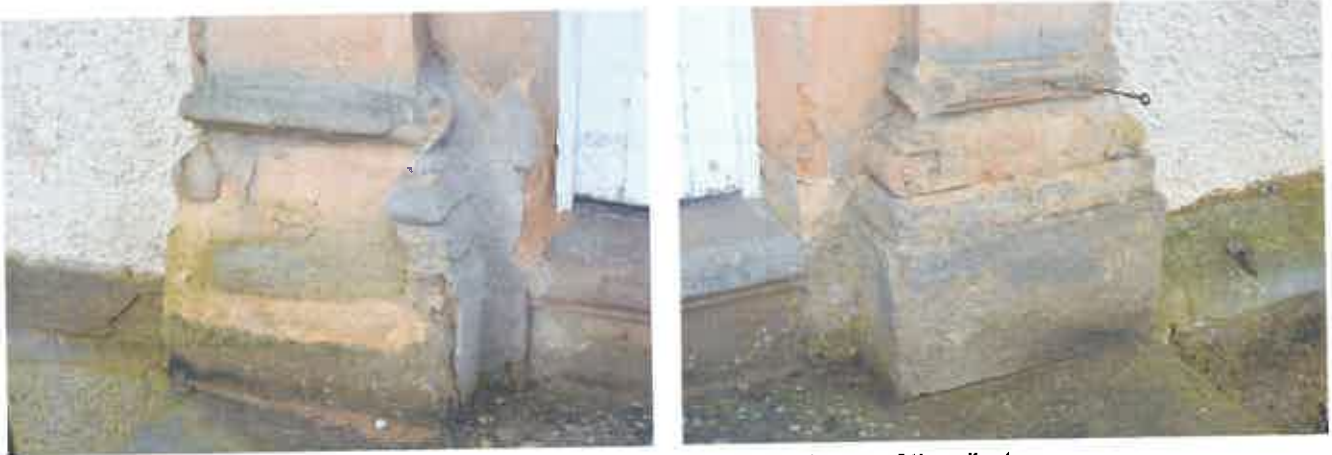
The stone used for the door surround appears to sandstone and is in a poor condition and is exhibiting evidence of both exfoliation, delamination and granular disintegration. This is likely to have been caused as a result of salt crystallisation within the surface pores as the stonework dries out following wet conditions, as well as the failure of the surface crust which is likely to have been caused as a result of hardening which will result in the restriction of moisture movement. Areas of open joints and missing pointing is also evident particularly to the stone steps and the vertical joint to the pediment. Some discolouration, staining and algal growth is also present to the stone surround.

Fig 15: Photographs showing degradation to the bases of the pilasters.

Stone indent repairs are to be carried out by a competent stone mason and are restricted to the pilaster bases and capitals of the door surround. Please refer to drawing reference 5327 - 02 for location of stone indent repairs.

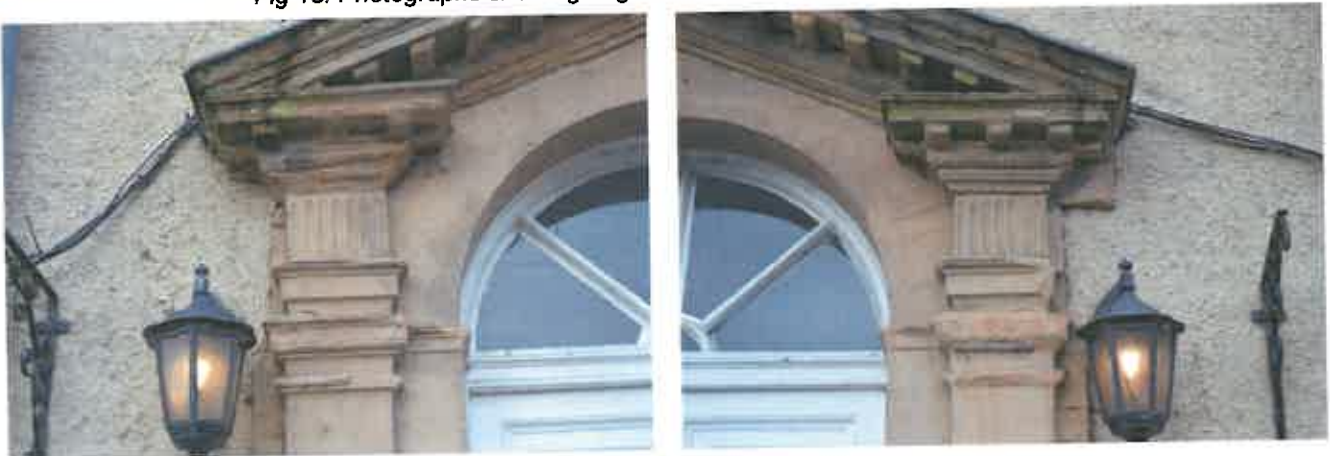
Fig 16: Photographs showing degradation to the pilaster capitals.

Previous repair attempts have also been carried out to the door and consist of a cement repair to the right side of the left pilaster base as well as a minor cement repair to the capital to the same pilaster.

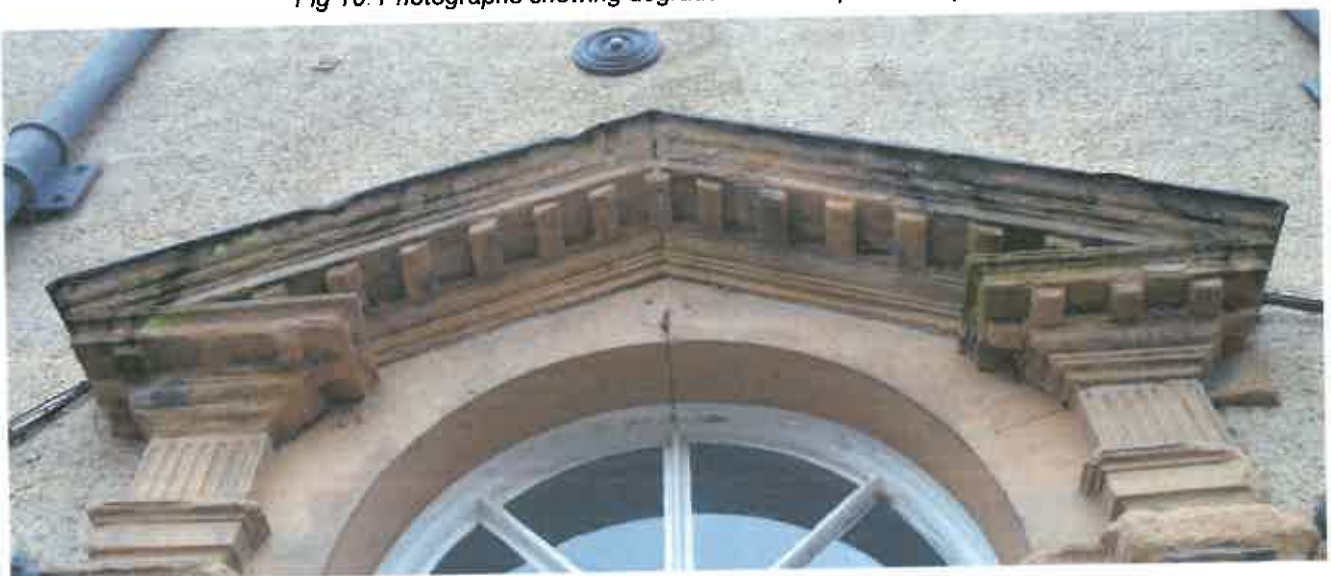
Fig 17: Photographs showing degradation to the pediment.

The joints to the stone steps are to be carefully raked out and any loose debris is to be brushed / cleared out and the joints are to be thoroughly wetted. The joints are to be deep tamped and packed and repointed using a hydraulic lime mortar. The vertical open joint to the pediment is to be cleaned out and repointed using a hydraulic lime mortar.

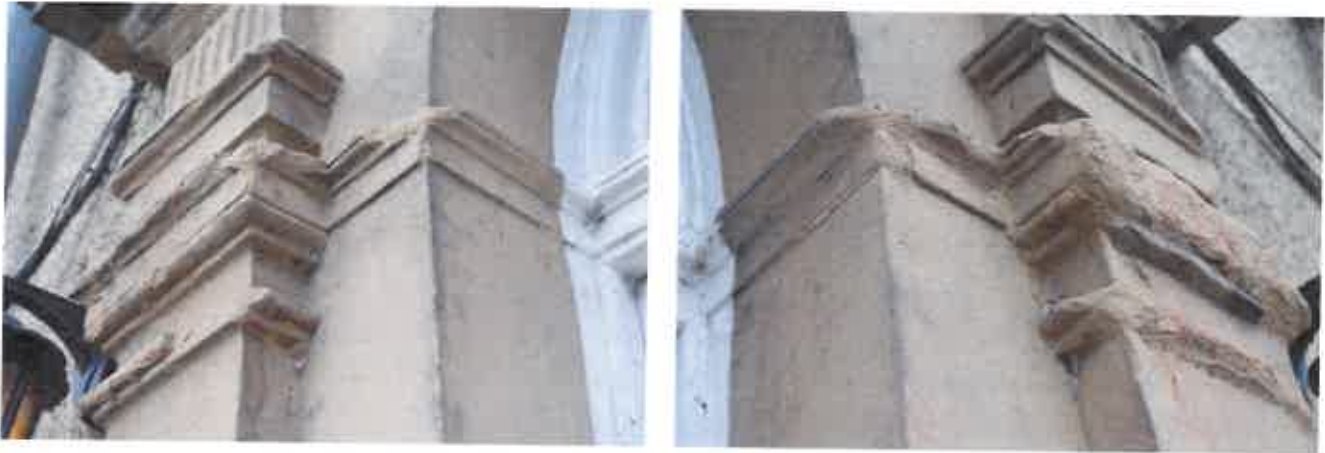
Fig 18: Photographs showing degraded arisses.

The damaged / degraded stonework is to be carefully cut back (by hand) to a sound substrate with the perimeter slightly undercut to avoid feather edges on the completed repair. Any small gaps and fissures are to be flushed out and with water and any surface cracks are to be grouted before any bronze wire or dowel armatures are fixed in place (if required).
