TREE CONDITION ASSESSMENT OF BEECH TREE LOCATED AT REAR OF 1 ST DENYS CROFT, CLITHEROE

Client: Mrs R Mckenzie 1 St Denys Croft, Clitheroe (The resident property owner)

Date of Tree Inspection: 11.8.15

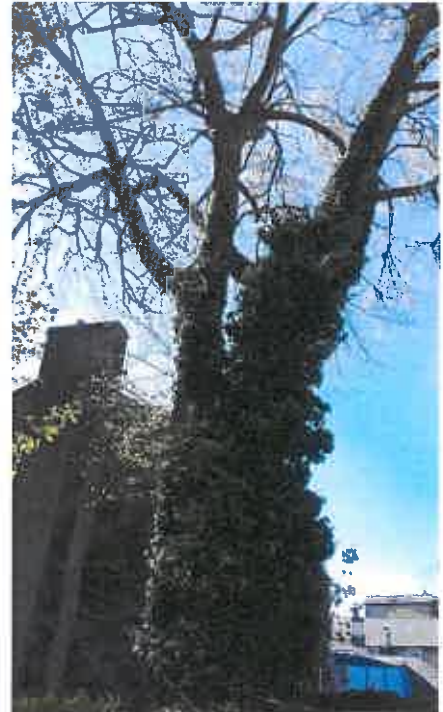
1. The mature Beech tree is located 300mm from the rear garden boundary wall and has a height of 19m and a girth Diameter at 1.5m of 1460mm. The tree is twin stemmed from 2m from ground level with a further co-dominant minor fork at 7m from ground level. Ivy infestation is present up to 8m and this has inhibited visual inspection.

4. The canopy was in early bud burst at the time of the inspection and less than 5% of the canopy tipped showed any sign of dieback. There was no indication or Twig 'crooking' or other signs of senescence. The lower fork showed no signs of an included bark union.

5. The root plate appeared free from any Ganoderma fungal fruiting bodies and there is no past evidence of Meripilus from last November. A digital microprobe tests at two locations around the root plate (Blue spot marked) showed sound timber to a depth of 350mm.

1. The tree has no visible signs of structural defects or internal butt decay or root dysfunction

1. The ivy should be severed at ground level and at 1000mm and allowed to die back allowing the upper branch attachments to be inspected more clearly in future years
2. A secondary branch pruning to achieve a weight reduction of 25% on the limb extending over 1 St Denys Croft would reduce the risk of limb failure. A reduction of the canopy spread by 2m would also be achieved.
3. The lower canopy of the tree is very low over the multiple chimney stack of the adjacent property. Secondary branch pruning to achieve a clearance of 3m is recommended.
