CONVERSION ASSESSMENT

**PROPOSED CONVERSION OF BARNES AT
LYME HOUSE FARM
CHIPPING ROAD
THORNLEY
CHIPPING
PRESTON
PR3 2TE**

FOR MR AND MRS ROPER

Date: 11th May 2017
Our Job Ref: 4971
Author: Louise Read MRICS

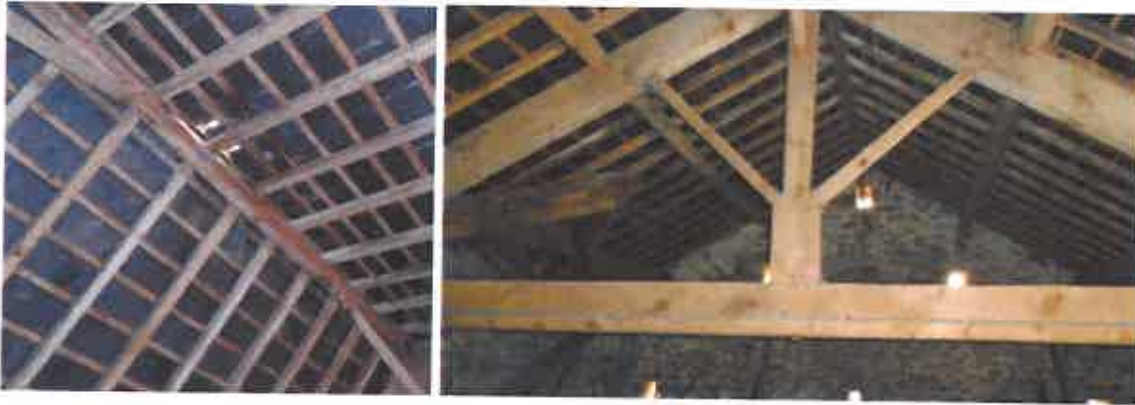
- 2.1 The main barn to the South West, North West lean-to and the Garage/Feed Store to the North West were all finished with slates roofs of varying conditions as discussed below. The roof to the barn to the North East was finished with fibre cement sheeting.
- 2.2 The Barn to the South West had a traditional truss, purlin and rafter construction which was finished with slate. No underlay was present. The roof on the whole was in good condition, with just a few slipped/missing slates noted during the assessment.

Photographs (1 and 2) – Roof structure to South West Barn.

- 2.10 During the course of the development, all of the roofs (excluding the single storey Garage/ Feed Store) will need to be stripped and re-roofed with breathable felt, to firstly bring the roof up to current standards and fully waterproof the structure. The majority of timber members present can be re-used, some will need to have isolated repairs and a few will need to be repaired. All of the slates will be retained for reuse and lead flashings present will need to be renewed to fix any leaks and new flashings introduced as required. The existing fibre cement sheets will be replaced with new profiled roof sheets.

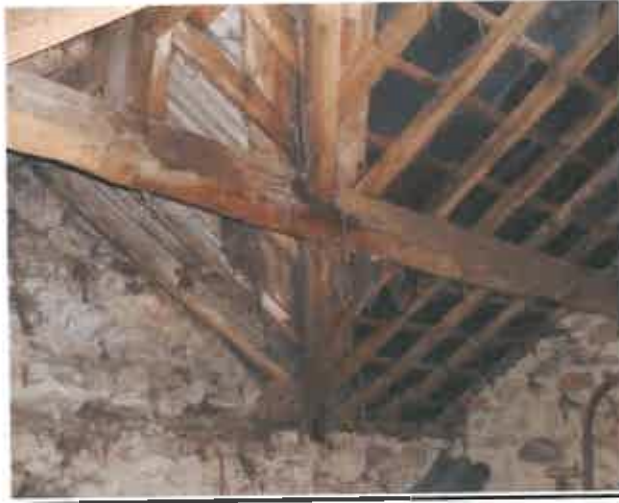
- 2.3 The valley gutter junction at the abutment of the roof to the South West barn and the North East barn was in poor condition, and water is entering the structure at this point.

Photograph (3) – Poor condition of roof junction to the South West and North East barn.

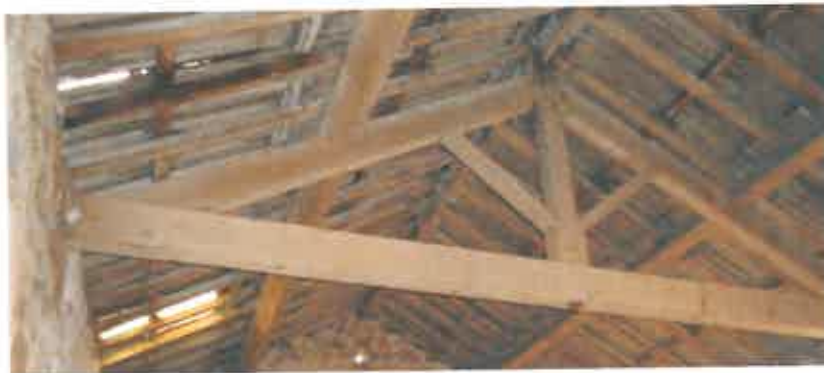
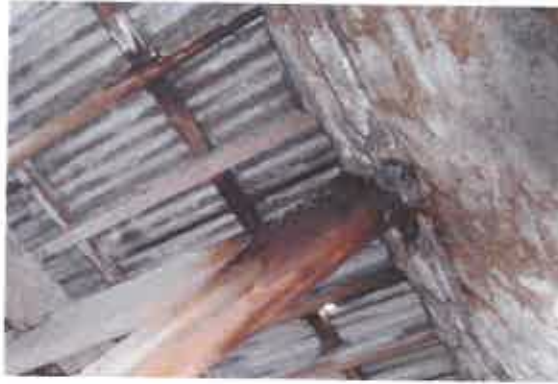
- 2.4 The roof structure to the North East barn consisted of timber trusses, purlins and rafters, supporting the fibre cement sheets. The roof was in average condition, with some obvious leaks visible. Areas of damp timbers were visible and where the timber trusses were built into the rear wall these were rotting.
- 2.5 The roof sheeting to the North East barn has reached the end of its lifespan and will be replaced during the conversion works with profiled sheets. Isolated repairs will also be carried out to the truss ends to ensure they can be retained during the development.

Photographs (4 and 5) – Showing condition of the roof to the North East barn.

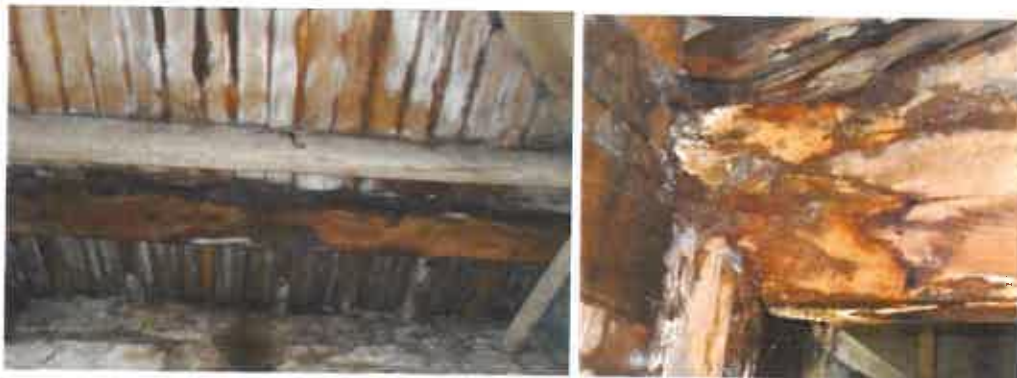
- 2.6 The lean-to barn to the North West's roof structure was made up of timber trusses with purlins over, lined to the underside of the slates with timber boarding. There were numerous areas of staining to the underside of the boards where the roof was leaking, the roof is clearly in poor condition.
- 2.7 The roof leaks were worse at the junction of the barn with the adjacent walls/ roofs and at the position of the valley gutter. The majority of timber trusses were rotten where they were built into the masonry walls, in these locations repairs will need to be carried out to the timber. The valley member will need to be replaced as it is likely this member is beyond repair and reuse.

Photographs (6 and 7) – General condition of the lean-to roof.

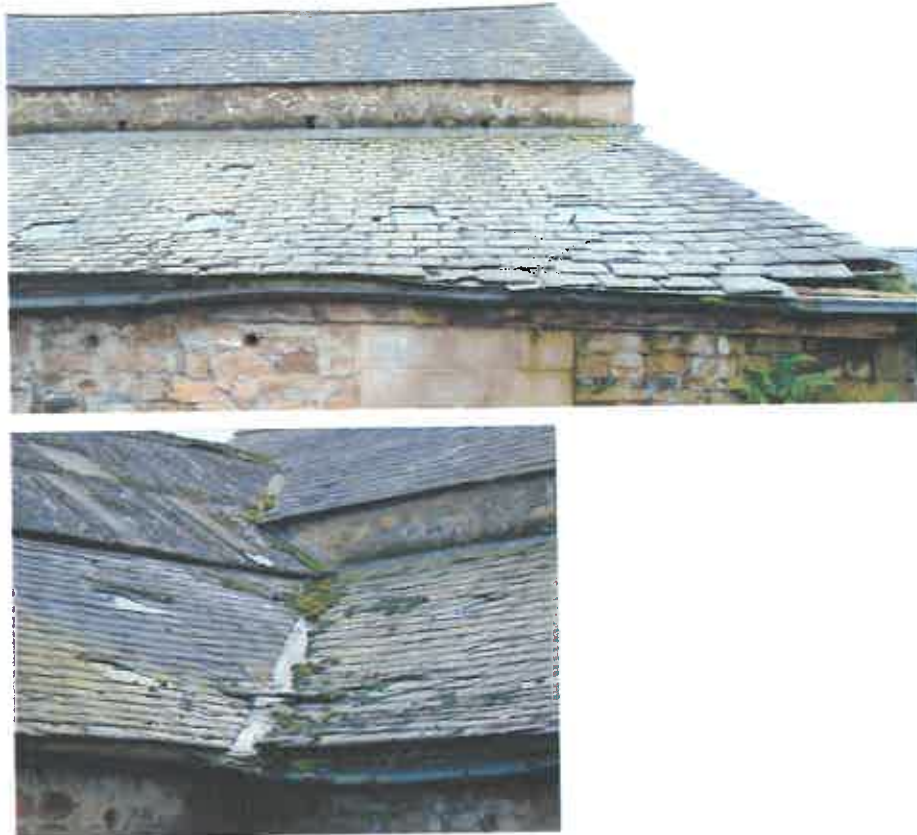
- 2.8 Externally the lean-to roof was sagging, a number of broken/ missing slates were visible at low level. At the top of the valley numerous slipped slates were visible, there was also widespread green staining

and moss growth. The flashing details to the top of the roof were poor/ none were present which has led to the damp noted internally mentioned in point 2.7. The slates at the eaves were also in poor condition.

Photographs (8 and 9) – General condition of the lean-to roof.

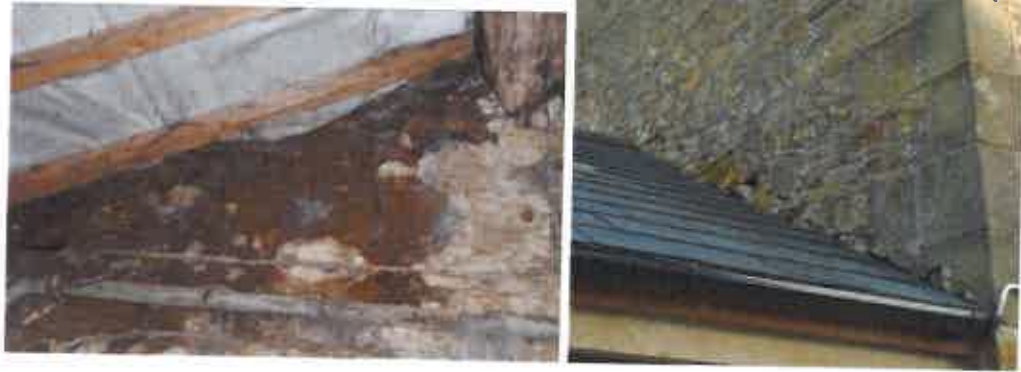
- 2.9 The roof to the single storey Garage/ Feed Store was constructed from purlins and rafters, felted with slate finish. The roof on the whole was in good condition, however slight water ingress was noted at the roof/ wall abutment where no lead flashing is present.

Photographs (10 and 11) – General condition of single storey roof.

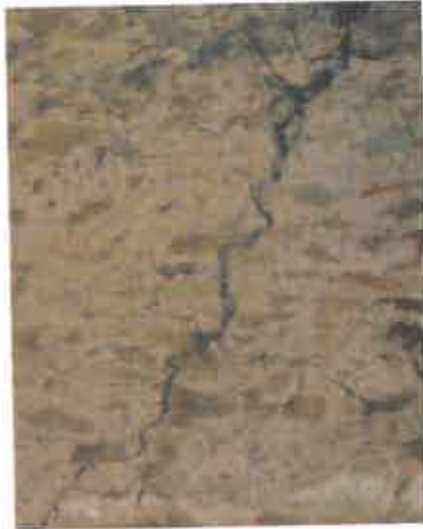
- 2.11 The barn walls are of traditional solid masonry construction. Walls of this type were traditionally built up in two leaves with rubble fill in the cavity between.
- 2.12 The walls were in reasonable condition given the barns age. The majority of walls were straight and true, however the walls to the Shippon/ Storage Area were in slightly worse condition than the other walls. In the first floor Storage Area a crack was visible to the wall abutting the store and part of the internal stone work had collapsed adjacent to the window, in this area isolated repairs will need to be undertaken.

Photograph (12) – Showing the crack within the Storage Area.

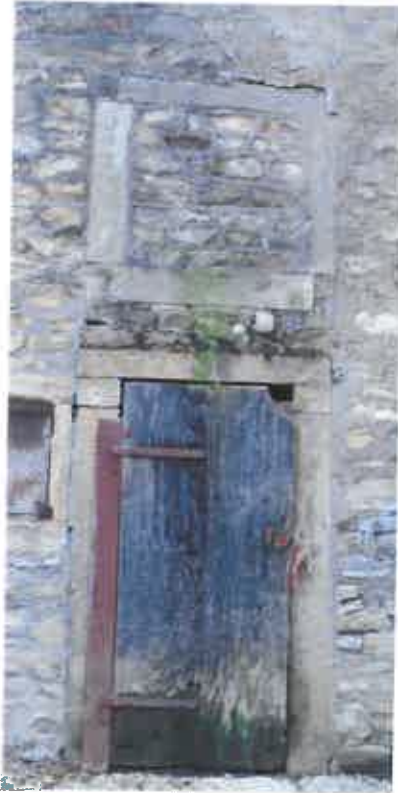
The external wall to the Store was bowing out slightly at door head height, the wall in this area requires re-building. The “L-shaped” external wall to the lean-to is extremely damp due to the poor condition of the roof. The 2 no external comers will need to be partially re-built as they are bowing out and cracks are visible. The LHS window surround to the first floor Storage Area when viewed externally needs to be replaced due to the extensive cracking present. All walls will need re-pointing during the conversion works.

Photograph (13) – Showing the Store wall which needs re-building.

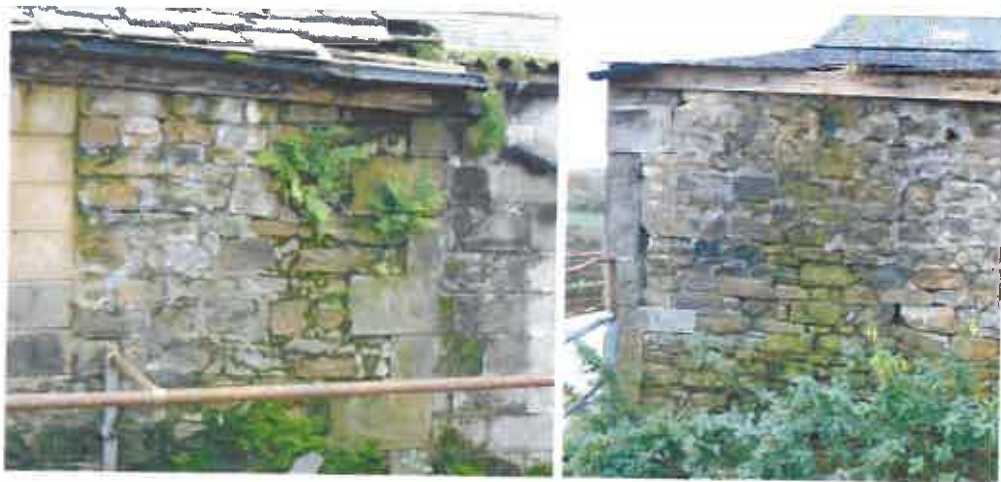
Photographs (14 and 15) – Showing the external corners to the lean-to which need re-building.

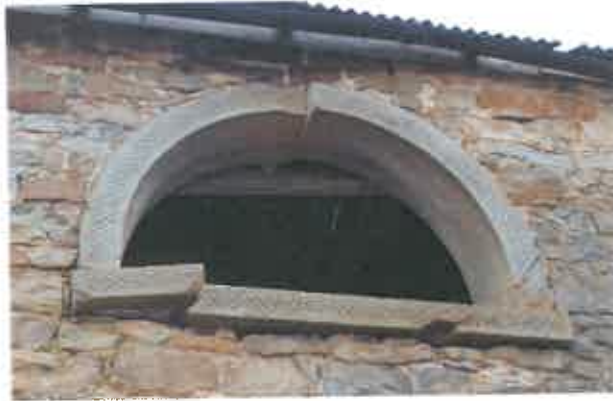
Photograph (16) – Illustrating the condition of the Storage Area window surround that needs replacing.

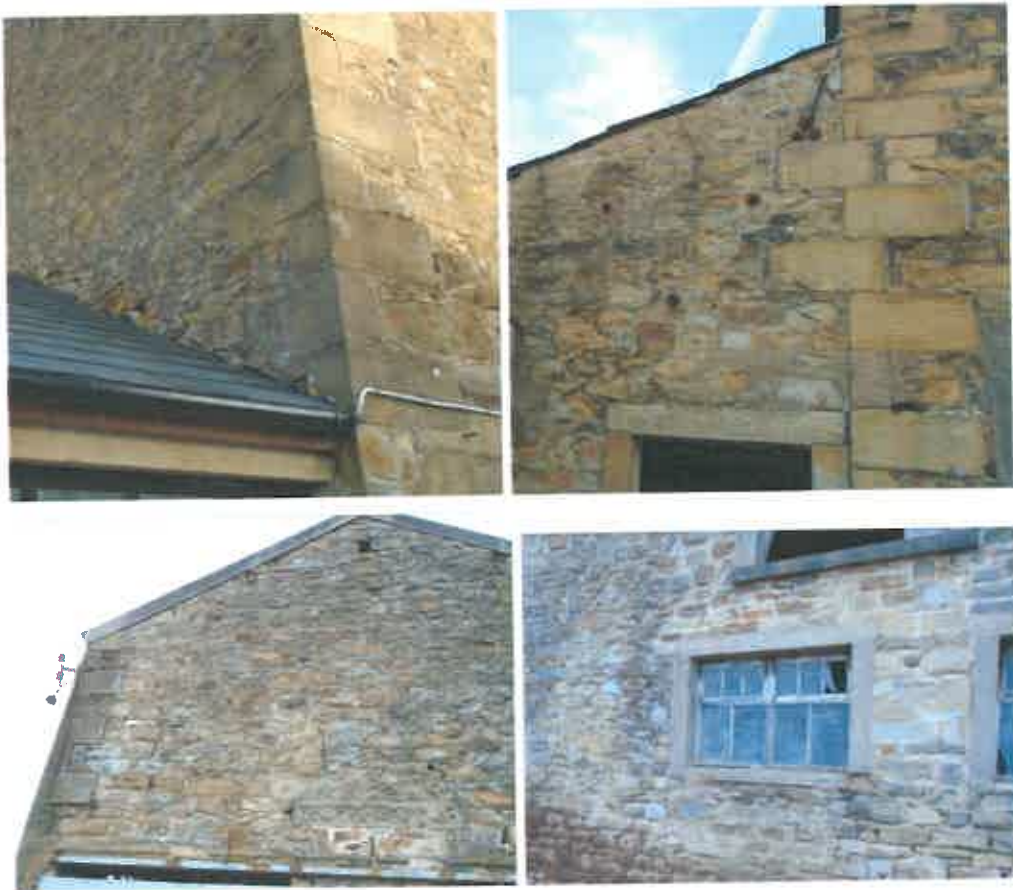
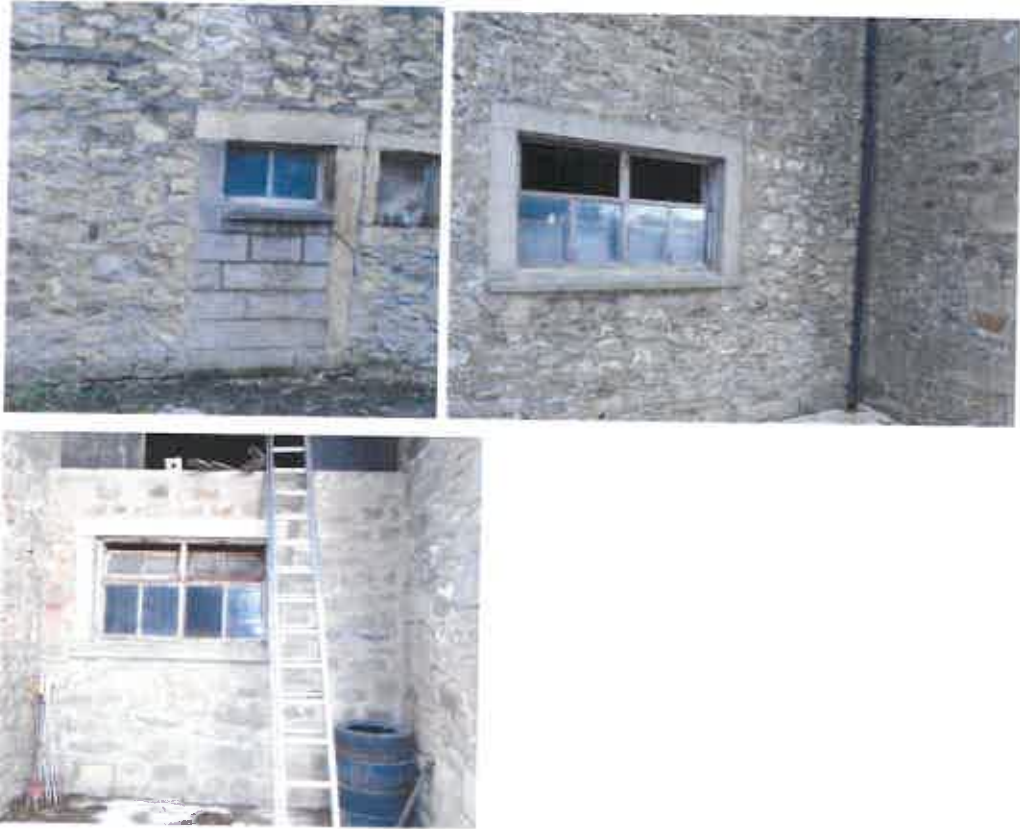
Photographs (17 - 23) – Illustrating the general condition of the walls.

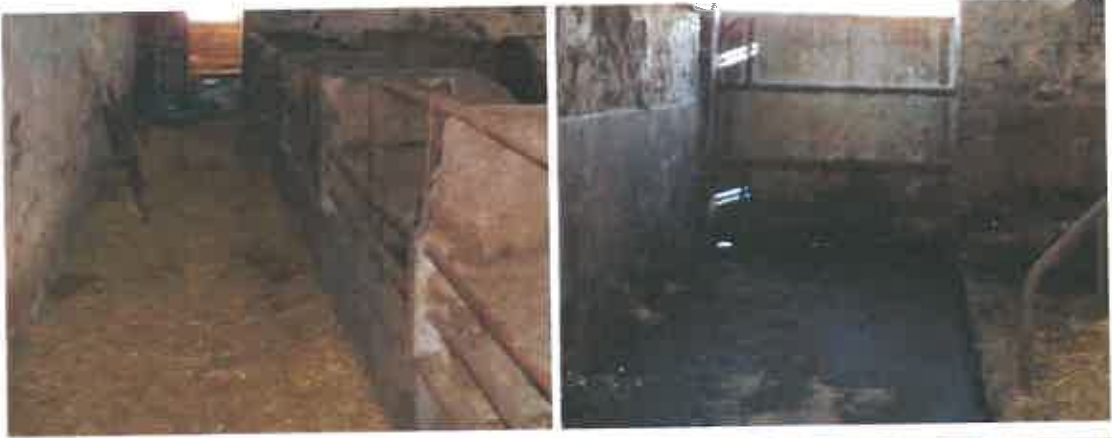
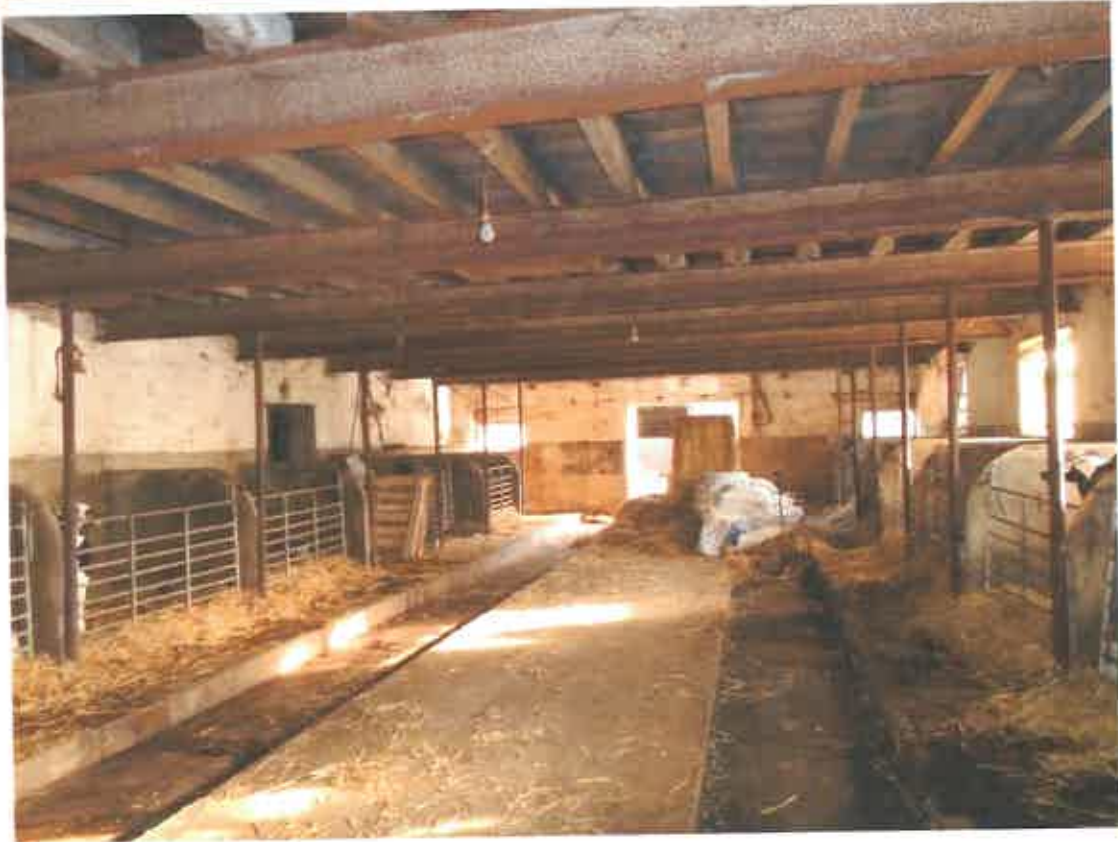
2.13 The existing floors to the barns (where visible) was constructed from concrete, the floors appeared in reasonable condition. They will however need to be dug up and a new floor laid during the conversion works in order to satisfy the requirements of the building regulations in relation to heat loss.

Photographs (24 - 26) – Illustrating the floors visible / condition of the floors within the barns.
