**Advice note – Clitheroe Castle**

**Inspection of area proposed for roof refurbishment – 13<sup>th</sup> June 2017**

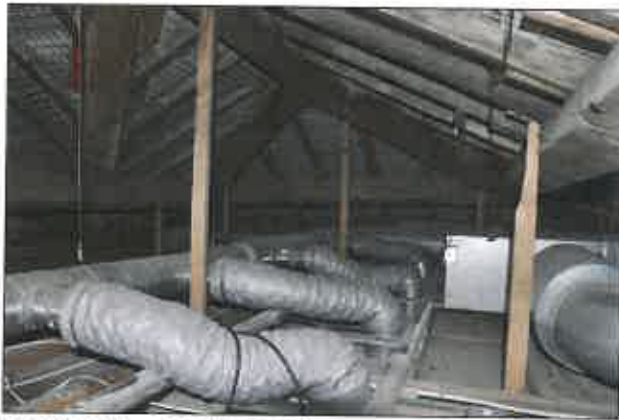
***Roof void – south section***

The roof is supported by rafters and comprises a slate covering, underdrawn with a modern breathable membrane. Metal mesh has been installed below the roof lining.

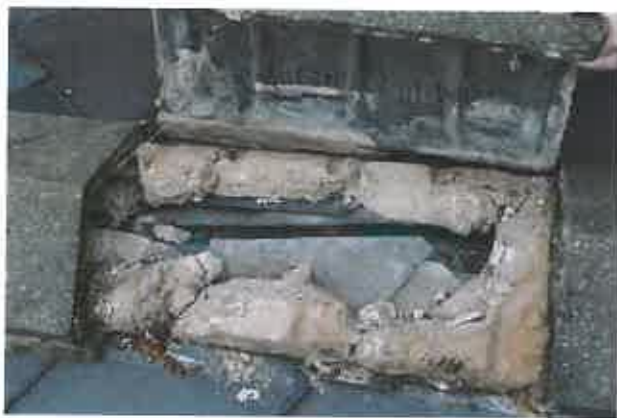
***Lifted ridge tile showing unmortared section beneath – potential bat roosting feature***

The roof coverings are in a poor condition, with deterioration clearly evident along the ridge and all pitches.

It is recommended that if possible, features are built in to the refurbished roof, that will provide permanent roosting opportunities for bats, without creating any issues with the fabric or condition of the building. An example of a bat slate is included below.

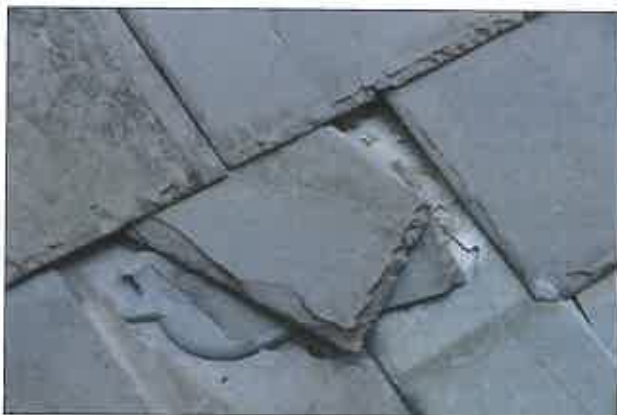
***Slipped and broken slates – potential access point for bats***

As a matter of good practice, it is also recommended that Type 1 bitumastic roof liner is used as part of the roof refurbishment works. This should be used in place of any modern roof membranes, which have been found to be harmful to bats.

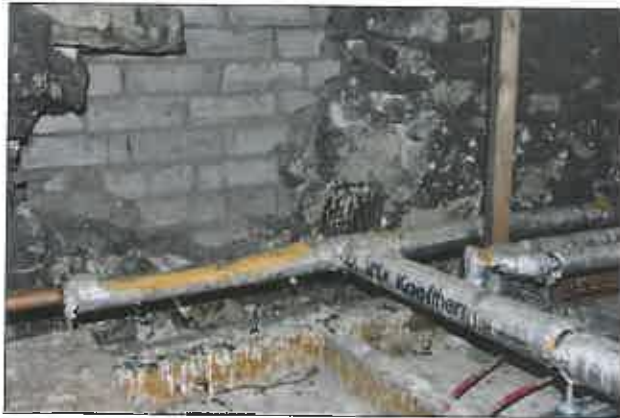
The roof void was dry at the time of the survey, and showed abundant signs of a previous feral pigeon infestation.

***Clear signs of previous pigeon infestation in roof void***

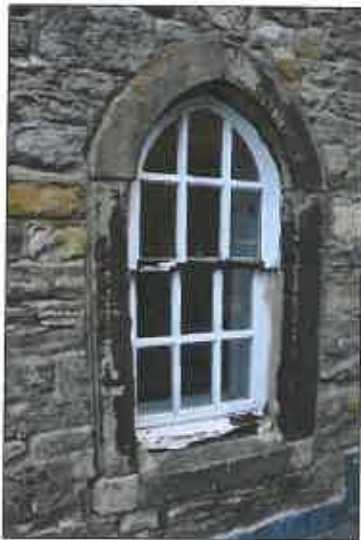
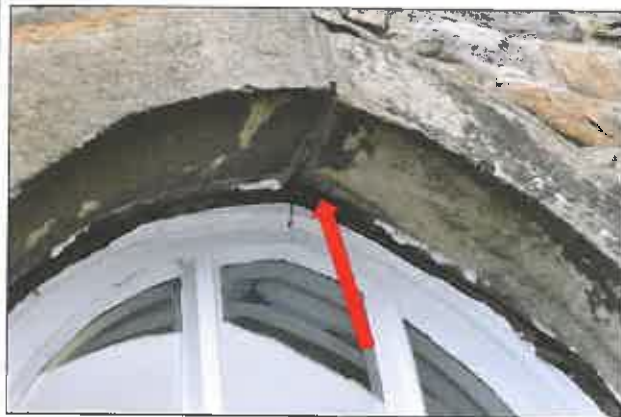
Two windows lie immediately adjacent to the proposed work area. Both windows support features with potential for use by roosting bats. The features comprise cavities between the window frame and the wall.

***Smaller window on south west elevation – cavity marked with arrow***

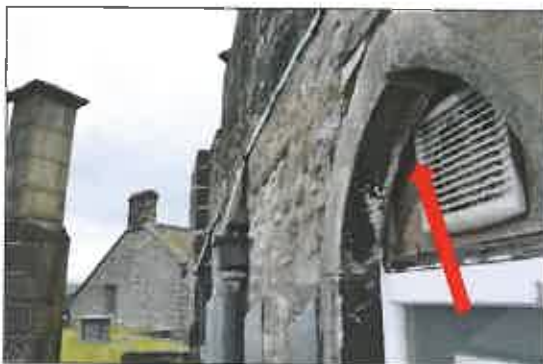
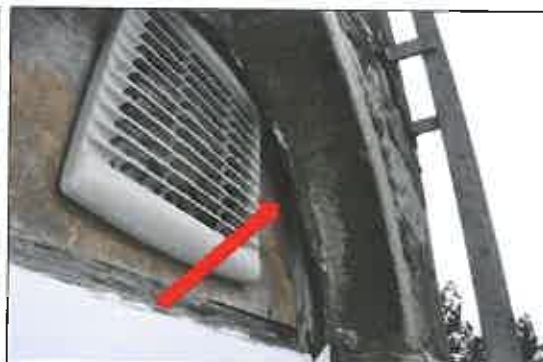
***Larger window on south west elevation (roof access point) – cavities marked with arrows***
