Tree Condition Report

Rear of St. Mary's Centre,
York Street,
Clitheroe,
BB7 2DG

St. Mary's Church

Job Ref: 1089

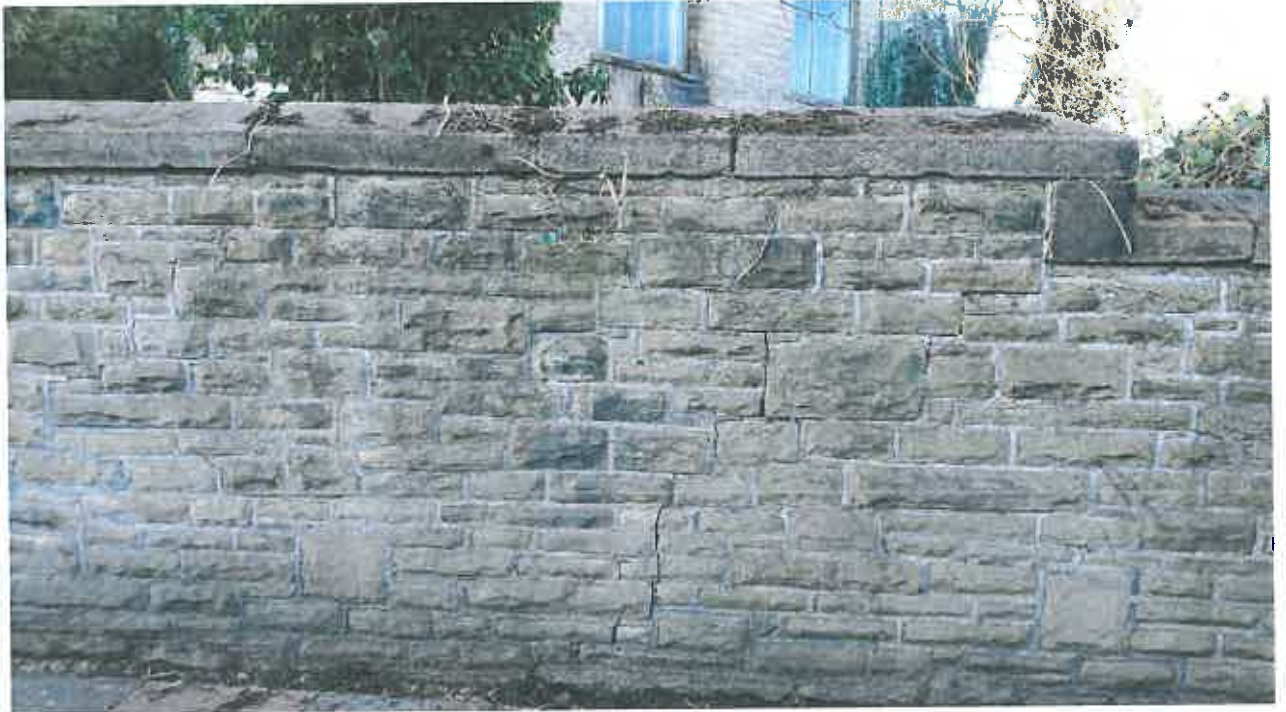
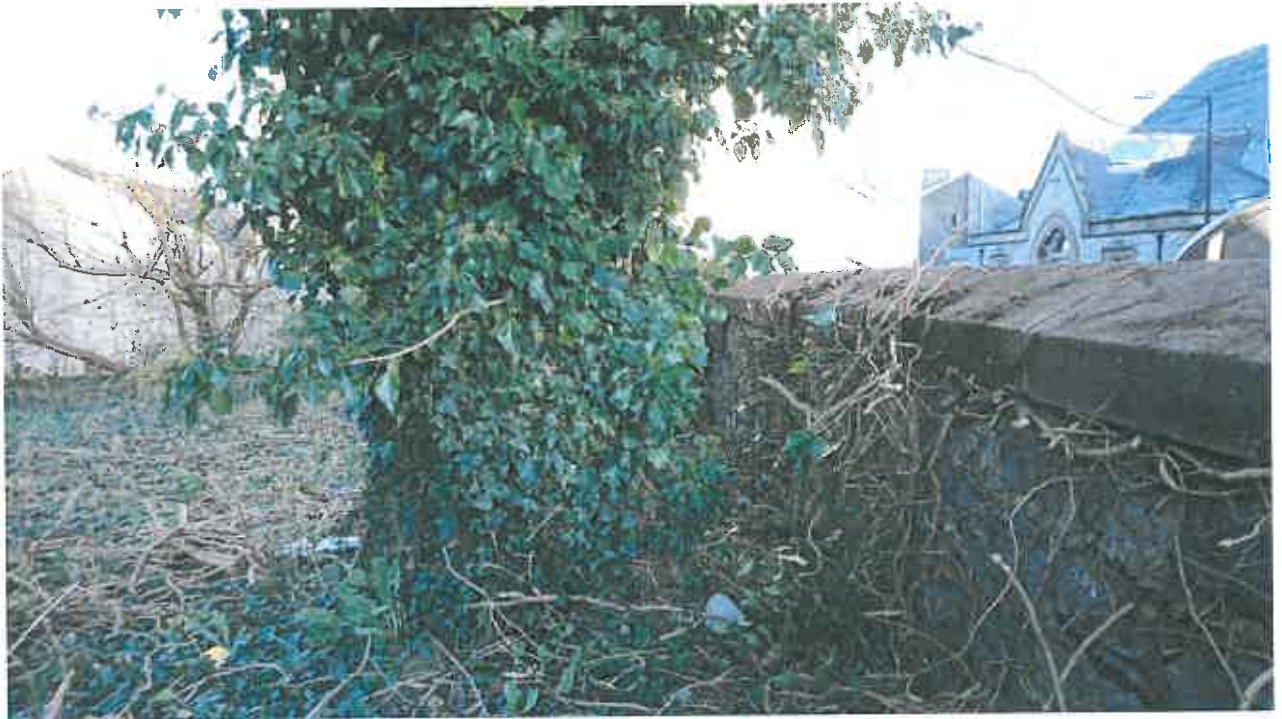
18. Photos

The Ash trees stem is located 60cm from the retaining wall. There are cracks visible in the masonry and pointing and there is a high probability that the trees root system has displaced the wall and caused it to crack due to incremental growth. Future growth of the tree will in my opinion continue to displace the wall, it is beyond my area of expertise to say how long this will take.

The structural engineer has stated that "it is difficult to predict when collapse of the wall will occur, but it may be sudden and without warning" – with this, in my opinion removal of the tree will minimise the risk of such a collapse both now and in the future and mitigate any foreseeable risk to the public and local properties.

As the retaining wall requires remedial works to make it safe both now and in the future as a long-term management solution I recommend that the tree is removed to mitigate any risk of the tree causing more damage to the retaining wall and therefore reducing any foreseeable risk to the public from a collapse of the wall and potential failure of the tree into this high occupancy area of the town. It is recommended that this work is undertaken within 6 months of the writing of this report.
