**STRUCTURAL INSPECTION**

**BARN AT WITTONS FARM  
BOLTON-BY-BOWLAND**

**MR STEPHEN FLANAGAN / IWA ARCHITECTS**

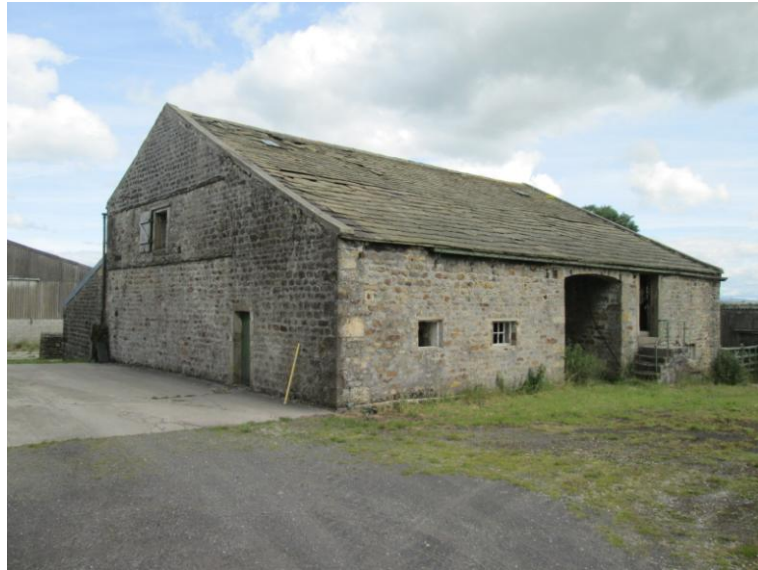
The property is a stone-built barn and has the date 1826 marked on the keystone of the arch above the main front door. It is generally single-storey, with a small first floor workshop accessed from an external stone stair located at the front right-hand corner (**photo 1**). A hay loft is provided above livestock stalls, also on the right-hand side of the barn. There is a single-storey lean-to shippon at the rear of the main barn, extending its full length (**photo 2**).

Photo 1 – Front of Barn

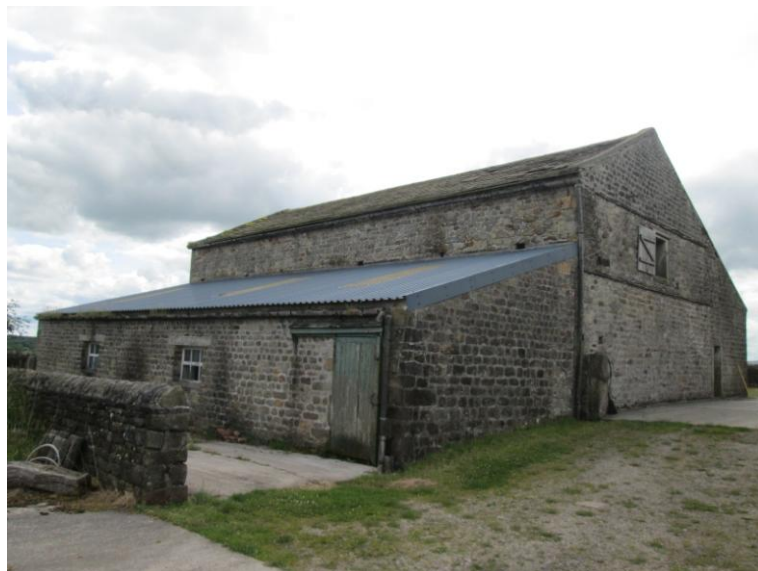
Photo 2 – Rear of Barn

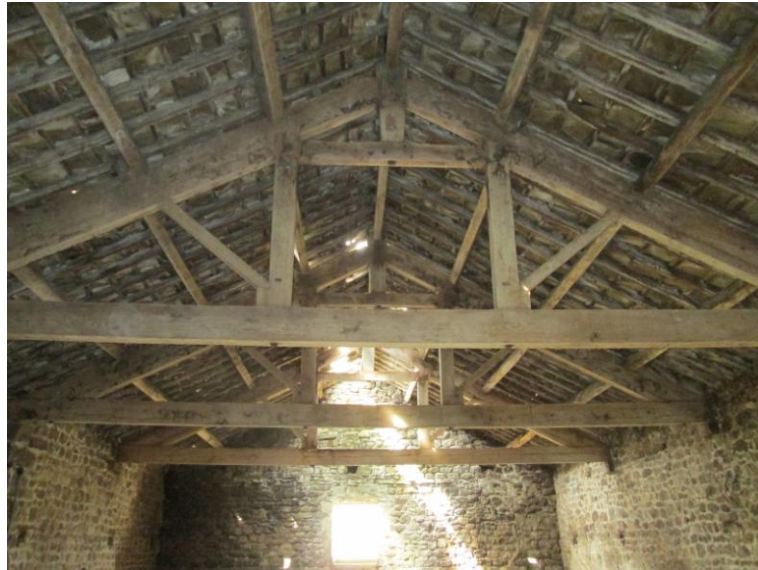
The walls of the barn are of traditional, solid, random stone masonry. The main roof is of stone slabs supported on timber rafters, timber purlins and timber queen-post trusses in the middle part of the barn, or sloping timber beams at the front (**photo 3**). The roof of the shippon is of modern steel sheeting supported on timber purlins and sloping timber beams. The upper floor of the hayloft is of relatively modern construction, of timber boarding on sawn timber joists supported by steel beams and posts (**photo 4**). The floor of the workshop is of older, perhaps original, construction, with rough timber boarding and hewn timber beams. The floor of the main part of the barn is of earth or stone cobbles. The floors of the shippon and other livestock areas are of concrete.

Photo 3 – Roof Structure

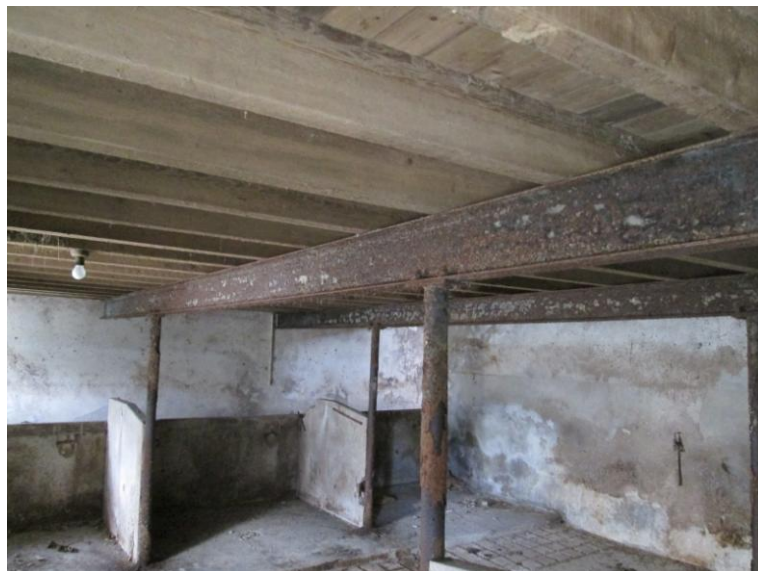
Photo 4 – Underside of Hayloft above Livestock Stalls

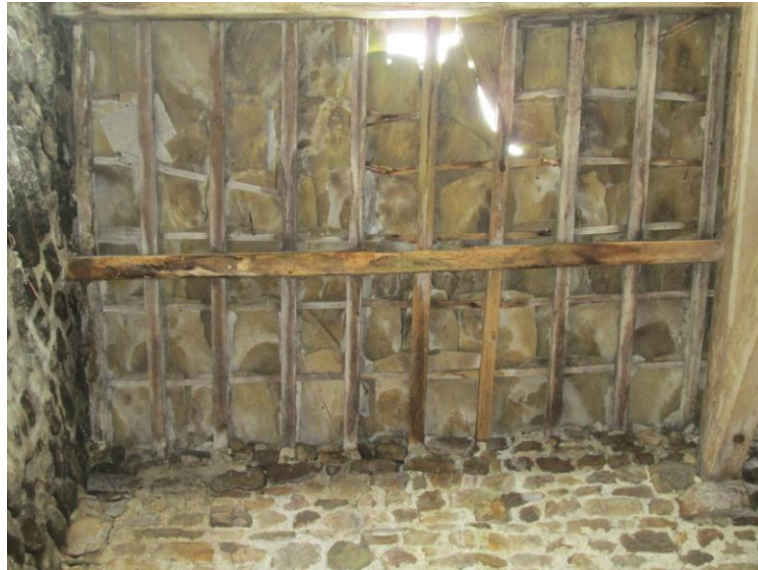
- In the main part of the barn, areas of missing and broken slates have allowed rainwater to cause localised damage to the roof timbers.
- The rafters and purlins closest to the left-hand gable are worst affected, in particular the lowest purlin on the left, which shows signs of advanced decay (**photo 5**). All purlins which are supported on the left-hand gable wall show signs of decay (**photo 6**).
- The roof truss closest to the left-hand wall shows signs of staining and localised decay (**photo 7**).
- A purlin above the workshop shows signs of water staining and localised decay (**photo 8**).

Photo 5 – Left-Hand Gable - Decayed Purlins and Rafters

The roof timbers of the main barn are in reasonable condition but have experienced localised decay where subjected to rainwater ingress due to missing slates, or to damp penetrating the stonework at purlin, truss and rafter bearings. We would recommend that the rafters are replaced, the purlins inspected and replaced where necessary, and the main timber roof trusses inspected and repaired as required, with particular attention given to the truss bearings at the walls.

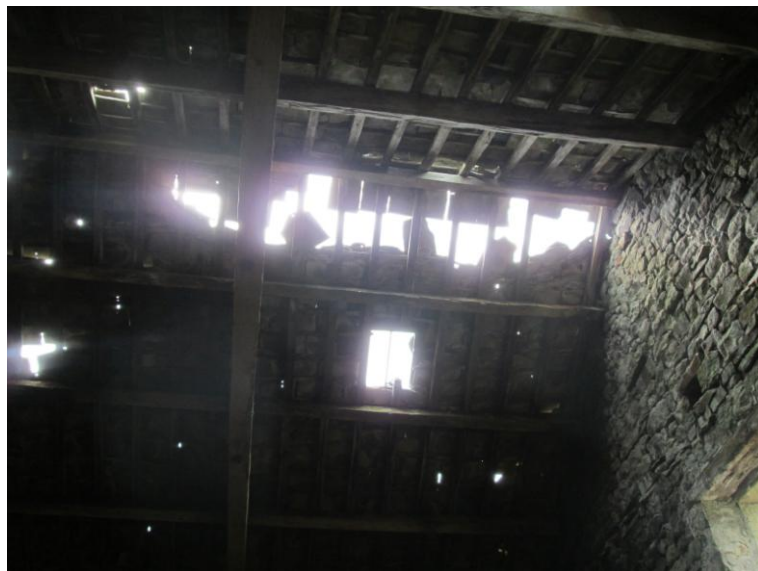
Photo 6 – Missing Slates and Damaged Timbers

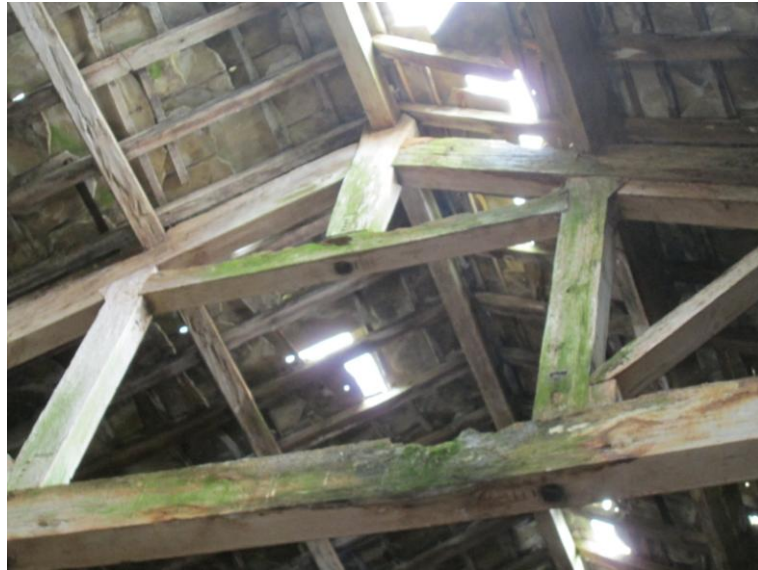
Photo 7 –Stained and Decayed Roof Truss

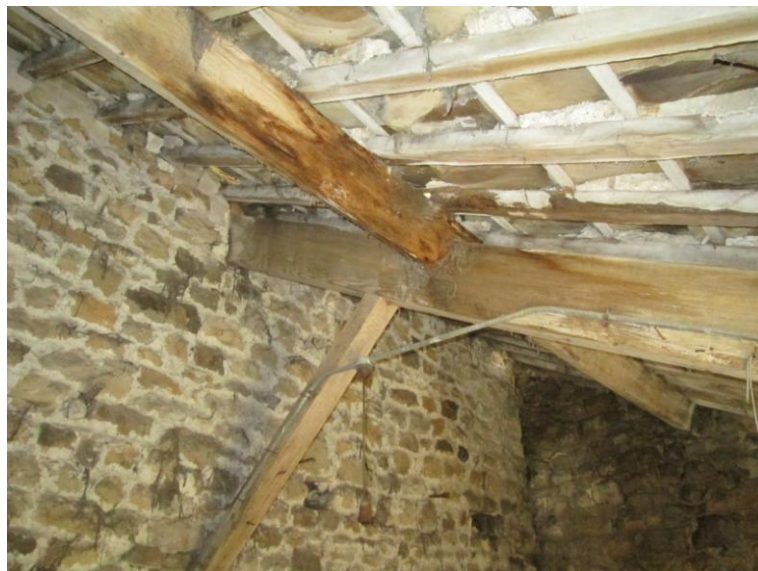
Photo 8 – Stained and Decayed Purlin over Workshop

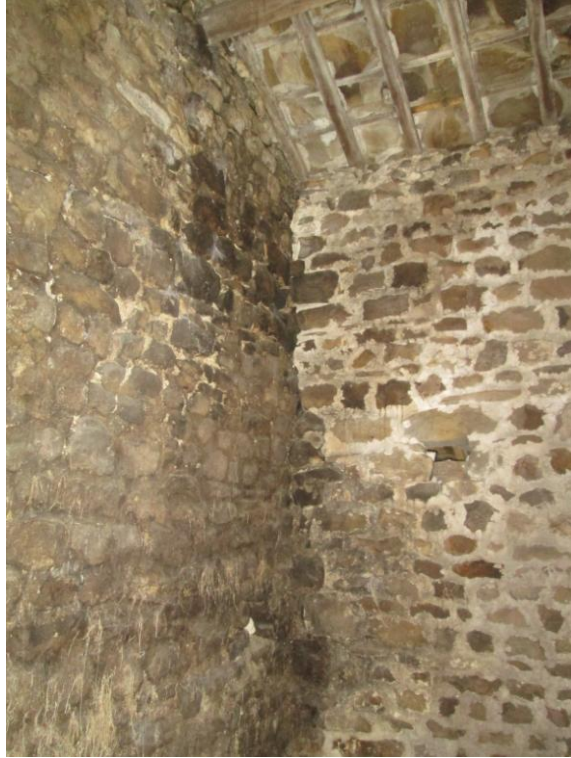
- There are signs of separation between the internal wall and the right hand gable wall, with a vertical crack forming at the junction (**photo 9**). A steep diagonal crack was noted close to where the rear wall joins the right-hand gable wall (**photo 9a**).

Photo 9 – Separation between Right-Hand Gable Wall and Internal Wall

The walls are reasonably straight and vertical apart from where noted in the previous section. Defects are generally associated with a lack of bonding at wall junctions, and cracking due to thermal movement. No signs of significant foundation movement were noted. Cracks in the stonework should be repaired by stitching, either with bonding stones or with steel reinforcement set in epoxy resin or concrete bond beams. Minor cracks and open joints in the stonework should be raked out and pointed with lime mortar. The upper part of the right-hand gable wall may need to be re-built to correct the outward lean. We would recommend that all timber lintels are removed and replaced with new concrete items. Poorly consolidated areas of stonework, mainly to in-filled windows or doors, should be re-built.

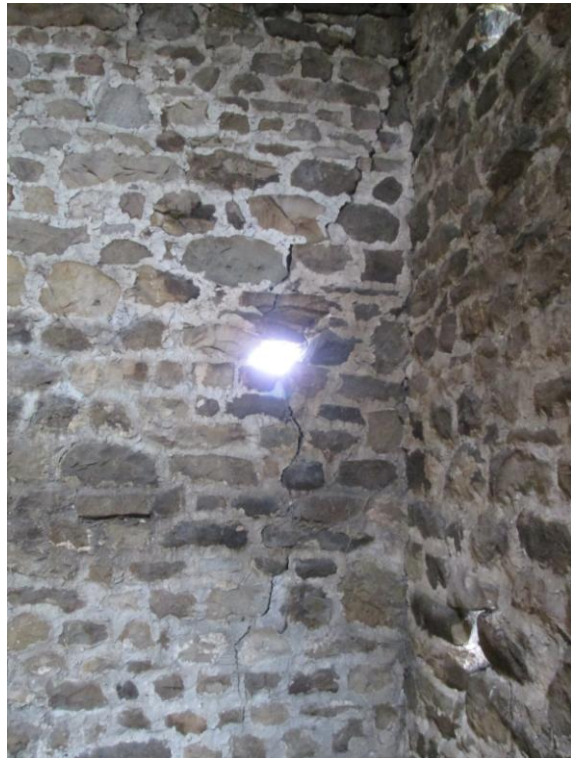
Photo 9a – Steep Diagonal Crack where Rear Wall joins Right-Hand Gable

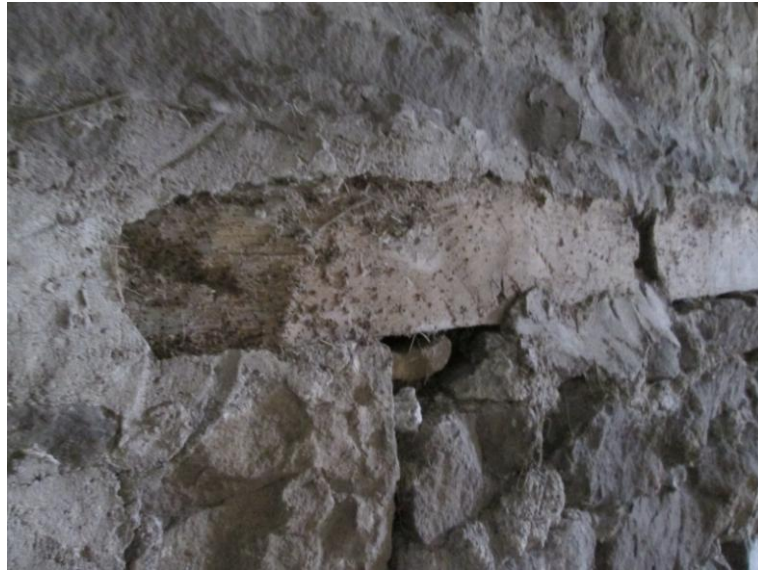
- A timber lintel above an opening in the wall between the hay loft and the workshop shows signs of widespread insect infestation. The opening has now been filled with stone masonry (**photo 10**).

Photo 10 – Decayed Timber Lintel

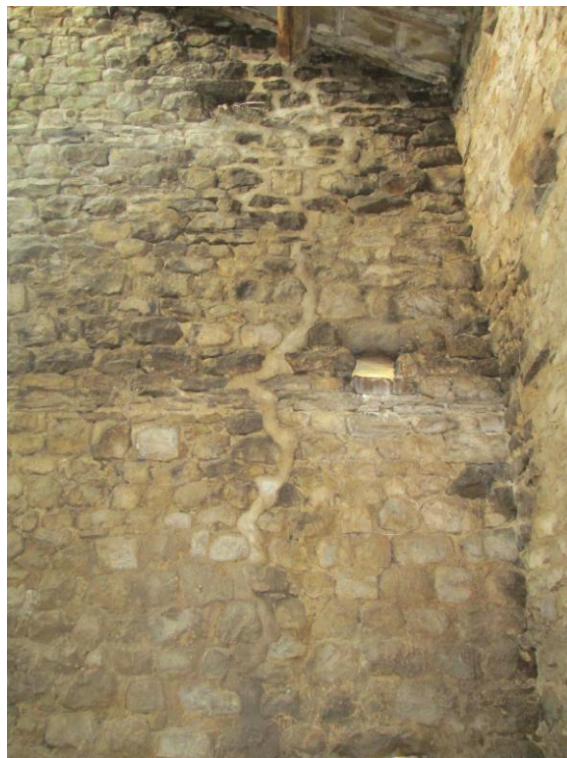
- A wide vertical crack extending over most of the height of the left-hand gable wall has been filled with mortar (**photo 11**).
- There is a vertical crack in the wall on the left-hand side of the main entrance, extending from door head to roof level on the inside face (**photo 12**), and from ground level to roof on the outside face (**photo 13**).

Photo 11 – Repaired Crack in Left-Hand Gable Wall

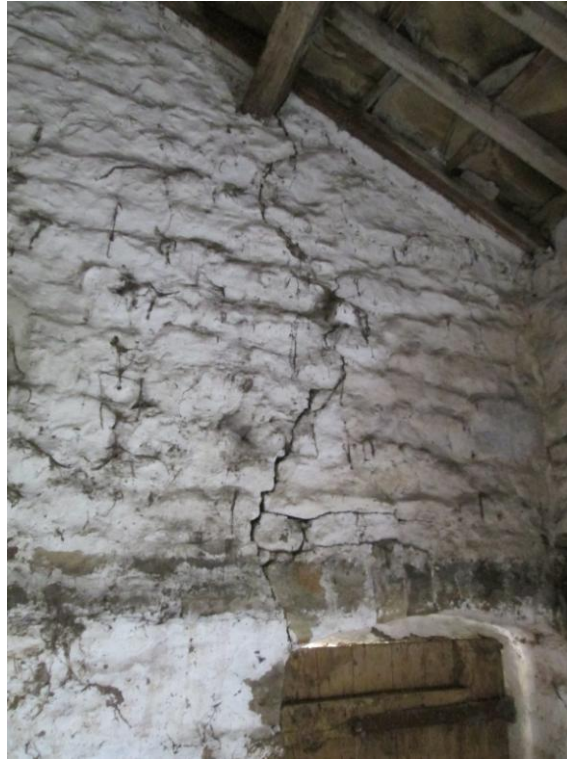
Photo 12 – Crack in Internal Face of Wall on Left-Hand Side of Entrance

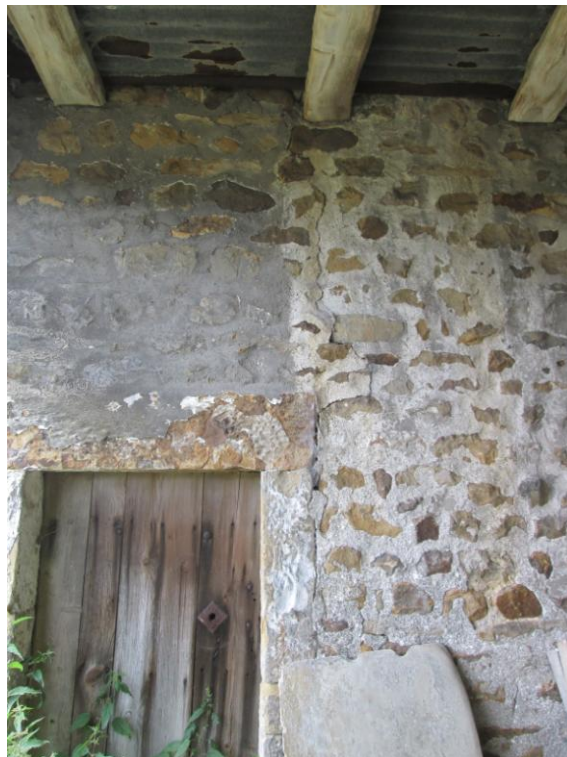
Photo 13 – Crack on External Face of Wall to Left-Hand Side of Entrance

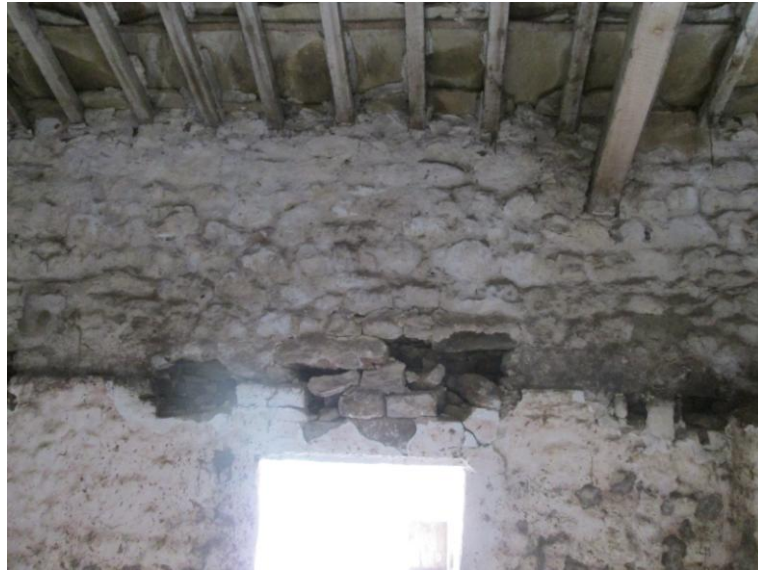
- In the room to the left of the main entrance, the first floor has been removed leaving holes in the walls where the floor timbers had been supported (**photo 14**). The area above the window is badly distorted and bulges inwards.

Photo 14 – Holes in Front Wall where First Floor Removed

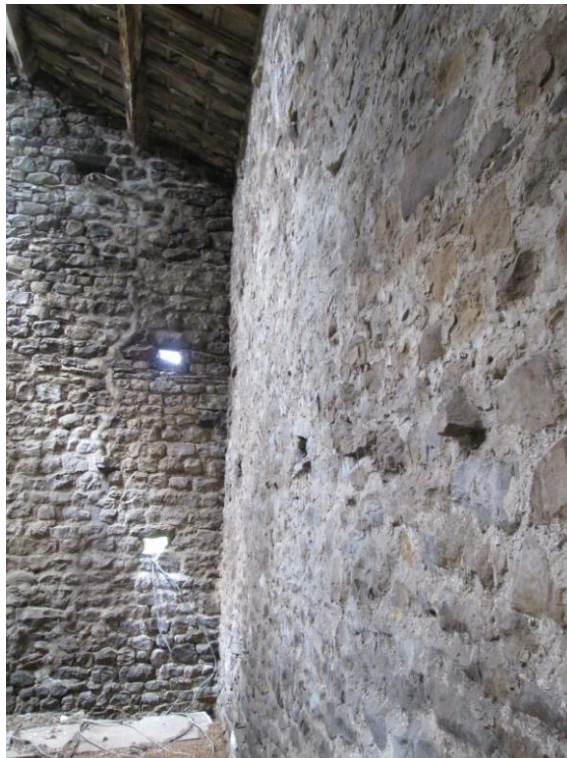
- The rear wall leans towards the shippon, most noticeable at the left-hand side (**photo 14a**).

Photo 14a –Rear Wall leaning towards Shippon

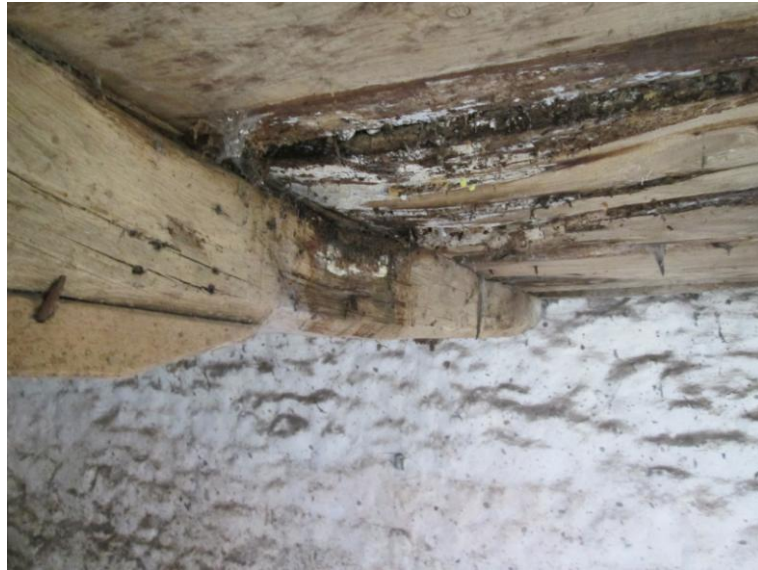
- The timber first floor to the workshop shows extensive signs of decay (**photo 15**).

Photo 15 –View of Decayed Workshop Floor Beams

The original first floor in the workshop is badly decayed and should be completely replaced. The more modern floor to the hayloft is in good condition, though again may need to be replaced as part of any proposed conversion works.

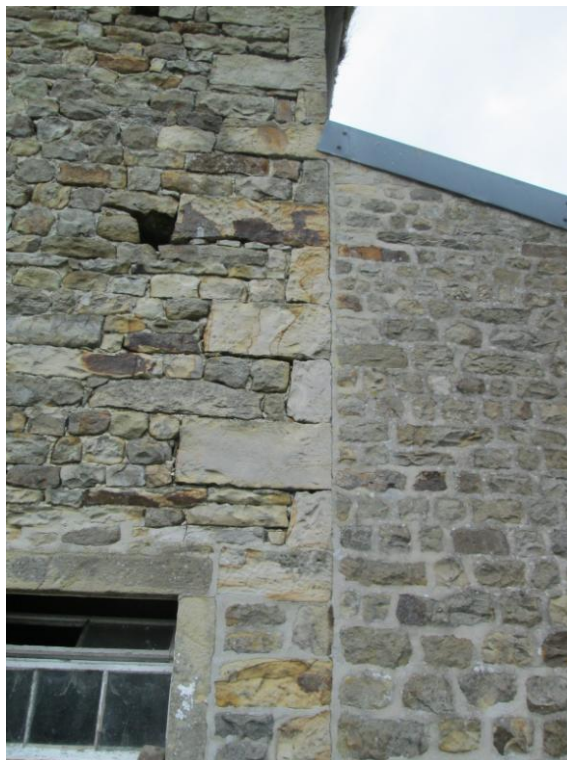
- A tapered vertical crack of up to 5mm in width has formed between the right-hand wall of the shippon and the main barn wall (**photo 16**).
- The right-hand gable wall curves outwards, with a bow of around 50-100mm at the top (**photo 17**).
- The stone arch above the main entrance door bows outwards (**photo 18**).
- There is a crack of around 10mm in width at mid-height near the front of the left-hand gable wall (**photo 19**).
- The vertical crack towards the rear of the left-hand gable wall noted internally also appears on the outer face. It has been filled with mortar but has re-opened to a width of around 10mm (**photo 20**).
- The left-hand gable wall shows a slight inward lean at the top.

Photo 16 – Separation between Shippon and Barn

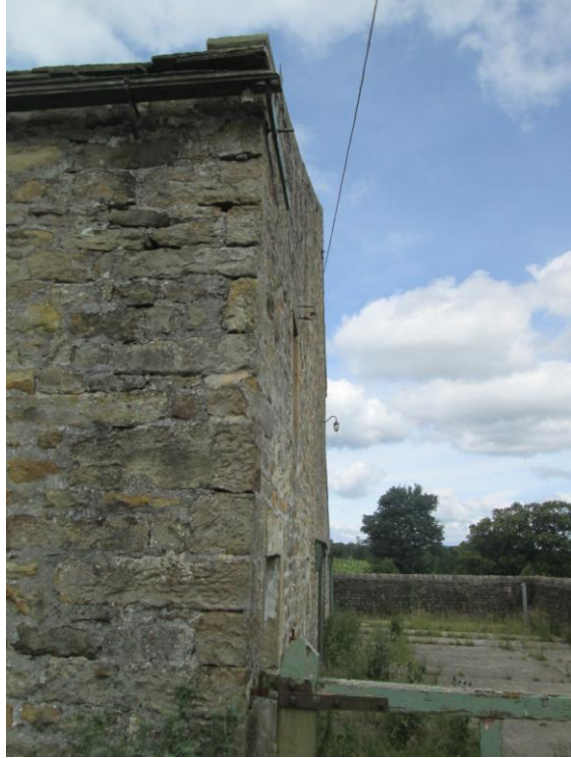
Photo 17 – Outward Curvature of Right-Hand Gable

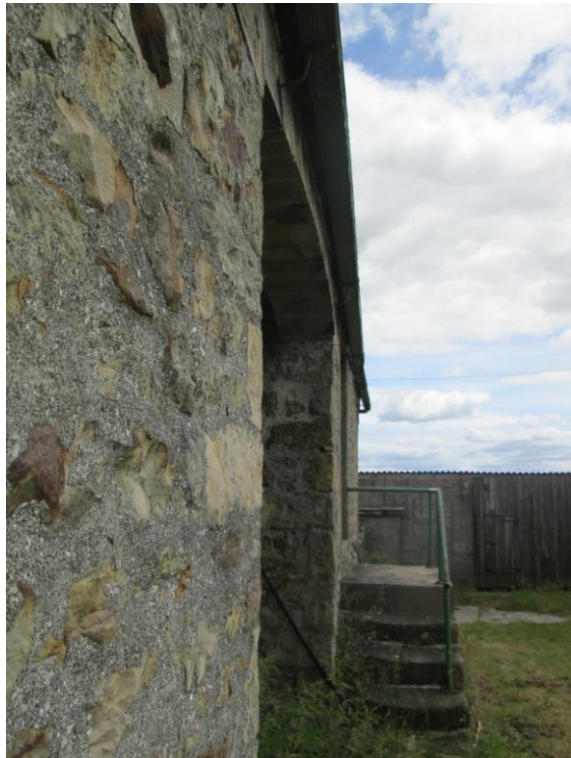
Photo 18 – Outward Bow of Arch Stonework above Main Entrance

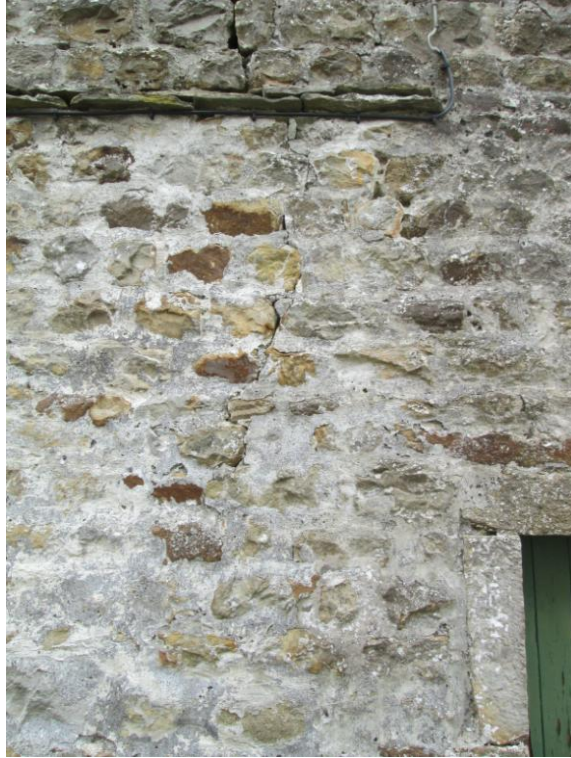
Photo 19 – Crack in Left-Hand Gable Wall (Front)

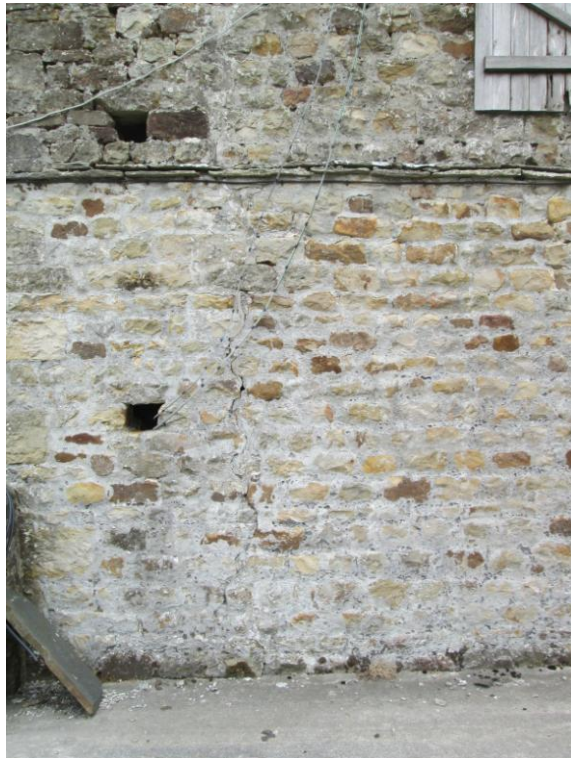
Photo 20 – Crack in Left-Hand Gable Wall (Rear)
