Project
Land off Chatburn Road, Clitheroe

Drawing title
Technical Appendix 2
Survey of existing trees

Drawing No.
c-981-01 Revision A

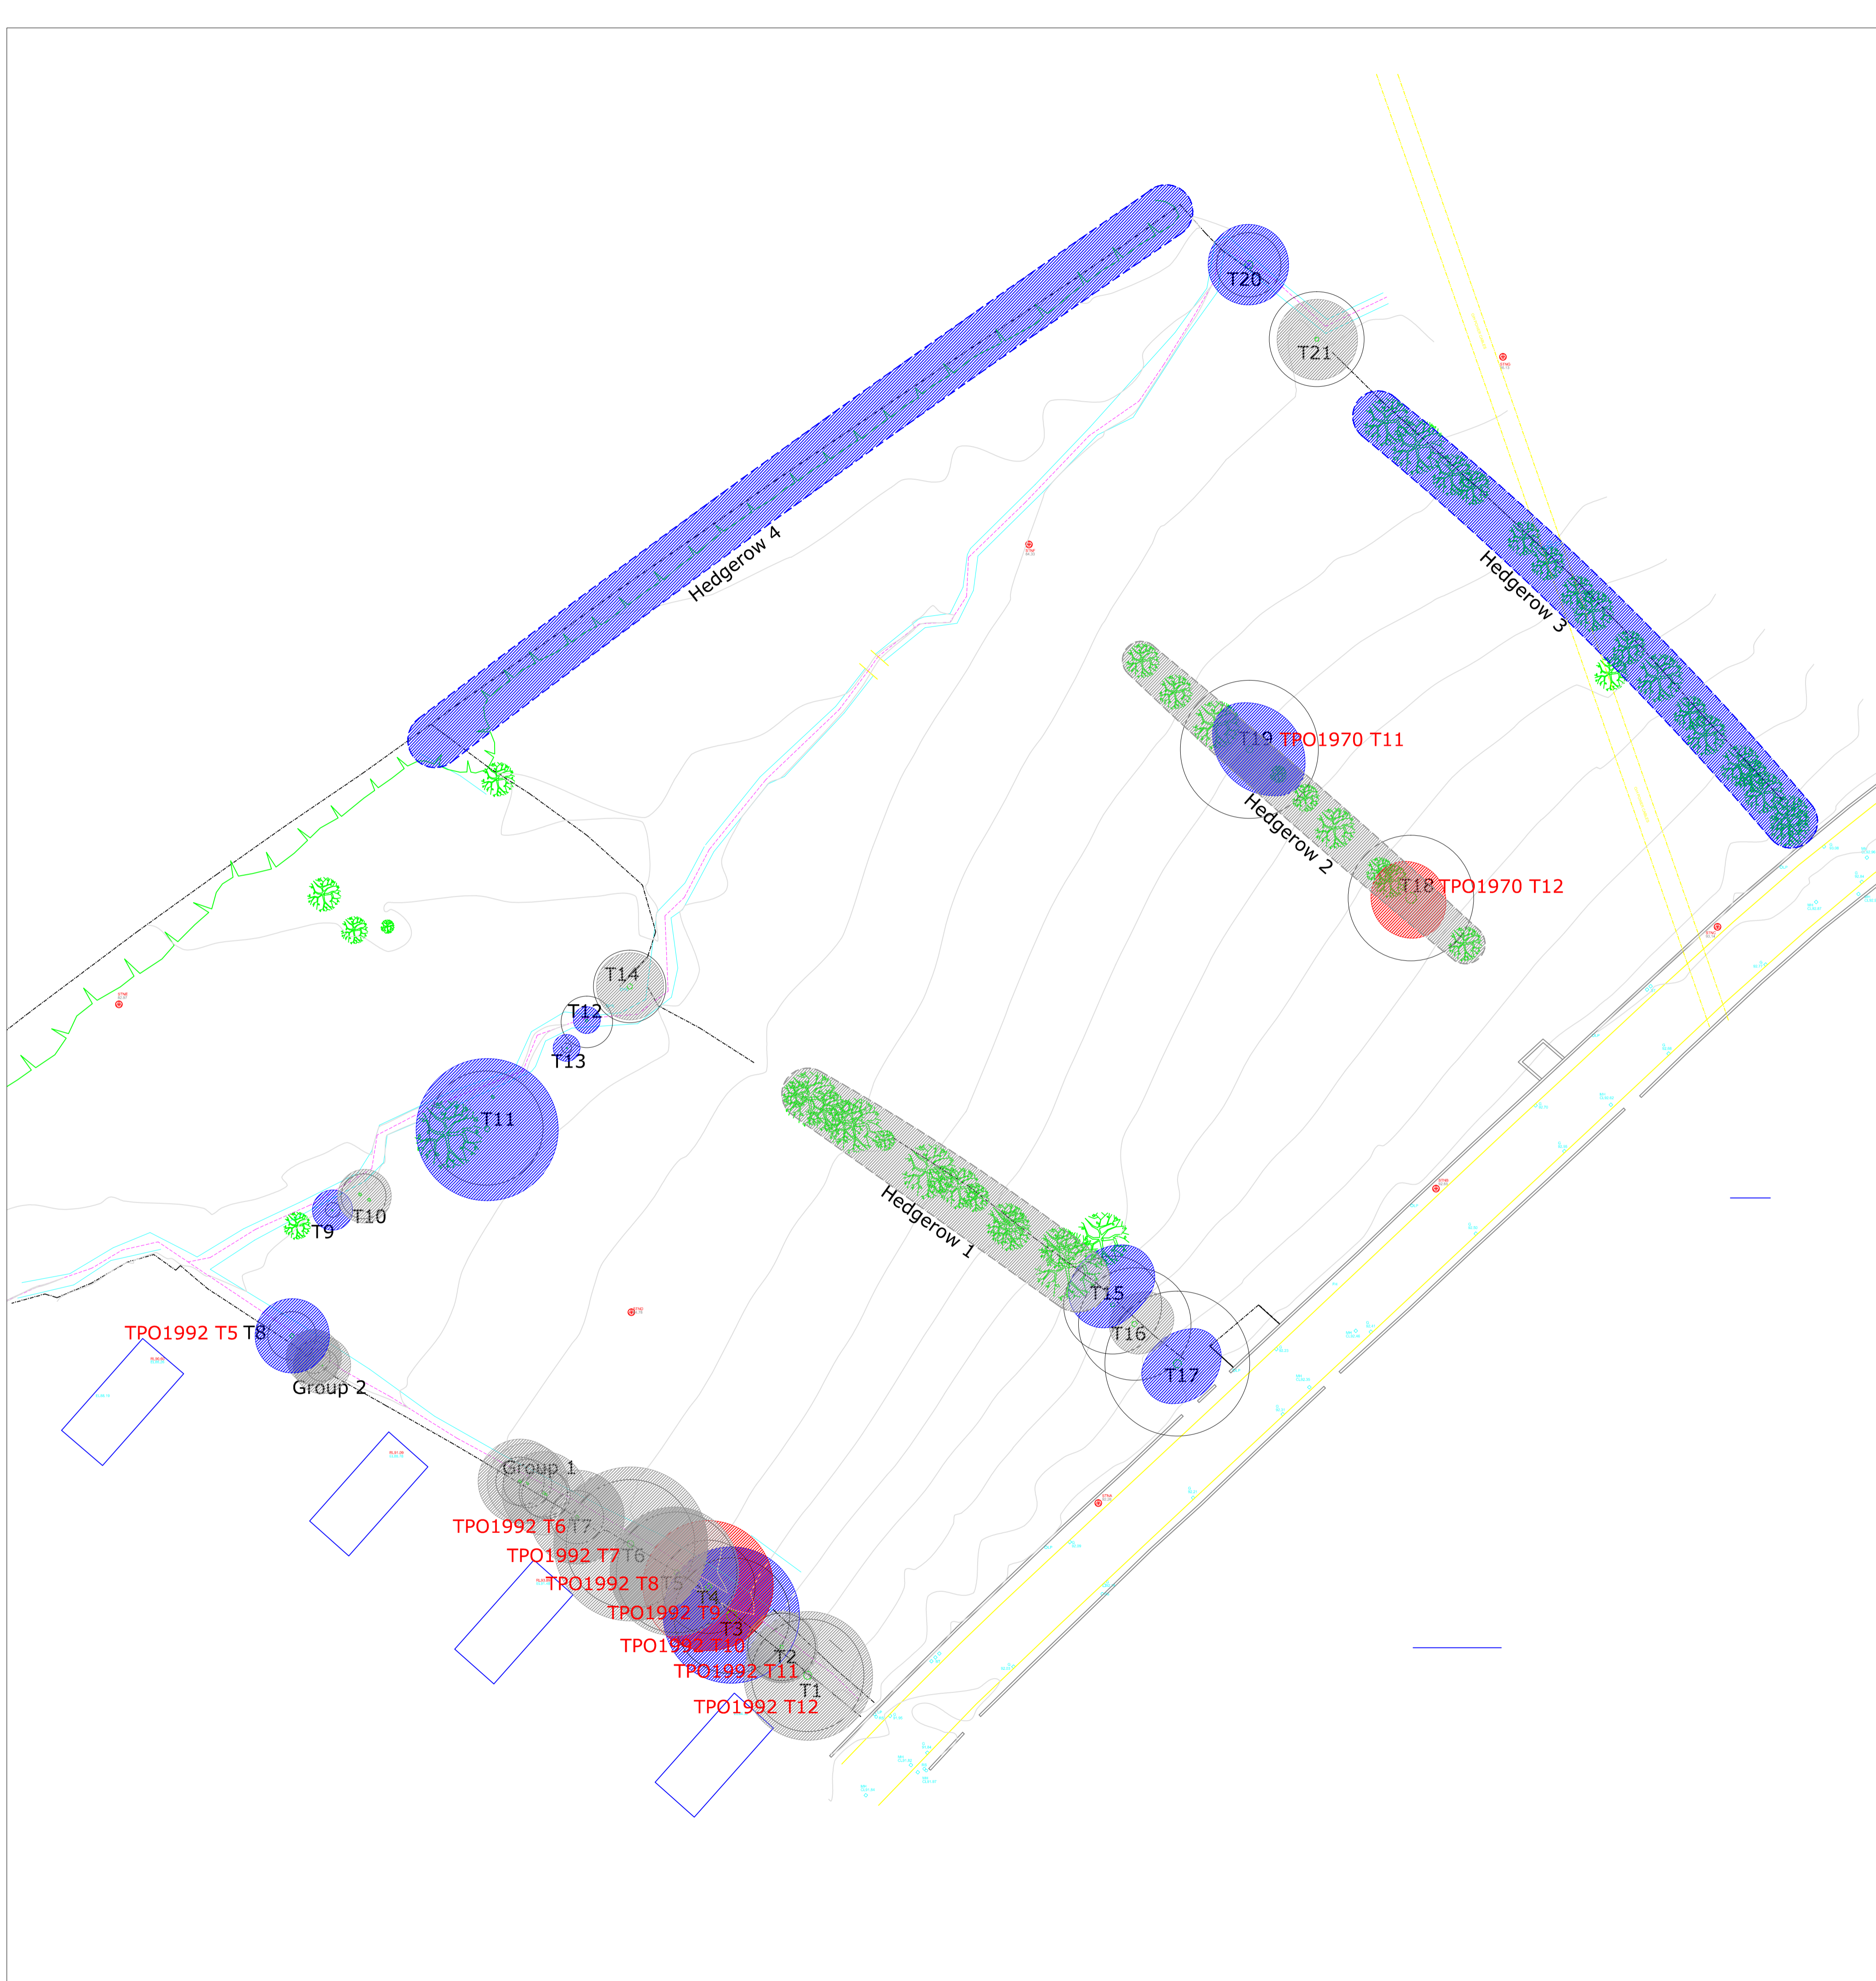
Tree number	Species	Stem diameter @ 1.5m above ground level	Approximate height	Crown spread	Crown clearance	Age Class	Notes	Recommendations	Category grading
1	Acer psuedoplatanus	700mm	18m	Encroaches 6m into site.	5m	Mature	Recent split limb high in the canopy and major limb recently fallen.	Suggested inspection of canopy and removal of dead or damaged wood.	C
2	Acer psuedoplatanus	420mm	15m	Encroaches 4m into site.	8m	Mature	Some basal growth and recent loss from canopy.	Remove basal growth and dead wood.	C
3	Acer psuedoplatanus	720mm	18m	Encroaches 8m into site.	2m	Mature	No sign of recent damage or loss from crown. Some basal growth.	Remove basal growth.	B
T4	Acer psuedoplatanus	580mm	17m	Encroaches 9m into site.	2m	Mature	No sign of recent damage or loss from crown. Some basal growth.	Remove basal growth.	B
T5	Acer psuedoplatanus	750mm	17m	Encroaches 8m into site.	2m	Mature	Recent surgery works within canopy, which appear to be healing. Fruiting bodies on base suggests Ustulina deusta fungal infection.	The tree will require removal if infection is confirmed.	R

T6	Acer psuedoplatanus	800mm	18m	Encroaches 10m into site.	5m	Mature	One-sided due to previous removal of adjacent tree. Ivy clad. Considerable previous surgery works.	No work required.	C
T7	Acer psuedoplatanus	330mm	14m	Encroaches 5m into site.	4m	Mature	Much smaller than adjacent trees with sparse canopy.	No work required.	C
Group 1	Crataegus mongyna Sambucus nigra	200-300mm	8m	Encroaches 4m into site.	1m	Mature	Sparse former hedgerow plants.	No work required.	C
Group 2	Crataegus mongyna	100-200mm	6m	Encroaches 3m into site.	1m	Mature	Group of former hedgerow plants.	No work required.	C
T8	Alnus glutinosa	600mm	12m	Encroaches 5m into site.	1m	Mature	Appears sound.	No work required.	B
T9	Acer pseudoplatanus	90mm	10m	Encroaches 3m into site.	2m	Young	Young and vigorous. Self-sown.	No work required.	B
T10	Acer pseudoplatanus	280mm	12m	Encroaches 4m into site.	2m	Middle-aged	Fair condition. Coppiced hazel embedded beneath.	No work required.	C

T11	Alnus glutinosa	710mm	14m	Encroaches 3m into site.	1m	Mature	Twin-stemmed tree with some dead wood.	Remove dead wood.	B
T12	Fraxinus excelsior	320mm	13m	Encroaches 2m into site.	2m	Middle-aged	Squat but good shape. Ivy clad.	No work required.	B
T13	Alnus glutinosa	60mm	5m	Encroaches 2m into site.	1m	Young	Self-sown, young Alder.	No work required.	B
T14	Alnus glutinosa	450mm x 2	13m	N 5m S 6m E 4m W 3m	2m	Mature	Wound in main bough, but does not appear progressive.	Monitor for any decline, otherwise no work required.	C
T15	Fraxinus excelsior	610mm	14m	N 8m S 3m E 9m W 5m	2m	Mature	Imposing former hedgerow tree with some recent limb damage.	Clean limb damage to flush with tree and remove dead wood.	B
T16	Fraxinus excelsior	700mm	16m	N 4m S 4m E 6m W 4m	5m	Mature	Considerable canopy damage, some very recent.	Tidy canopy and remove dead or damaged wood. During work, assess for further damage.	C

T17	Fraxinus excelsior	900mm	15m	N 4m S 6m E 7m W 6m	4m	Mature	Very large, imposing tree with dead wood within canopy.	Remove dead-wood.	B
T18	Fraxinus excelsior	780mm	18m	N 6m S 6m E 6m W 5m	3m	Mature	Considerable dead and damaged wood within canopy. Large cracks within main stem and cavities. Major wound on eastern side.	Fell and remove due to safety concerns.	R
T19	Fraxinus excelsior	860mm	17m	N 7m S 9m E 7m W 5m	3m	Mature	Good shape to canopy with moderate amounts of recent loss.	Tidy any broken limbs in canopy and remove dead wood.	B
T20	Alnus glutinosa	400mm x 2	13m	Encroaches 6m into site.	2m	Mature	Twisted form, but highly attractive and in fair condition.	No work required.	C
T21	Alnus glutinosa	590mm	12m	Encroaches 6m into site.	1m	Mature	Attractive tree but with evidence of decay within main leader.	Small tree so retention possible is not in a position to be dangerous. Requires further assessment.	C

Hedge 1	Crataegus monogyna	90 - 200mm	Up to 8m	Approximately 2m	Ground level	Mature	Former hedgerow now in over mature state with plants in moderate condition.	Retention and enhancement possible. No work required.	C
Hedge 2	Crataegus monogyna	90-200mm	Up to 8m	Approximately 2m	Ground level	Mature	Former hedgerow in poor condition with major damage to constituent plants.	Low useful life expectancy of remaining plants, but not considered dangerous.	C
Hedge 3	Crataegus monogyna	80-220mm	Up to 10m	Approximately 2m	Ground level	Mature	Mature hedgerow, with gaps, and constituent plants in fair condition, forming pleasing boundary to field.	No work required other than reinforcing if considered desirable.	B
Hedge 4	Crataegus monogyna Sambucus nigra	70 - 140mm	Up to 7m	Approximately 1m	Ground level	Young	Young hedgerow, with many gaps, but good, vigorous plants, ready to form significant boundary.	No work required other than reinforcing if considered desirable.	B
