Barn No. 1 at Wheatley Farm, Four Acre Lane, Thornley with Wheatley , PR3 2TD

Structural Condition Survey for Conversion to Dwelling

PSC-001 Rev A

March 2017

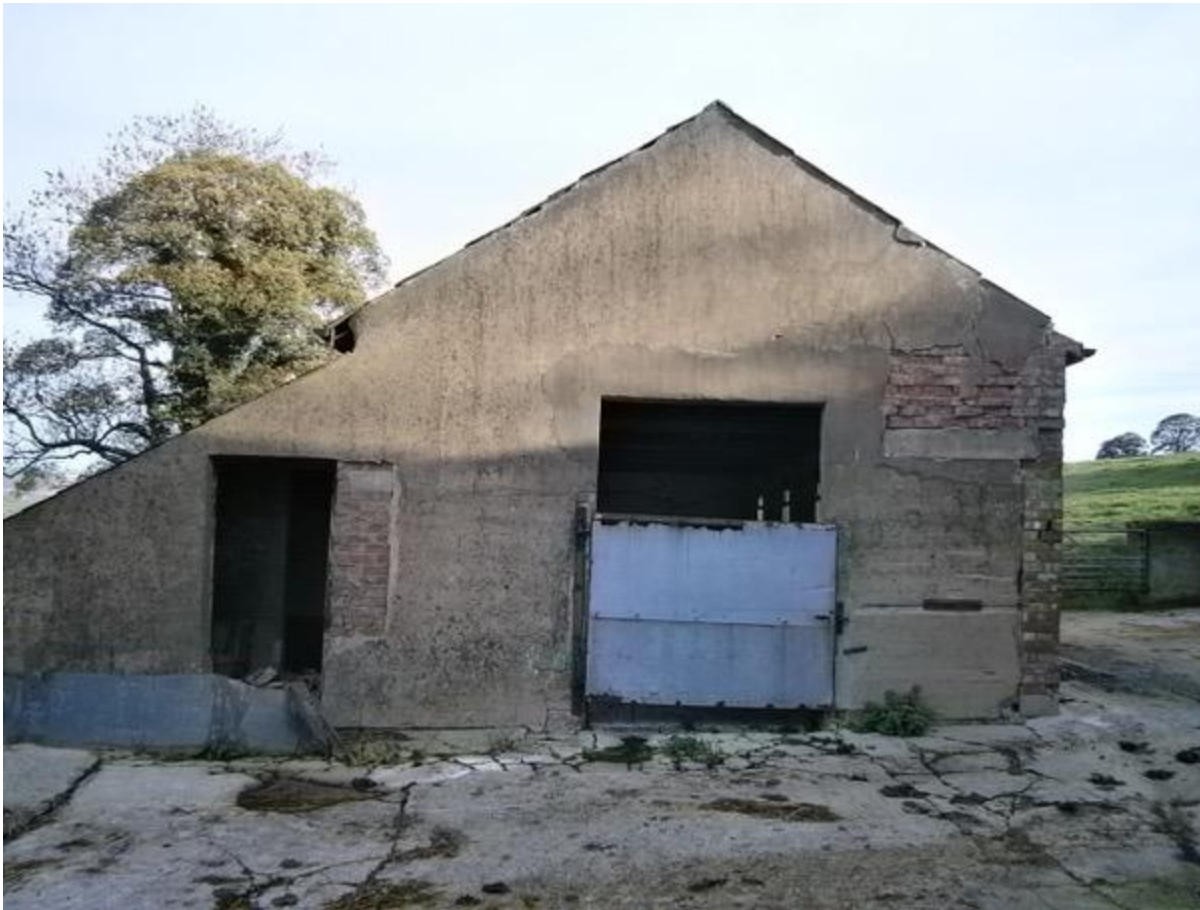
Photo 1 - South West Elevation

This brick built gable is 225mm thick (double brick) and has been rendered externally as can be seen on the photos. There are two existing openings with evidence of a former opening to the right (lintel evident on photos 3 & 4). The wall is in a poor condition with bowing across its length and damage to the right hand corner. The existing large opening is proposed to be retained, whilst the small opening is to be bricked up. In carrying out this work, an allowance of 75% (approx. 20m²) of this wall should be taken as requiring rebuilding due to the bow and damage.

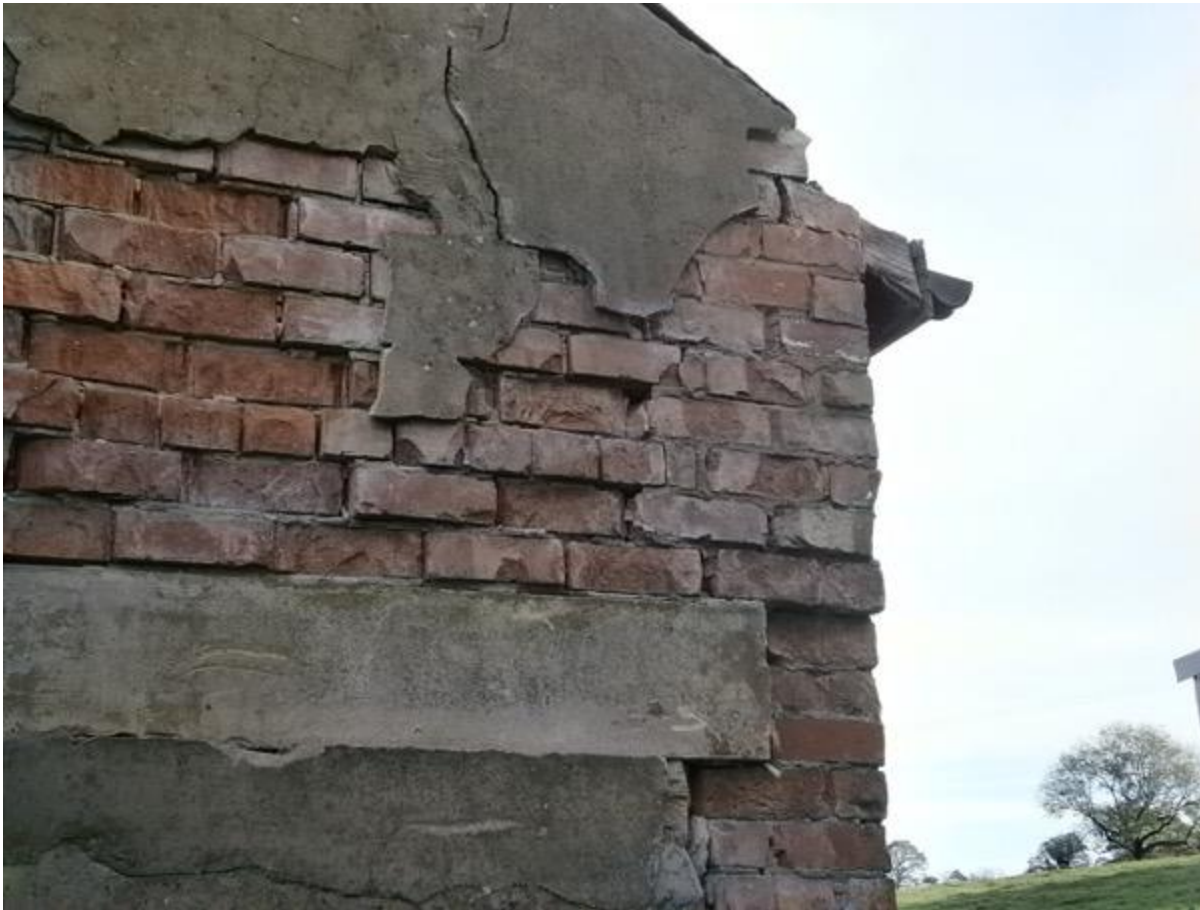
Photo 3 - South West Elevation – damaged corner

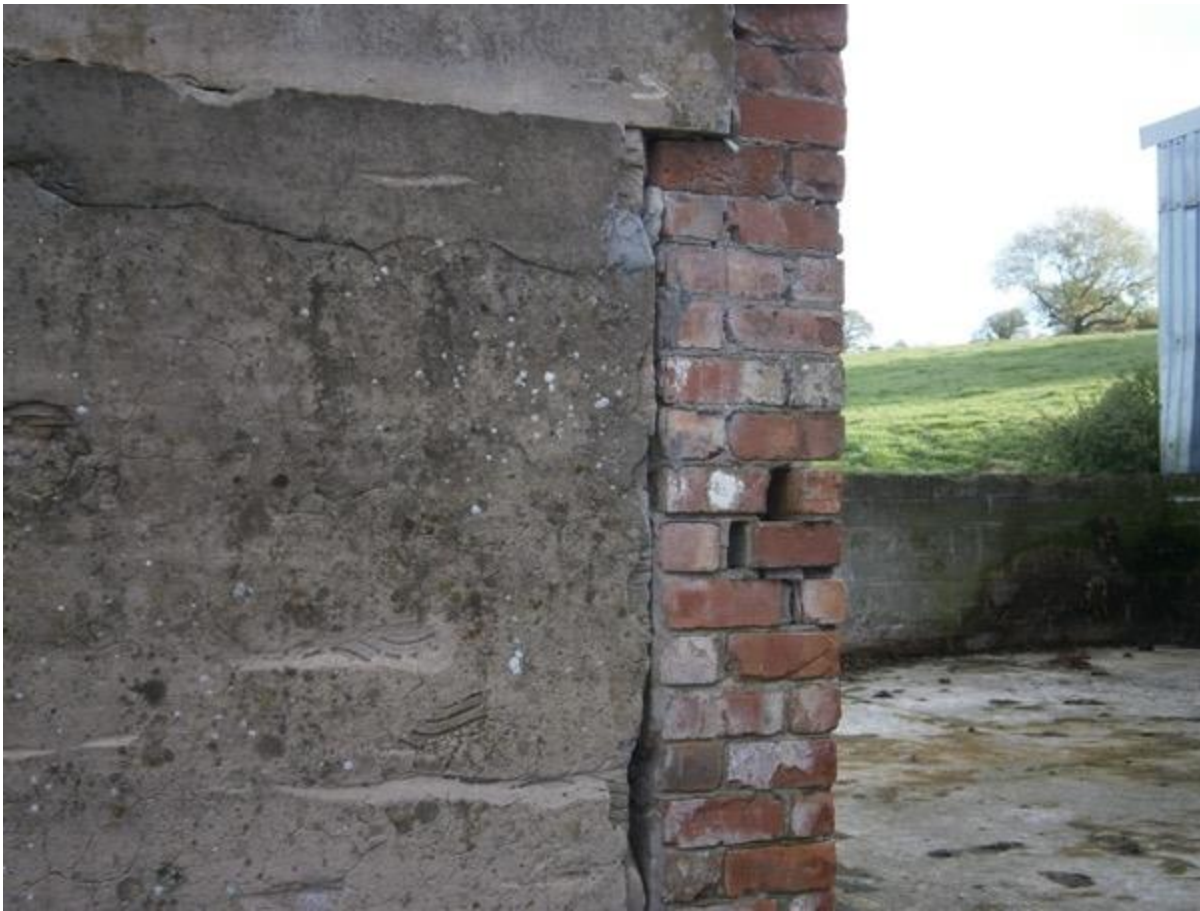
Photo 4 - South West Elevation – damaged corner

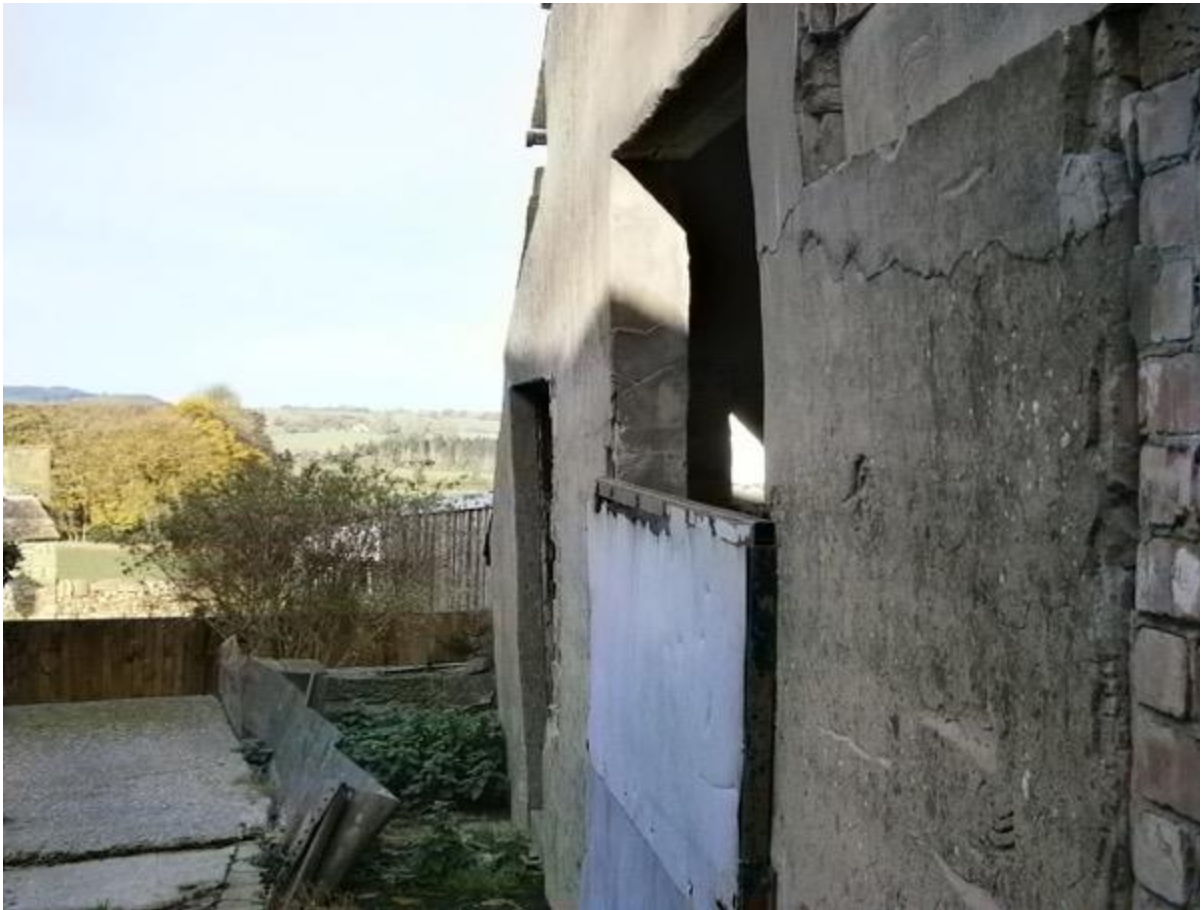
Photo 5 – South West Elevation – showing bowing/movement

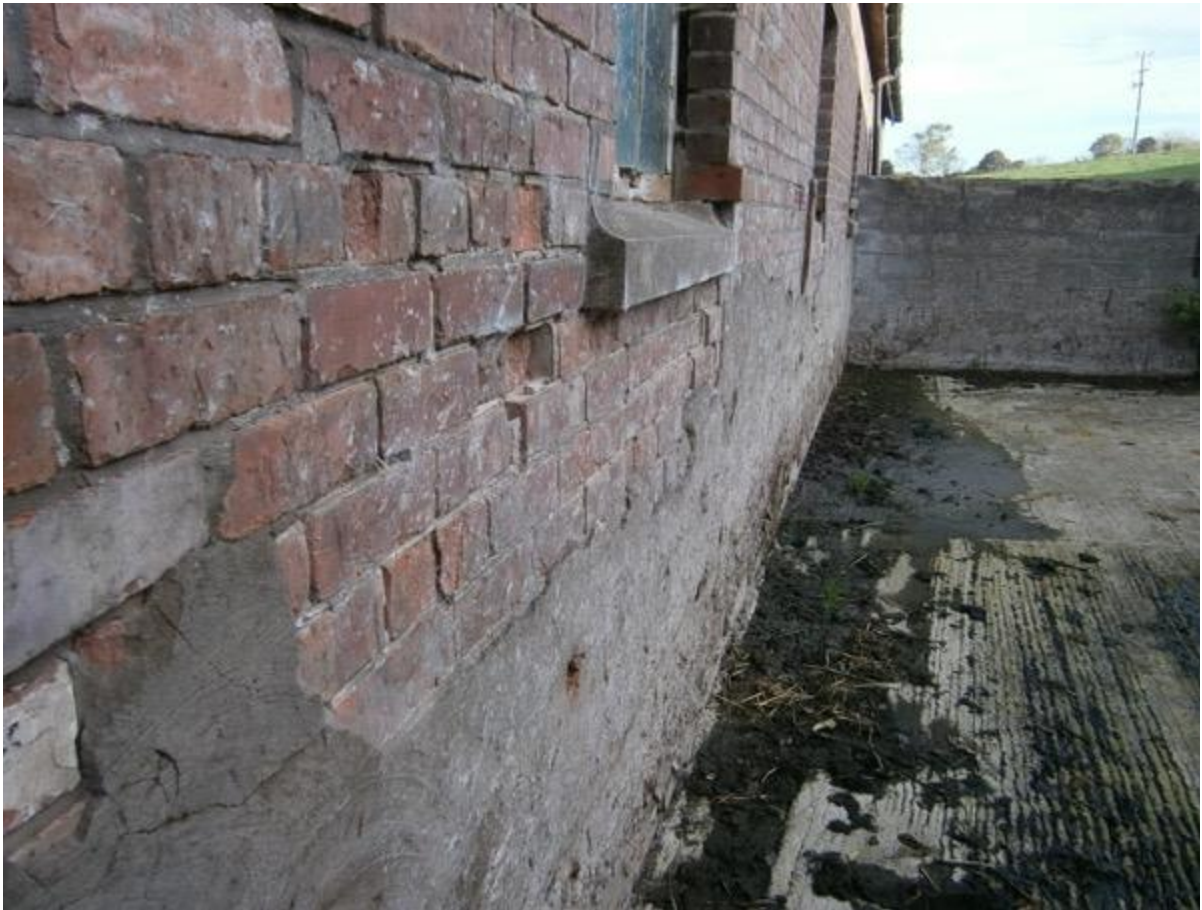
This elevation is a 225 mm brick wall. The wall is plumb, reasonably well pointed and free from signs of movement. There are some blown bricks to the lower part of the left hand side but these are to be rendered under the proposals. Photo 9 shows more severe damage to the brickwork around the existing downspout and this will require replacement over 1m². There are 5 existing openings on this elevation which are to be retained with no further openings proposed.

Photo 7 – South East Elevation – blown bricks

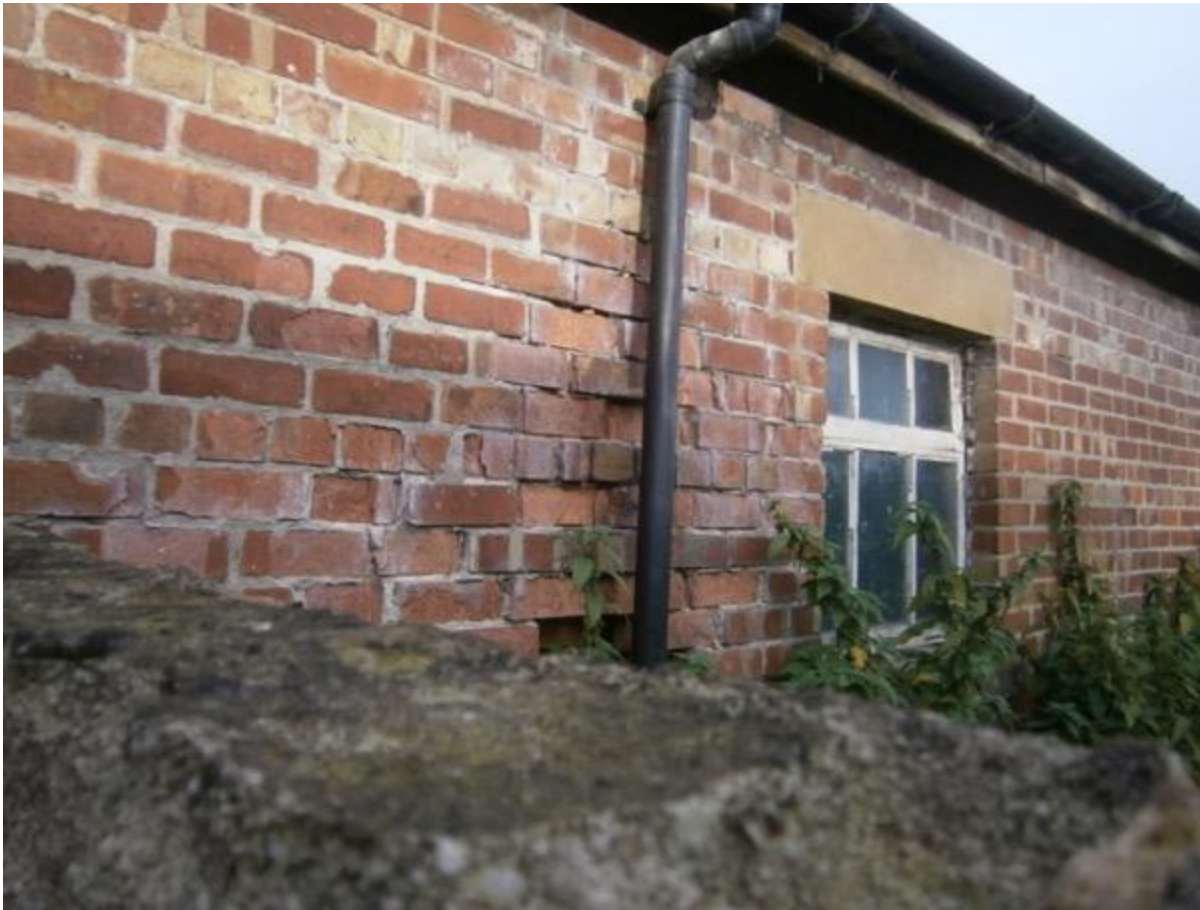
Photo 9 – South East Elevation – damaged around downspout

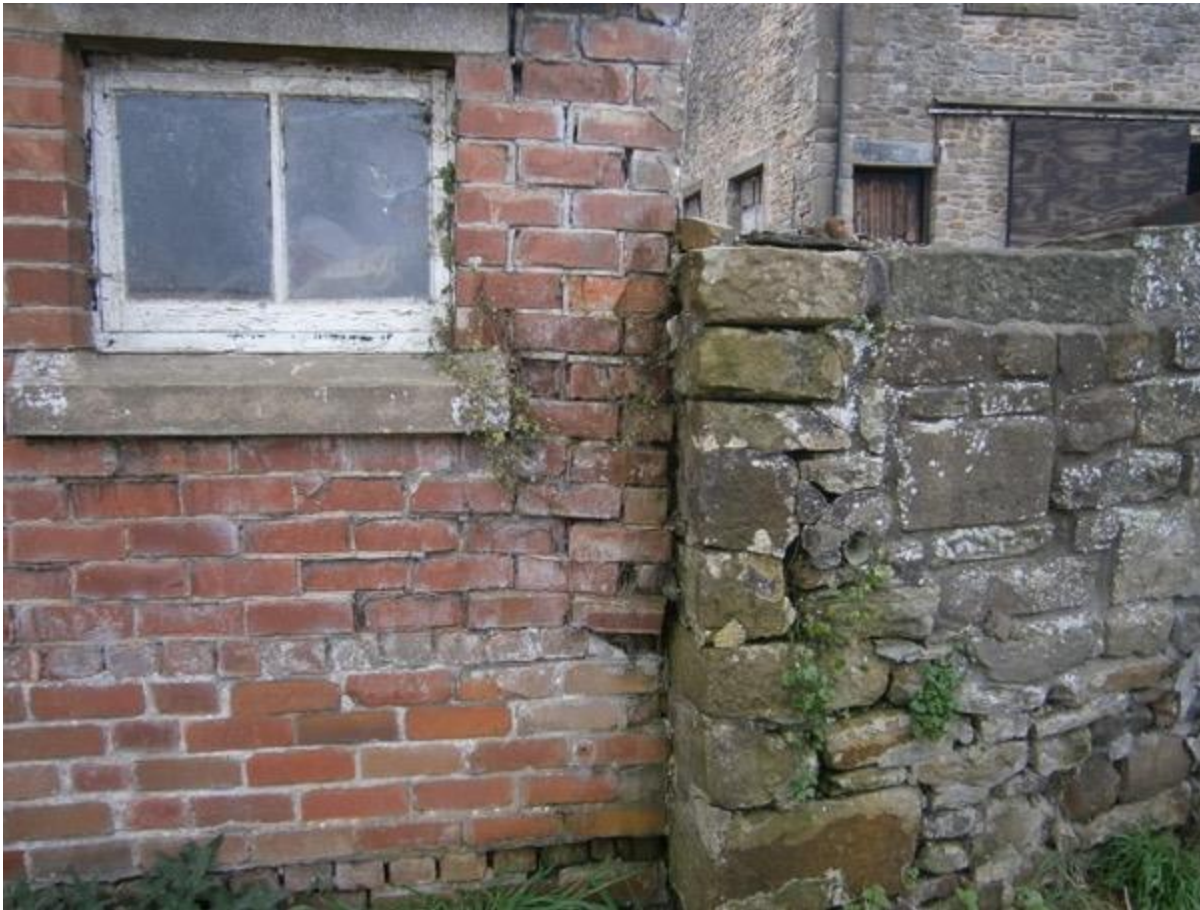
The elevation is a 225 mm brick wall with a lower outrigger section to the right. The outrigger section has damaged brickwork to the right of the doorway, below the windows and at the junction with the gable. This will require re-building over 2m².

Photo 11 - North West Elevation – damage at gable corner

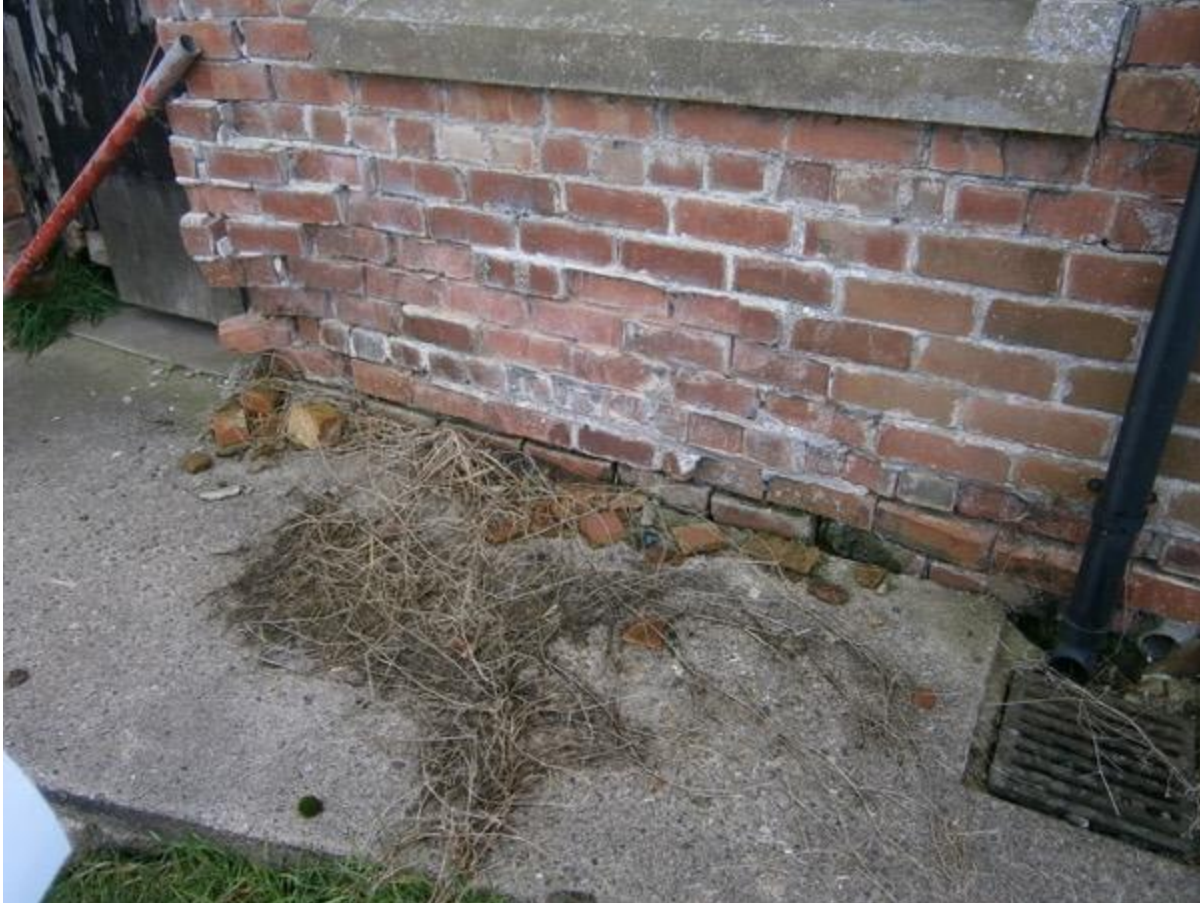
Photo 12 - North West Elevation – damage at below window

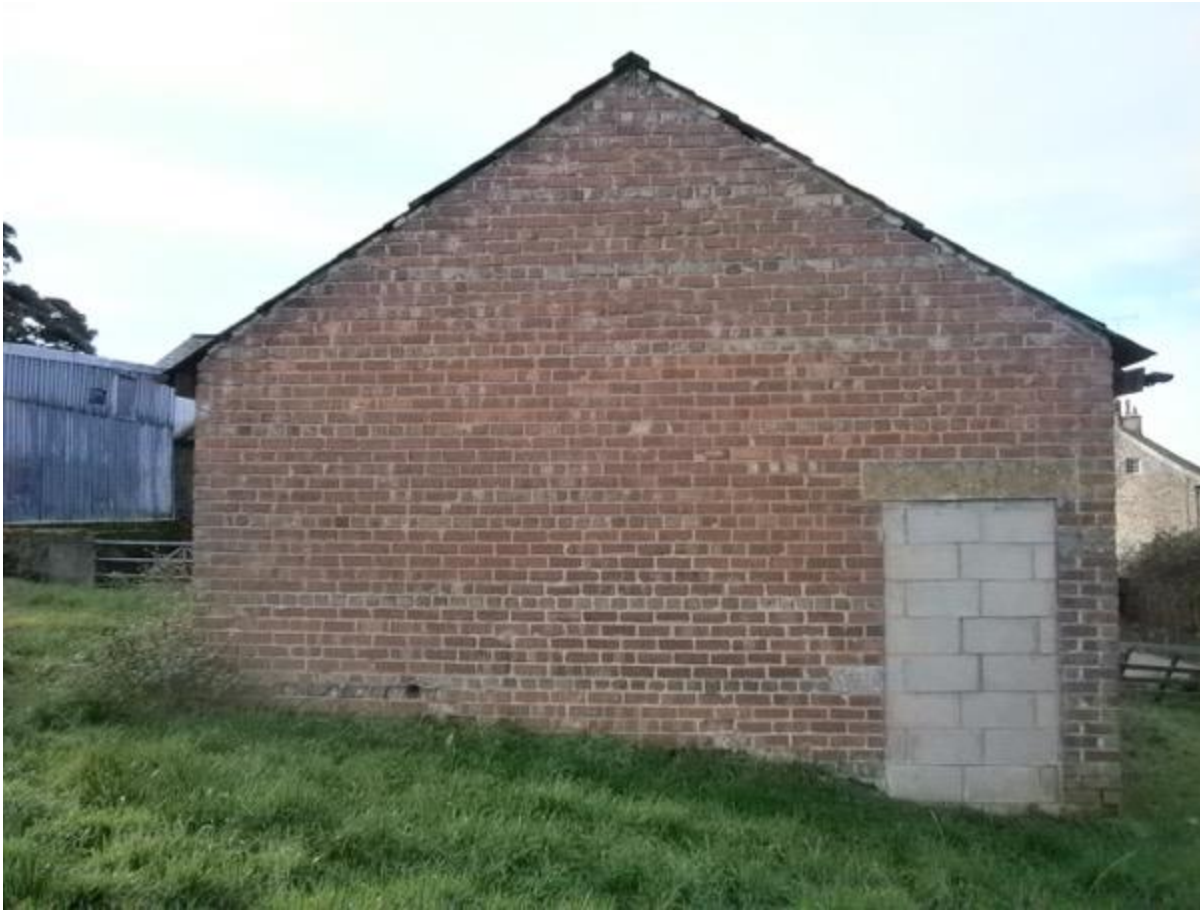
Photo 15 - North East Elevation

This gable wall is a 225mm brick wall. There is a single existing opening which has been closed with blockwork (photo 15) and this is to be re-opened. There is a small area of damaged brick at a low level (photo 16) but this area is to be rendered under the proposals. The wall is plumb, reasonably pointed and free from movement.

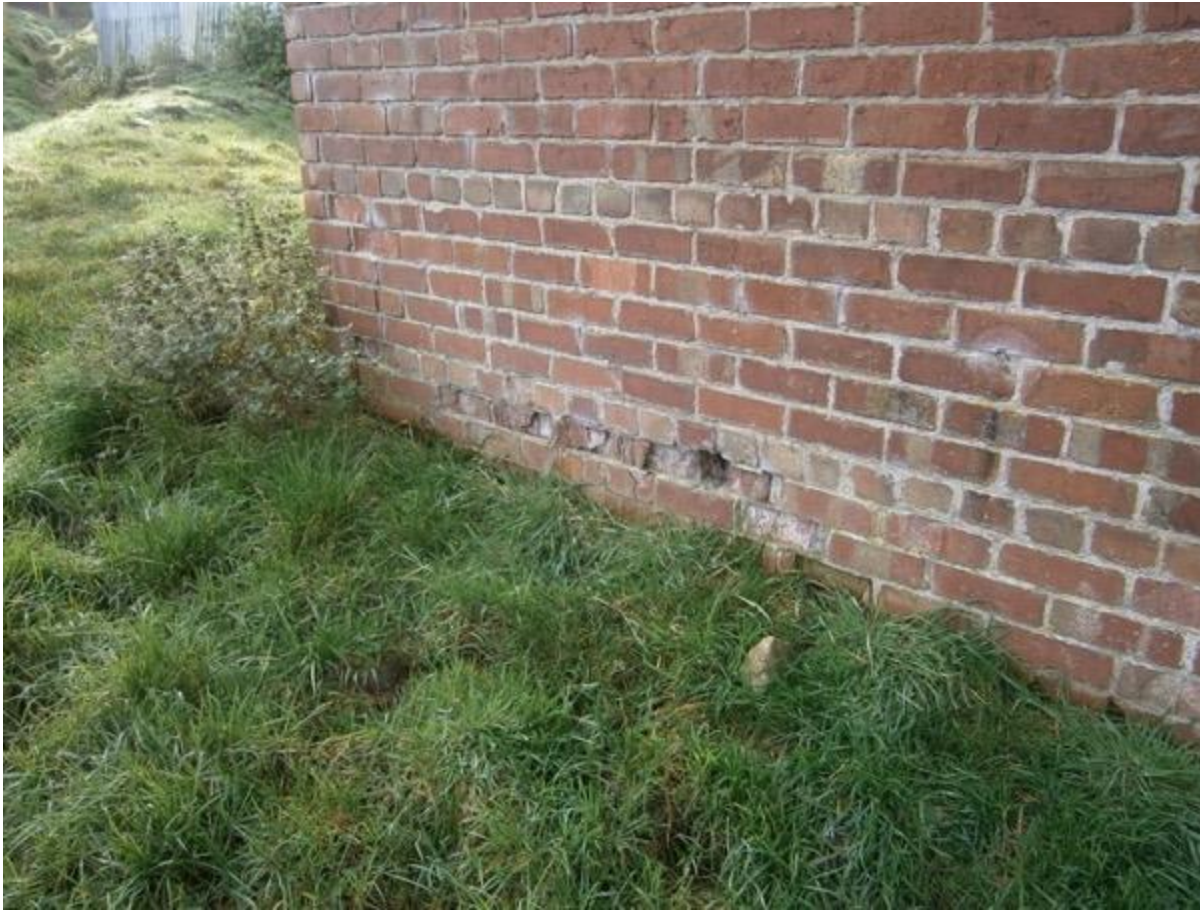
Photo 16 - North East Elevation – row of damaged/blown bricks

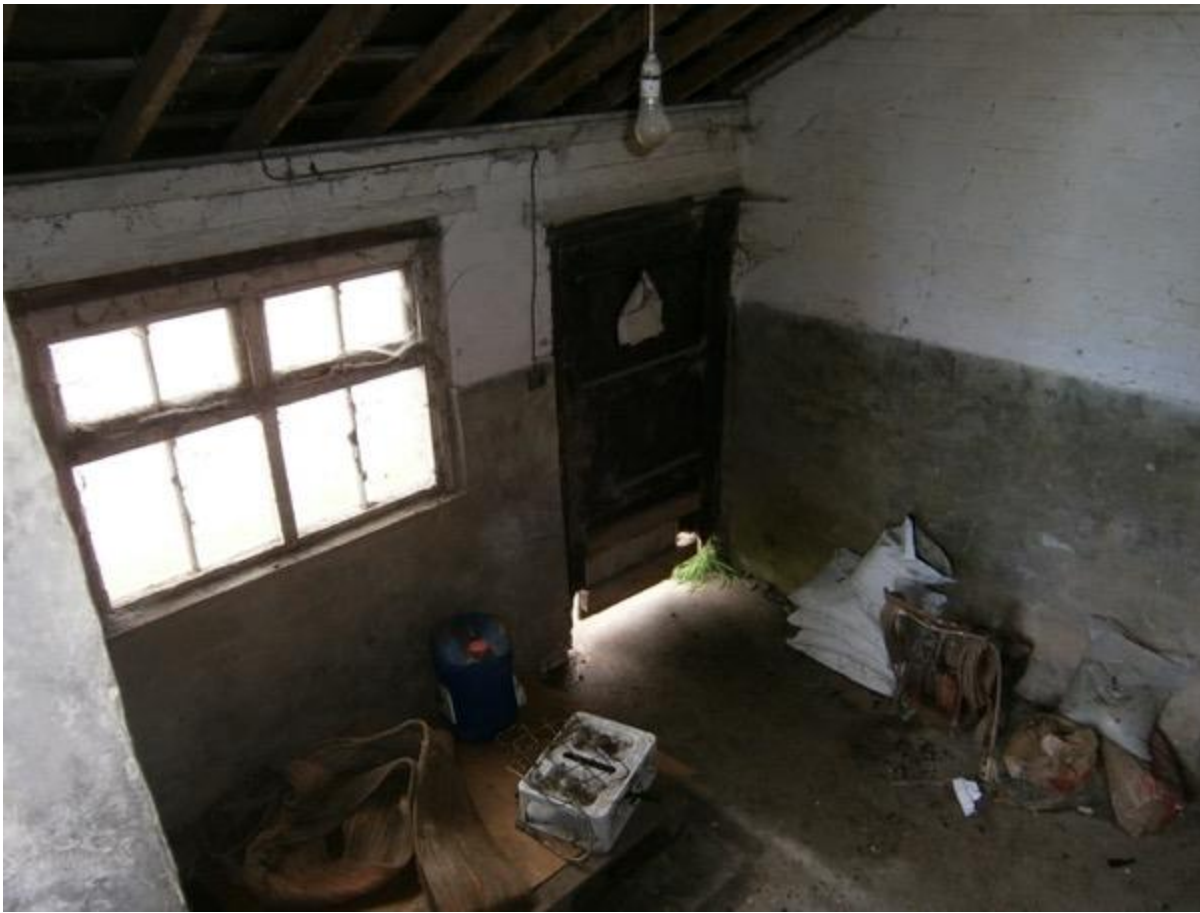
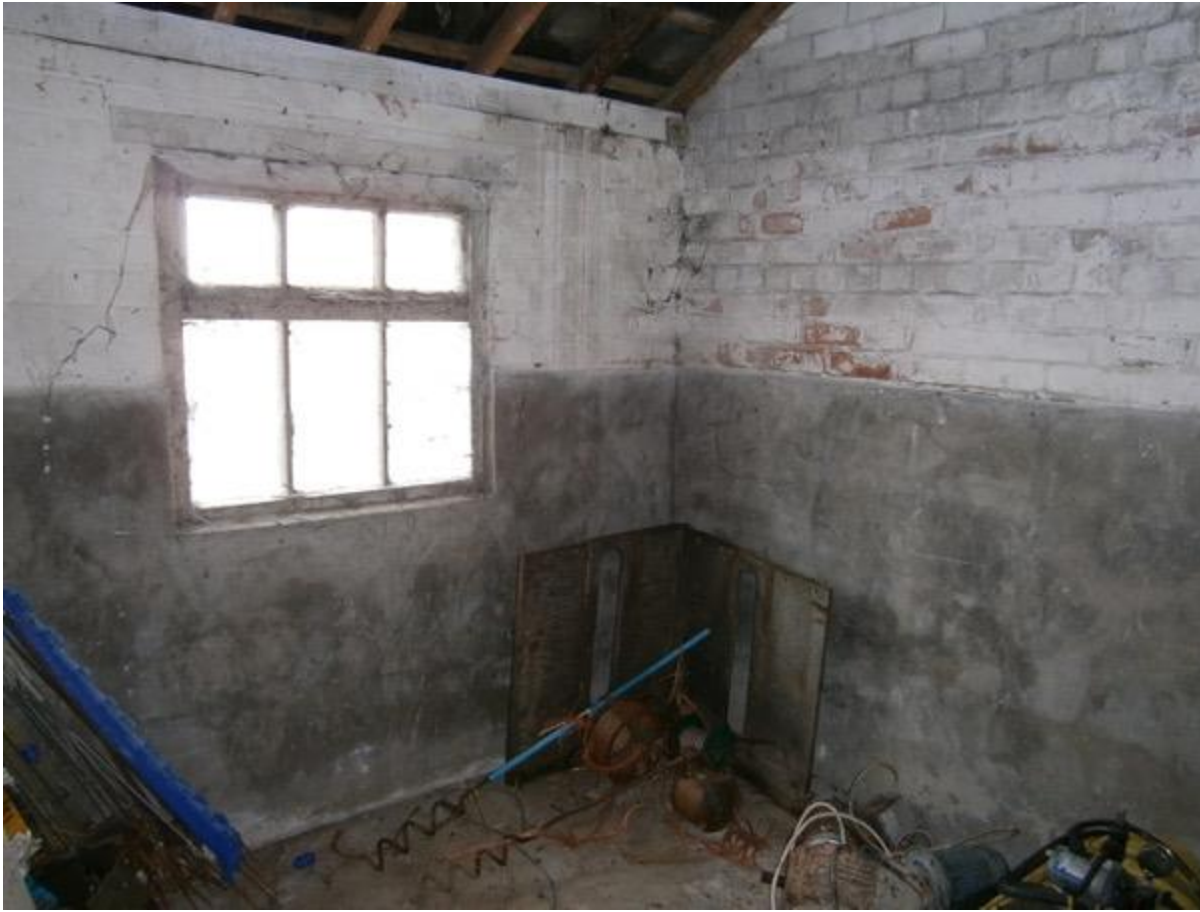
The ground floor is in two separate sections divided by a solid 225mm thick brick wall. The lower section has a solid concrete floor with rendering to the lower sections of the walls. The walls are generally in good condition but do reflect the damage noted externally. The timbers do not exhibit any sign of rot or infestation.

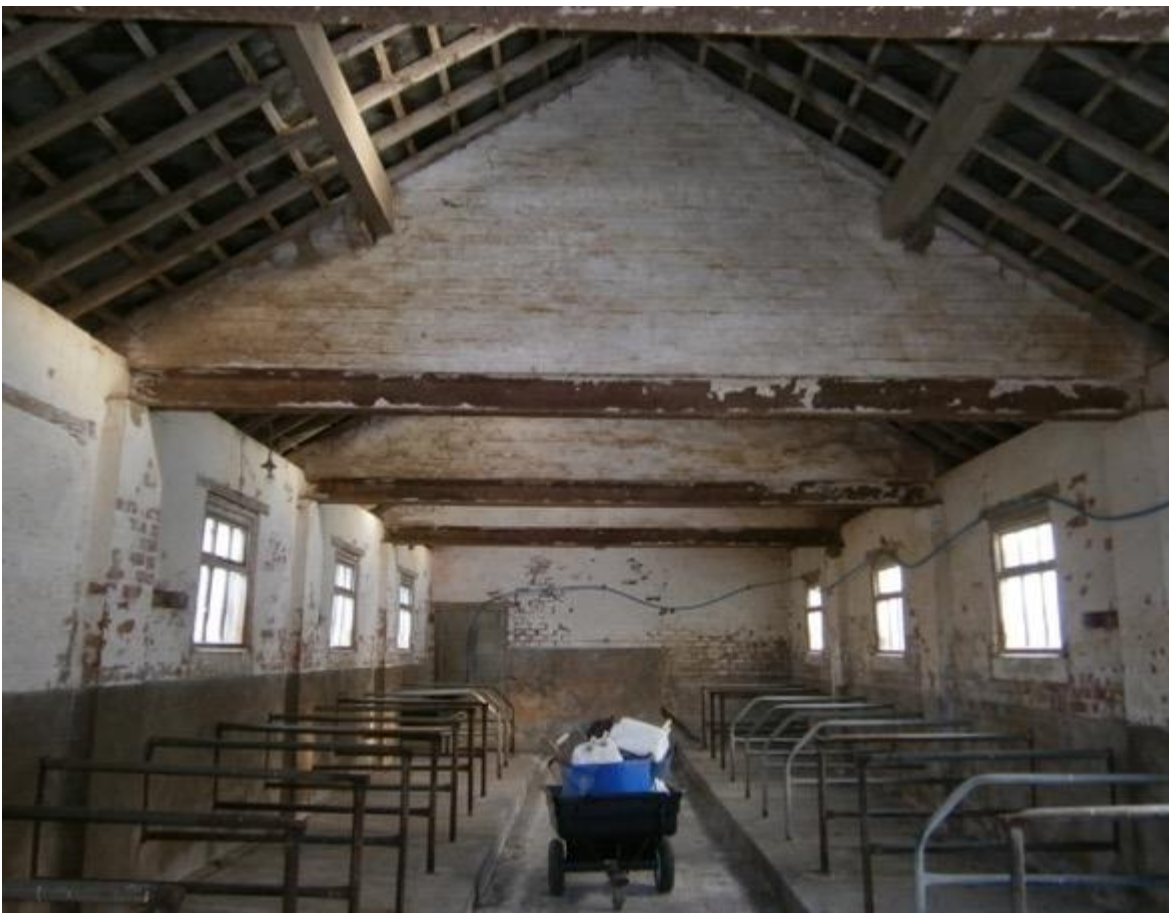
Photo 20 – Internal main section

The roof is slate on traditional rafters and purlins. In the main, upper section of the building it is further supported by brickwork carried on steel beams which in turn are sat on buttress sections within the elevations (photo 20). The roof is in reasonable condition with little sign of movement, rot or infestation. The roof will be re-constructed under the proposals but existing elements may be retained subject to structural checks and treatment for rot/infestation.

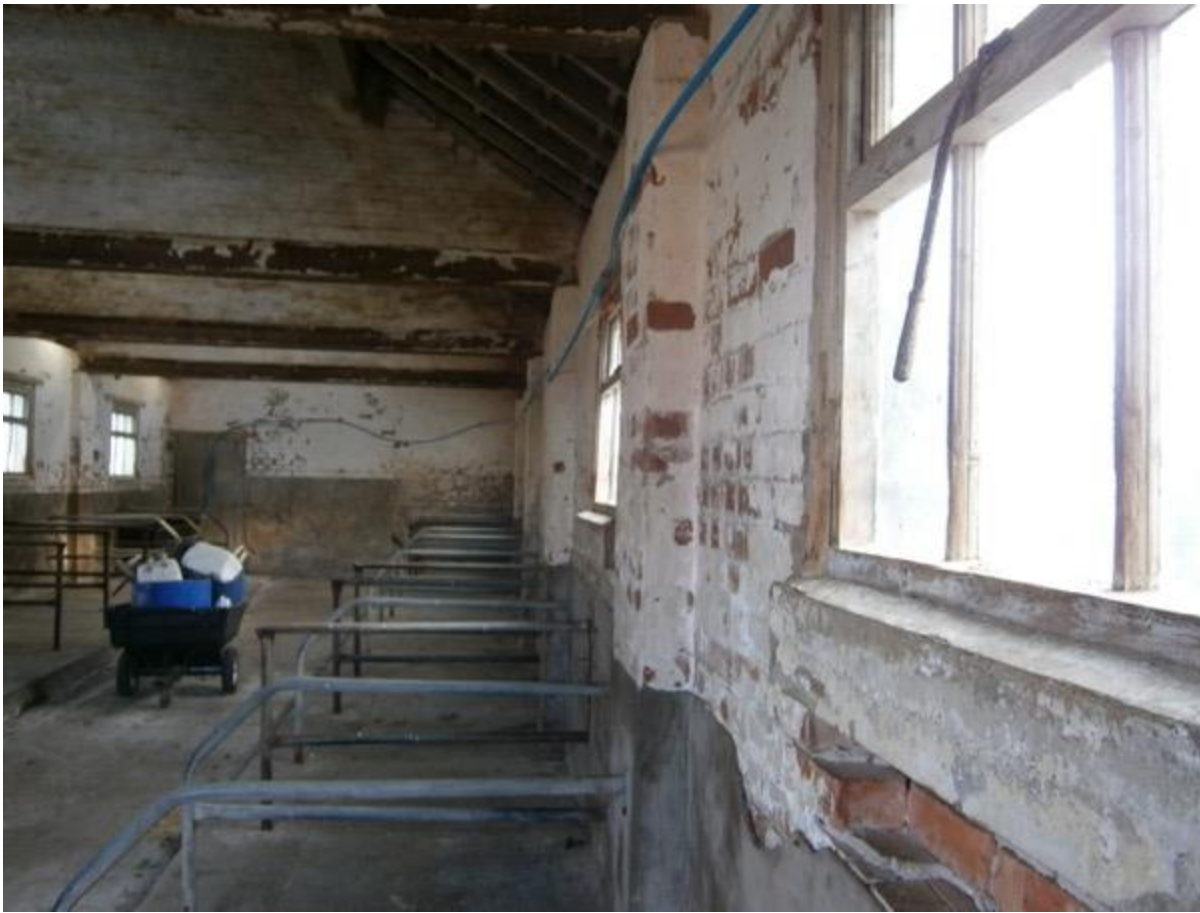
Photo 21 - Internal main section

The upper end of the barn is a large open area with stalls for cattle and a concrete floor. The walls to this area are all in good condition with rendering to the lower sections. There are buttress sections to carry the steel beams and brickwork supporting the purlins at regular intervals.

The timbers to the roof can be seen on the photos and show little or no sign of rot or infestation. The roof is to be reconstructed but some of the timbers may be re-used either structurally or cosmetically, subject to design checks and appropriate treatment.

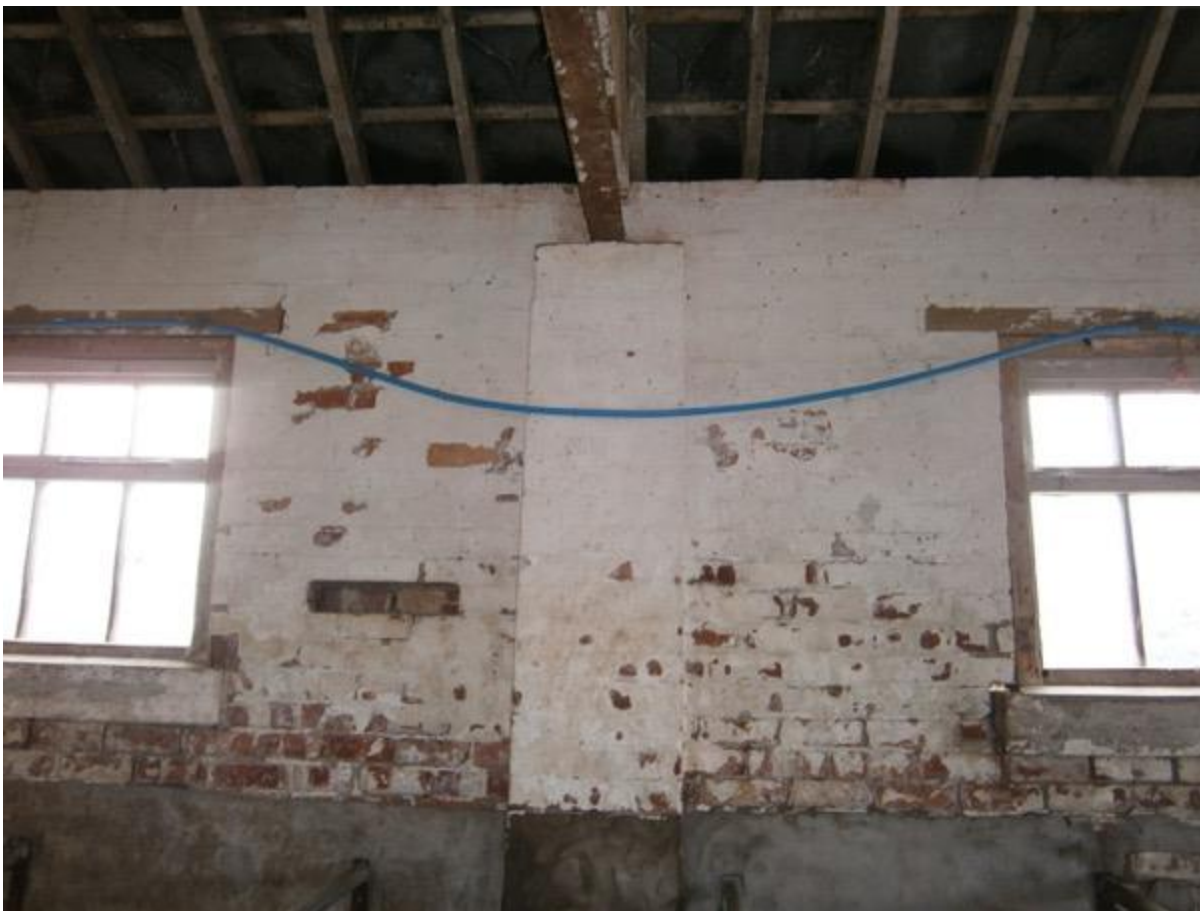
Photo 22 - Internal main section – showing buttress to beams
