**STRUCTURAL APPRAISAL
OF THE BARN
AT
STARTIFANTS FARM
LONGRIDGE ROAD
CHIPPING**

MR. & MRS. R. ROBINSON

J HADFIELD ENGINEERING SURVEYING
SPRINGS HOUSE, CHIPPING, LANCASHIRE. PR3 2GQ
Tel: 07740 929096 ~ Fax: 08708 362185

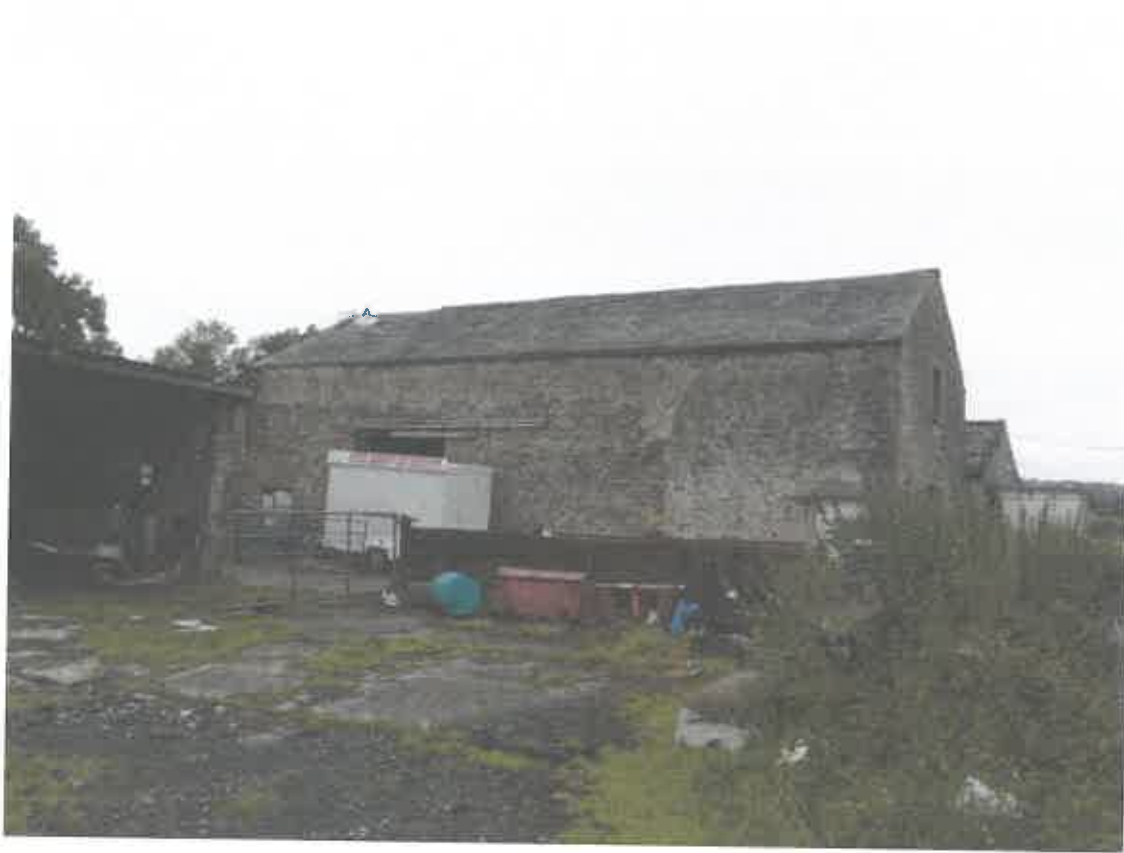
2.2.2 The barn is constructed of random rubble stonework, which although now weathered would originally have been flush pointed. The masonry to the west of the large barn door opening to the front elevation is very poor, having been badly weathered to the point of voids having developed across the stonework.

An outward lean of this section of masonry can also be detected, although being at its worst at high level, it is difficult to quantify accurately. It was estimated to be a maximum movement of 35mm in 1m, with the outward movement commencing at ground level.

The barn door opening has been formed by a very shallow arch of stone visors, which have a timber lintel below. The low level masonry to the eastern side of the barn door is in much better condition, although between the barn door and the pedestrian door at the eastern end of the elevation, evidence remains of what appears to be the lean to extension to the barn, with a visible step between the two sections of masonry of up to 50mm (see photograph 1).

1 : Photo of the front elevation.

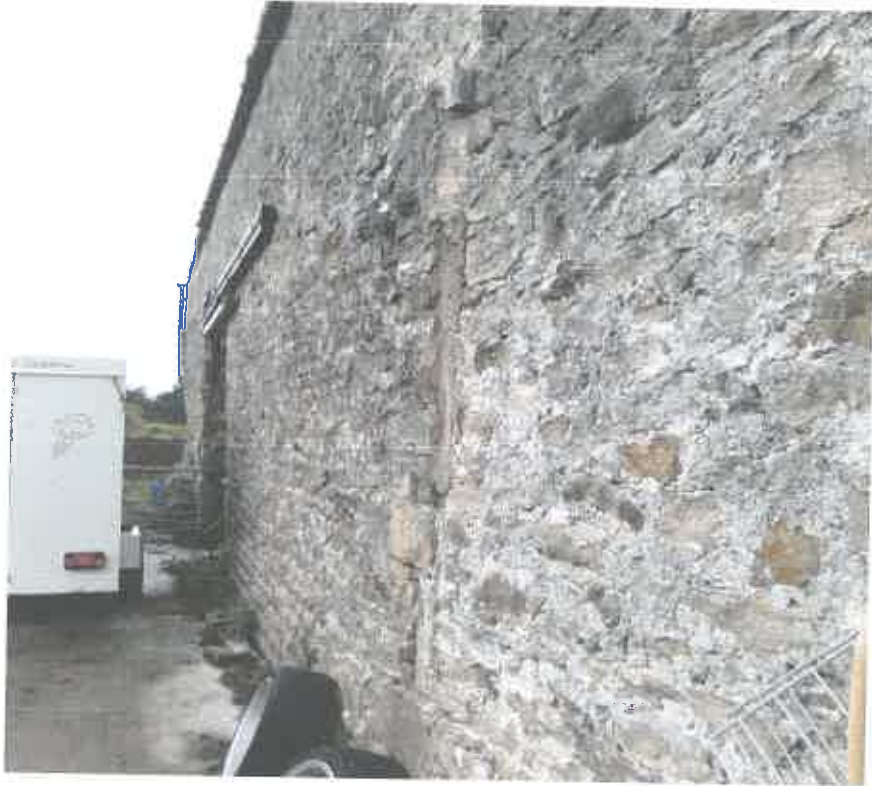
3.12 It is misleading to see the misalignment in the front & rear elevations are a defect as the inward / outward bulges to the rear and front elevations respectively, are considered to be the result of the way in which the barn was extended eastwards. (see appendix B, Photo 2)

The removal of high level quoins, removal of at least part of the roof covering, and the removal of the first floor masonry would have left a very unstable structure, even in the short term. That said, the step in the stonework to the front elevation would suggest that that of the original barn may have moved forwards prior to it being extended.

2a : Photo of Step in front elevation masonry

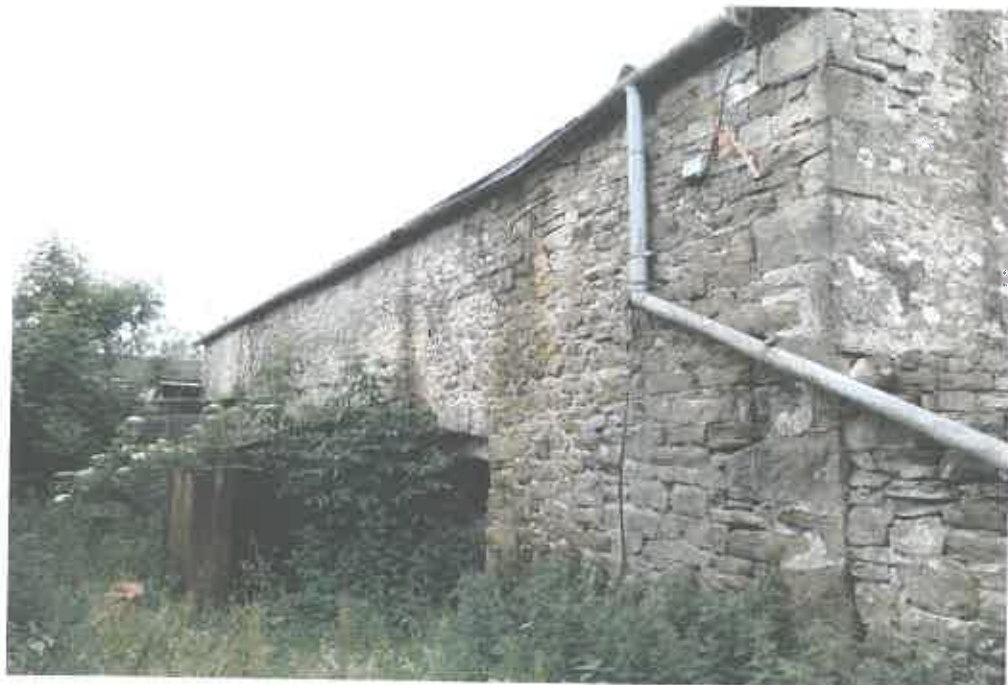
2.2.4 The eastern aspect of the rear elevation is difficult to assess in close detail as there is a dilapidated lean to and numerous semi-mature trees in close proximity to the wall. The centre of the rear elevation has noticeably distorted, with the upper part particularly water ingress due to the erosion of the pointing.

This area coincides with that on the front elevation where the barn was probably extended. The alignment of the front and rear walls is not correct and gives an impression of movement on the rear elevation though there is no sign of movement internally on the walls or roof structure components or where they join.

2b : Photo of Step in rear elevation masonry

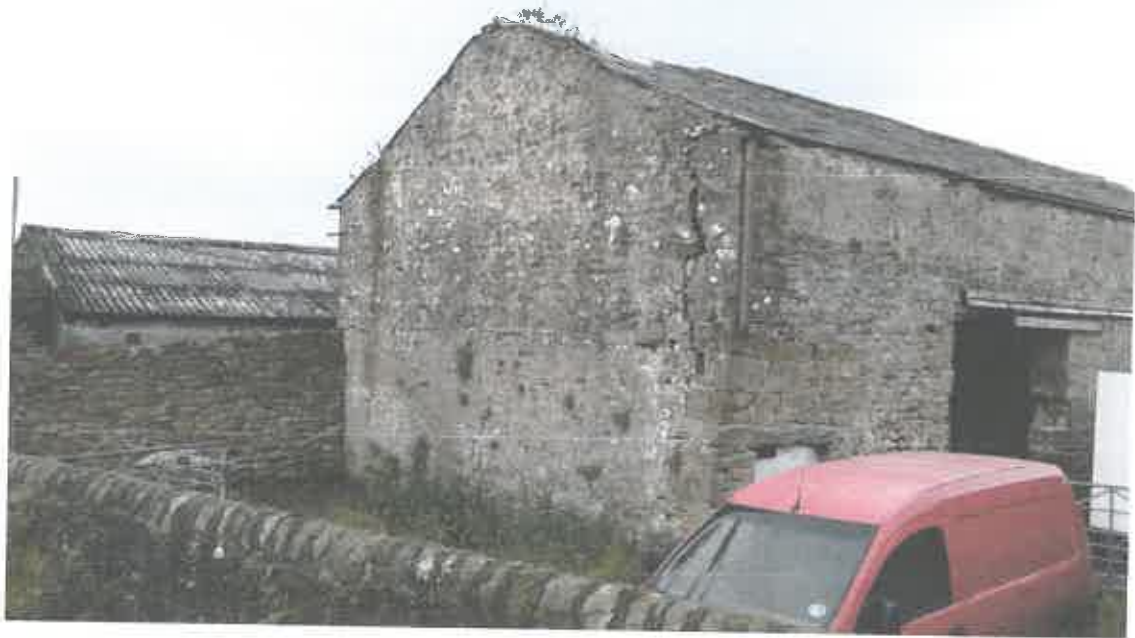
The gable is dominated by a crack where it should join to the front elevation which extends from approximately 1.5m above ground level up the eaves, and is estimated to be, at its most severe, 75mm in magnitude (see photograph 3). The movement has occurred between the quoins and the remaining gable stonework, and even extends over the uppermost quoin suggesting that the movement is entirely limited to the front elevation. Pockets were noted in the stonework at approximately 2m above ground level, where timbers were previously seated to form the lean-to adjacent to the barn. Again, no fascia boards are present along the roof line, and the stonework below the missing slates to the front elevation is particularly uneven.

The position of the crack to the eastern gable is further indication of poor tying between the perpendicular walls, common when this type of rounded rubble stone is used in construction, and the outward movement is clearly limited to just the front elevation. (see appendix B, Photo 3 a, b & c)

3a : Photo of West gable.

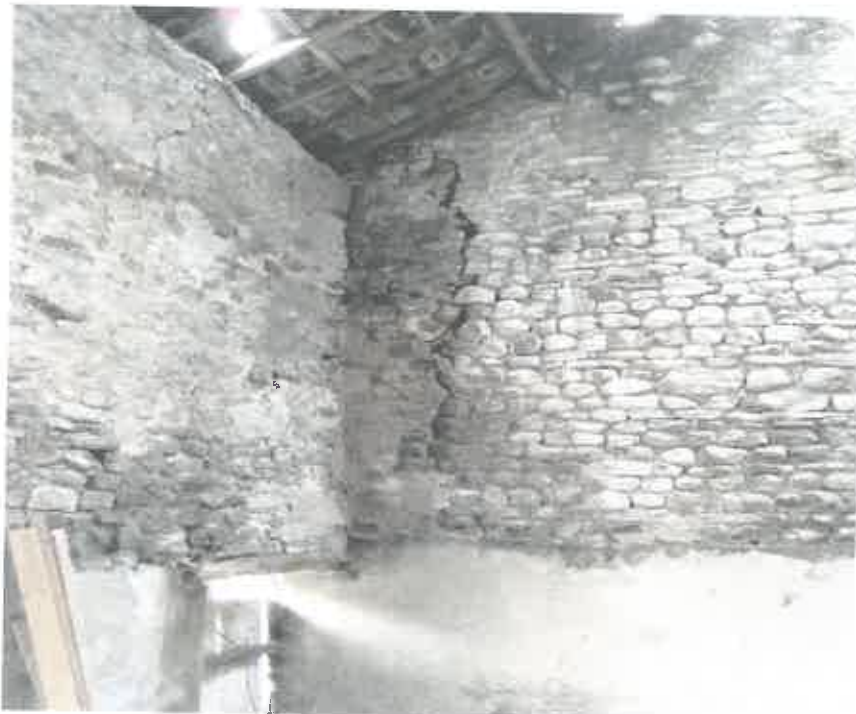
2.3.3 There is poor bonding of the perpendicular walls internally, and much of the internal masonry is formed from rounded cobble-type stones. The movement noted to the western gable is also visible internally, albeit not to the same extent.

3b : Photo of West gable (Internally)

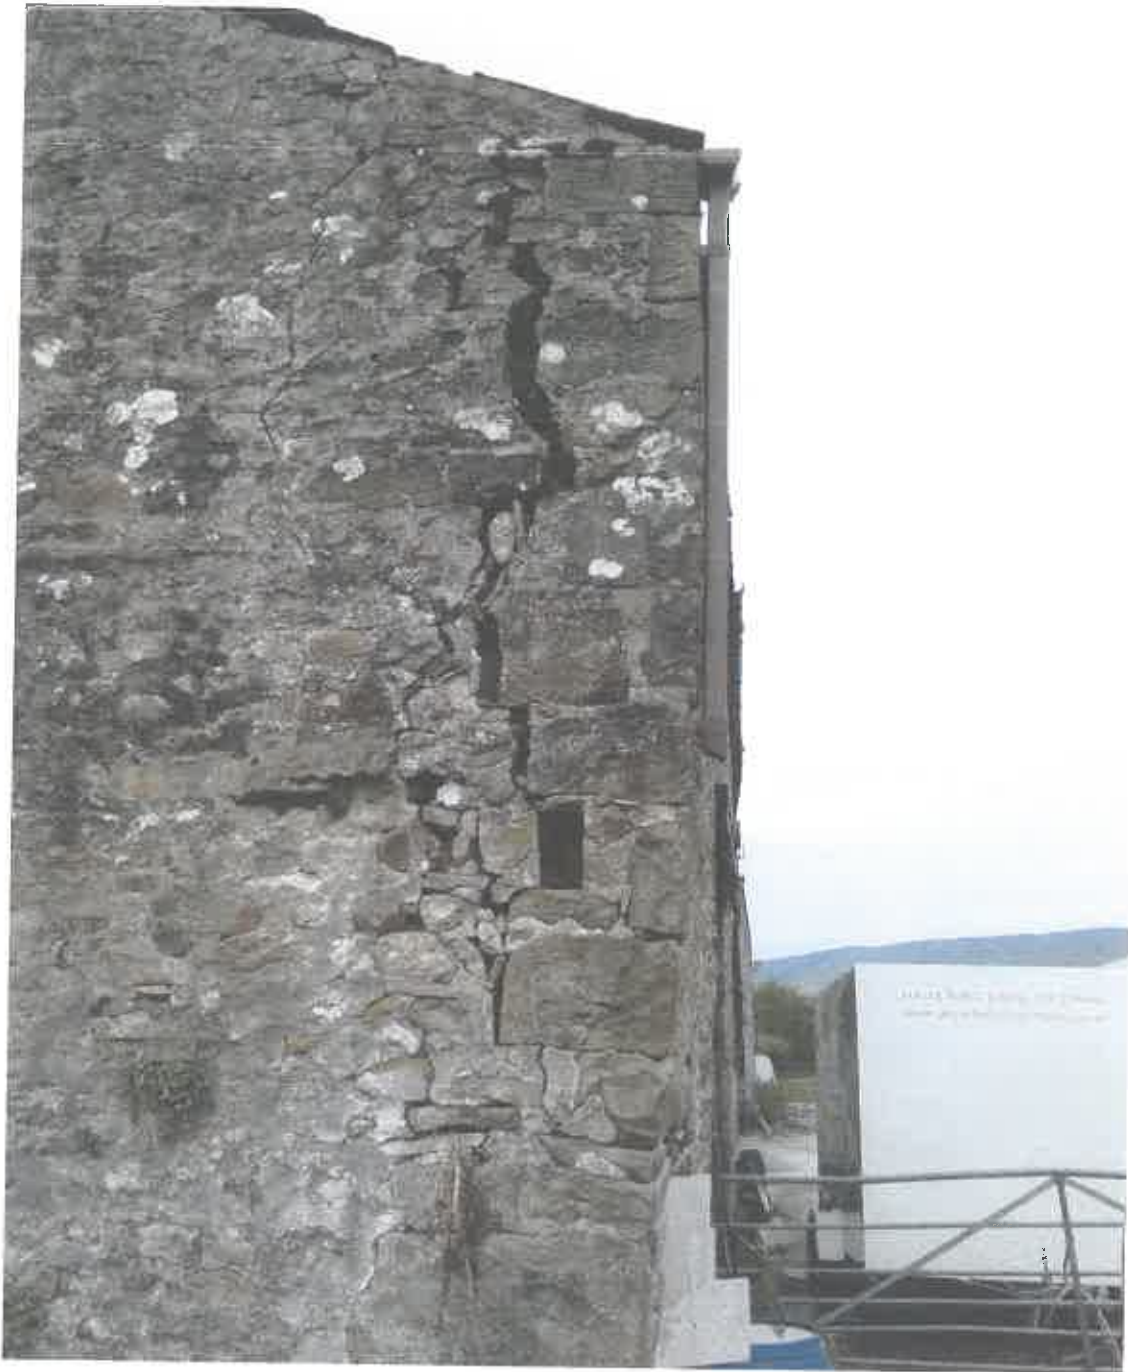
3c : Photo of West gable.

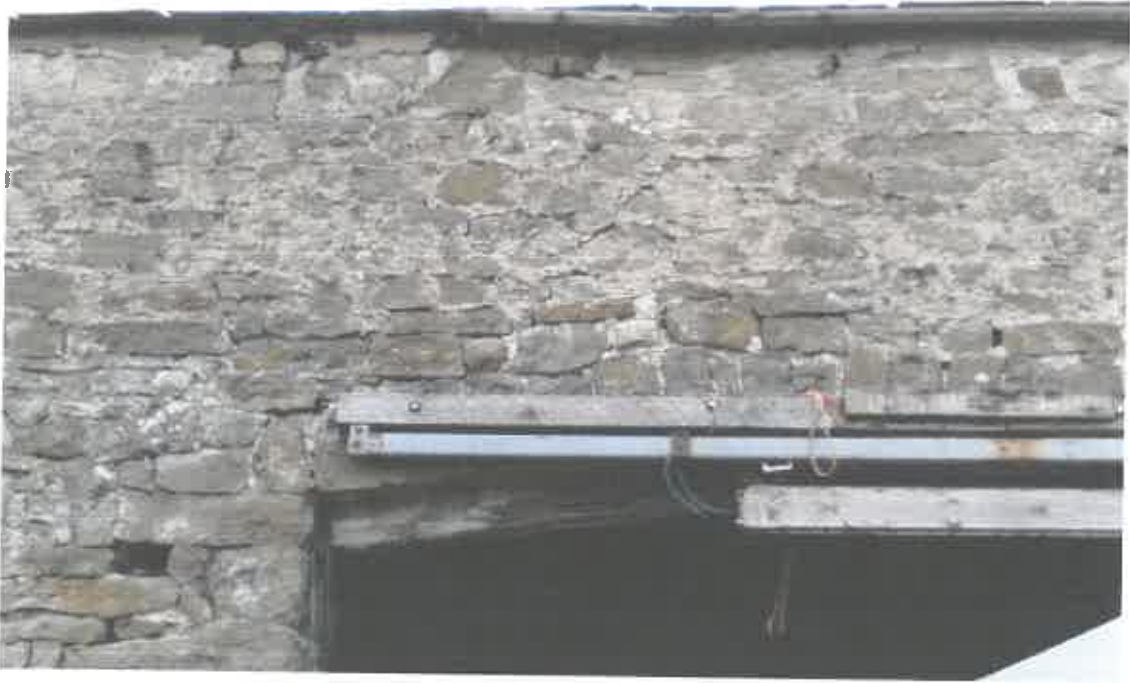
The installation of the timber lintel below the stone arch is an unusual arrangement, however given the shallow nature of the arch, it is unsurprising that an additional support to the opening was required. This lintel was noted to have wood boring insect damage, and diagonal cracking to the masonry above would suggest that some deflection of the lintel has occurred.

Although there is little evidence of the arch having dropped externally, the addition of the timber beam below is an unusual step, but probably a necessary one to support what is inherently a weak structure. The existing stone voussoir's could be reused if required. (see appendix B, Photo 4)

4 : Photo of Front elevation arched door-way.

3.15 We would recommend that the nominal arch to the main barn door opening be rebuilt with a galvanised right angled lintel hidden behind to give additional support.

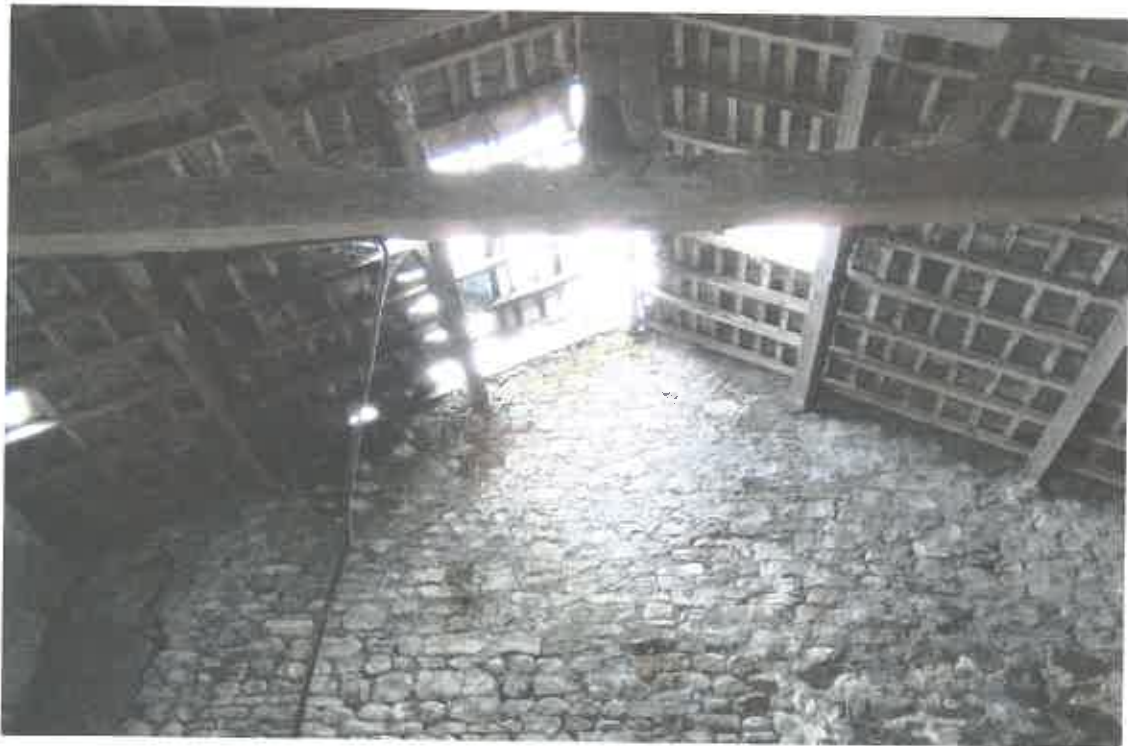
2.3.1 The roof of the barn is of timber rafters bearing onto two lines of timber purlins per pitch and a ridge board. The purlins in turn are supported off the gable walls and three timber kingpost-type trusses. Whilst close inspection of the westerly timbers was not possible, they do not appear to be suffering from wet rot or any noticeable wood boring insect damage as neither is the truss that can be inspected from the first floor loft area.

The purlins are slender, and although they are not noticeably deflecting, despite those below the void in the roof being wet, they are unlikely to be suitable for retention. (see appendix B, photo 5 a & b)

5a : Photo of internal roof structure – East gable end

3.16 Consideration should be given at Building Regulations stage to allow sufficient headroom to accommodate the retention of the existing trusses.

Aside from requiring treatment for wood boring insects, the timbers do appear to be in good condition, and as they are supporting a slated roof now, there will be little increase in load on the structure once it is converted. Given that the purlins are slender (and some affected with wet rot) it is unlikely that these could be retained, and the rafters will require replacement in order to accommodate the necessary insulation.

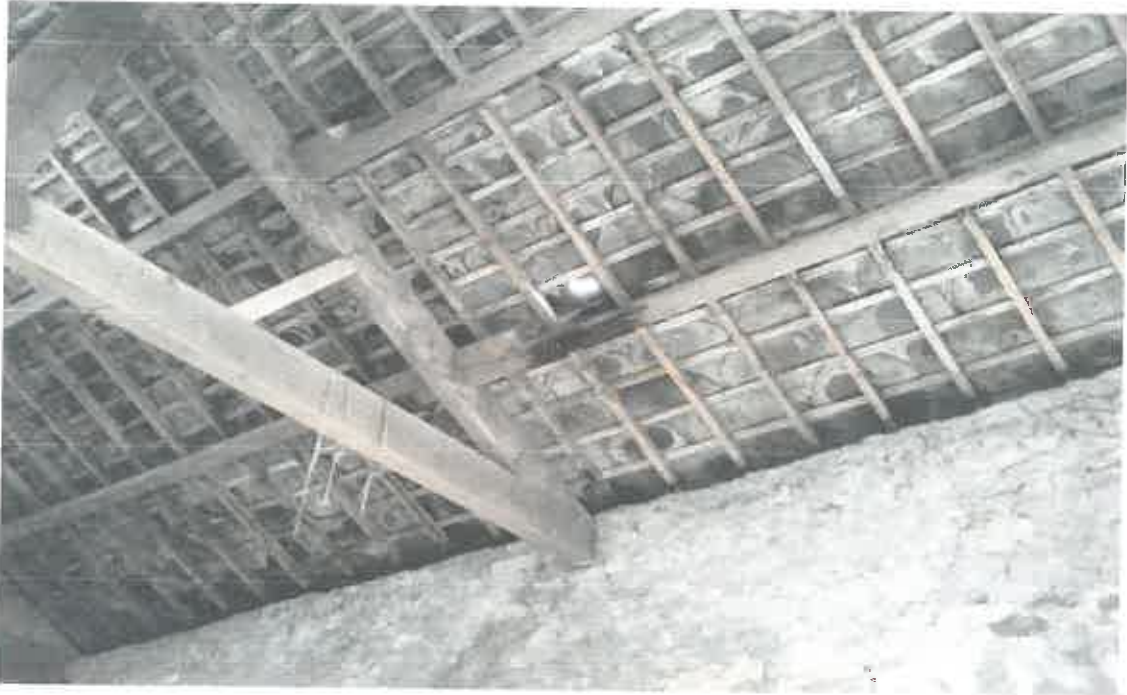
5b : Photo of internal roof structure – West gable end
