**Re: Structural Condition Report of the Barn Slated Laithe, off Paa Lane,  
Paythorne, Clitheroe**

### **Terms of Reference**

At the request of Mr J. Athay I have carried-out a visual, structural inspection for the titled property with consideration for converting the existing barn into three-bedroomed family home The inspection was undertaken on 11 November 2017.

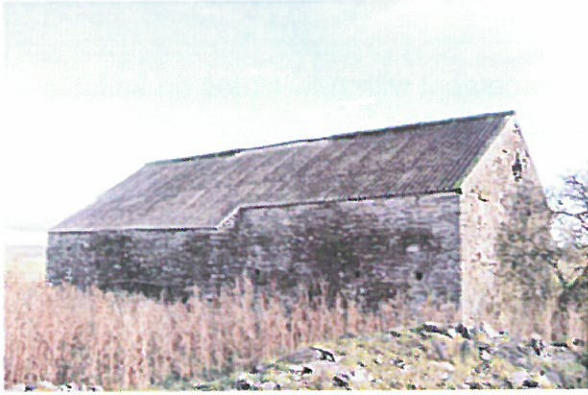
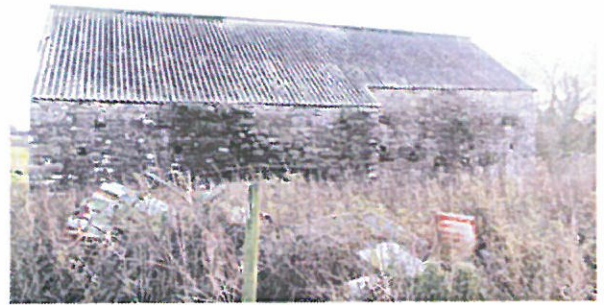
Plates 1 and 2 Illustrating the North-West elevation

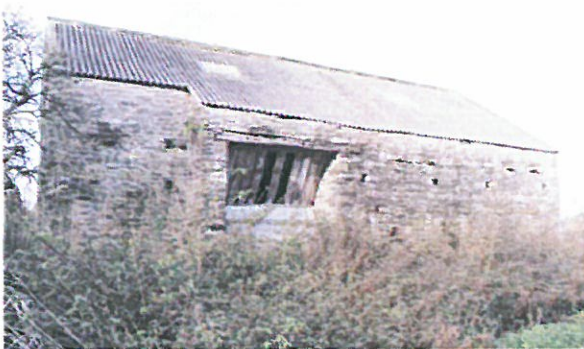
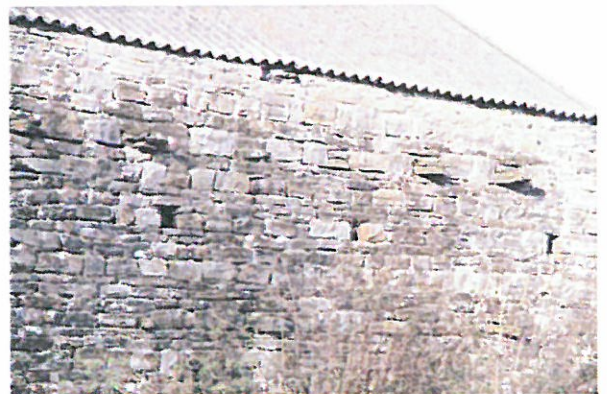
Plates 6.and 7 Illustrating the view of the South-East elevation

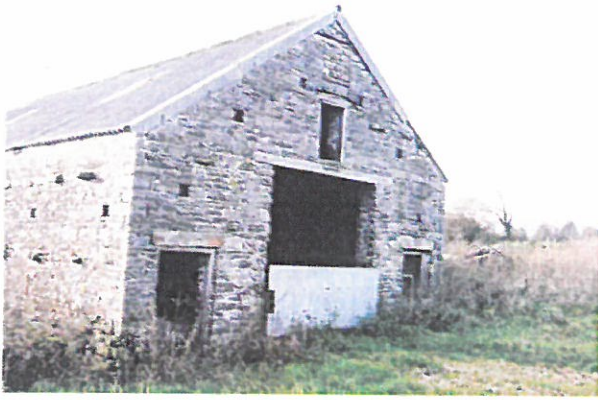
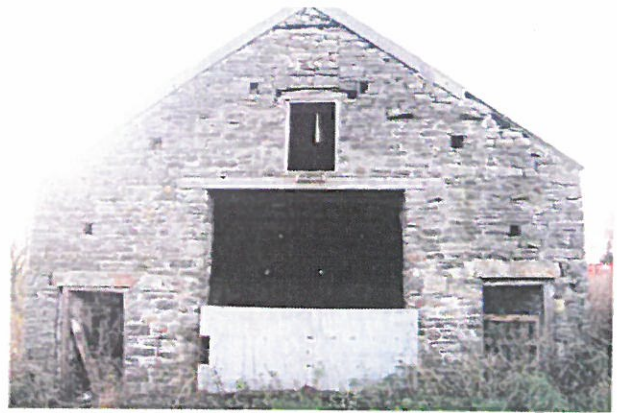
Plates 8.and 9 Illustrating the North-East elevation

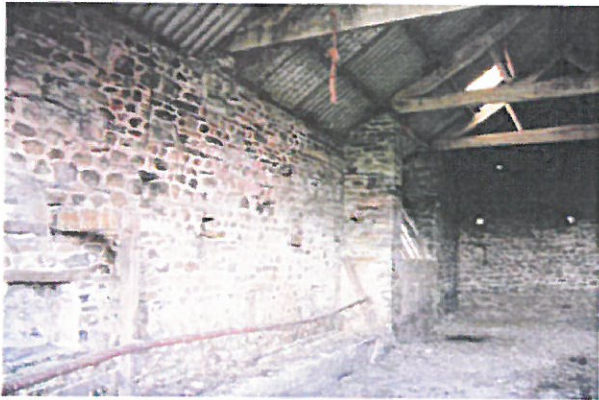
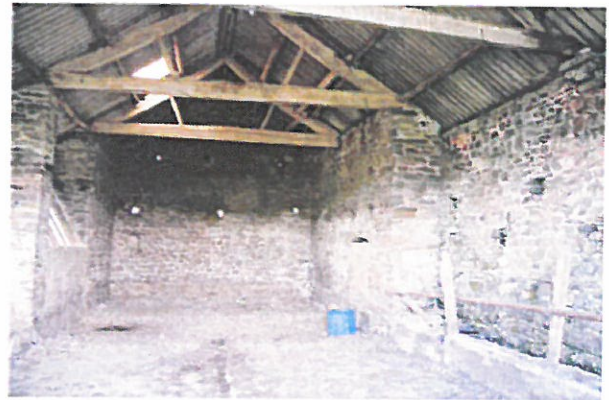
Plates 10 and 11.  
Illustrating the internal layout looking towards the South-West Gable

The existing roof covering will need complete, replacement with new slates on suitable felt on new timber rafters and purlins, appropriately insulated, Provision of guttering and rainwater pipes will prevent future deterioration of the external walls.
