Ecological Advice Note: 12 Somerset Avenue

Bowland Ecology Ltd was commissioned by Chelsea Leach to complete a daytime internal and external building inspection for bats of a single storey residential property at 12 Somerset Avenue, Clitheroe. Planning permission is sought for extension works to the property.

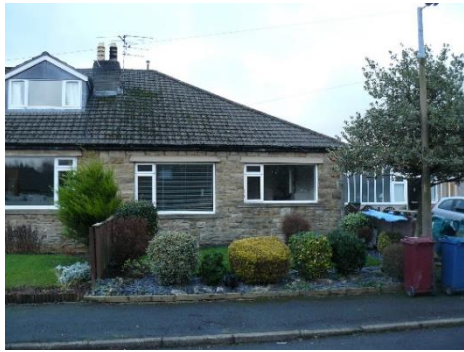
Figure 1: Western elevation

The western elevation forms the front of the house with stone cladding and two windows. A wooden fascia board and soffit runs around the base of the roof, beneath plastic guttering. There are no gaps within the stonework, window frames or within the fascia board and soffits providing potential roosting features for bats (PRF). The roof appears to be in moderate condition with no missing or lifted tiles. However, the shape of the tiles provides a small gap underneath which may provide a PRF.

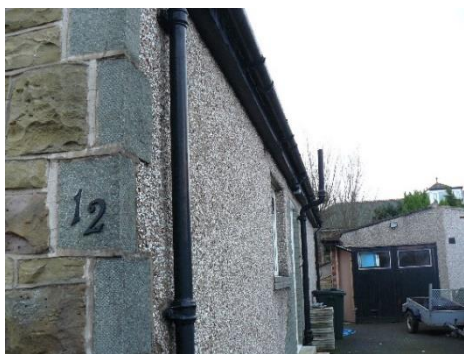
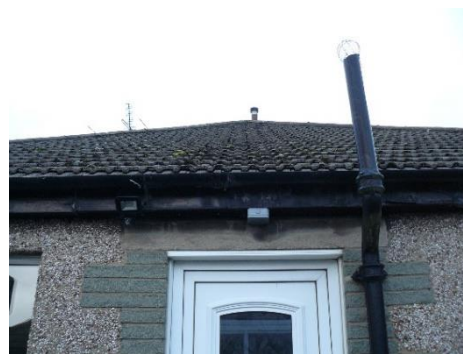
Figure 3: Southern elevation

The southern elevation comprises the properties front door and two small windows with the eastern elevation comprising two large windows. The walls of both elevations have a pebble-dash render with no gaps or crevices observed. The fascia board, soffits and window frames are in a moderate condition with no gaps allowing internal access for bats. The roof appears to be in moderate condition with no missing or lifted tiles. However, the shape of the tiles provides a small gap underneath which may provide a PRF.

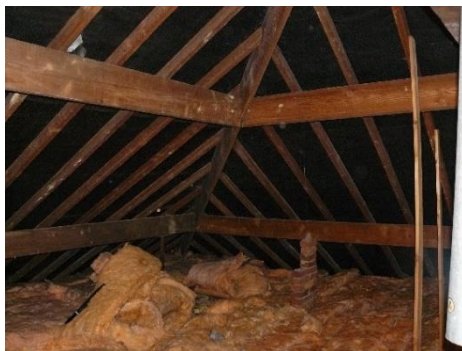
Figure 7: Loft space

The loft area comprises the entire roof space, with a layer of insulation throughout. The vertical wall separating the property from the adjoining property comprises breezeblock and brick (Figure 8). The roof is constructed of timber beams and rafters with a lining between these and the tiles (Figure 7). The lining is mostly in good condition, however a number of small holes were observed within the roofs southern elevation (Figure 10). The cause of these holes is unknown, however it is likely that they were created to investigate the roof construction prior to the proposed works. A small hole in the roof tile at the location of one of these holes was observed, potentially allowing bats to access to the loft area. Furthermore, with the lights off, daylight was observed at the base of the roofs eastern elevation, suggesting that a gap allowing potential internal access for bats is present at this location.

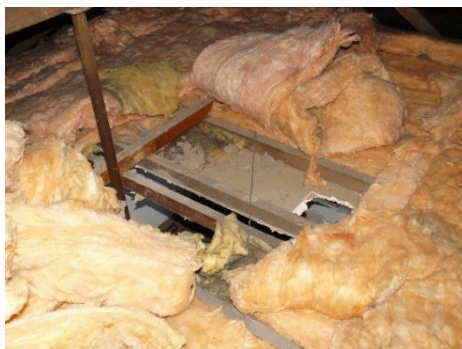
A large hole in the floor of the loft space was observed above the room at the south-western corner of the property (Figure 9). Construction works are currently underway within ground floor rooms and is likely to cause light and noise disturbance to the loft area. In addition, the property is currently occupied providing further disturbance. Furthermore, the large gap in insulation will create fluctuating temperature conditions further reducing the suitability for roosting bats, including for hibernation.

Figure 9: Hole in floor of loft space

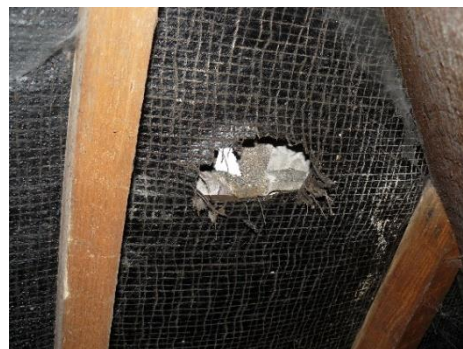
Figure 10: Hole in roof lining
